# **Routine Thrice-yearly Inspection Report #8**

## **Keats Landing Keats Island, BC**

Date on Site: May 31st 2022  
Report Submitted: July 18, 2022

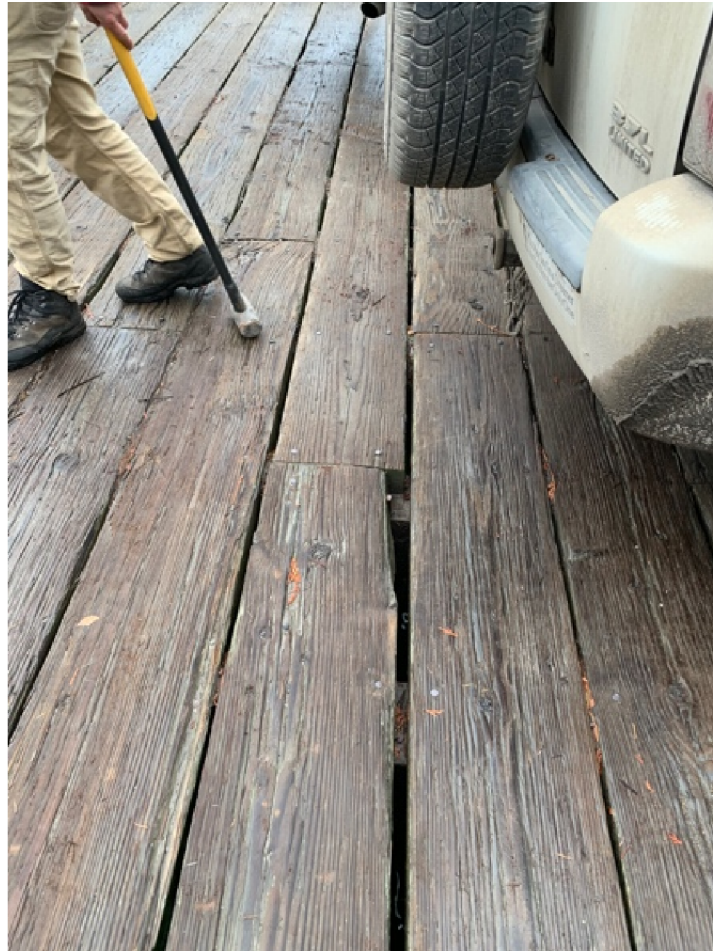
- (from Previous Inspection) Some large gaps 1"+ between boards and uneven deck surface. (continue to monitor)

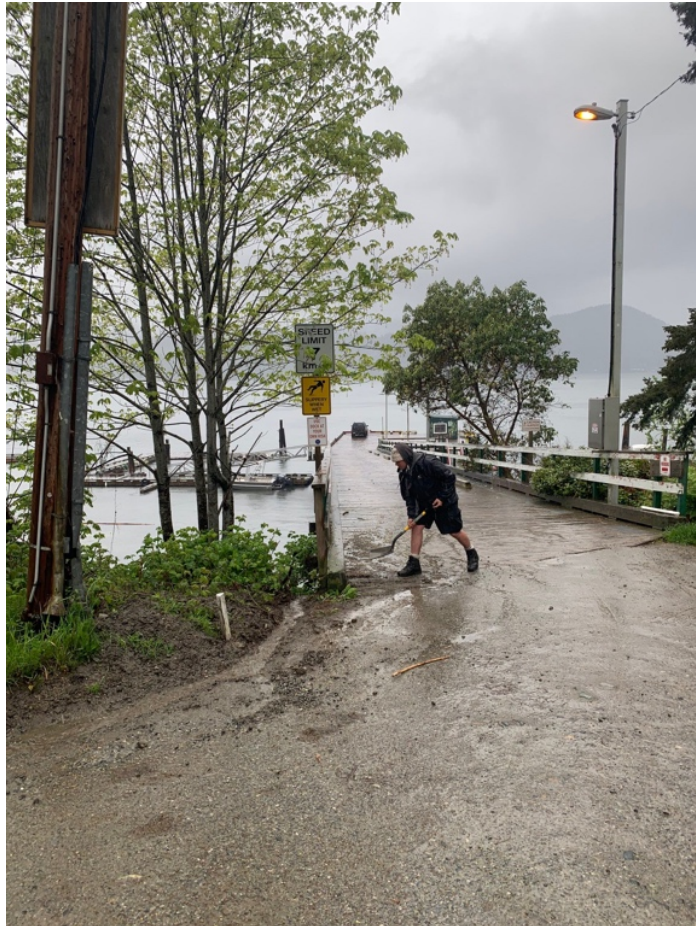
- The wharf head still requires pressure washing at the next opportunity when there are fewer cars on deck. Approved, deferred due to time limitations.
- Rains are continuing to bring sediment onto the approach, the temporary ditch was deepened to promote better drainage. All vegetation and a larger trench dug on the uphill side will extend the life of the wharf significantly. Recommend adding trench drain at the approach entry.

<i>Work Item</i>	<i>Description</i>	<i>SCRD Contract Category</i>	<i>Status</i>
K13	Review Pile footing upgrade with engineer		
K14	Bolt replacement 10A&B, 12A, 13		
K15	Shed to be upgraded, or paint over graffiti.		
K16	Consider upgrade options for the gangway and hinges		
K17	Replace one fiberglass billet on float which has failed beyond repair		
K18	New transition ramp at the bottom of gangway		
K19	Consider drainage ditch at approach entry to reduce debris flow

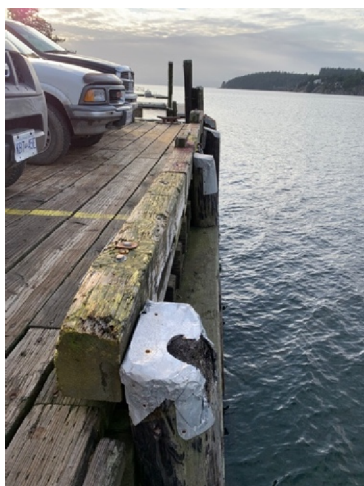
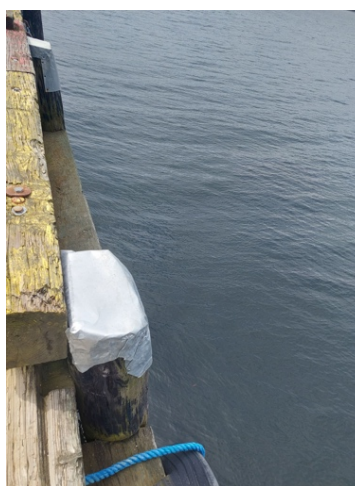
- (From previous inspection April 2019) Red and yellow caution paint requires touchups on Wharfhead curb rail. (Deferred)
- 2 Aluminum top caps were replaced during round 8

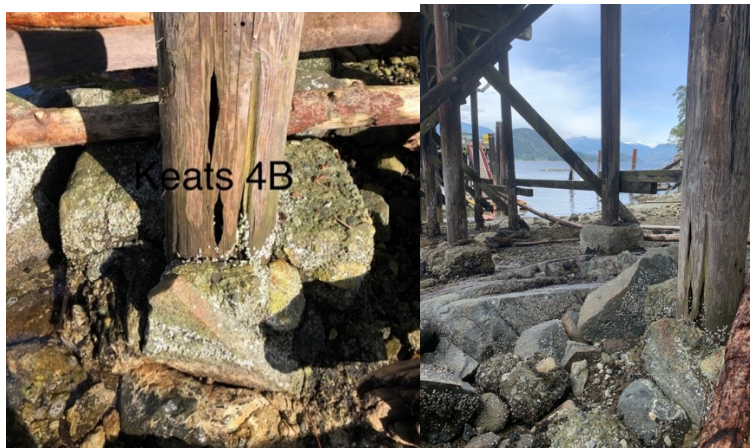
Several pile footings (see locations below) are showing significant wear and are undercut, should be reviewed by an engineer.

- **Bent 2** (From Previous inspection January 2021) is a small diameter pile and footings are getting undermined. Recommended to have Herold Engineering review
- **Bent 3** Pile 3A need new bolt on Cross brace
- **Bent 4** (From Previous Inspection May 2021) Piles 4B concrete footing is showing significant deterioration. Almost half missing. Also loose bolt on lateral brace.
  - Herold Engineering to review photo below and advise on remediation.
  - Tighten lateral brace bolts

Herold Engineering to review and advise on the existing condition of the pile footings at Bents 3,4 & 5 as noted in this report and the loose lateral cross brace located at pile 14E. Gangway condition is deteriorated, consider upgrade options. Pile well wear strips require attention, unless entire float is to be replaced.

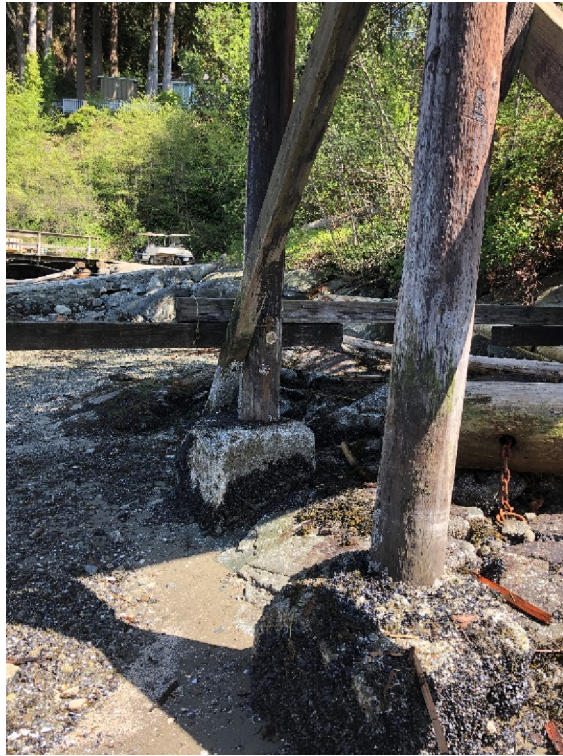
- **Bent 5** (From previous inspection September 2019) Piles @ Bent 5 installed on concrete footings which are showing deterioration (30% failed on 5A) and possible movement. Loose bolt on Lateral Brace and cross brace similar to Bent 4
  - Herald Engineering to review photos and advise on remediation for footings
  - Tighten lateral brace bolts

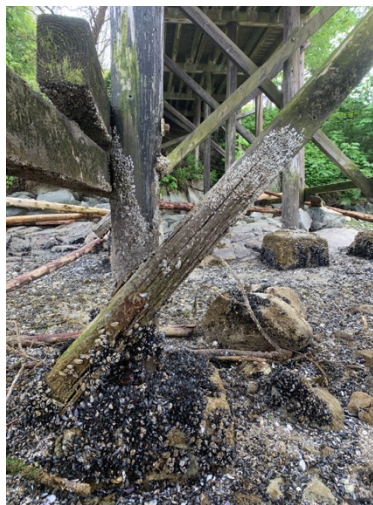
- **Bent 6** Pile 6A rotting, multiple holes in Pile. Lower 6C needs new bolt. 30% of crossbrace has failed

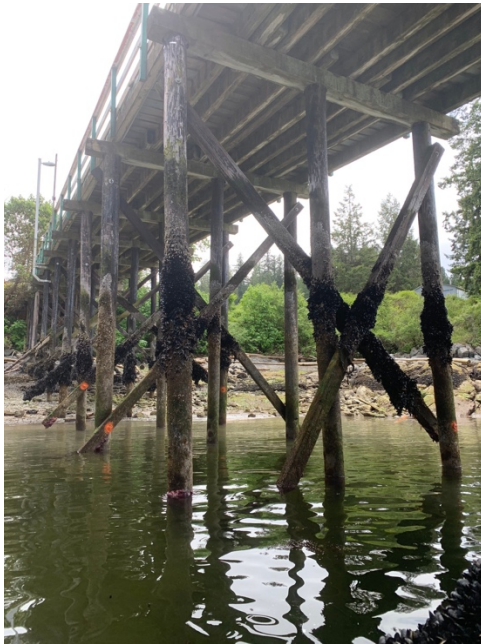
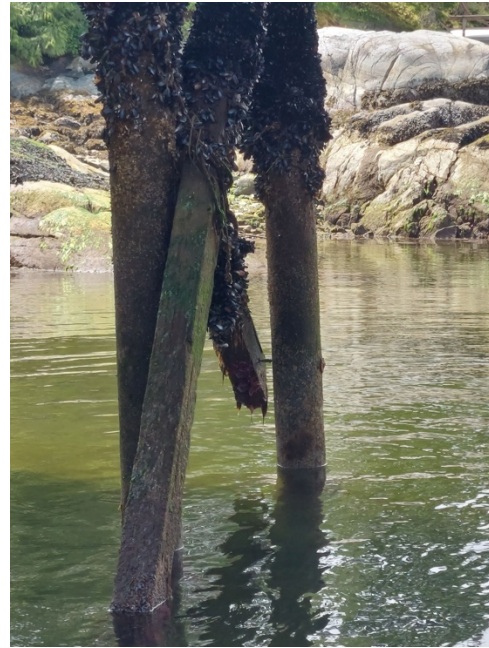
- **Bent 7** Needs New Bolt on crossbrace.

Spray paint applied on site to damage, indicates bolts that need replacing.

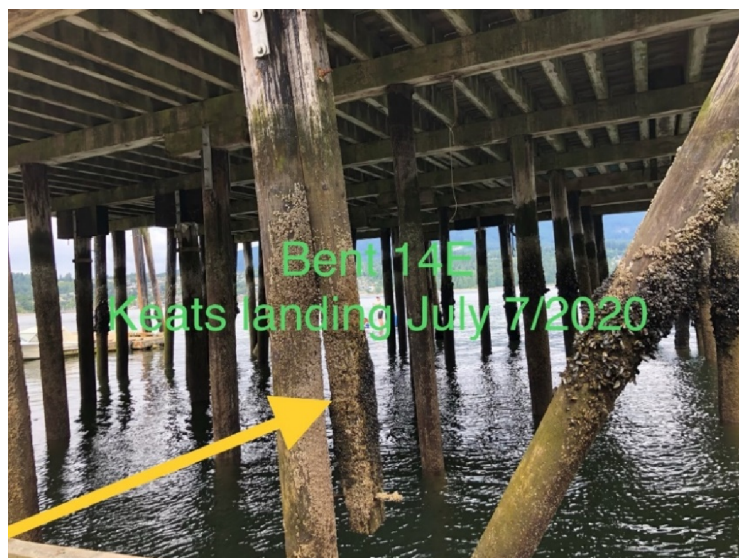
- **Bent 9** (From Previous Inspection May 2021) Pile 9B has a rusting bolt.
  - Monitor at future inspections
- **Bent 10** 10B Bolt rusting. Bolt on 10 B needs new bolt, 10A will need replacing soon also.
- **Bent 11** 11C lower cross brace bolt needs replacing
- **Bent 12. Lower Cross brace has failed (12A lower Bolt failed),** 12B mid cross brace bolt failed. 2' Tide needed when replacing bolts.
- **Bent 13** Appears to have broken cross brace or bolt
  - Inspect and create action plan during next inspection, low tide required
- **Bent 14** (From previous Inspection May 2021) Broken cross brace with slight damage to fender pile and rusted bolt. (Mid-low tide removal recommended)
  - Consult with Herold Engineering to confirm if brace is required.

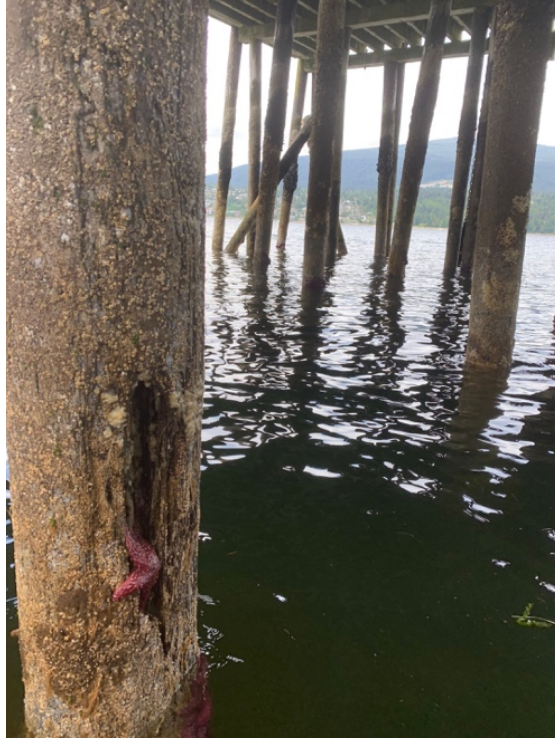
- **Bent 15** Monitor rot in Pile 15D

- (From Previous Inspection) Wharfhead corner brace batter pile at Bent 15 between Row E & F appears to be loose at the bottom.
- Dive inspection recommended to determine underwater condition of batter piles. Engineer to review and advise on findings
- Cracks in upper Pile 15C. (Banded during round 7)

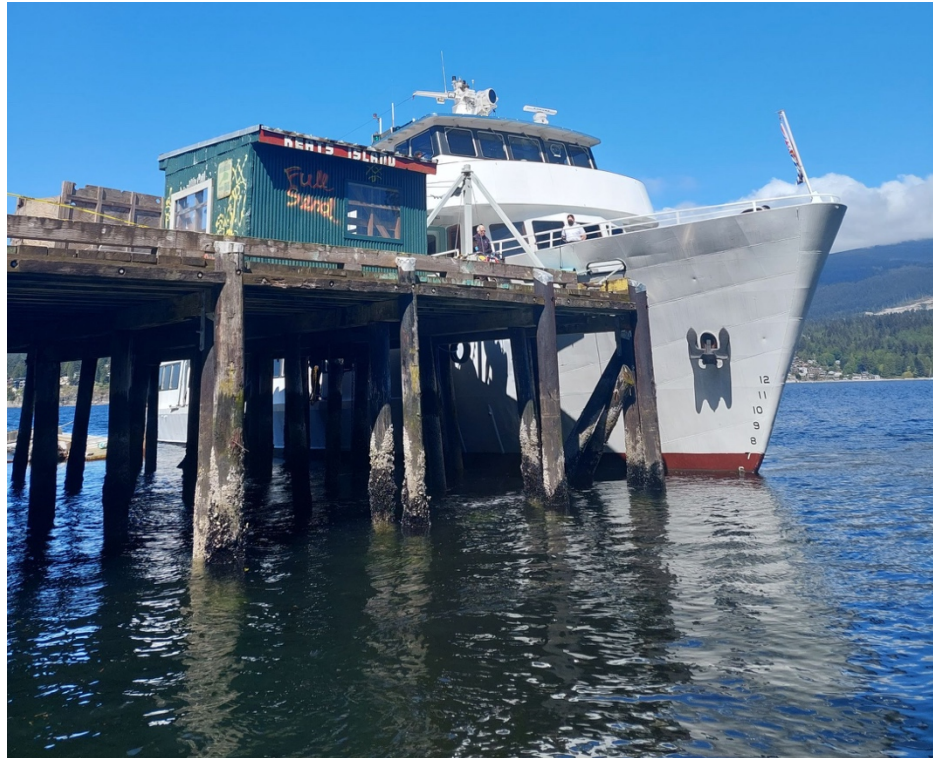
- (From previous inspection April 2019) Metal wall cladding and fascia trim showing some signs of wear and damage, but generally in serviceable condition.
- Graffiti on Shed. Recommend either pressure wash or repainting shed.

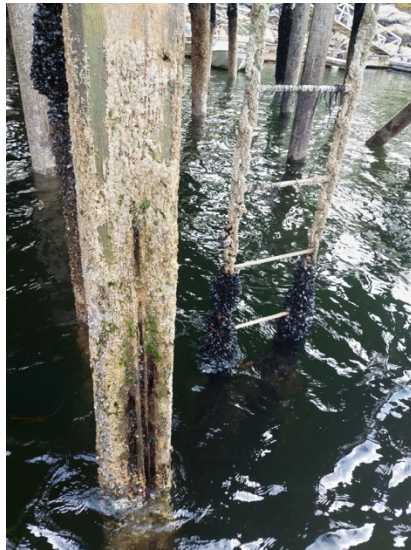
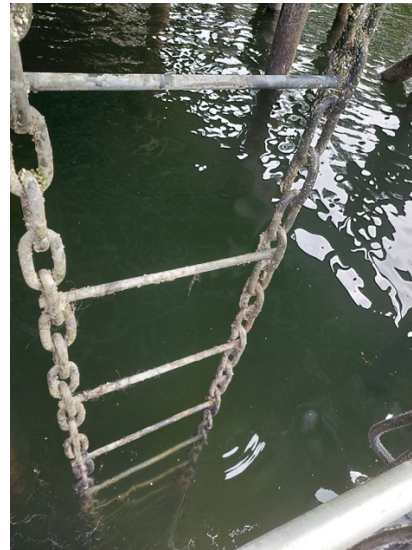
- (From Previous Inspection May 2021) Eyebolts beginning to rust. (Monitor)
- Ladder was cleaned during inspection round 8

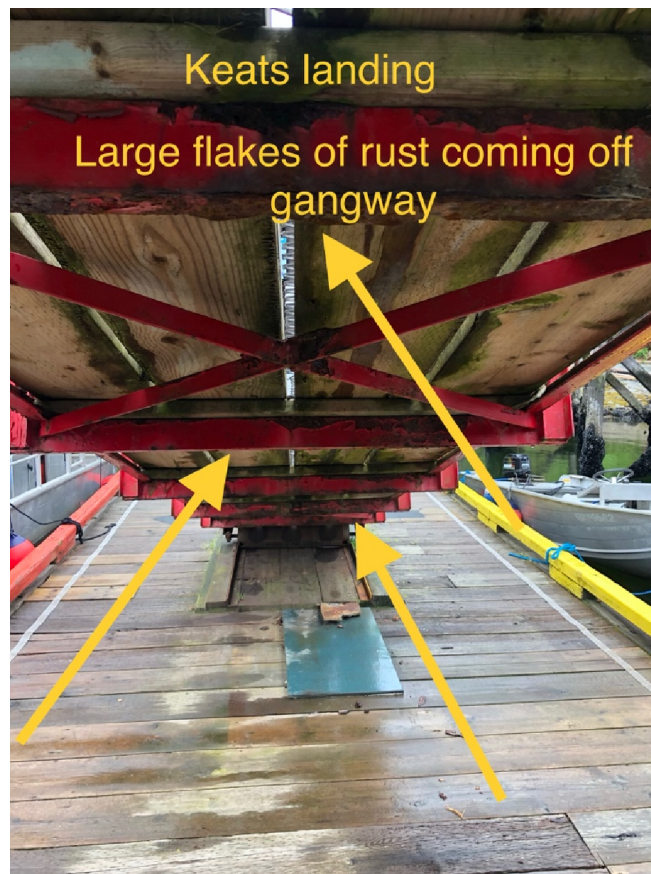
- (From Previous Inspection May 2021) Generally, in reasonable condition, photos show some rust below, possibly undermining structural integrity. Recommend consulting with Herold Engineering, and/or discuss upgrades soon.

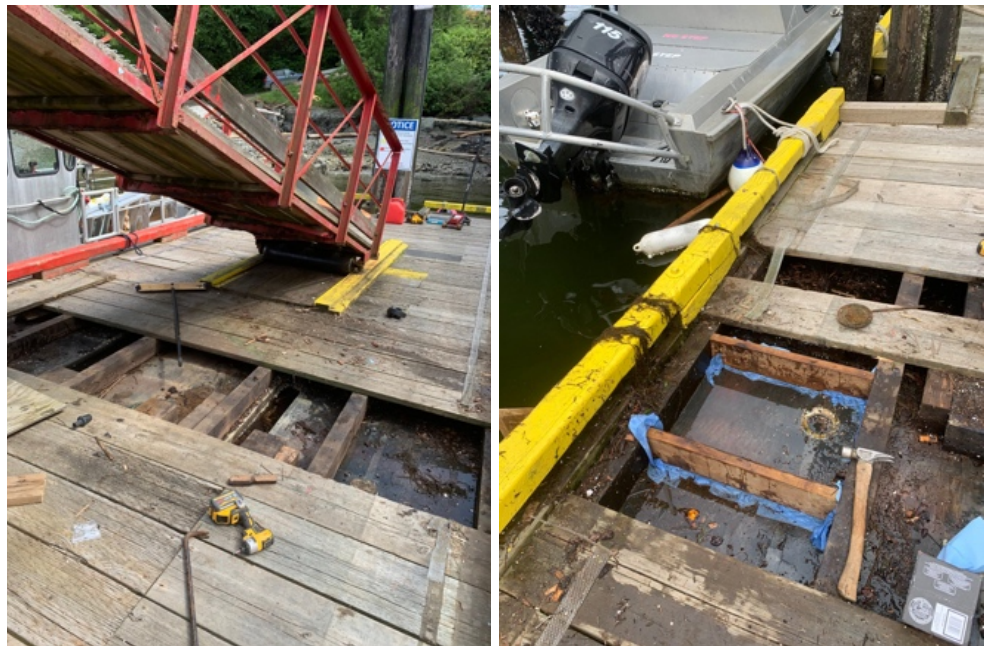
- This float needs attention and or replacing. The float is sagging significantly in the middle towards north west side. We pumped all 3 billets in sagged location to discover the Western most billet has a significant hole in it and needs replacing. Deckboards that need to be removed to access billets were spraypainted for referencing.

West side of float, fiberglass billet failed. Not repairable

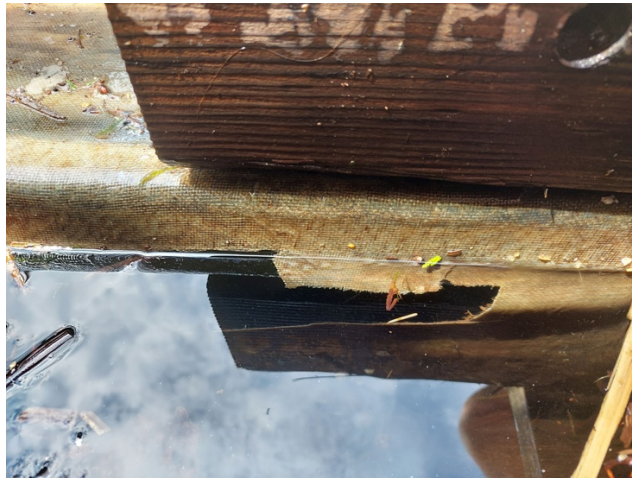
West side of float, fiberglass billet failed. Not repairable

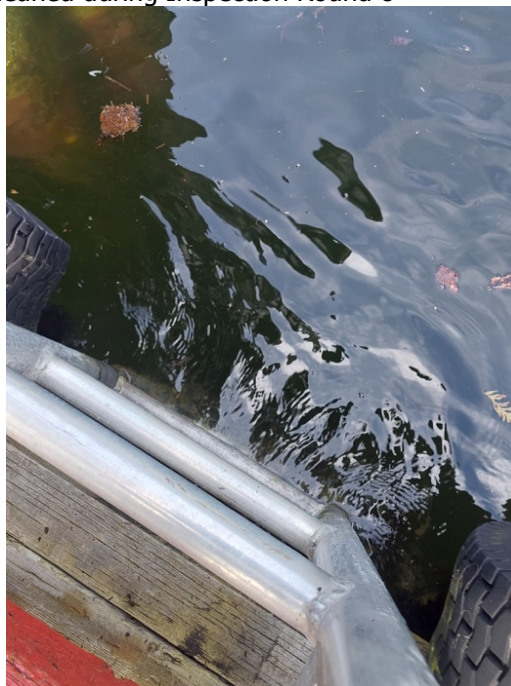
Float ladder was cleaned during Inspection Round 8
