Potable Water Reservoir Inspection: Egmont

Inspection Date: June 29th, 2023

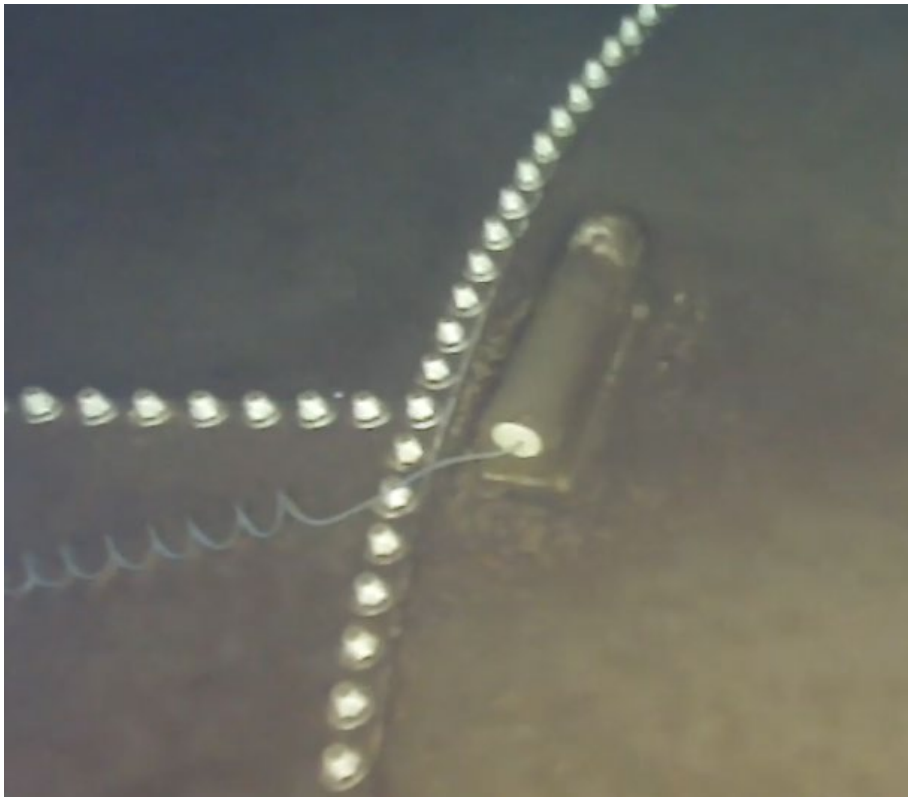
Inspection Conclusion
