Reference: Sir Thomas Lipton Park Bridge Inspection Program

We are pleased to submit our draft letter for the Sir Thomas Lipton Park Bridge Inspection Program. This program includes the inspection of three timber pedestrian bridges located in Sir Thomas Lipton Park on Gambier Island: East Creek Bridge, MacDonald Creek Bridge and West Creek Bridge.

Structure Name: East Creek Bridge

PROJECT : 31256 NAME: East Creek Bridge

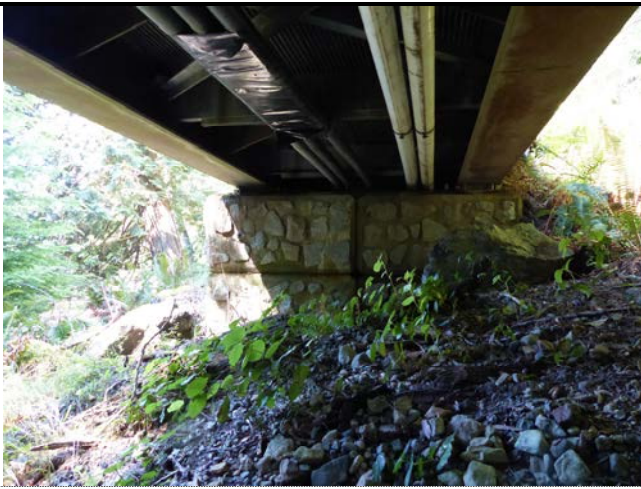
001 – Lock Block Foundation at West end of Bridge (B.1)

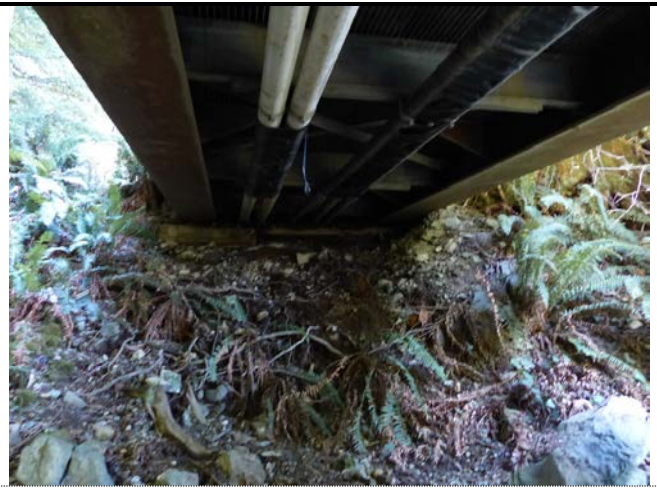
002 – Foundation at East End of Bridge (B.1)

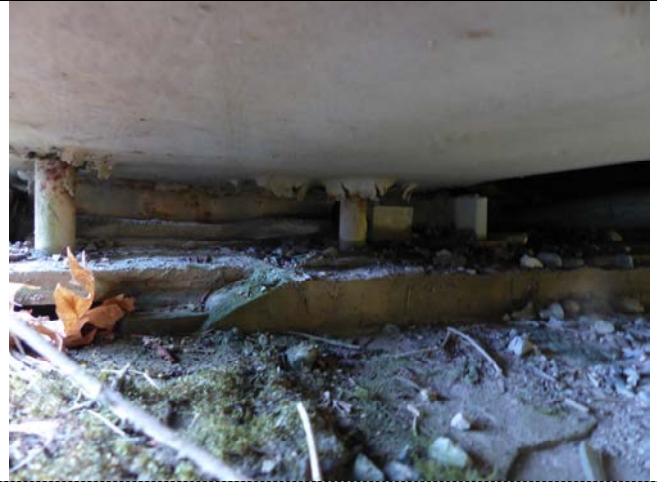
004 – Anchor Bolts at SW Corner of Bridge (B.6)

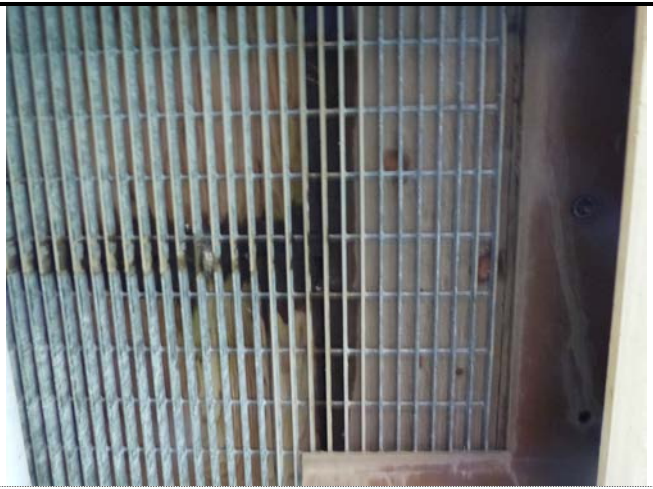
008 – Plywood between Steel Grating and Timber Planking (D.1)

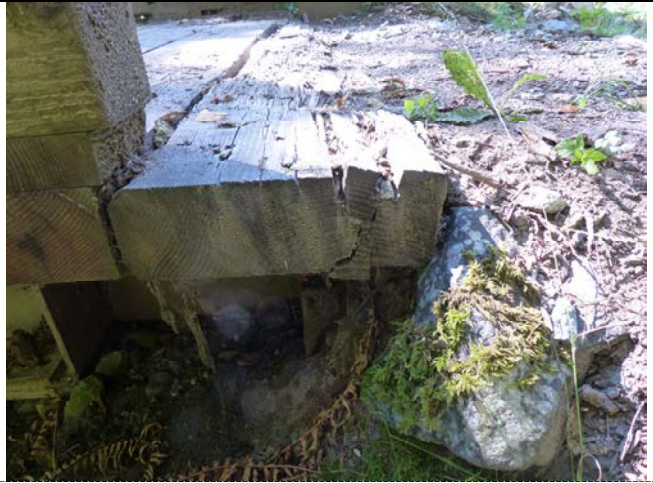
D.2.a – Superficial damage to timber planking. Apparent vehicular tread marks along entire bridge length, but especially apparent at corners of the bridge at approach. Wheel paths are obvious: several meters long, approx. 800mm wide.

010 – Damaged Plank at NW Corner of Bridge (D.2)

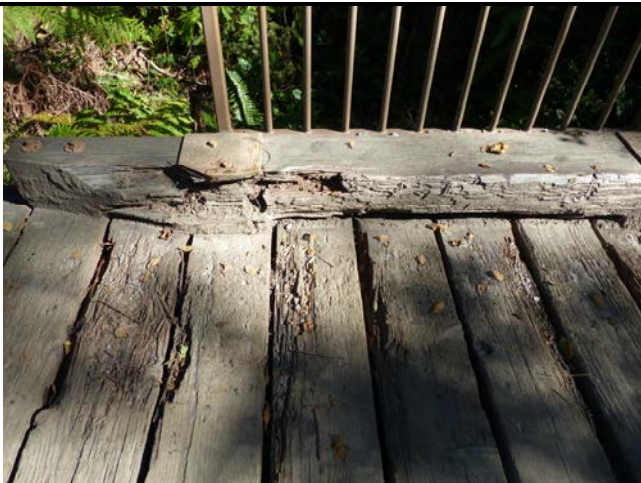
D.4.c – Collision damage at NW end: ~1.080m. Collision damage at NE end: ~0.800m long. Wanes and occasional checks along curb.

E.2.a – Sharp turns at both approaches. Problematic for oversized vehicles for proper alignment onto bridge; cause of collision damage of curb and railing.

011 – Tread marks and Collision Damage at Bull Rail, NW corner of Bridge (D.2, D.4)

- Would recommend replacement of damaged curbs and missing railing.

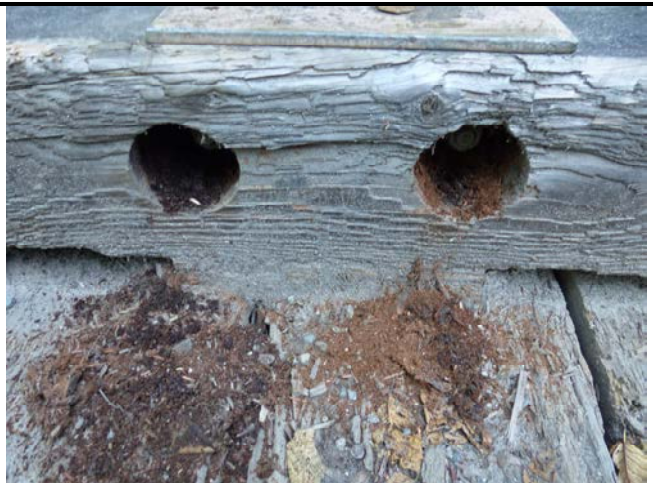
D.4.d – Rot at boltholes in curbs.

012 – Rotted Wood from Bolt Holes in Bull Rail (D.4)

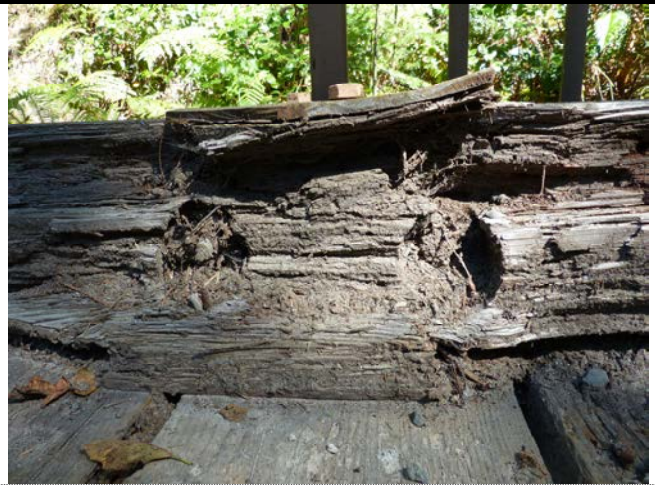
014 - Close-Up of Collision Damage at Bull Rail, NW Corner of Bridge (D.4)

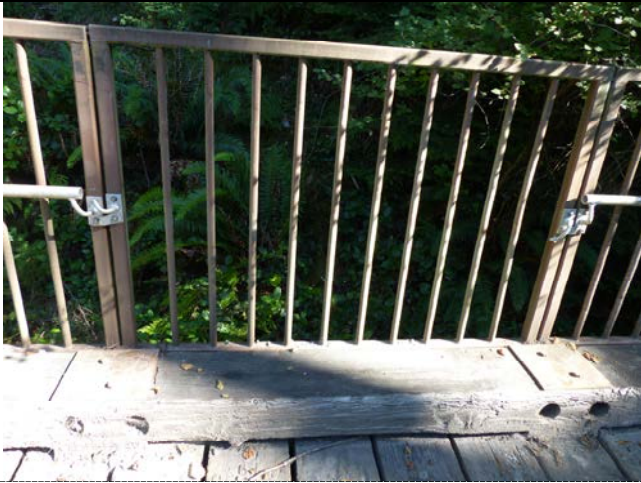
015 – Missing Railing - Appeared to be Torn off (D.6)

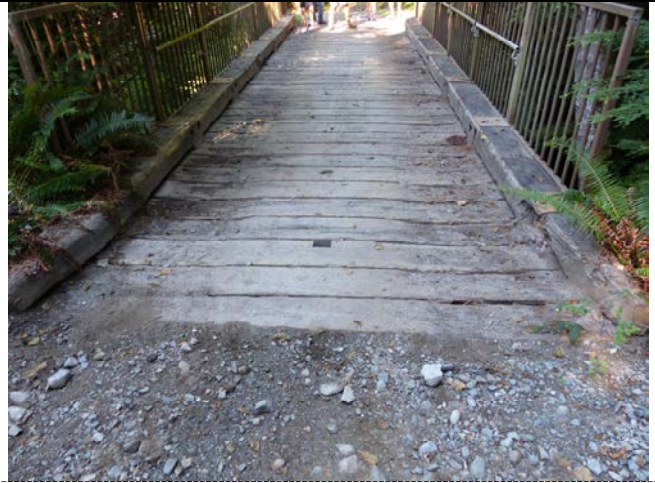
016 – Deck and Approach at East end of Bridge (D.2, E.2)

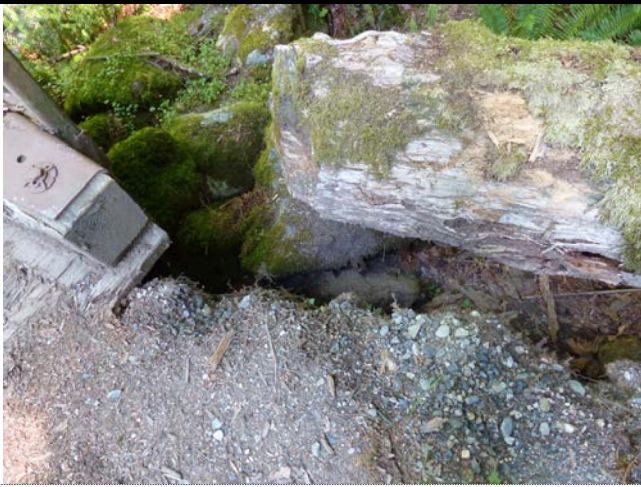
001 – Erosion at NE Corner of Bridge (A.2)

- The missing section of the timber planks at the SE corner of the bridge and the eroded bank at the NE corner of the bridge could be a tripping or falling hazard; these should be repaired immediately.

- Would recommend monitoring bank erosion at road approaches.

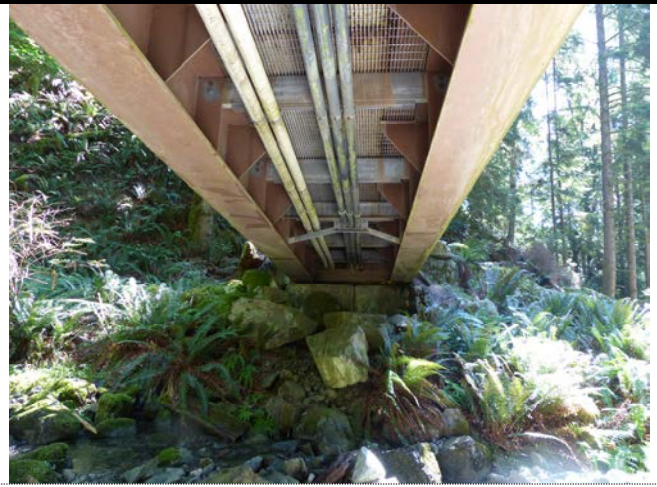
002 – View Underneath Deck and Foundation at East End of Bridge (B.1)

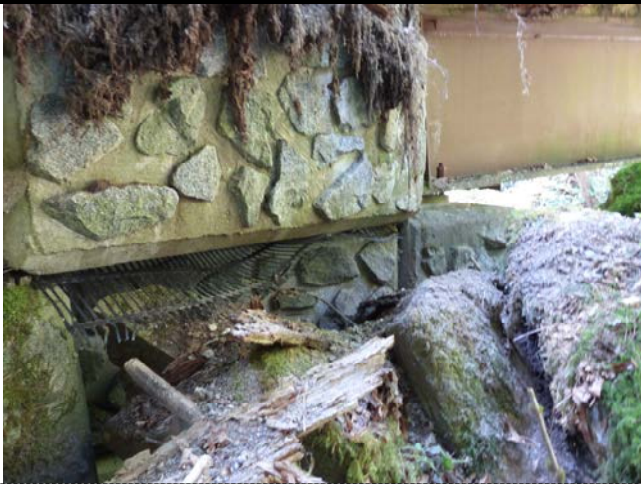
003 – Exposed Geotextile at Lock Block, West End of Bridge (B.1)

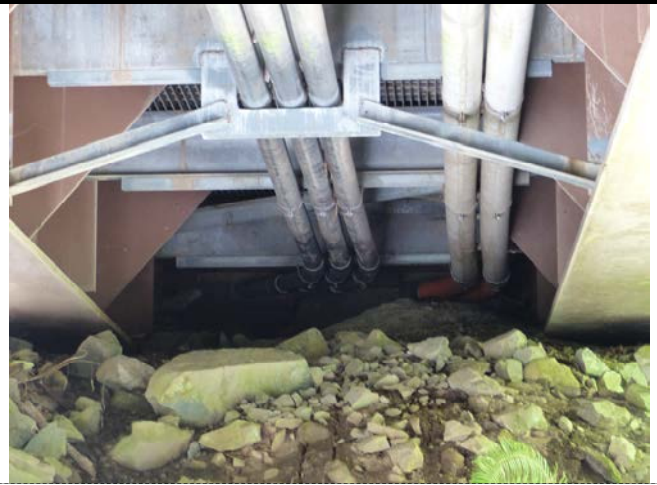
004 – View Underneath Deck at West End of Bridge (B.1)

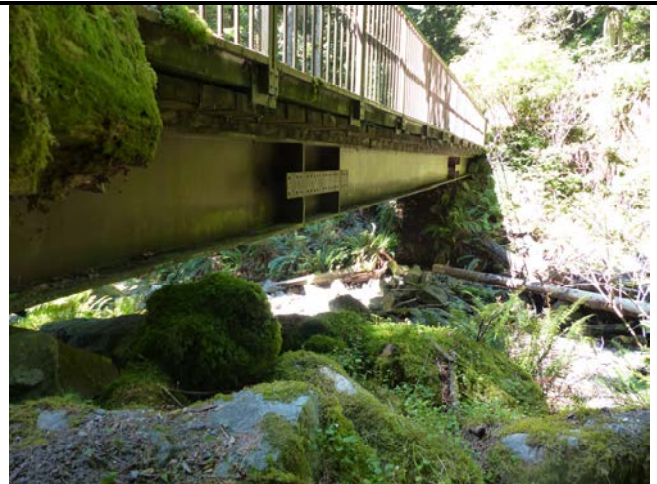
006 – View of Steel Girder along North side of Bridge (C.3)

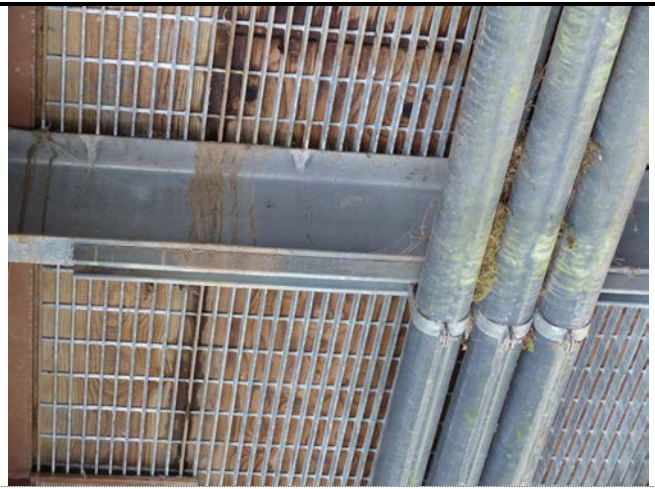
008 – Plywood, Steel Grating and Steel Floor beam, Typical (C.1)

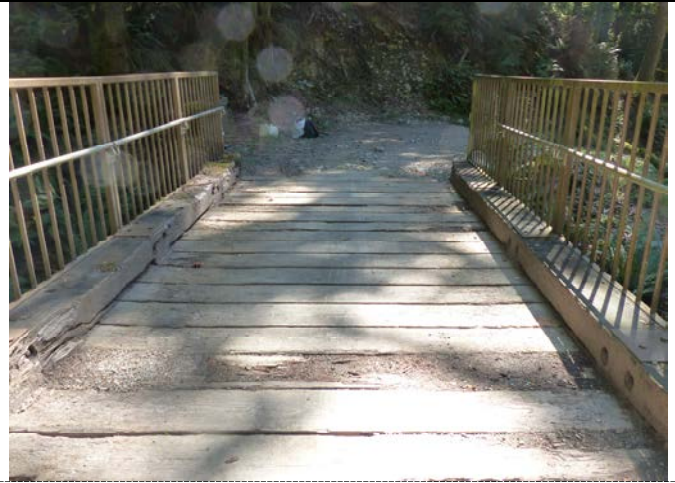
010 – Deterioration of Entire Timber Plank, View Looking East (D.1)

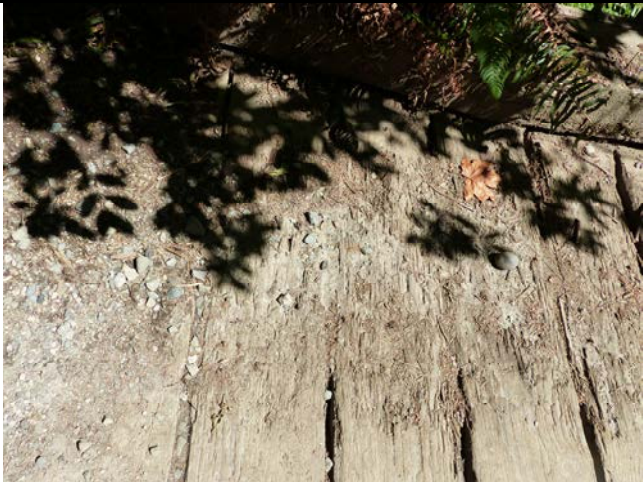
D.2.a – Superficial damage to timber planking. Apparent vehicular tread marks along entire bridge length, but especially apparent at corners of the bridge at approach. Section of deck planking missing at SE corner, approx. 0.75m long x 0.3m wide section missing.

011 – Tread marks on Planking, NW corner of Bridge (D.2)

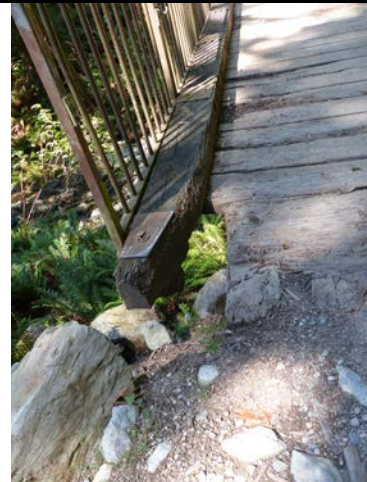
012 – Damaged/Missing Plank at SE Corner of Bridge (D.2)

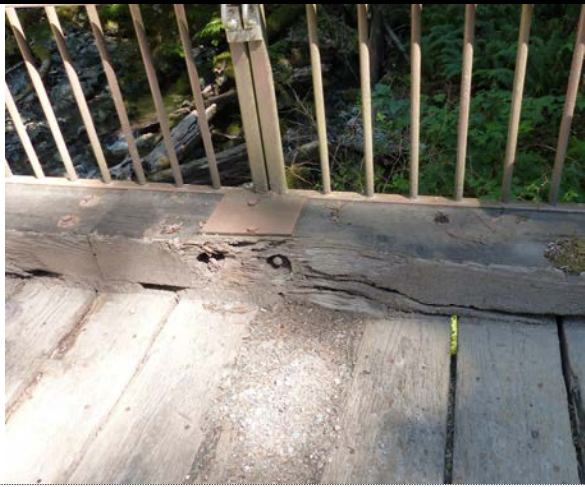
D.5 – Rot at some boltholes in curb.

013 – Collision Damage at Bolt Holes in Bull Rail (D.4)

- Would recommend replacement of damaged curbs and missing railing.

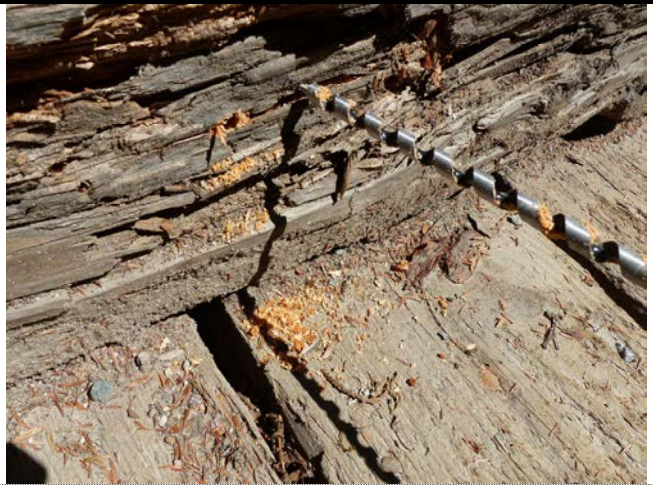
D.4.b – Drill-hole near NE corner: rot at center of curb. Remainder of curb appears OK; other drill holes were generally dry, with some superficial dampness (approx. within top half inch).

014 – Drill Hole at Rotting Bull Rail and Typical Timber Condition (D.4)

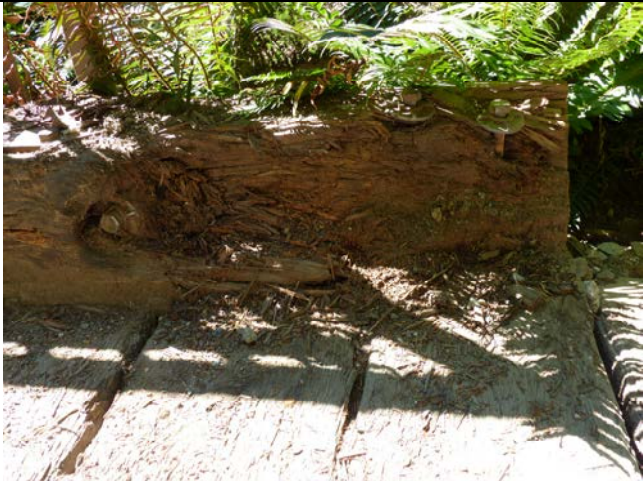
D.4.c – Bull rail collision damage at SW end: ~1.000m. Wanes along bull rail.

015 - Close-Up of Collision Damage at Bull Rail, SW Corner of Bridge (D.4)

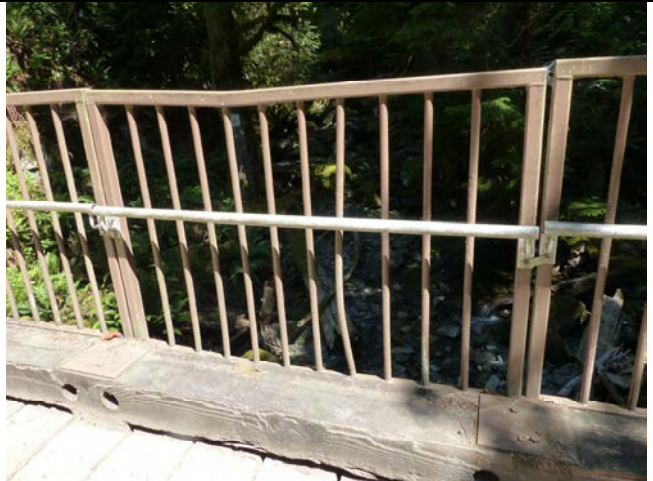
016 – Damaged Guardrail (D.6)

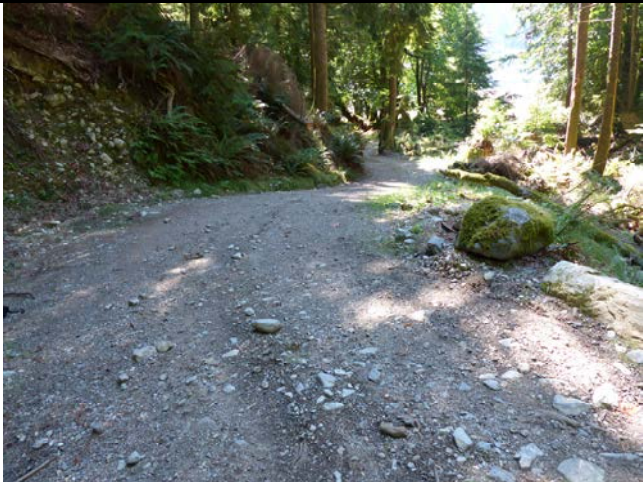
E.2.a – Sharp turns at both approaches. Problematic for oversized vehicles for proper alignment onto bridge; cause of collision damage of curb and railing.

017 – Downhill Road Approach at East End of Bridge (E.2)

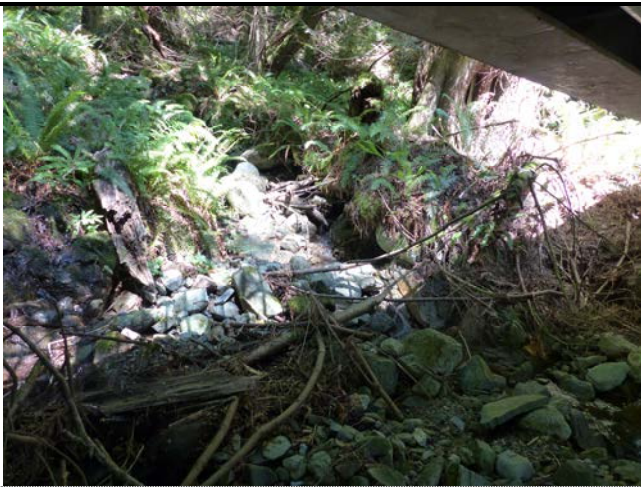
001 – View Upstream, looking North (A.1)

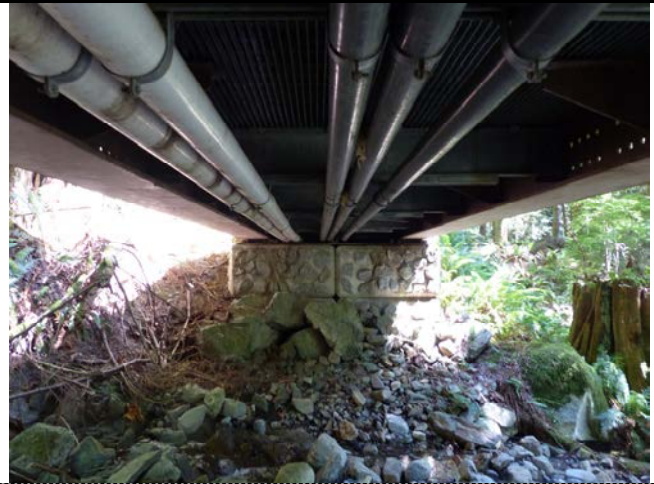
004 – View Underneath Deck and Foundation, East End of Bridge (B.1)

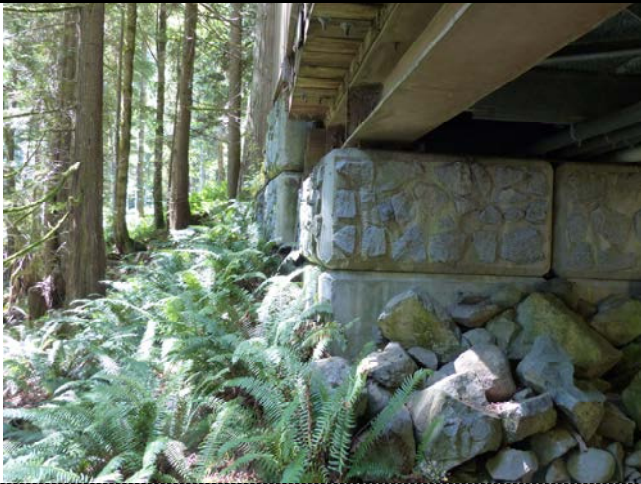
005 – Lock Block Foundation at West End of Bridge (B.1)

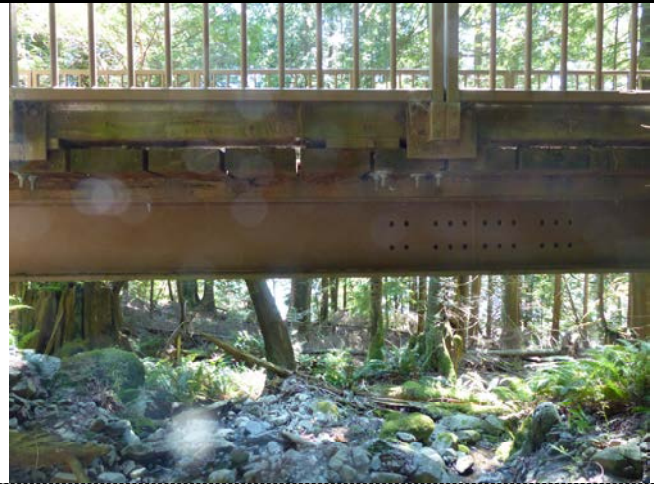
006 – Typical Condition of Bridge, View of North Side of Bridge (C.3)

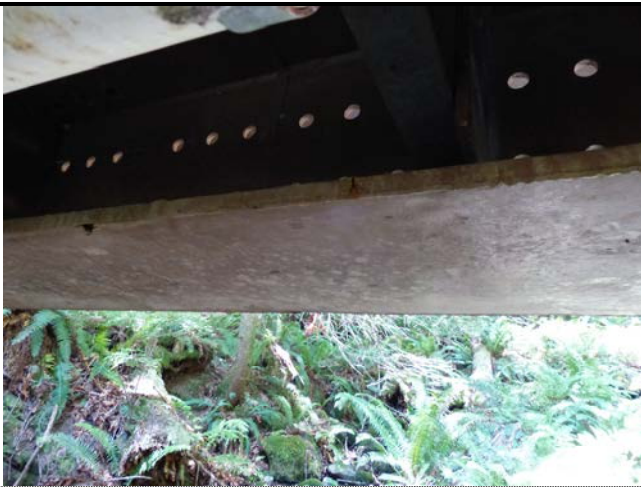
007 – Close-Up of Rusting Steel Girder, South side of Bridge (C.3)

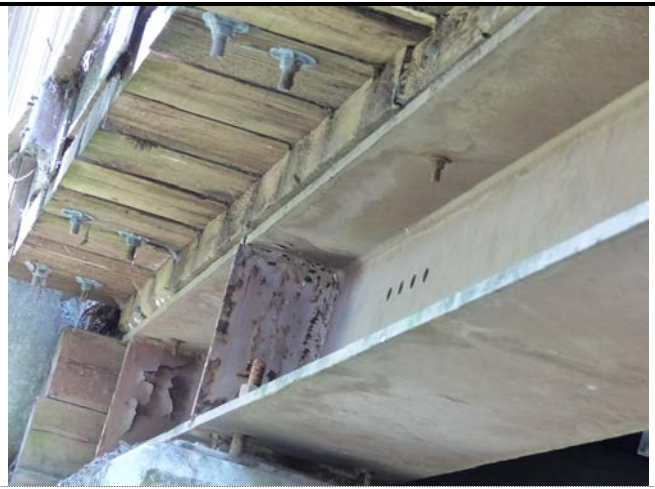
008 – Close-Up of Rusting Stiffeners, SW End of Bridge (C.3)

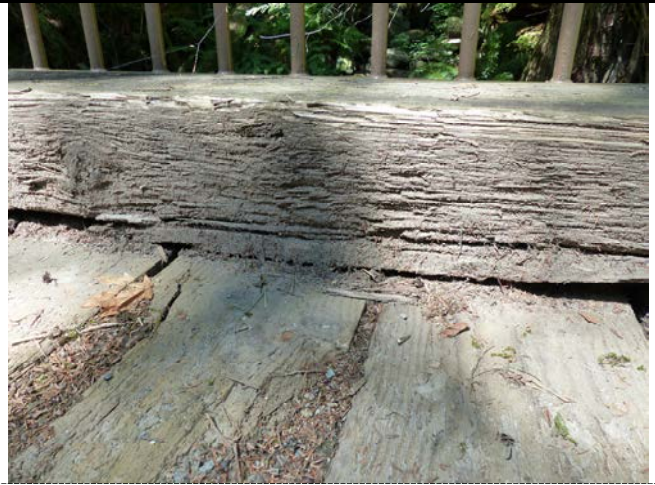
D.2.a – Minor superficial damage to timber planking particularly at corners of bridge. Localized section loss at top of planks.

012 – Damaged Planking and Collision Damage on Bull Rail (D.2, D.4)

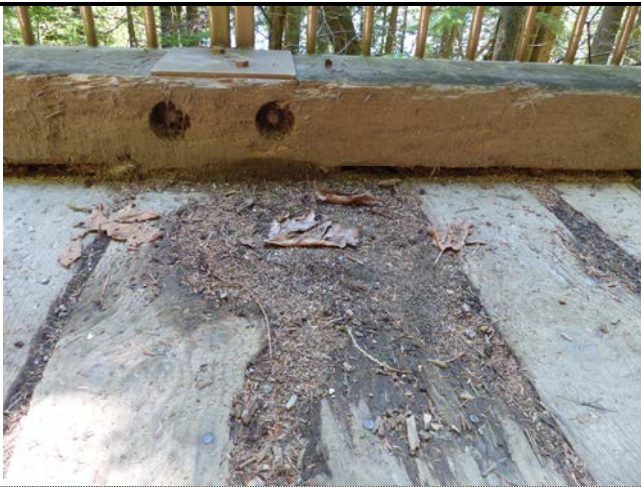
013 – Plank Deterioration and Isolated Rot in Bull Rail, Near SE corner of Bridge (D.2, D.4)

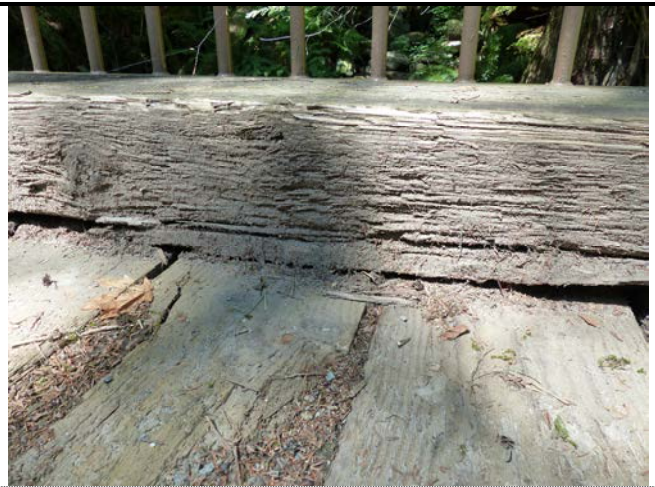
014 –Typical Timber Condition (D.4)

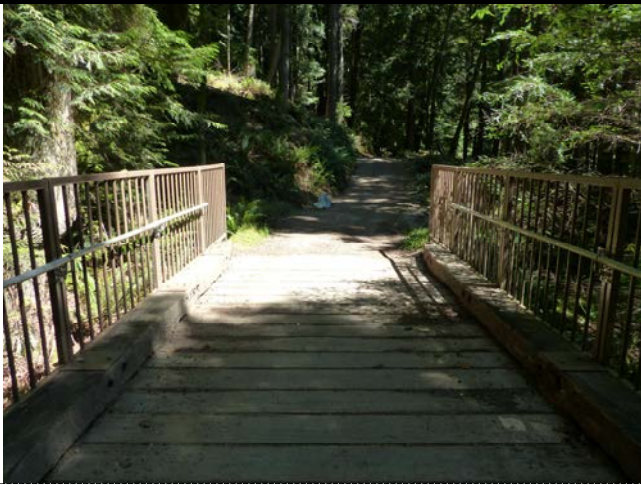
015 – Roadway Approach at East End of Bridge (E.2)

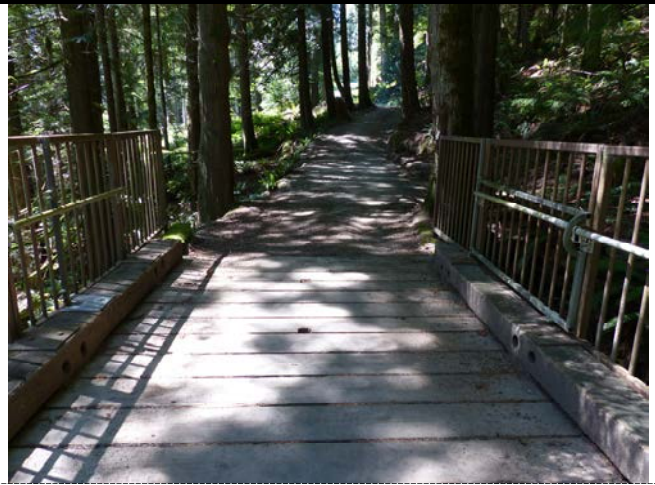
016 –Roadway Approach at West end of Bridge (E.2)
