P.O. BOX 464, SECHELT, BC, V0N 3A0
TEL: 604-885-8982
EMAIL: design@coasteng.ca

November 17, 2016

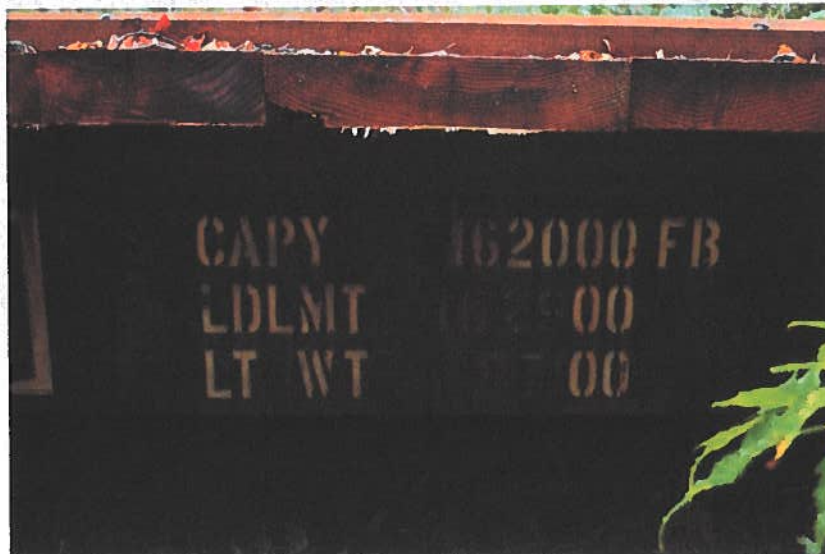
Photo 2 Lions Field Bridge - Freight Car Load Limit 162900

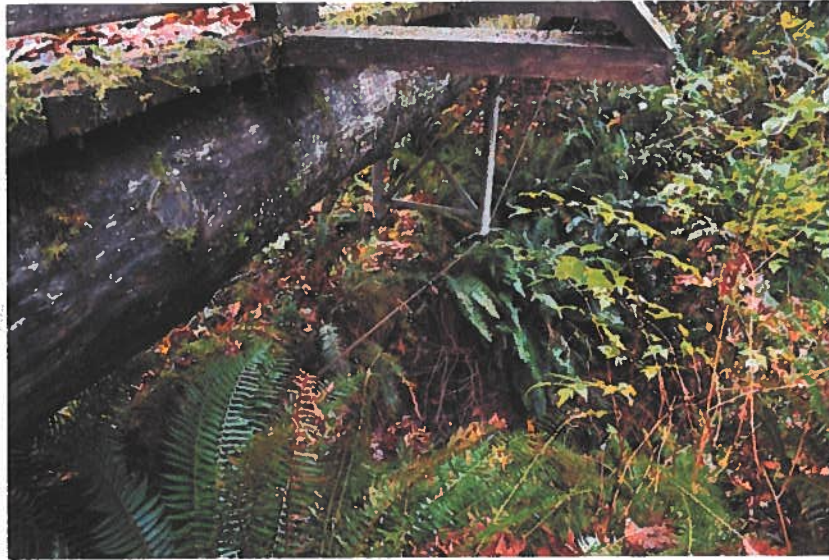
Photo 2 Vine Brook Bridge showing stringers supported at mid-span on steel frame and tension cables.

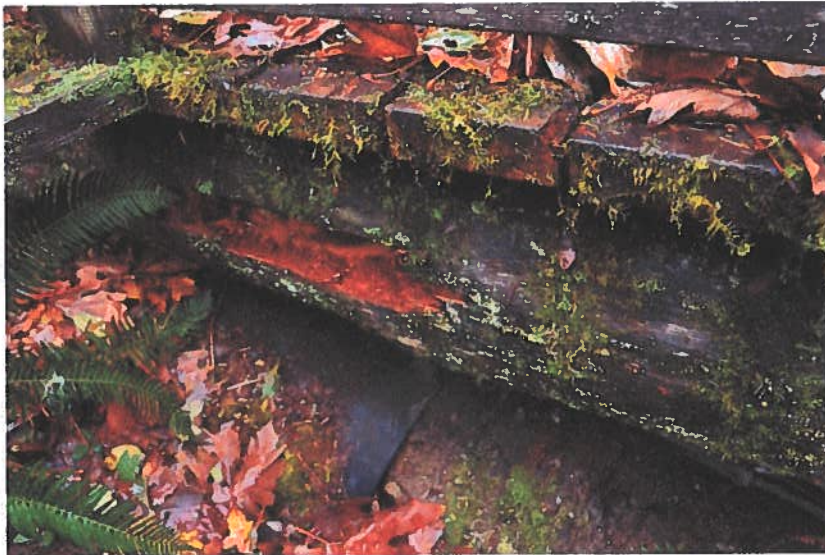
Photo3 Vine Brook Bridge. North end of West stringer log showing much deterioration.

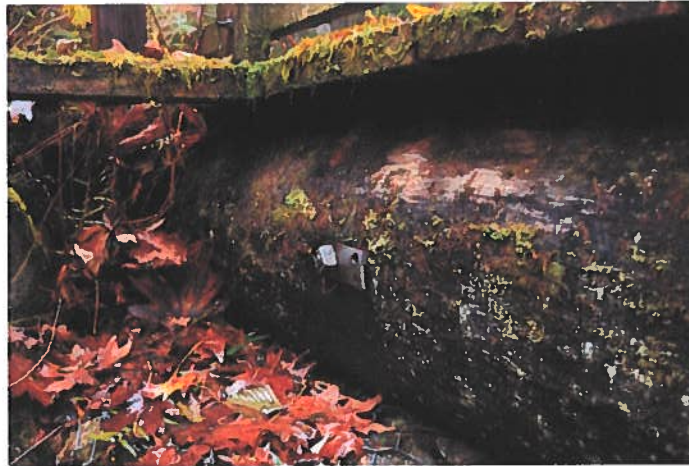
Photo 4 Vine Brook Bridge. South end of East stringer showing the end of the cross bar between the logs.
