Inspiring sustainable thinking

Sunshine Coast Regional District

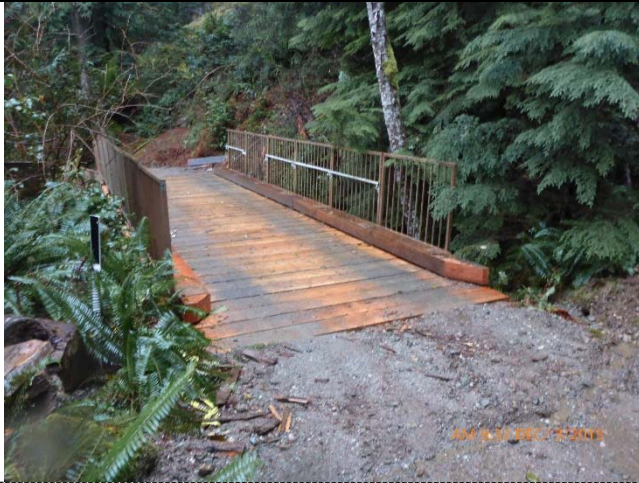
001 – View of Bridge from East Approach –
Note missing handrails at N side

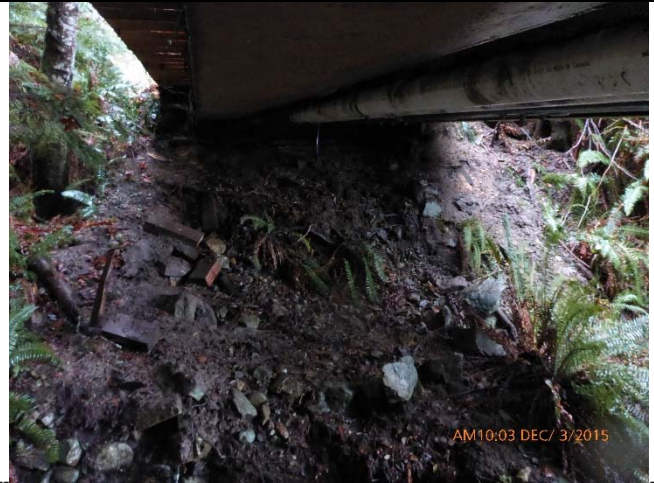
002 – Embankment at East End of Bridge (B.1)

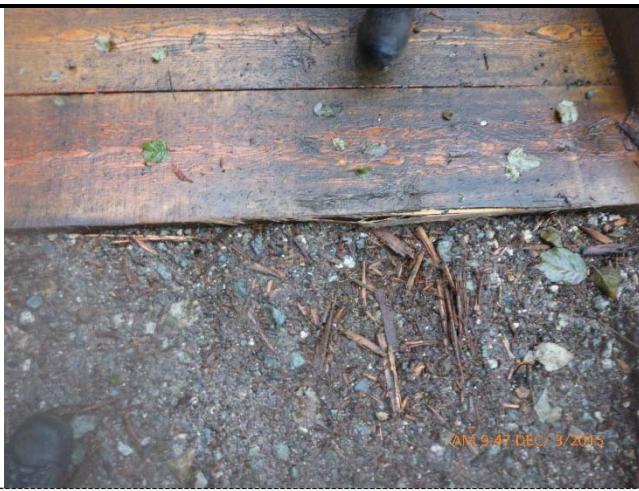
007 – Wearing at Planking, W Approach (D.2)

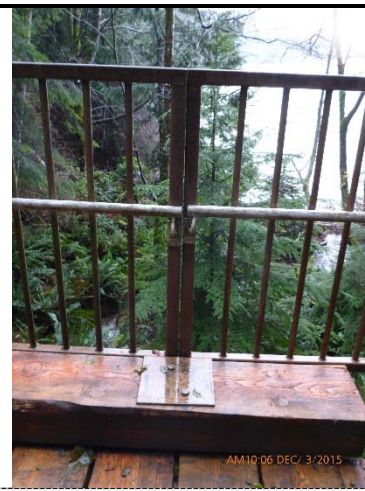
008 – Typical Guard Rail & Curb Rail Condition (D.4, D.6)

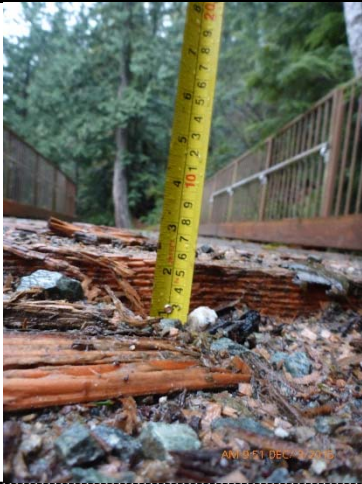
009 – East Approach Deck Elevation 55mm above Roadway Grade – Note wearing at planking (E.2)

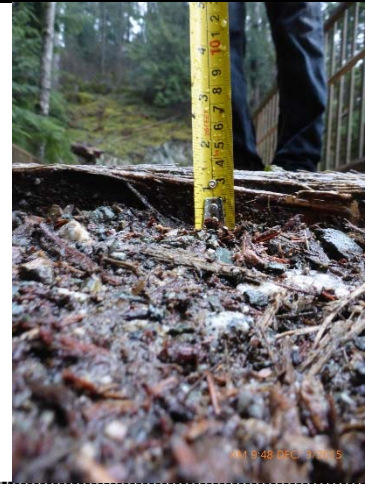
010 – West Approach Deck Elevation 35mm above Roadway Grade – Note wearing at planking (E.2)

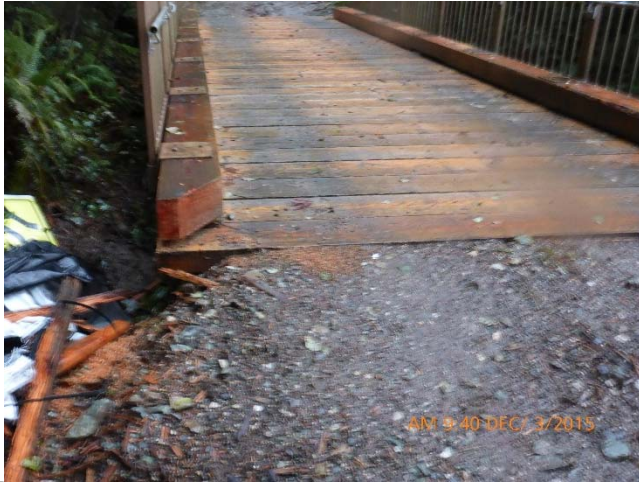
011 – Minor Erosion at NW Approach (E.2)

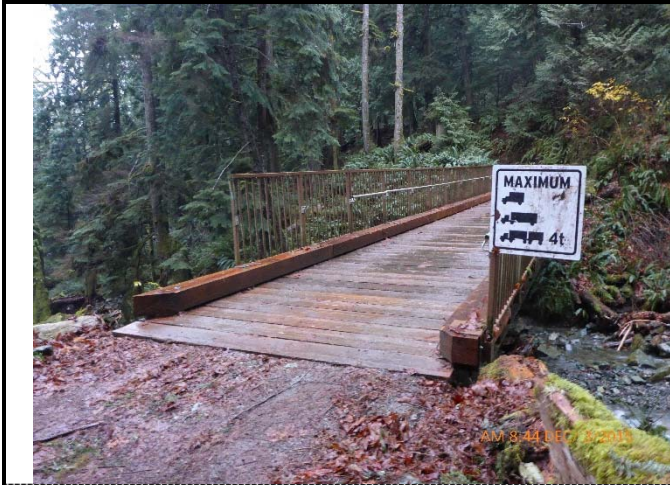
001 – View of Bridge from East Approach –
Note missing guardrail and handrails at SE corner

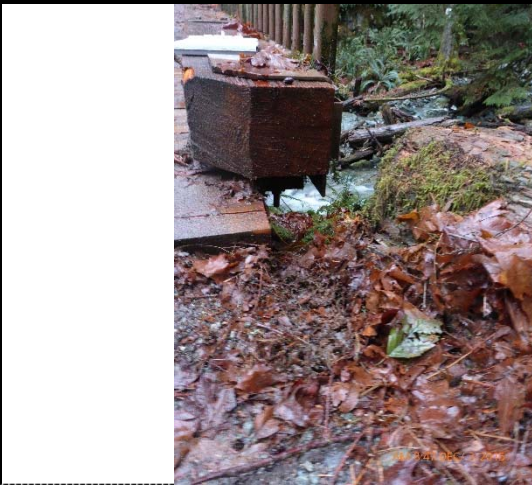
002 – Erosion at NE Corner of Bridge (A.2)

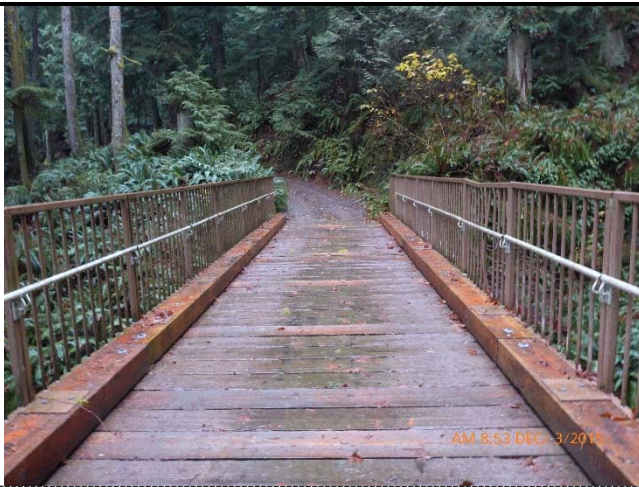
007 – View of General Condition of Bridge Deck & Curb Rails (D)

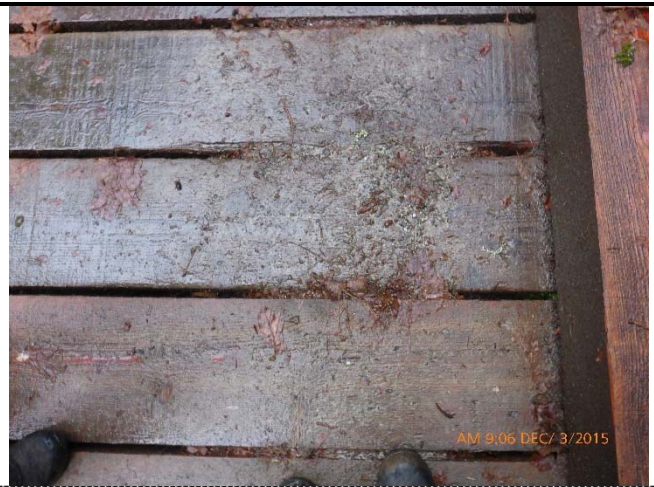
008 – Debris Accumulation Between Planks (D.1)

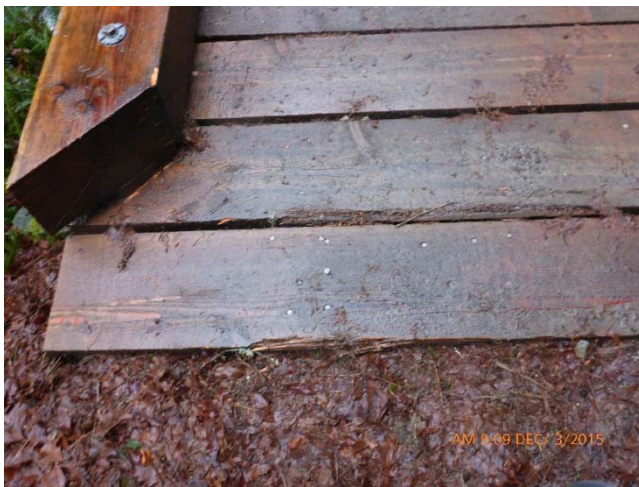
009 – SE Corner of Bridge, Repaired – Note minor wearing at plank edge (D.2)

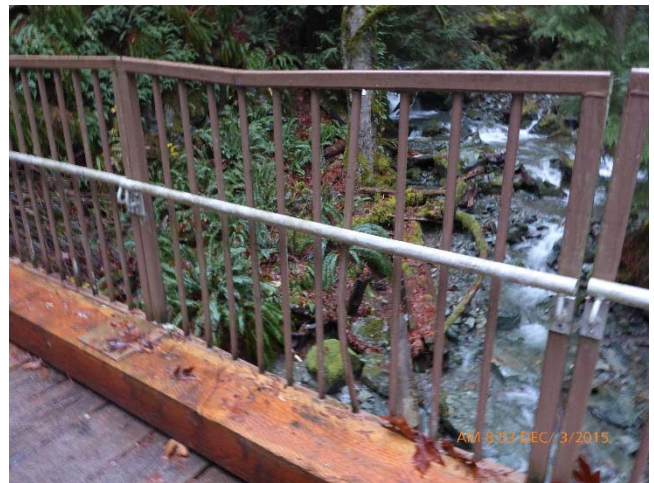
010 – Re-Used Guard Rail with Collision Damage near NE Corner of Bridge (D.6)

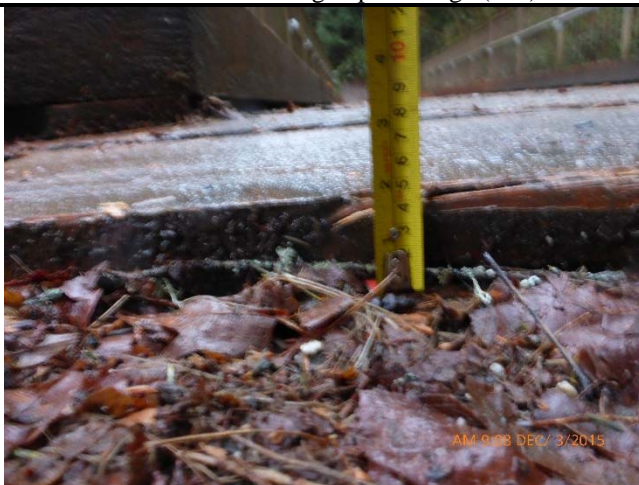
011 – East Approach Deck Elevation 45mm above Roadway Grade (E.2)
