## Sunshine Coast Regional District

## 2017 Trail Bridge Inspections – Final Report

Purchase Order # 3000710

Submitted December 1, 2017

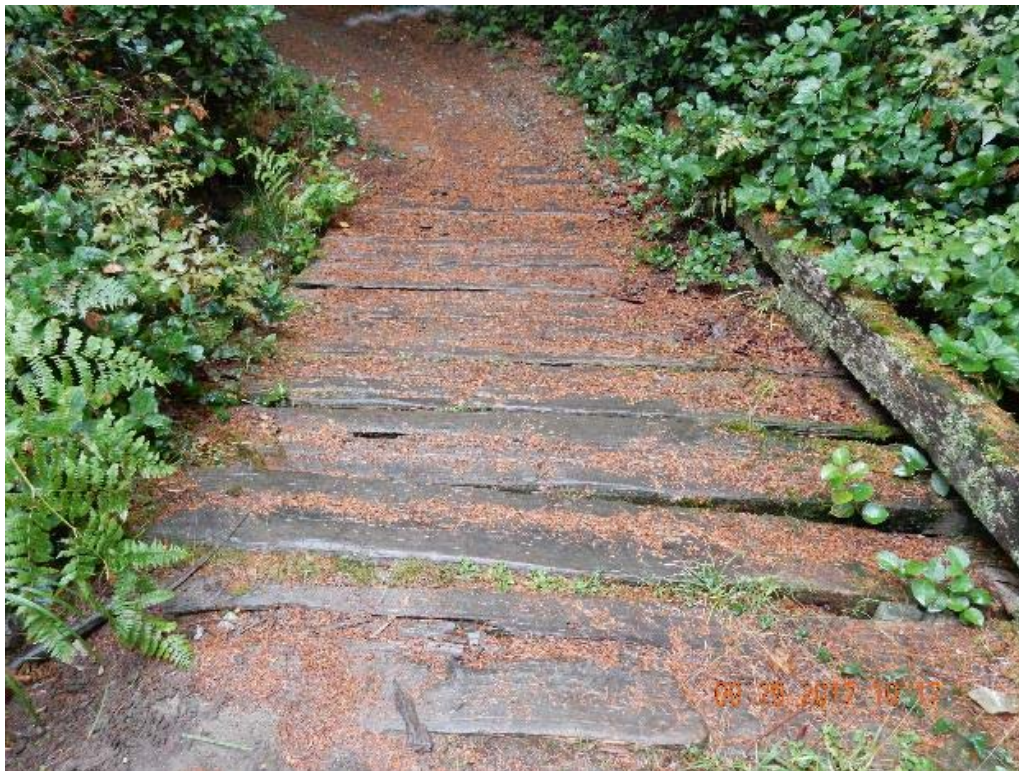
Element	Rating	Comments	Maintenance Recommendations	Estimated Cost	Priority
<b>Primary Components</b>					
Embankments	4				
Foundations	4				
Abutments	4				
Beams, Girders	2	Logs are collapsing onto rocks below bridge	Replace bridge	\$5,000	Low
Deck	2	Deck planks are deteriorating	Replace deck planks	\$2,000	Medium
<b>Secondary Components</b>					
Approaches	5				
<b>Auxiliary Components</b>					
Slope Protection	5				
Signs	4	No load restriction sign present

P02 – Overall decking, deck is in poor condition  
(DSCN9925.jpg)

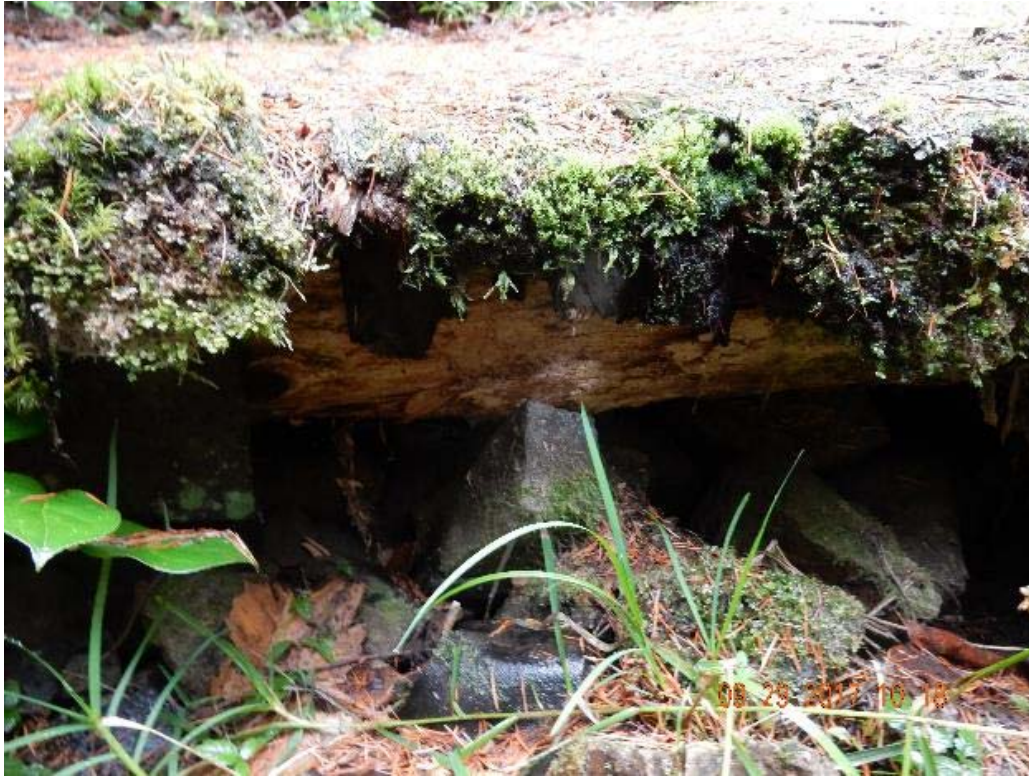
P05 – West side of the bridge, the entire deck is collapsing on rocks below it (DSCN9929.jpg)

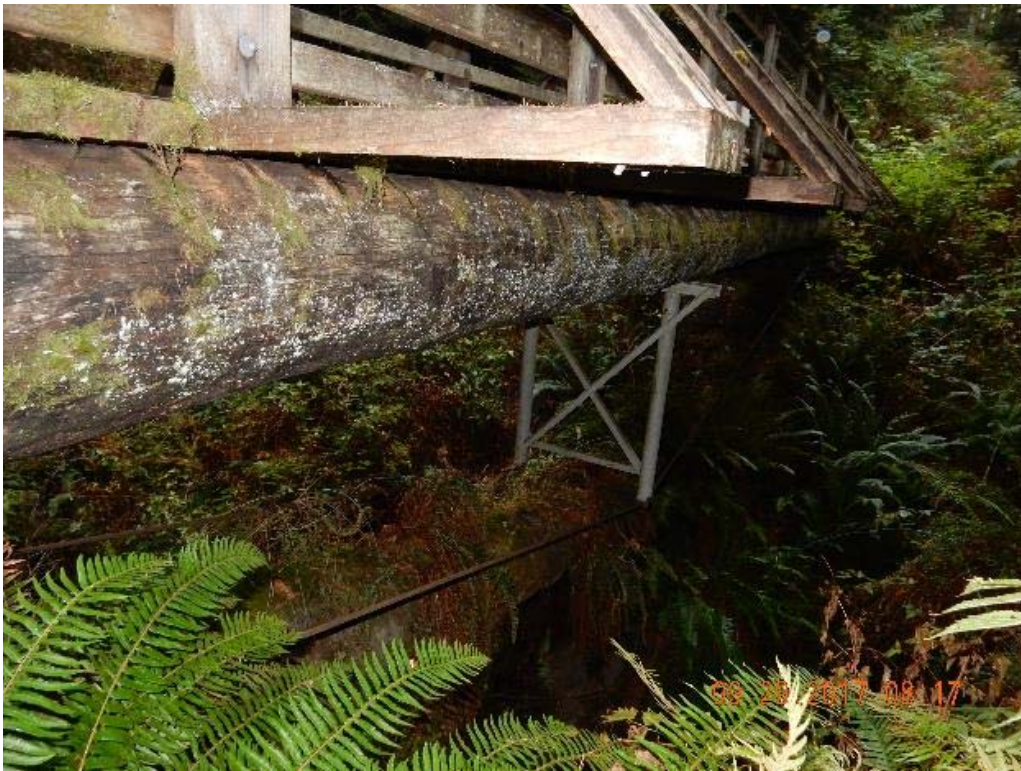
P11 – Northwest corner of the bridge, log is breaking apart  
(DSCN9859.jpg)
