To: **Sunshine Coast Regional District** Date: **January 24, 2024**
Attention: **Drew Brennan** Project No.: **33642**
Cc:
Reference: **Chaster Park Pedestrian Bridge and Revetement Wall Planning Options**
Cliff Gilker Park Bridges and Trail Recovery Options – REVISED MAY 22, 2024
From: **Richard Avedon-Savage and Janet Tong**

This memo summarizes the evaluation of existing trail and bridge conditions, reviews conceptual options and provides recommendations for bridge replacements and trail improvements.

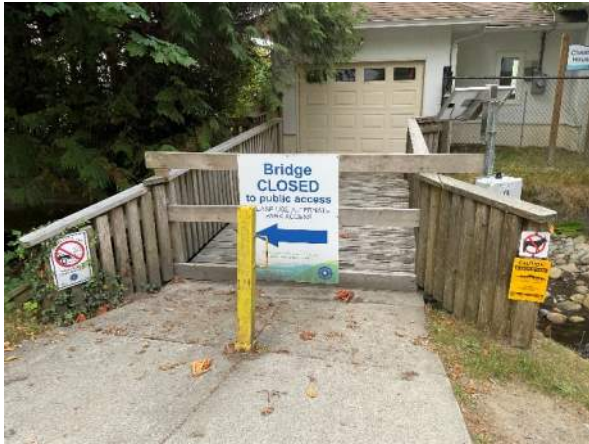
| Superstructure | Substructure | Deck and Railing | Length (m) | Width (m) | Comments |
|---|---|---|---|---|--|
| Steel Girders with timber plank decking | Concrete abutment wall | Timber | 5.5 | 2.0 | Bridge superstructure in good shape, eroded backfill behind north abutment and undermined revetment wall on south side |

Chaster Park Bridge

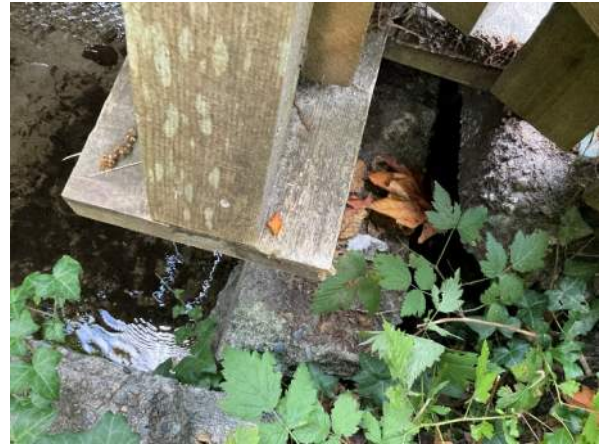
The main access to Chaster Park was damaged by excessive flooding during the 2021 atmospheric river events. Damages include erosion behind the existing bridge North abutment and undermining and cracking along the face the concrete storm water management revetment wall. A preliminary engineering review assessment of the pedestrian bridge confirmed the foundation had been compromised and it was unsafe for public access. Consequently, Parks staff immediately closed Chaster Park, and blocked off access to the bridge. Subsequently, the Sunshine Coast Regional District (SCRD) provided an alternate access to the Park via a gravel driveway.

Erosion behind North abutment

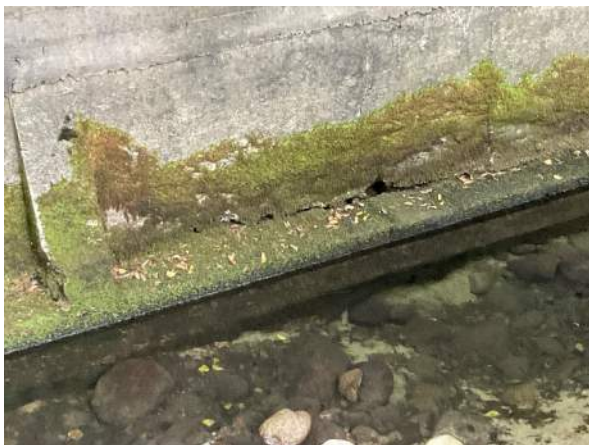
Crack in revetment wall upstream of bridge crossing

There are localized areas of undermining along the south revetment wall. In addition, cracks and spalls were noted on the front face of the wall. The spalled sections of concrete should be locally demolished and patched with concrete or grout. Larger cracks should be filled with epoxy and sealed. The undermined sections of the wall should be filled with flowable concrete and protected with rock armouring at the foot of the wall.

A4b. The repair strategy is to patch any spalled concrete and cracking on the front face of the revetment wall as well as add foam or CDF fill at the undermined slab footing locations. In addition, new rip rap will be installed to prevent future scouring. The intent of the repair was to extend the service life, not increase the wall height.

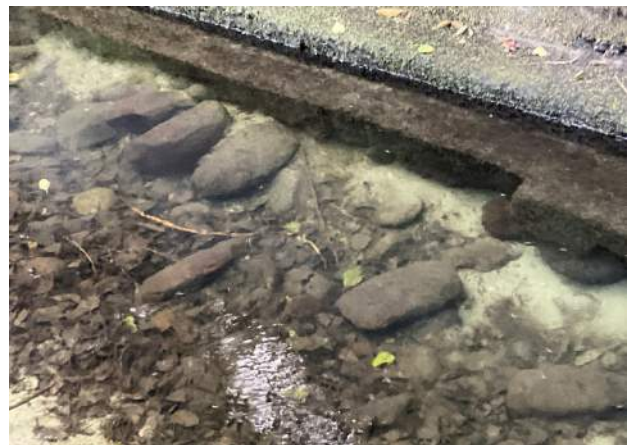
Undermining at revetement wall

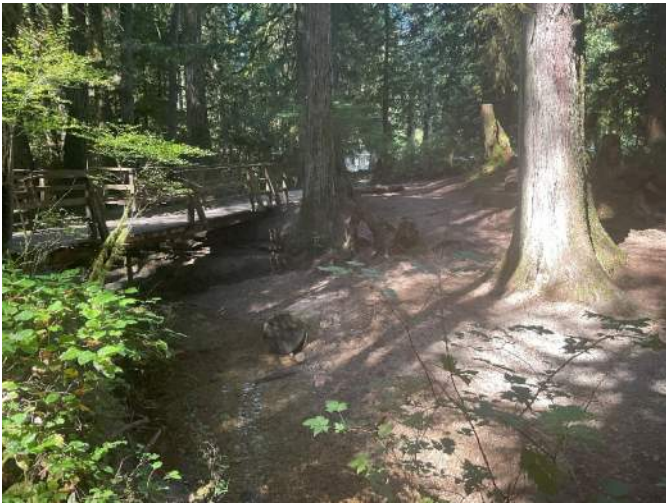
| Superstructure | Substructure | In-stream Supports | Length (m) | Width (m) | Comments |
|---|---|---|---|---|---|
| Wooden log stringers with wood deck and wood railings | Pressure treated wood and concrete | 4x4 wood posts with framing anchors in bedrock within creek bed | 10 | 1.3 | Excessive vibration, Replacement recommended as soon as possible, high risk of failure without load limits enforced |

Upper Waterfall Bridge – Upstream view

Excessive vibration is noticeable to users crossing the bridge, indicating undersized or deteriorated stringers. Options to reduce vibrations include reducing the span length or strengthening/replacing the stringers. Based on recent photos of water flows in the park, instream piers are not recommended. Strengthening existing log stringers is difficult due to the varying diameter of the stringers. Therefore, ISL recommends replacing the bridge and Table 6 below shows options for the proposed bridge.

Should the SCRD want to keep the bridge open, it is recommended closing off access to the viewpoint, add additional stringers where possible and posting a sign to advise that a maximum of 2 people on the bridge at the same time.

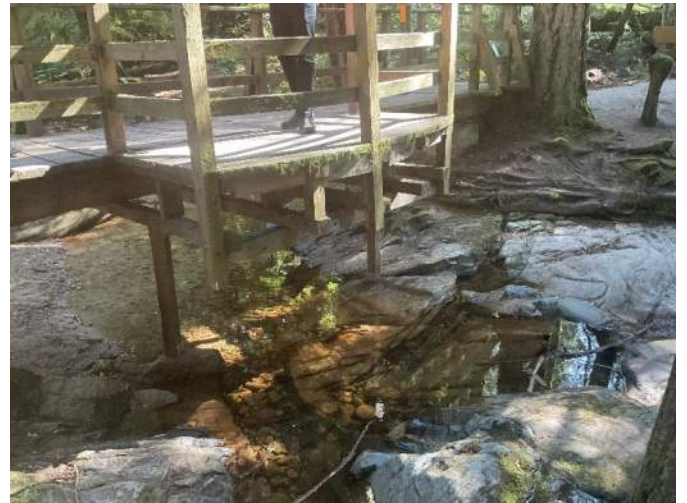
Upper Waterfall Bridge - Instream supports

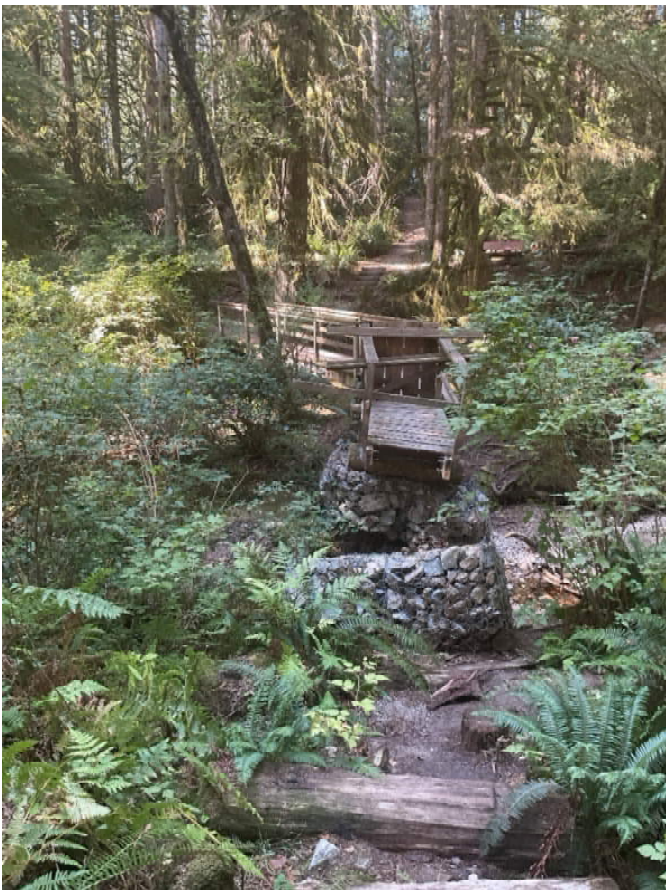
| Superstructure | Substructure | In-stream Supports | Length (m) | Width (m) | Comments |
|---|---|---|---|---|--|
| Wood 2-2 x12 stringers with wood deck and wood railings | Wood logs and riprap erosion protection | Rock gabion baskets | 20m total (2 segments) | 1.0 | East side partially washed away, west side in fair condition but high risk of further damage during high creek flows |

Lower Waterfall Bridge – View from north approach

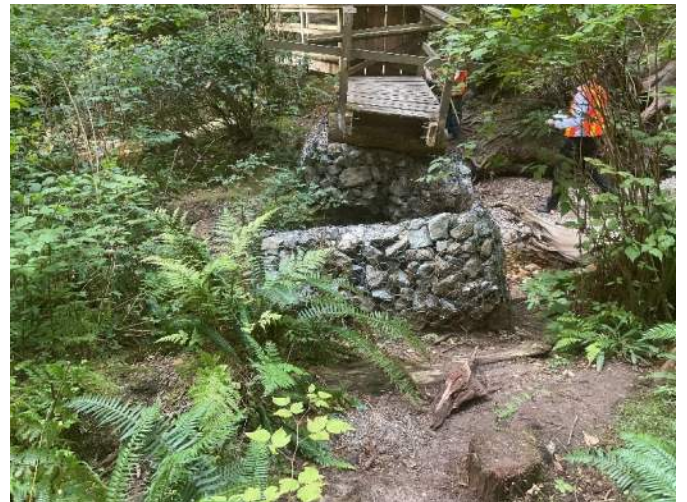
Lower Waterfall Bridge – Damaged gabion abutment at Island

An atmospheric river event in 2021 destroyed the middle gabion supports that were on an "island" in the center of the creek. This resulted in the failure of the east span of the bridge. The west span is still in good shape. Visual inspection of the island showed few places for new pier supports. There are signs of erosion at the west span abutment. Table 11 below presents the options for the Lower Waterfall Bridge.

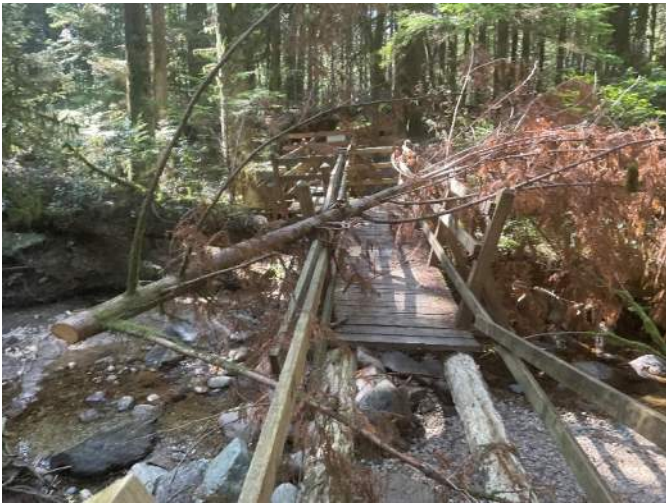
| Superstructure | Substructure | In-stream Supports | Length (m) | Width (m) | Comments |
|---|---|---|---|---|--|
| Wooden log stringers with wood deck and wood railings | Wood logs and riprap erosion protection | Fallen log support @ midspan within creek bed | 25m total (2 segments) | 1.2 | Badly damaged, log stringers are extremely deteriorated, south side deck and railing in fair condition |

Zig Zag Bridge – view from south approach

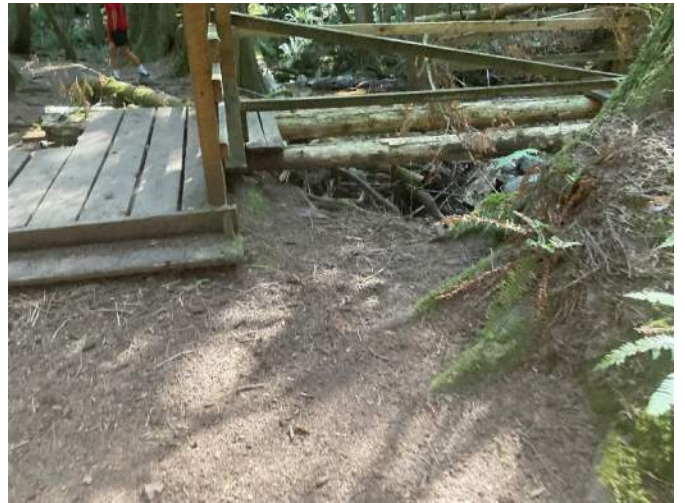
Zig Zag Bridge - North abutment

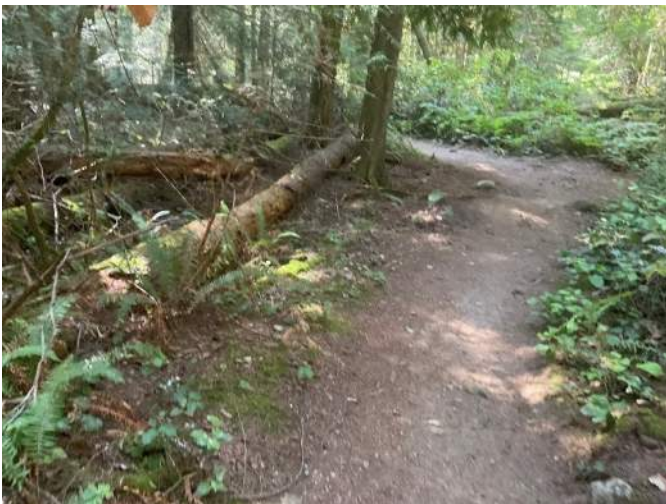
Existing trail section that was flooded in November 2021

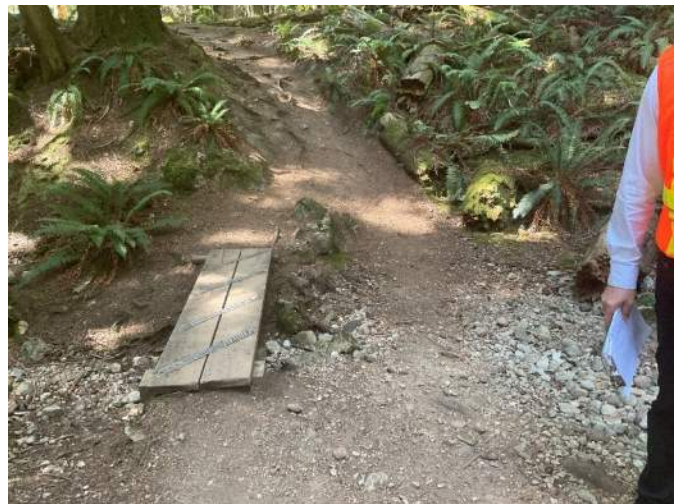
Existing trail section that was flooded in November 2021

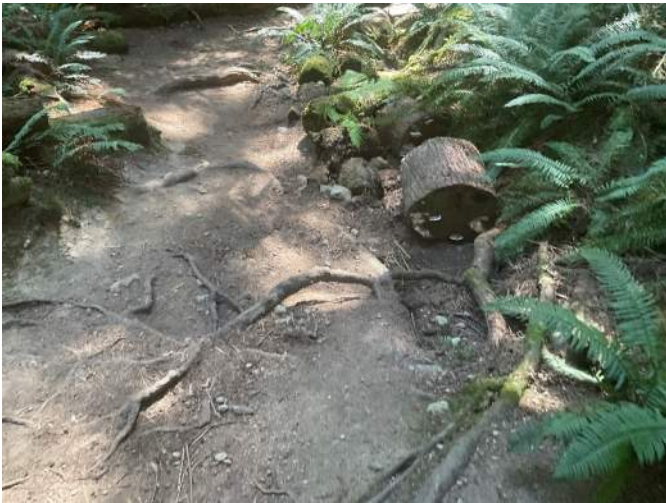
Erosion of existing trail section

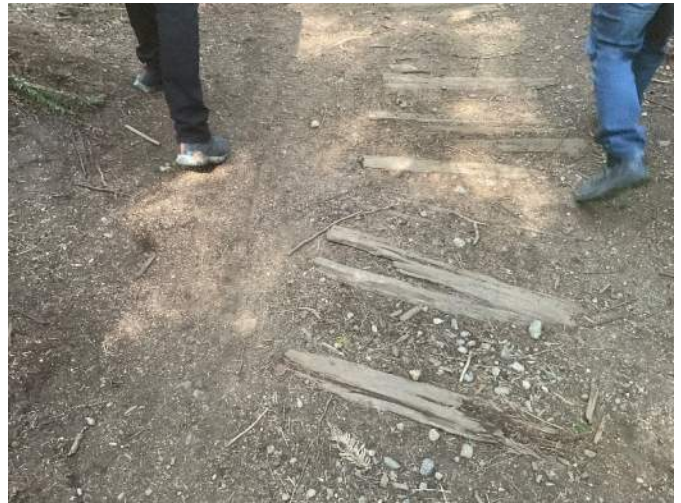
Existing timber planks to be removed

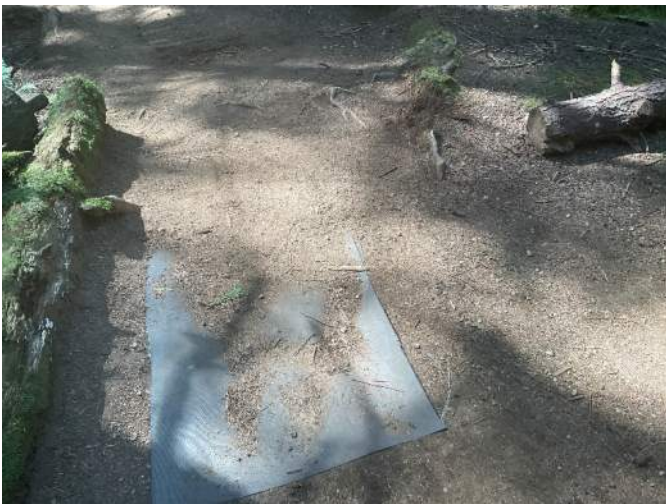
Existing geotextile to be removed

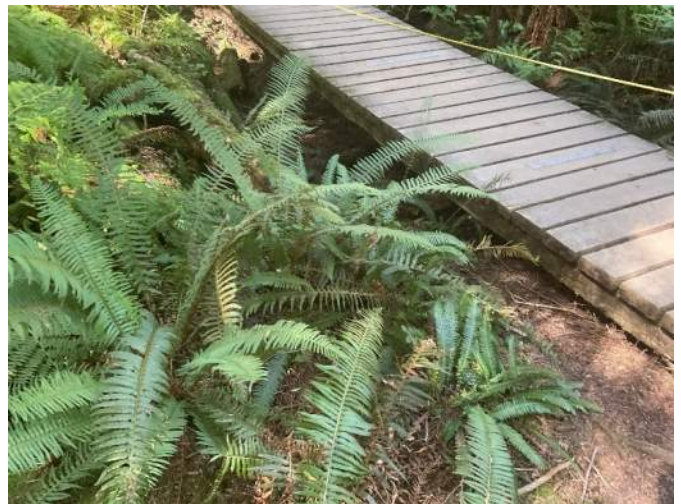
Existing boardwalk to be replaced

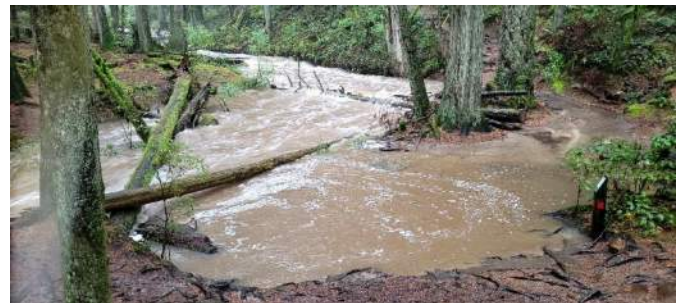
Trail Flooding by Gorge Bridge
