February 20, 2020

Our File: 13-5854

**Re: Preliminary Geotechnical Report**  
Sechelt Landfill Sinkhole  
4905 Dusty Road, Sechelt, BC

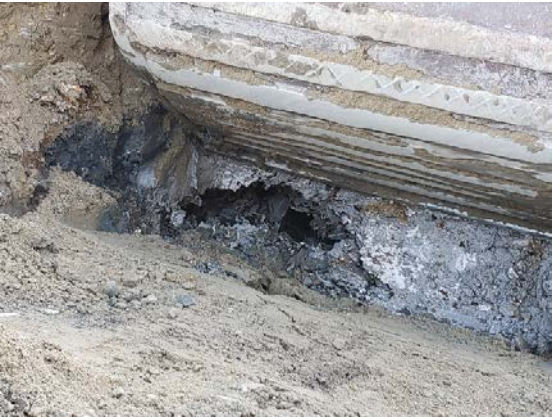
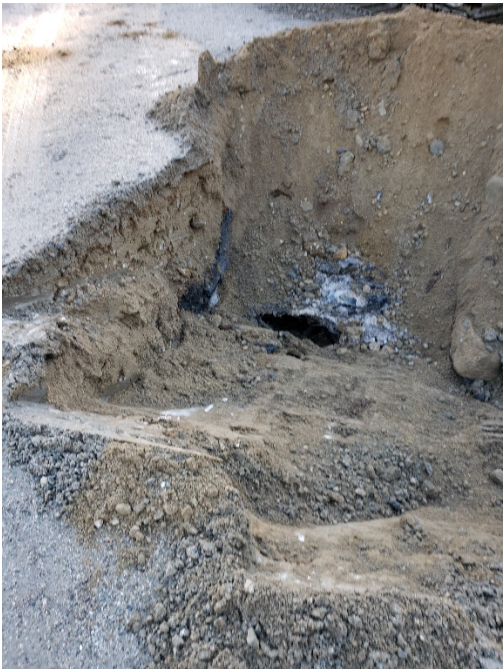
<b>Photo 1:</b> Void beneath drywall material	<b>Photo 2:</b> Void beneath drywall material

There is no historical information regarding MSW placement procedures/methodology in this area. From our observations of the test pit excavation (at the sinkhole), the drywall material appears to have been placed on top of construction debris such that the material was suspended/supported by the debris which resulted in a void. It is likely that as the drywall material degraded, the granular fill supported by the drywall likely collapsed into the void and a sinkhole eventually formed at the ground surface. Groundwater within the fill and surface water entering from above could accelerate the collapse of the fill.

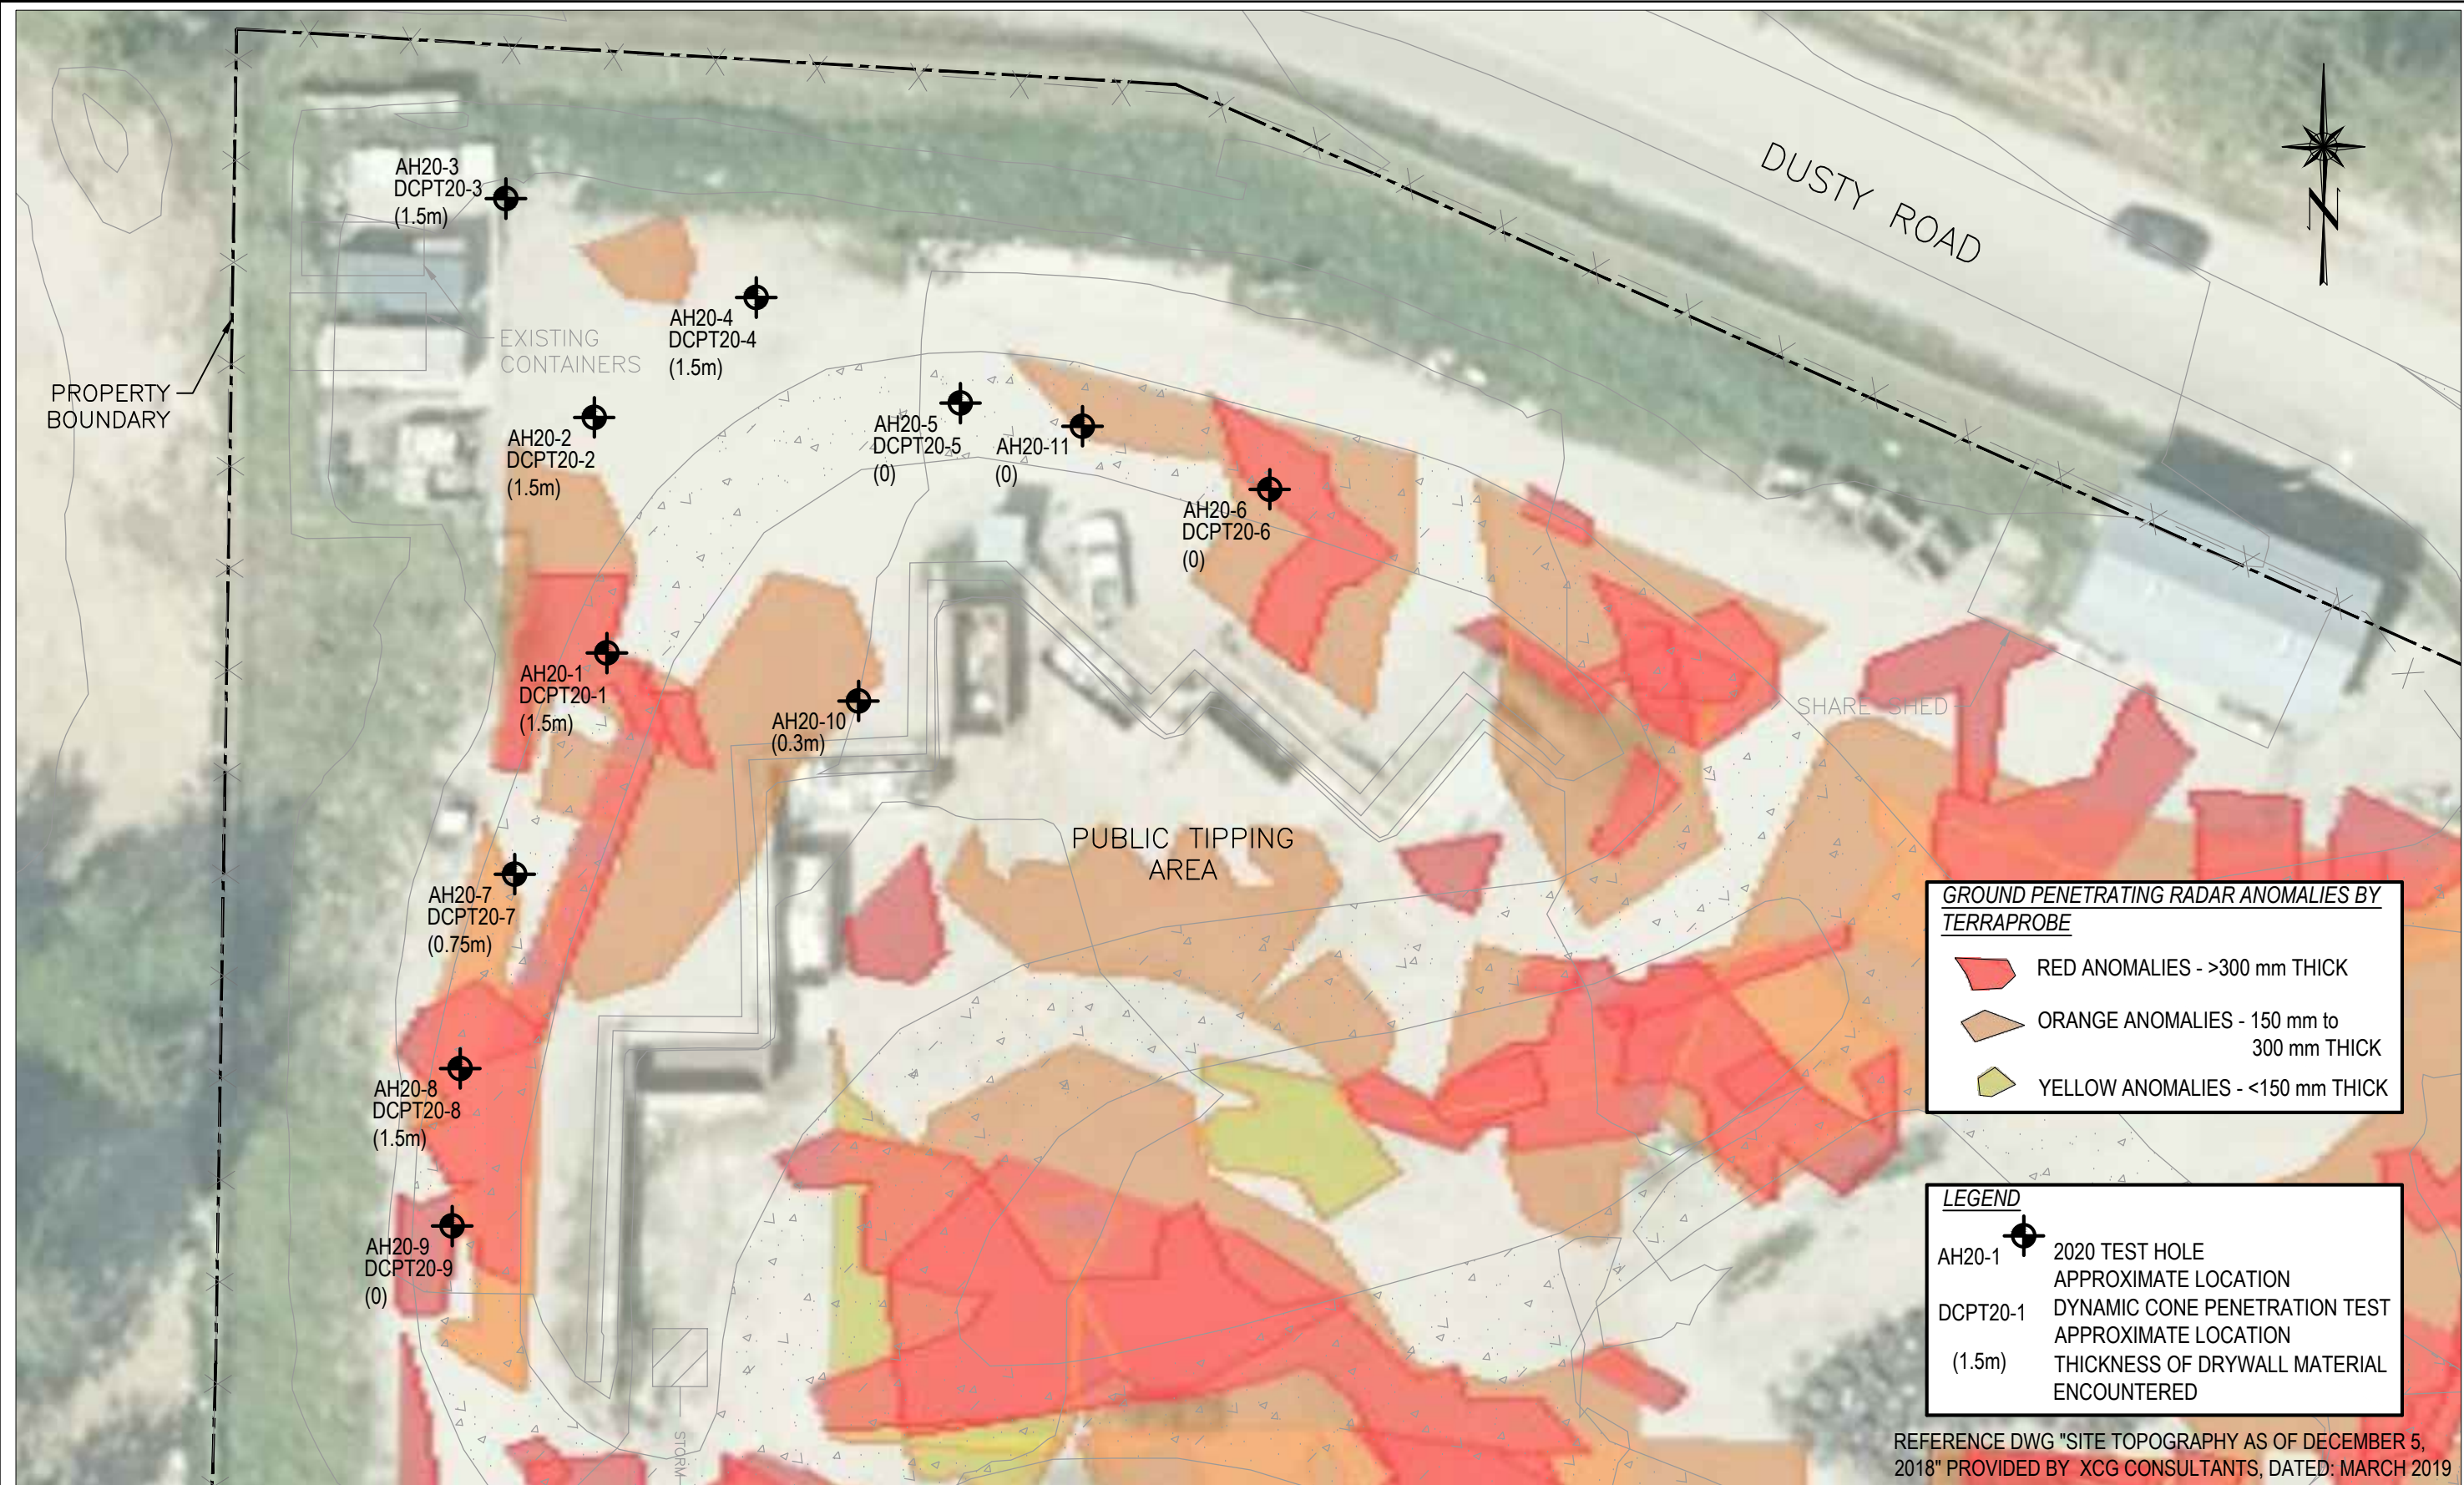
Title			LOCATION PLAN		
Date	February 10, 2020	Scale	1:300	Drawing no.	13-5854-01

On February 3, 2019, we mobilized personnel and a drill rig to the site to explore the soil conditions in the area of the sinkhole and the extent of the MSW/drywall material. A total of eleven solid stem auger holes were advanced to about 3 m depth. Nine Dynamic Cone Penetration Tests (DCPTs) were conducted adjacent to select auger hole locations to a maximum depth of about 4.3 m. Approximate test hole locations are shown on the attached Test Hole Location Plan (Dwg. No. 13-5854-01).
