SCRD Water Intake Inspections

Trout, Ruby, Waugh, McNeil, Garden Bay & Hotel Lakes

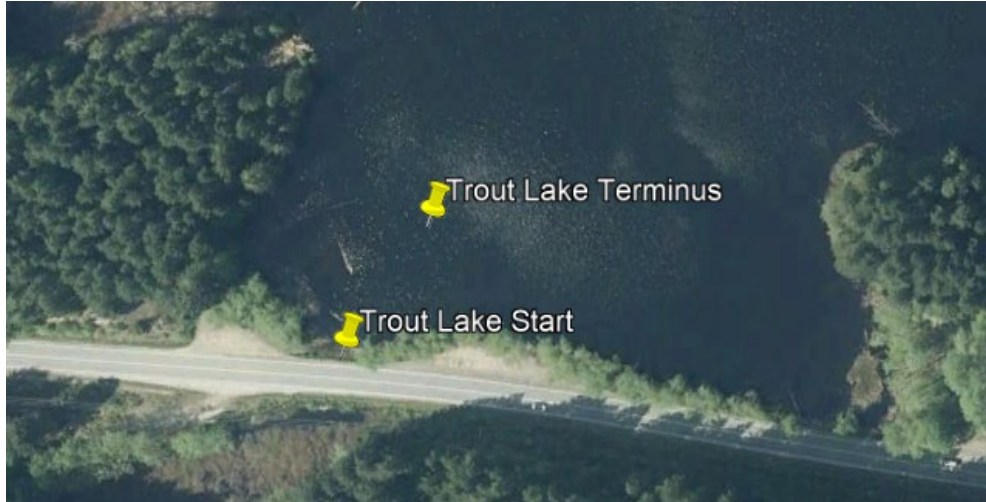
FREEDOM DIVING SYSTEMS LTD
LOCATION: Trout Lake
PROJECT: Intake Inspection

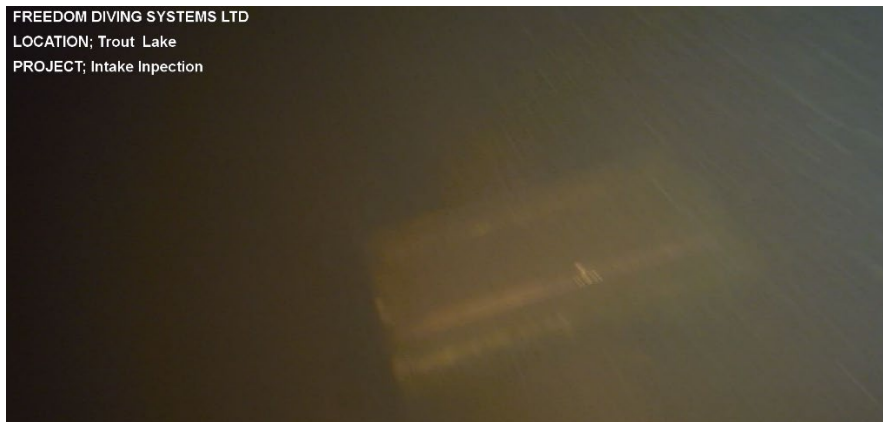
FREEDOM DIVING SYSTEMS LTD
LOCATION: Trout Lake
PROJECT: Intake Inspection

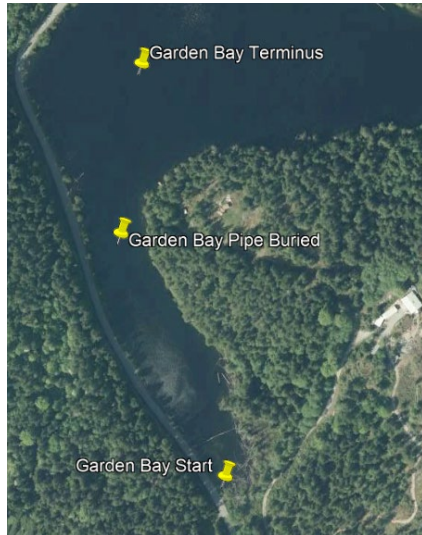
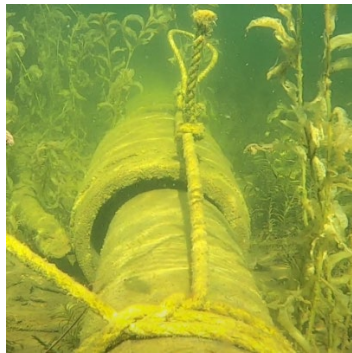
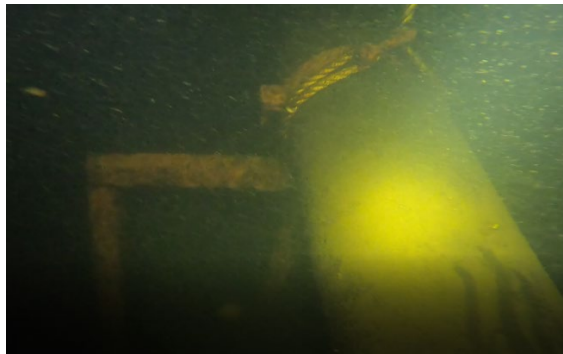
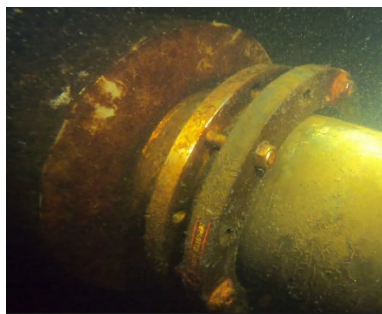
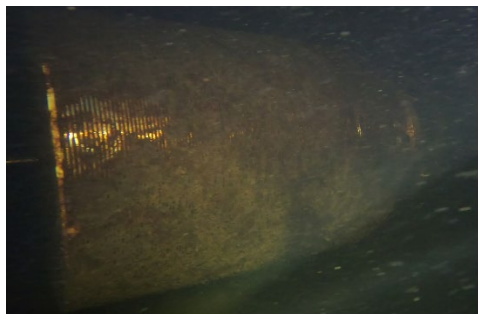
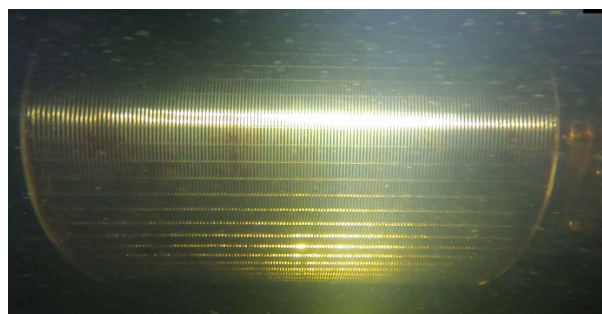
Garden Bay Lake Photos
