Potable Water Reservoir Inspection: Cove Cay

Inspection Date: June 29th, 2023

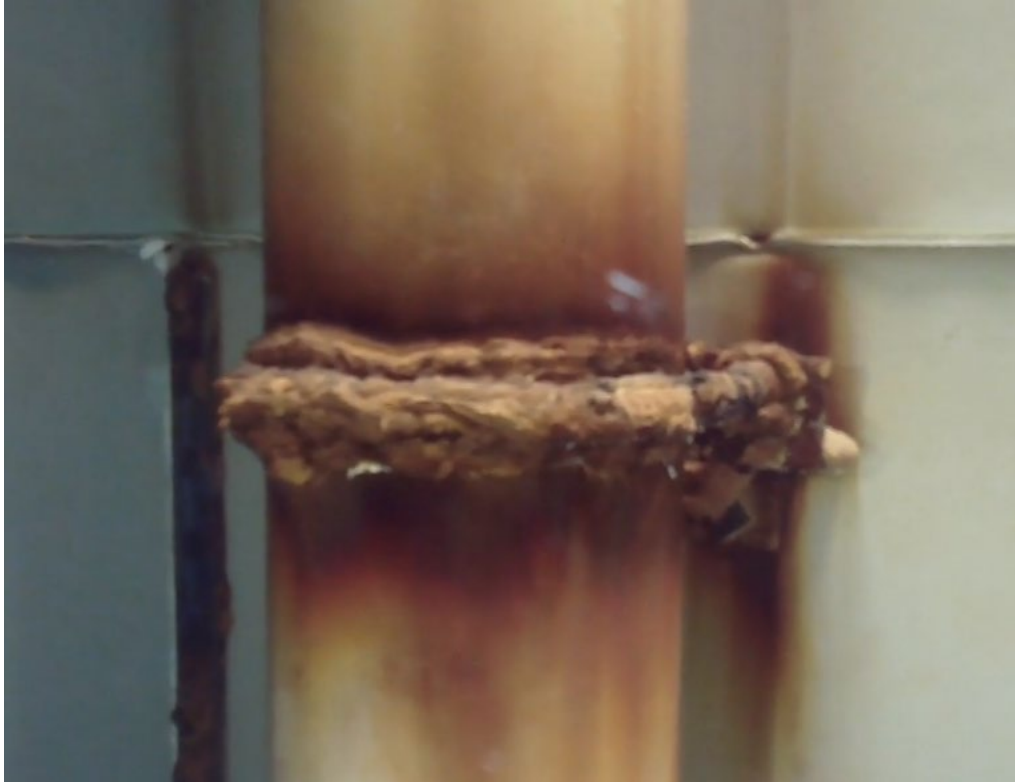
Image 2 & 3 - 00:02:07 – 00:07:10 Isolated corrosion along plate seams.

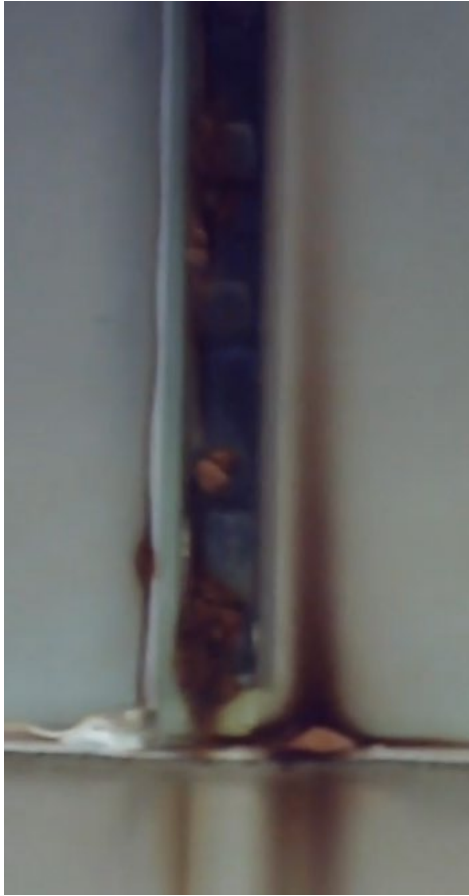
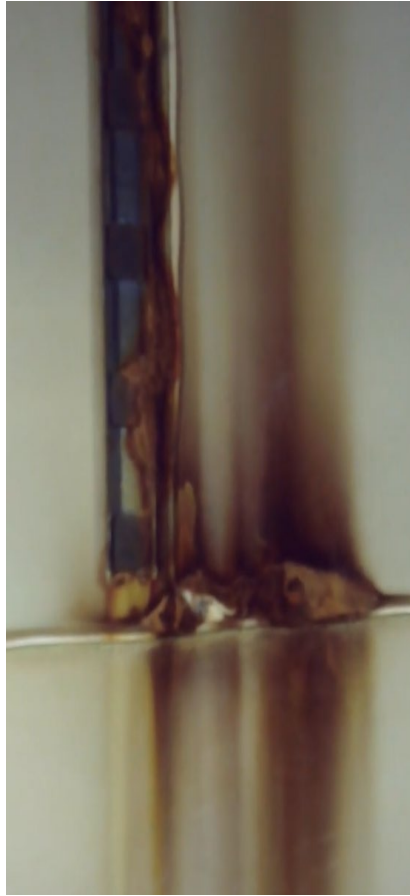
Image 4 - 00:07:30 Right of hatch overflow pipe upper support bracket, Observed heavy corrosion.

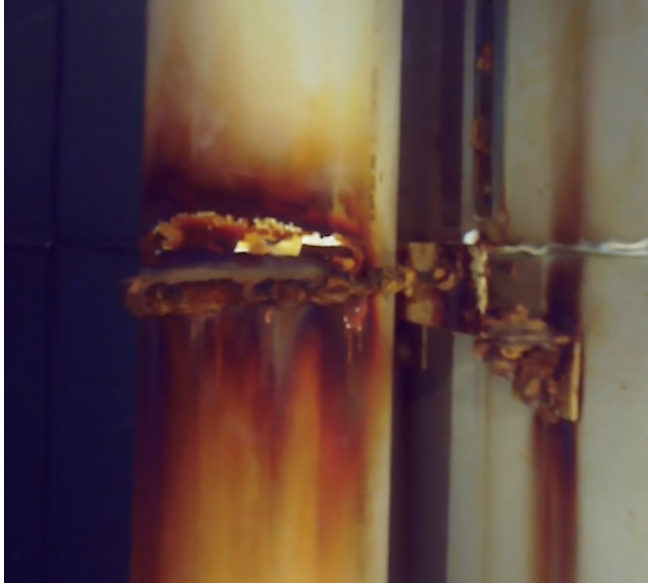
Image 5 - 00:08:51 Right of hatch overflow pipe lower support bracket, Observed heavy corrosion.

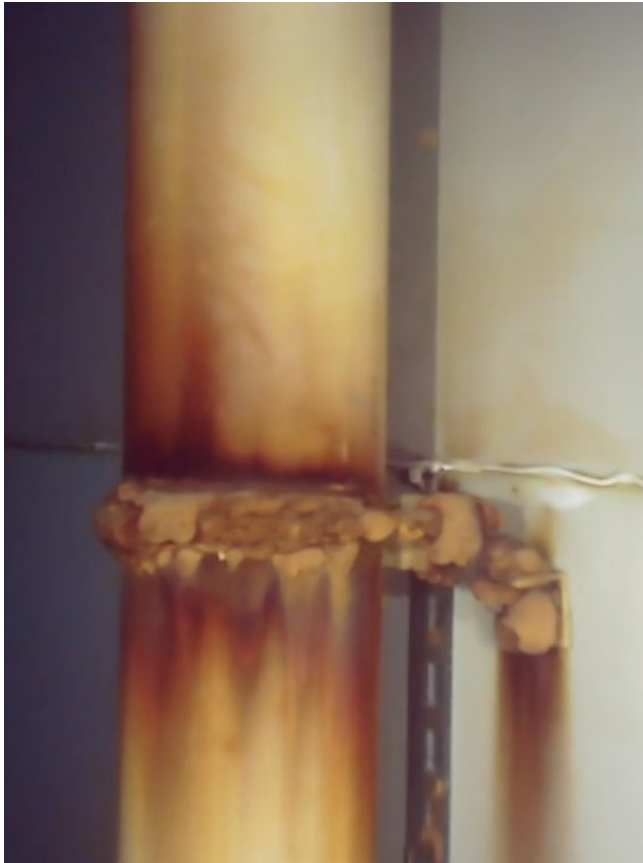
Image 6 - 00:11:07 Left of hatch inlet pipe lower support bracket, Observed heavy corrosion.

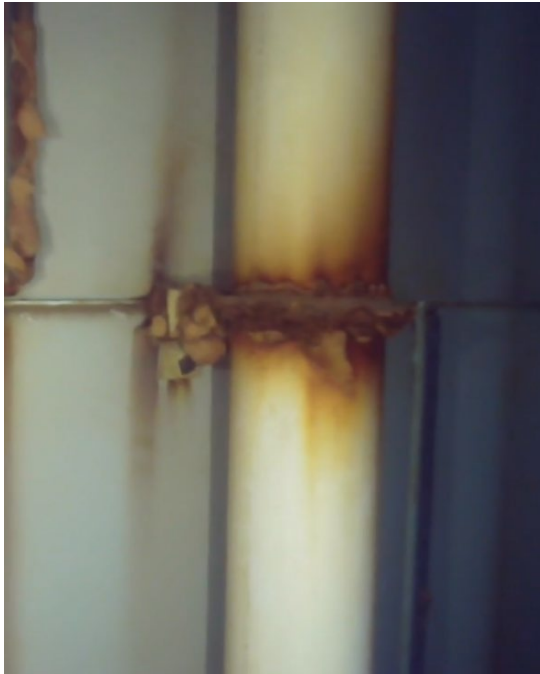
Image 7 - 00:13:22 Left of hatch inlet pipe lower flange, Observed heavy corrosion.

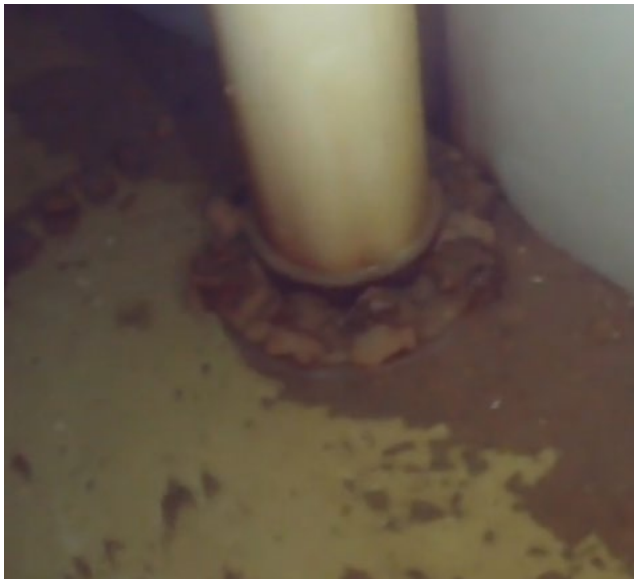
Image 8 - 00:13:43 Sump.

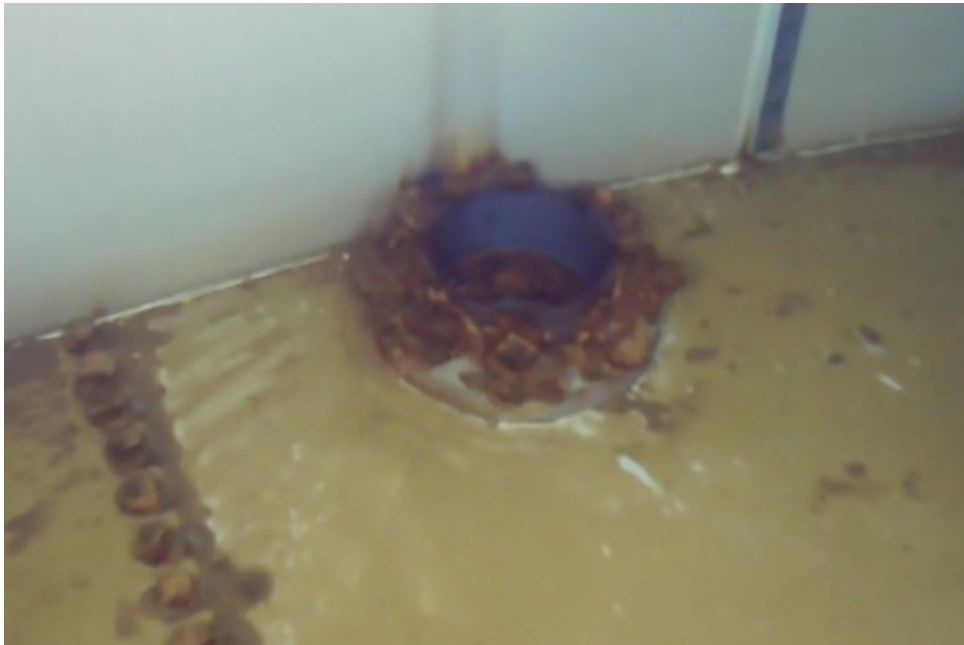
Inspection Conclusion
