# SUNSHINE COAST REGIONAL DISTRICT

## Hopkins Landing, Gibsons, BC

# PORTS CONDITION ASSESSMENT

## HOPKINS LANDING, GIBSONS, BC

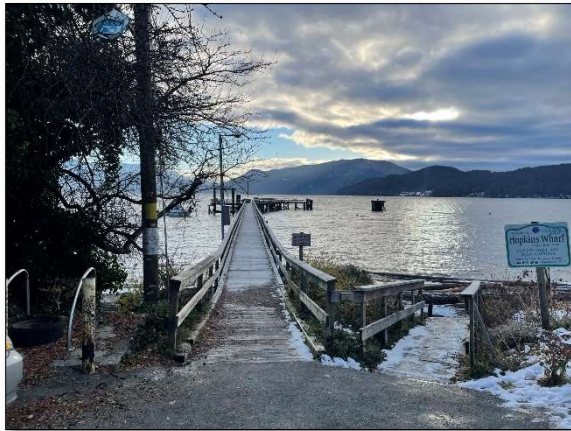
**Photograph 1:** Hopkins Landing, note: general arrangement from shore looking south

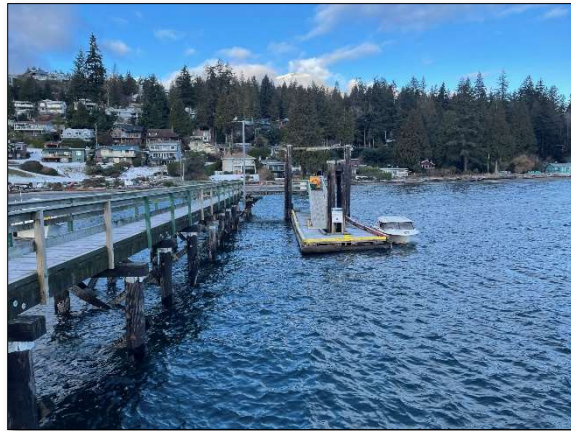
**Photograph 2:** Hopkins Landing, note: general arrangement from seaward end looking north

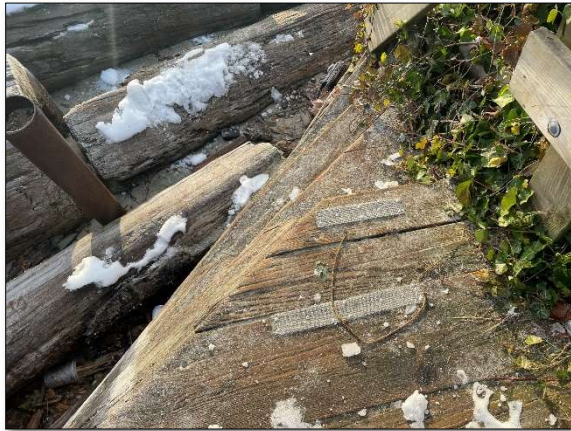
Adjacent to the abutment is a timber walkway that extends to the beach. The stairs at the end of this walkway are not typical. The treads have very little depth, and this could be a tripping hazard for the public. Consideration should be given to providing stairs which conform to BCBC 2018.

**Photograph 3:** Beach access stairs, note: atypical configuration

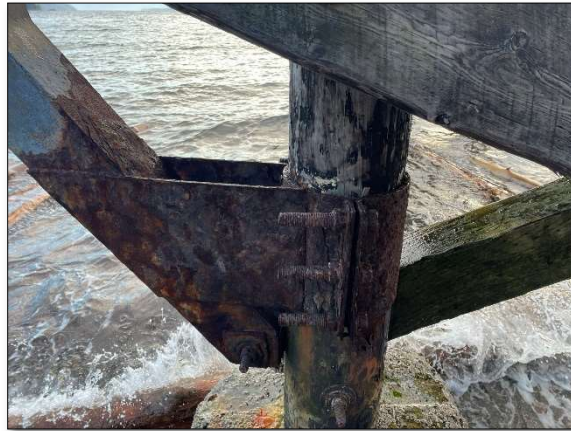
There is lighting at the facility. The light post brackets are significantly corroded and require replacement. There are localized areas where the insulation around the service wires has failed and there are exposed wires below the structure.

**Photograph 4:** Light post mounting bracket, note: significant corrosion

It is recommended that the brackets be replaced and the services be inspected by a registered professional.

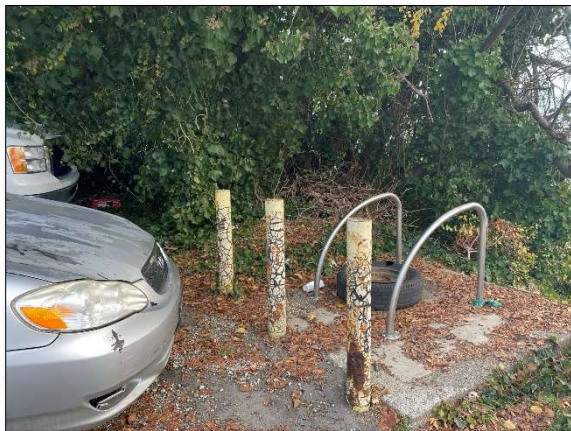
**Photograph 5:** Traffic bollards, note: coating failures

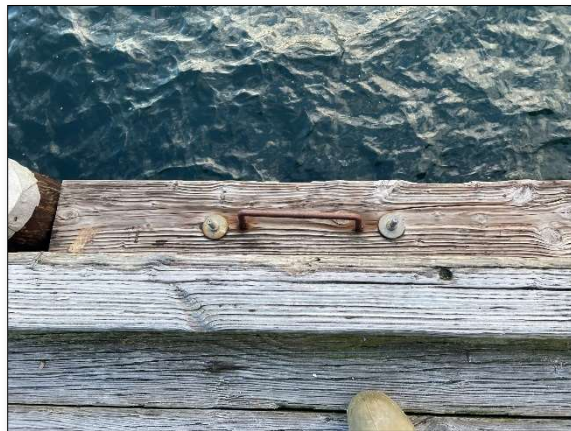
Their safety ladders require some remediation. The ladder at the end of the wharfhead does not have a complete concrete anchor and requires replacement. Signage is recommended to be installed indicating the ladder location from shore, as well as from water.

**Photograph 6:** Safety Ladder, note: no signage

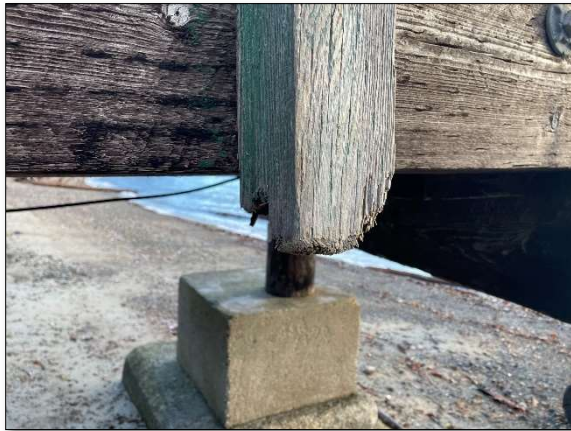
**Photograph 7:** Handrail post, note: cross section loss at cut end

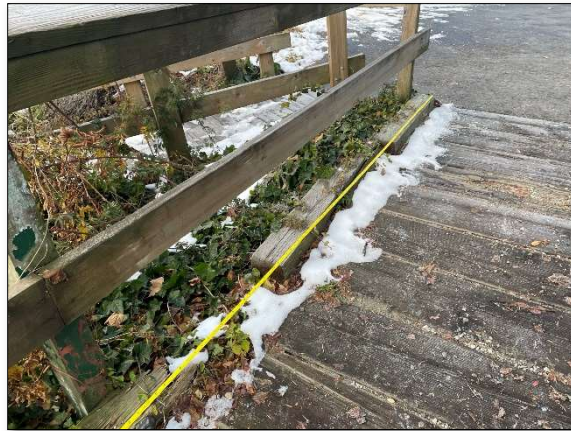
**Photograph 8:** Timber guard at 1.22m Gridline E, note: cross section loss and biological damage

There are ten sections of timber guard and one riser recommended to be replaced within the next year, and it is recommended that the approach and wharfhead be power-washed to remove debris and biological accumulation.

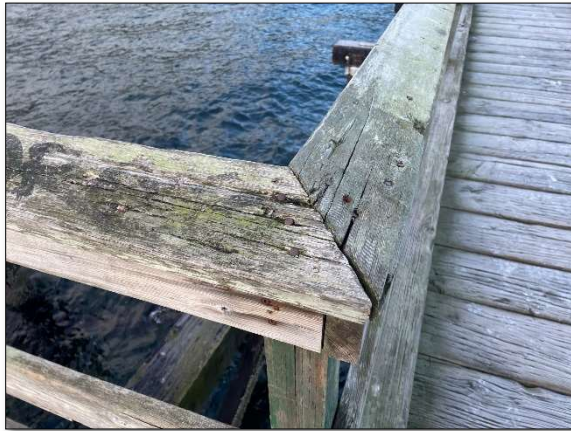
**Photograph 9:** Handrails, note: general condition is fair to poor

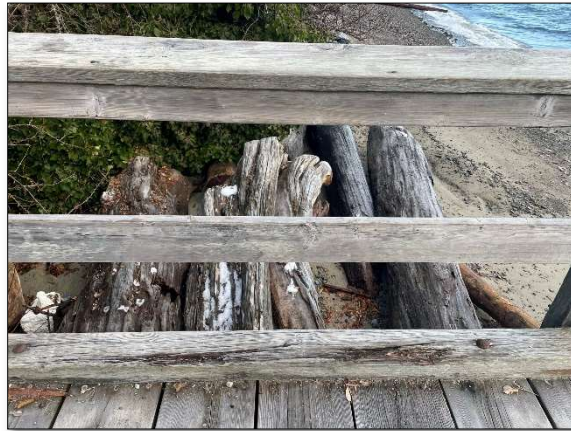
**Photograph 10:** Timber guard at 7.9m Gridline E, note: damage to cross section

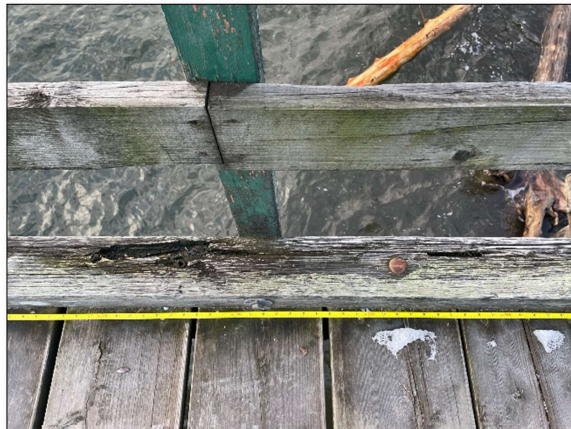
**Photograph 11:** Timber guard at 61m Gridline E, note: cracking through hardware, soft interior

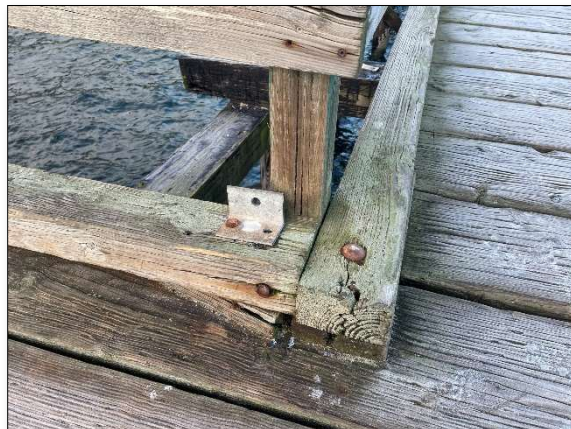
**Photograph 12:** Timber guard riser at 26E, note: damaged and decayed:

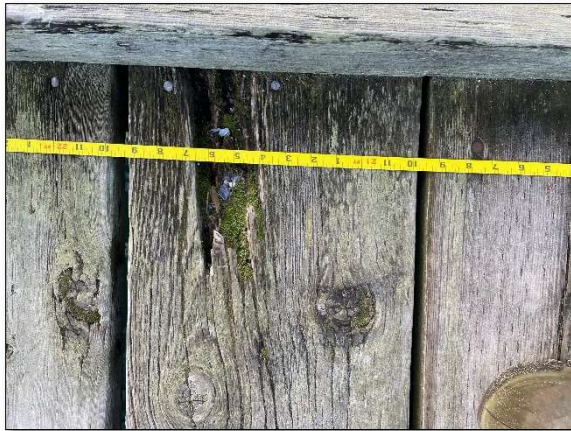
**Photograph 13:** Decking, note: general condition is fair to poor

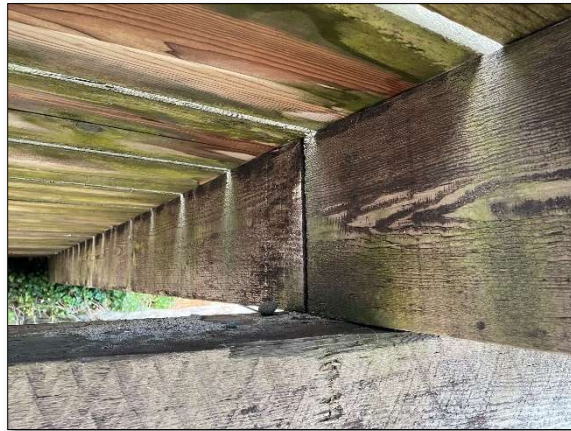
There are two stringer butt connections missing splice blocks and connection hardware. Splice blocks and appropriate hardware are recommended to be installed.

**Photograph 14:** Stringer butt joint, note: missing splice connection

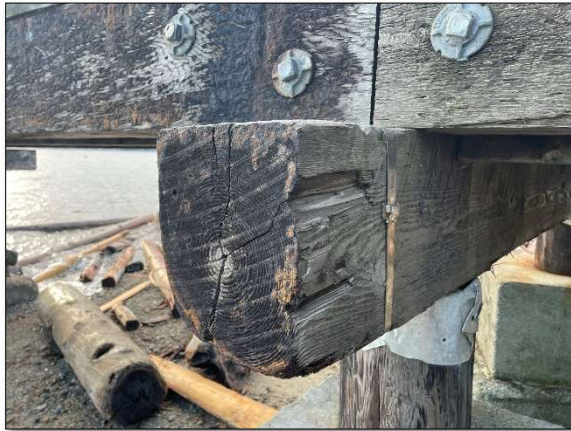
**Photograph 15:** Pile cap at Bent 1, note: strap repair and cracking

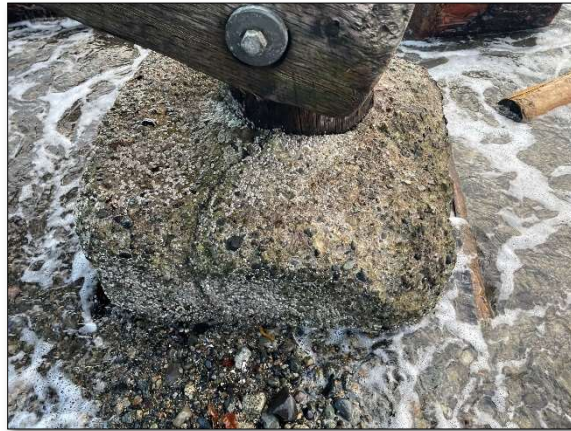
**Photograph 16:** Bearing pile 2E, note: spalls and cracks in footing with cross section loss

Within the next year, sixteen bearing piles require replacement, three footings are required to be re-cast, and sixteen bearing piles require remedial repairs such as strapping, patching, and/or installation of shims to restore full bearing.

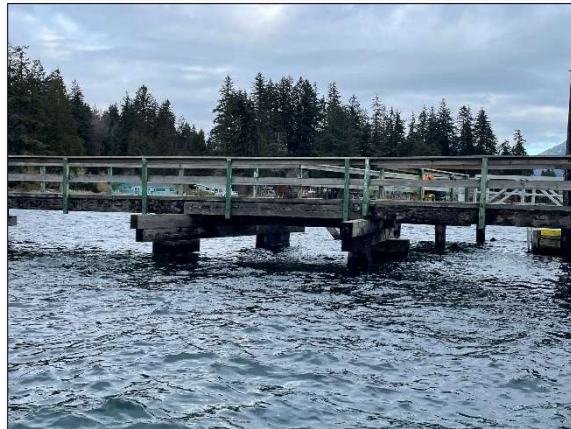
The bearing piles are in overall poor to very poor condition. Several bearing piles have been remediated using corbel repairs. In some areas there are more than one corbel (up to three) between the pile cap and the top of the bearing pile. This configuration is considered structurally unreliable for nominal lateral loads and all of these locations are required to be remediated.

**Photograph 20:** Bearing piles 15E and 16E, note: corbel repairs with pile submerged at HHWLT

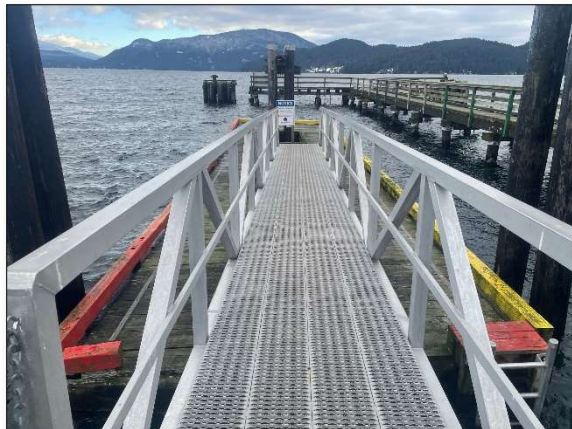
The gangway is in overall good condition. There are two sections of serrated aluminum decking which require replacement.

**Photograph 21:** Gangway decking, note: damage to two sections

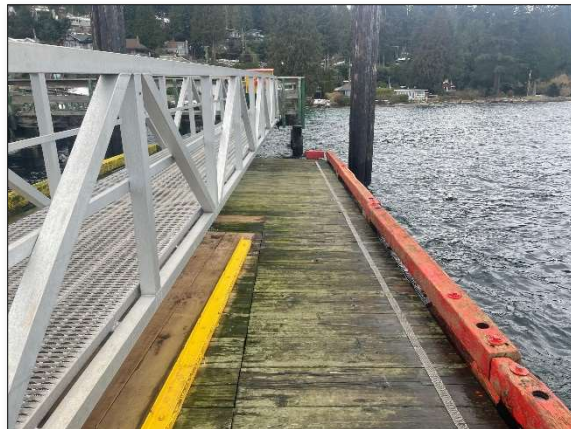
The freeboard around the float perimeter is inconsistent and deviates from acceptable design heights and tolerances. This is likely due to the deterioration within the substructure, as well as the condition of the polystyrene floatation.

**Photograph 22:** East edge of float, note: listing

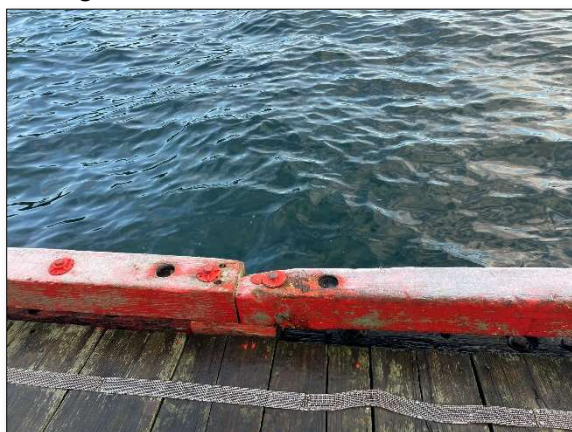
The substructure is in poor to very poor condition. There are two flanges that have failed and are hanging down below the underside of the float. The failed flanges have resulted in a significant list in the float freeboard (see below). The flanges are recommended to be replaced, as well as all the flange splice block hardware as is considered best practice.

**Photograph 23:** Float flange splice location, note: failed connection resulting in "sagging" of the bull rail/flange arrangement

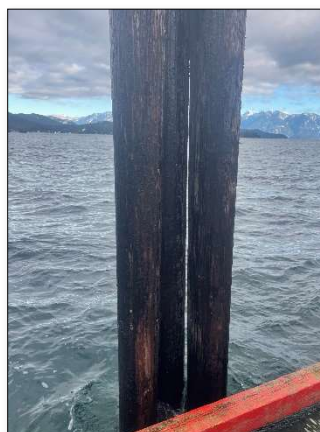
The mooring system is in overall poor condition. Three mooring piles are significantly abraded with areas of greater than 50% cross sectional loss. It is recommended that four mooring piles be replaced.

**Photograph 24:** Spread dolphin mooring piles, note: abrasion through the intertidal zone

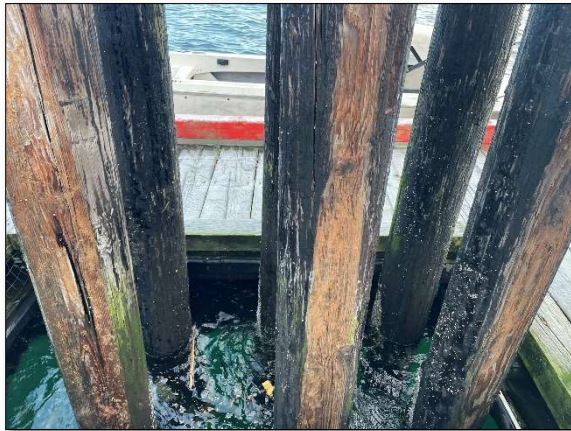
**Photograph 25:** Compact mooring dolphin, note: significant abrasion and cracking in the intertidal zone

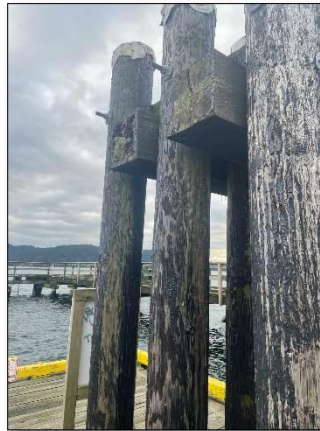
**Photograph 26:** Compact mooring dolphin, note: blocking significantly decayed

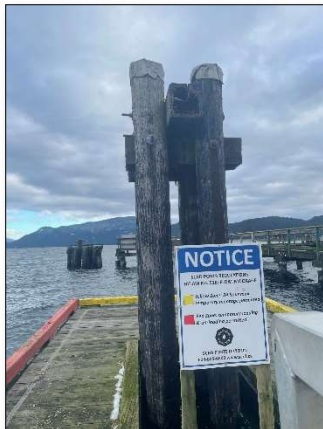
**Photograph 27:** Compact mooring dolphin, note: significant cross section loss to blocking

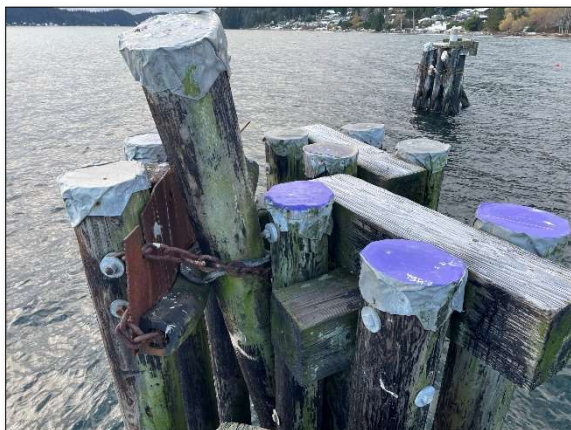
**Photograph 29:** Mooring Dolphin #2

Mooring Dolphin #2 has a broken pile below the water surface. It is recommended to be removed as it could be a potential navigation hazard.
