Hopkins Landing

Ports Load Limit Safety Assessment

February 15, 2019

HOPKINS LANDING PORT FACILITY STRUCTURE CONDITION INSPECTION AND REPORT

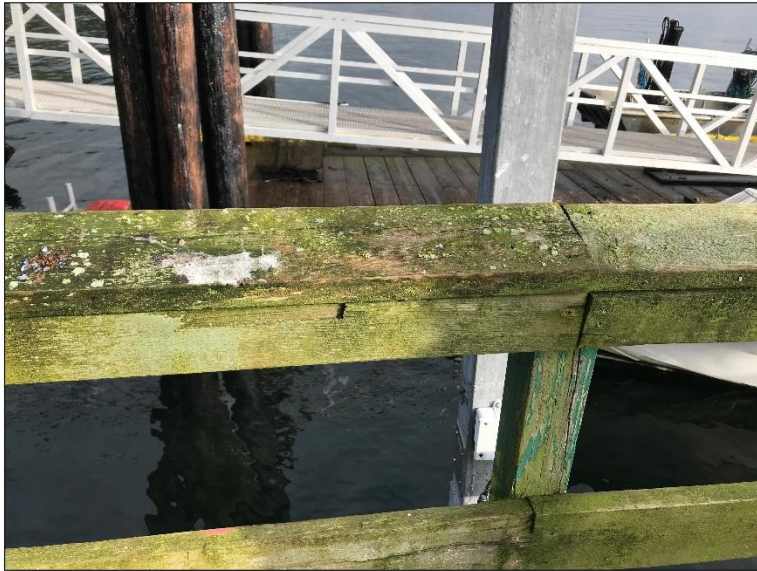
The topside elements have significant biological growth and damage. The superstructure is recommended to be power-washed, and one handrail, one top-rail, and three posts are

Photograph 2: Approach handrails, note: significant biological growth

recommended for replacement, as well as seven sections of the guard. The remaining guards and risers is recommended to be replaced within the next 1-3 years.

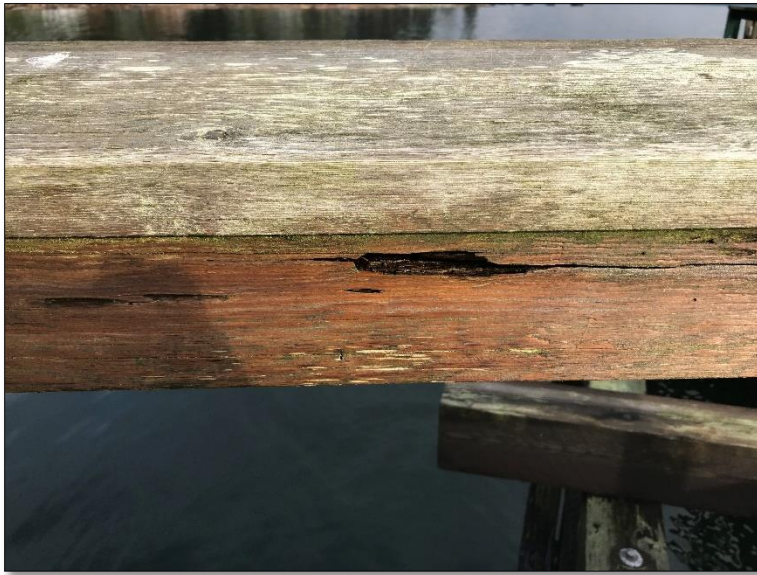
Photograph 3: Approach handrails, note: biological damage

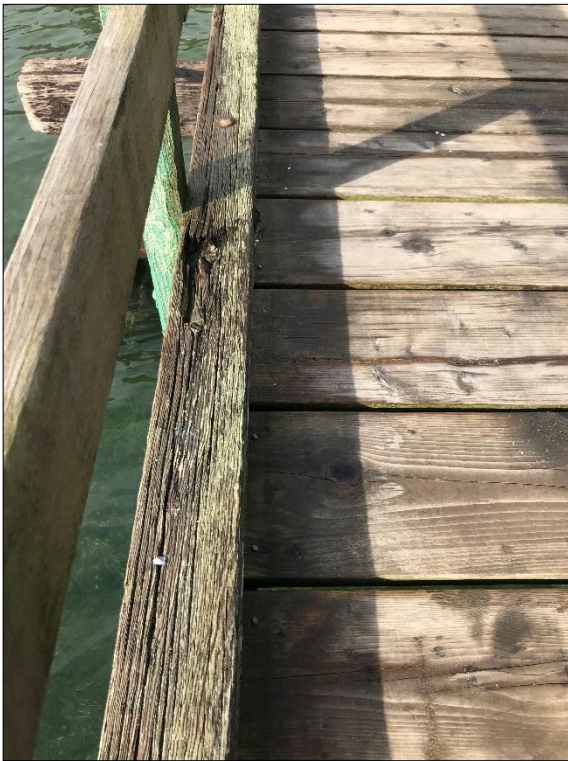
- The guard timber along the approach and wharfhead do not meet minimum height requirements of 250mm consistently at the facility. It is recommended that guarding be replaced with minimum height requirements.
- There is no guard along the face of the wharfhead. The wharf deck width is only 1.83m. It is recommended that the edge be guarded.

Photograph 4: Approach guard, note: biological growth and decay

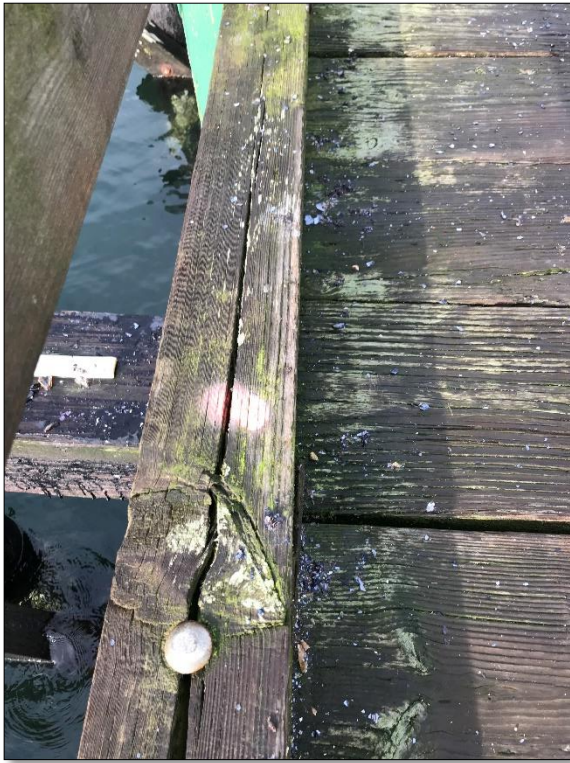
Photograph 5: Approach guard, note: biological damage and splitting

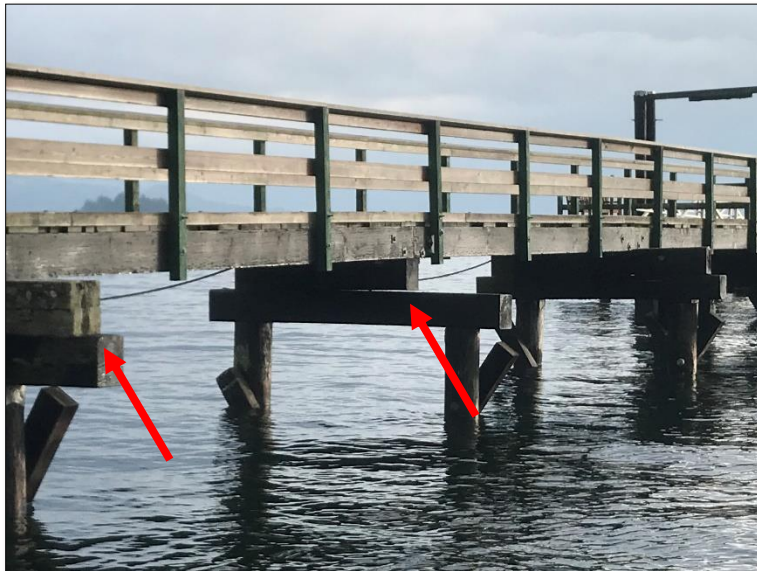
There is one pilecap which is recommended to be replaced. Ongoing monitoring and coring of the pilecaps at the next scheduled inspection is recommended.

Photograph 6: Bent 11 and Bent 12, note: decayed upper pilecap and pilecap not in bearing respectively

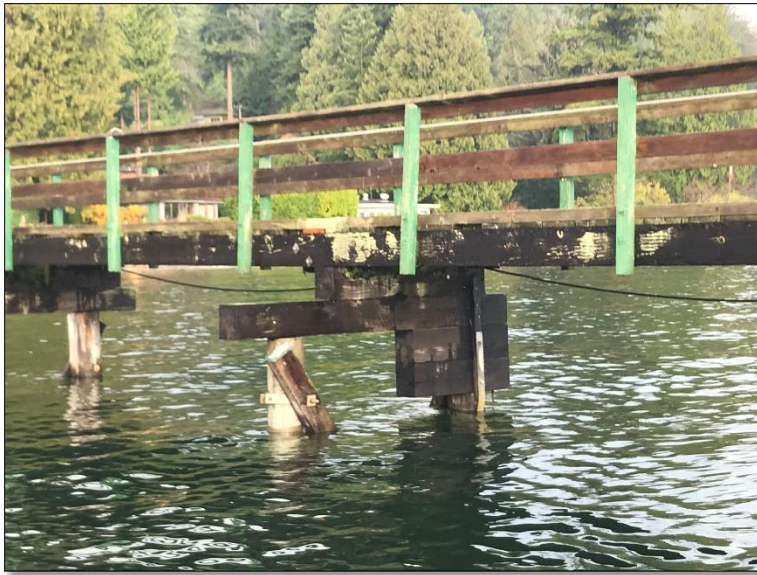
As general good engineering practice, the number of corbels and pilecaps is not recommended to exceed three elements between the stringers and the bearing pile. Once this limit is exceeded, stability begins to be an issue. Three bearing piles are recommended for replacement based on exceedance of this number of corbel installations.

Photograph 7: Bearing pile 13D, note: unstable arrangement

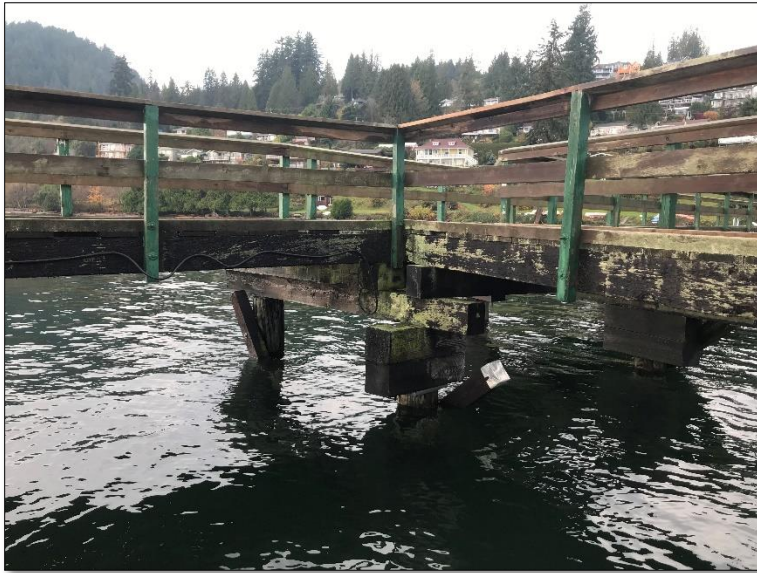
Photograph 8: Bearing pile 17D, note: unstable arrangement

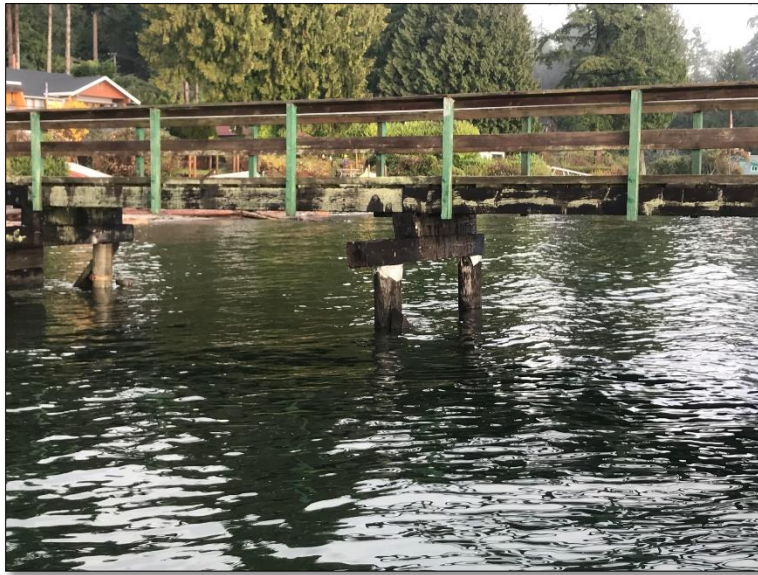
Three cross braces have been recommended for replacement, and six braces are recommended to be repaired.

Photograph 9: Bent 6 Cross Bracing, note: missing

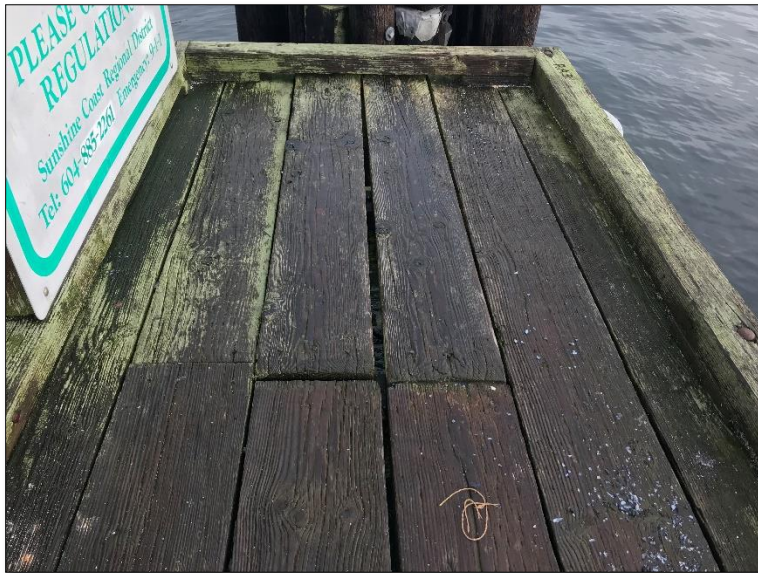
The decking is in overall fair condition. Power-washing is recommended, as well as ongoing monitoring.

Photograph 10: Decking on wharfhead, note: 13mm trip hazard

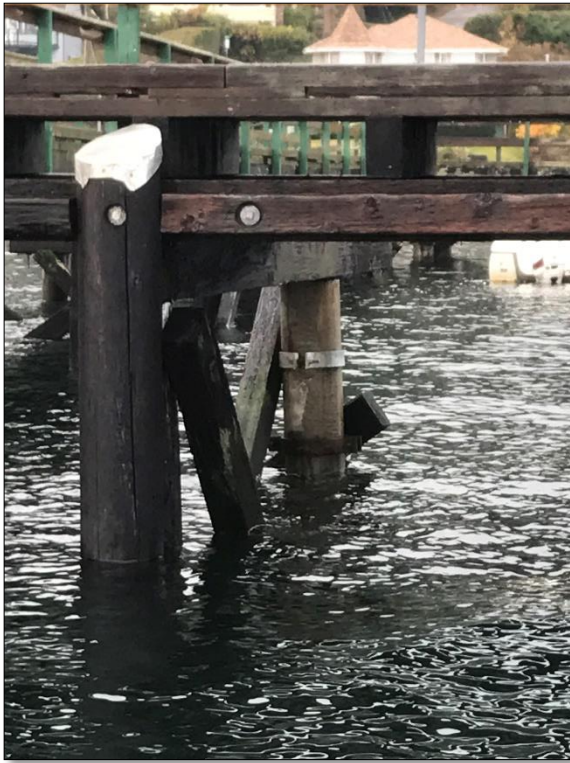
The bearing piles are in overall fair-poor condition. Several piles have been repaired using corbel blocks, strapping, concrete pile replacement, and/or steel angle strapping.

Photograph 11: Bearing pile 27B, note: concrete pile repair

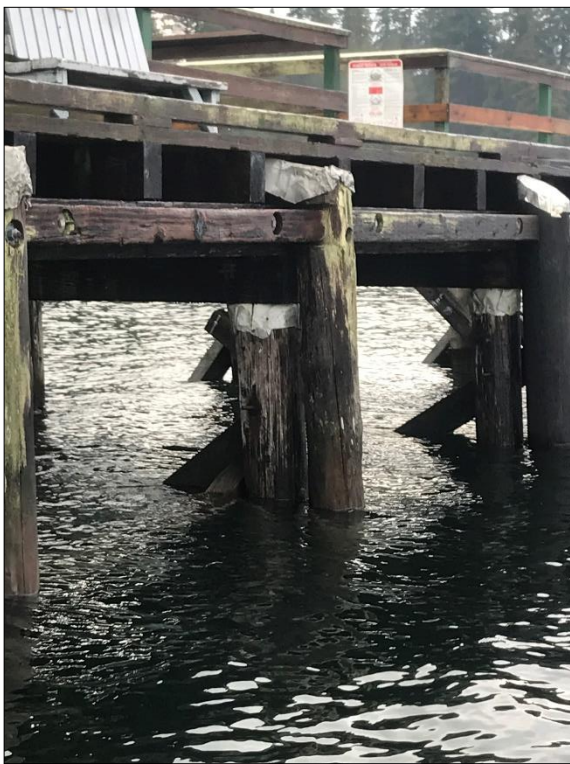
Photograph 12: Bearing pile 28F, note: damage at cross brace thru-bolt

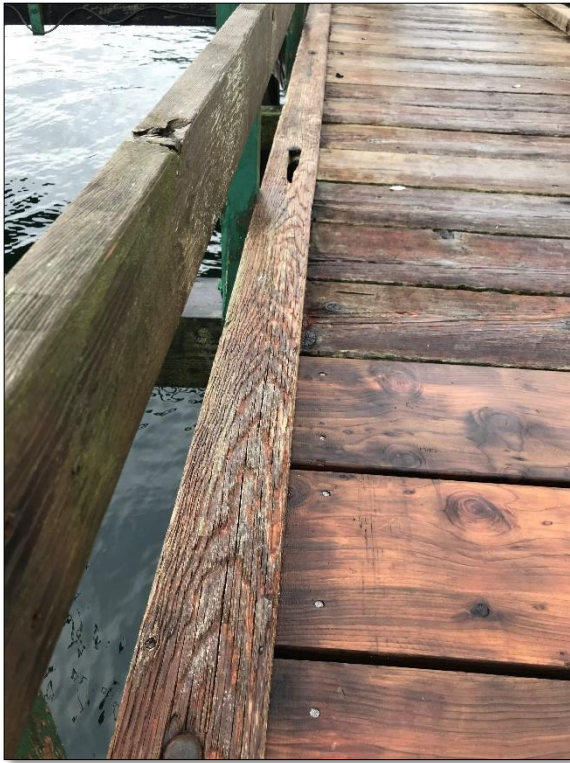
Photograph 13: Guard along approach gangway, note: to be replaced

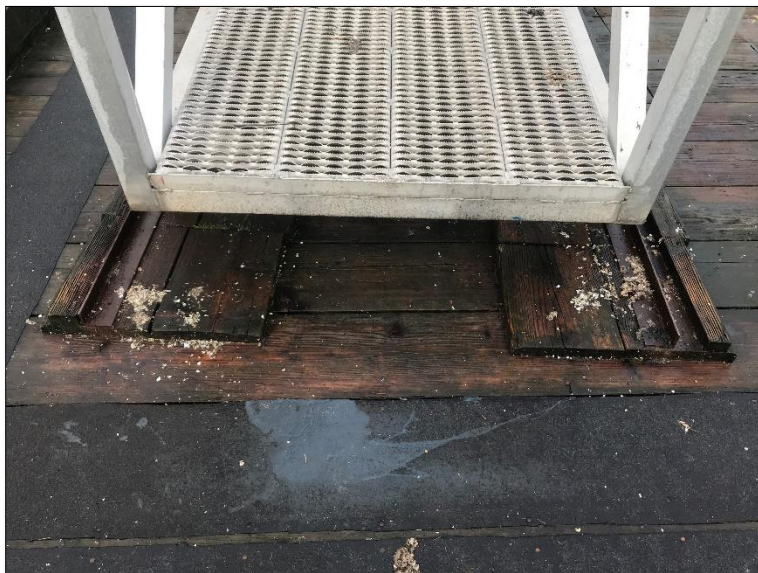
The landing pad is in overall fair-good condition. There is moderate amounts of biological growth on the timbers. Power-washing of the float deck and landing pad is recommended.

Photograph 14: Gangway landing pad, note: moderate splitting

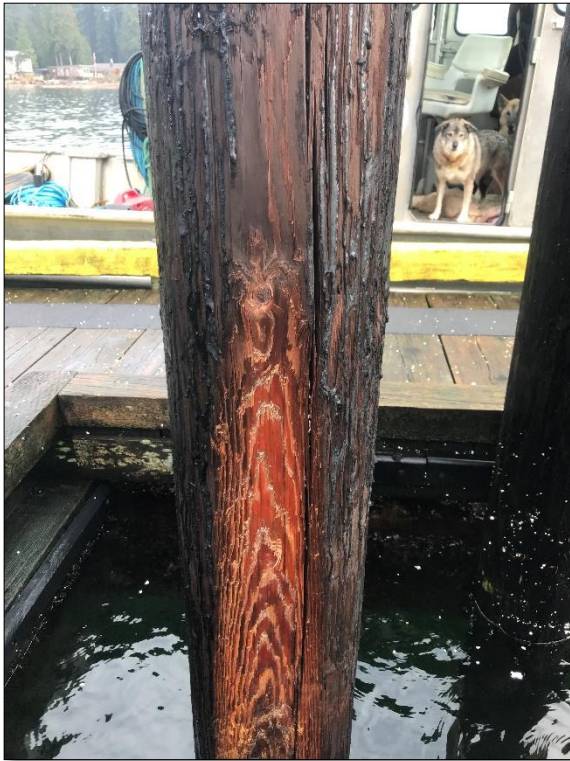
The mooring piles are in overall good-fair condition. There is moderate abrasion along the intertidal length of the piles, in some areas as much as 10% CSL was observed. Eight piles have been recommended to have UHMW wear strips installed, and one pile and the blocking at this dolphin is also recommended for replacement.

Photograph 15: Mooring pile, note: abrasion and splitting

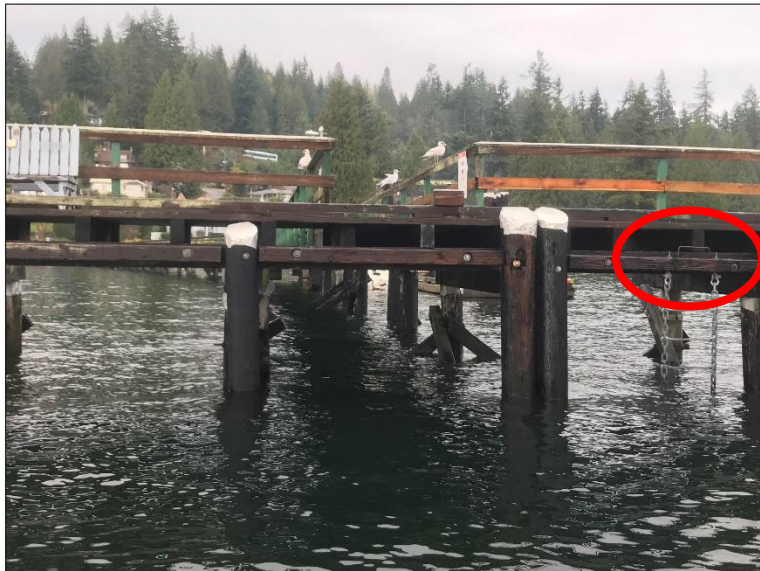
- The ladder along Bent 28 has its grab rail installed on the fender chock. This is not sufficient for egress from the water. The grab rail is recommended to be installed along the guard (once replaced).
- Ladders along the float and the approach and wharfhead are spaced at intervals exceeding 30 meters.
- The ladder locations are not identified with signage and/or high visibility paint on either side of the bullrail on the float, as well as at the wharf face.

Photograph 16: Safety ladder, note: secured to fender chock

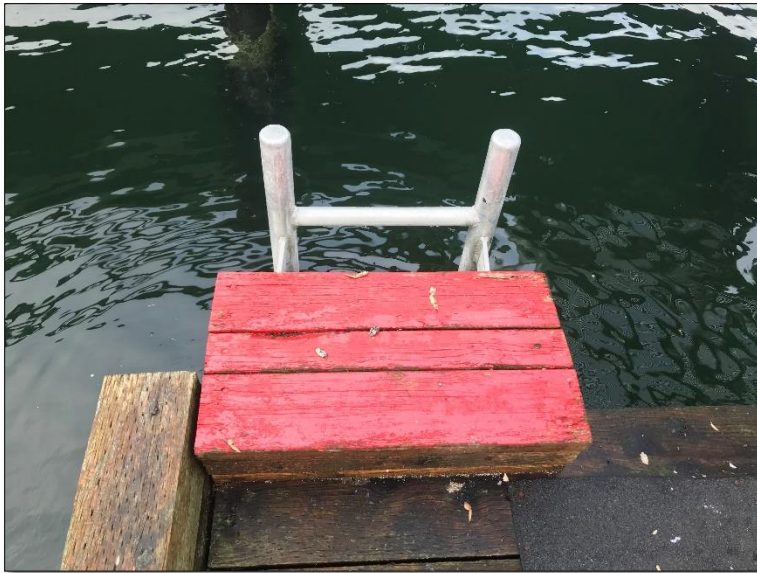
Photograph 17: Safety ladder on float, note: high visibility paint at location

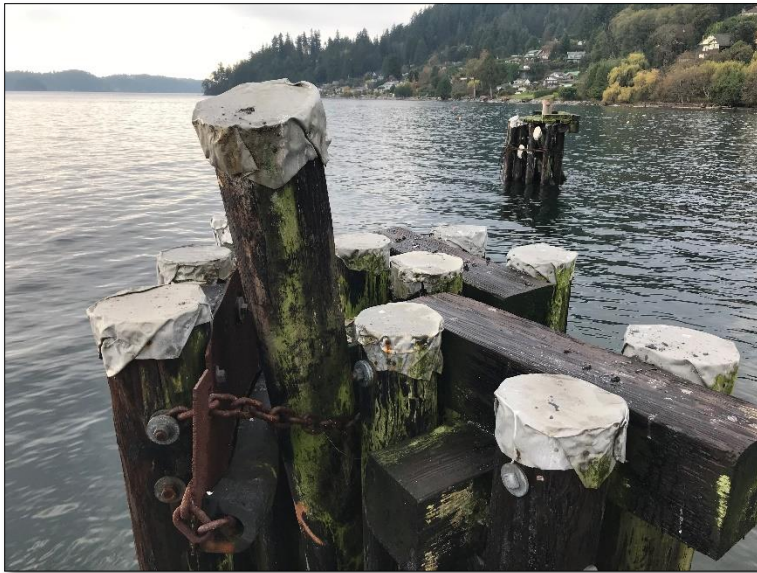
- Three derelict dolphins are located within the facility. There is evidence of public use as diving platforms. It is recommended that all three structures be removed from the facility.
- There is an abandoned pile south of the approach, which is not visible at higher tides. This is a navigation hazard and is recommended for removal.

Photograph 19: Derelict mooring dolphin at 28G and south of the facility, note: to be removed

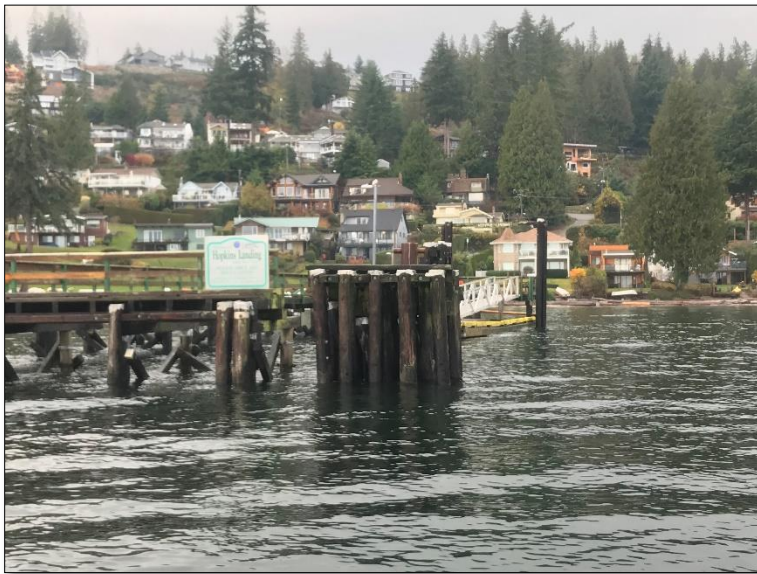
Photograph 20: Derelict mooring dolphin at 28A, note: to be removed
