SUMMERHILL
f i n e h o m e s i n c.

Routine Thrice-yearly Inspection Report #9

Hopkins Landing Port

Date on Site: April 11th, 2023
Report Submitted: May 29, 2023

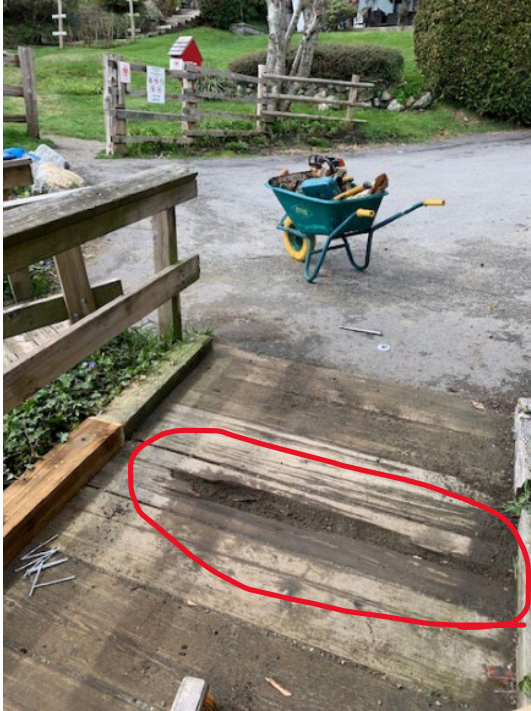
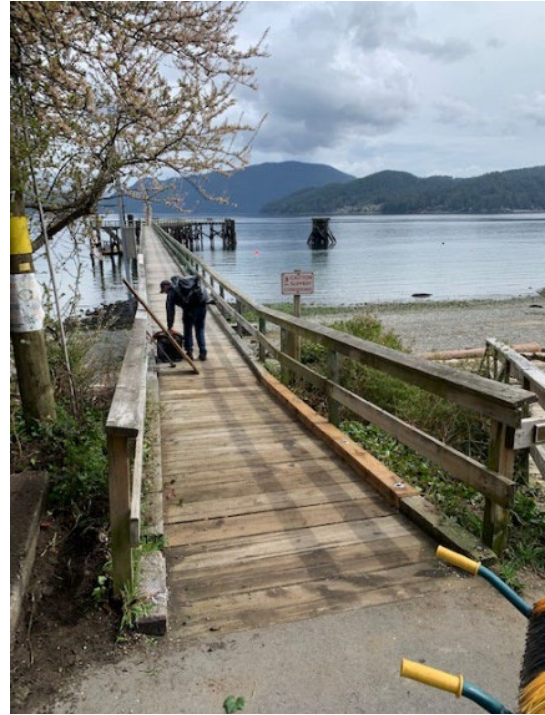
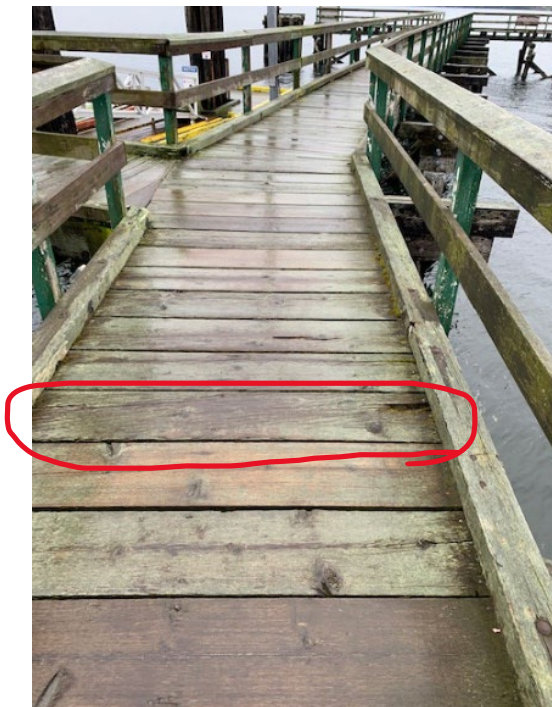
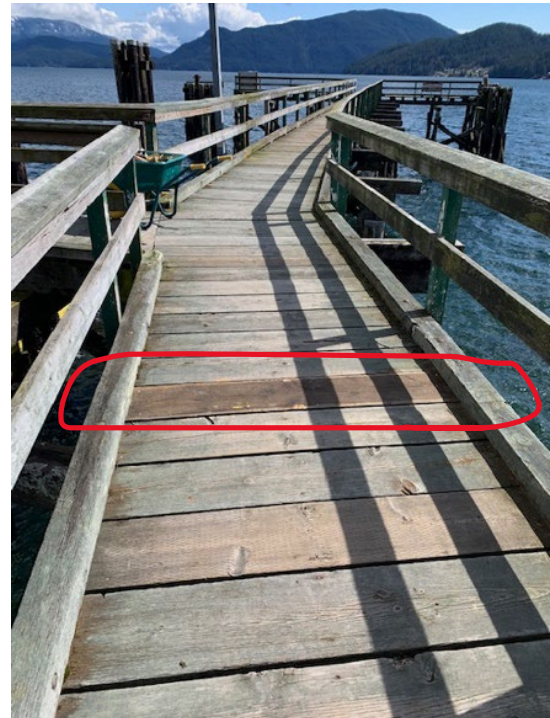
- 2 deck boards on the approach were replaced during round 9 (safety concern)

- 2 additional deck boards on approach require replacement in 1-2 years.
- Nails were set during round 9 per contract.

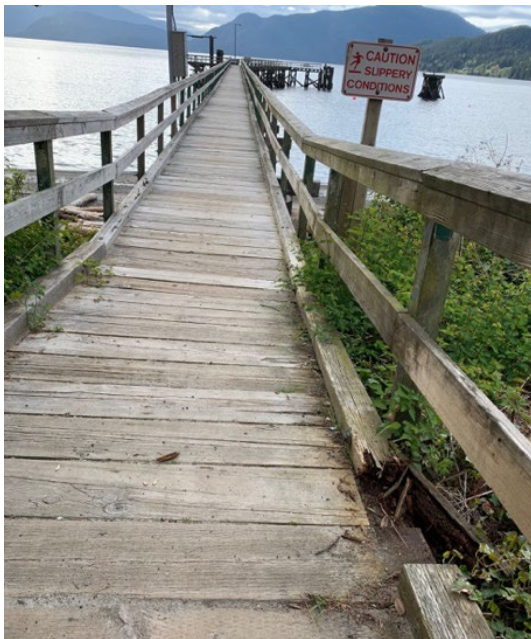
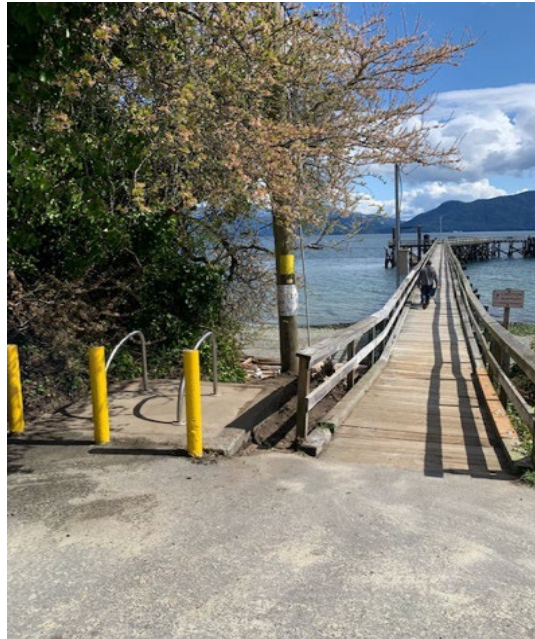
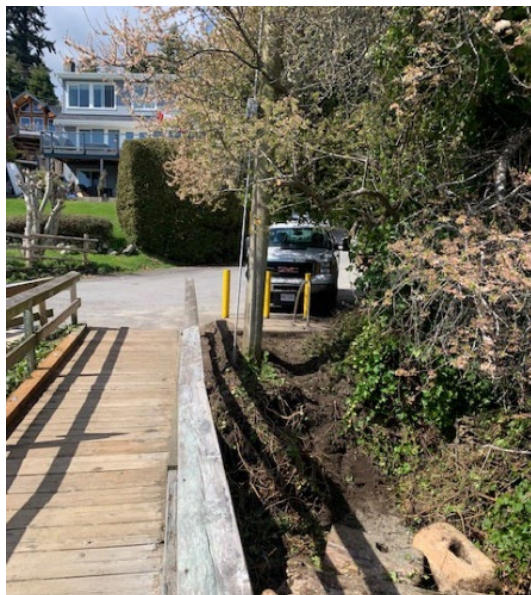
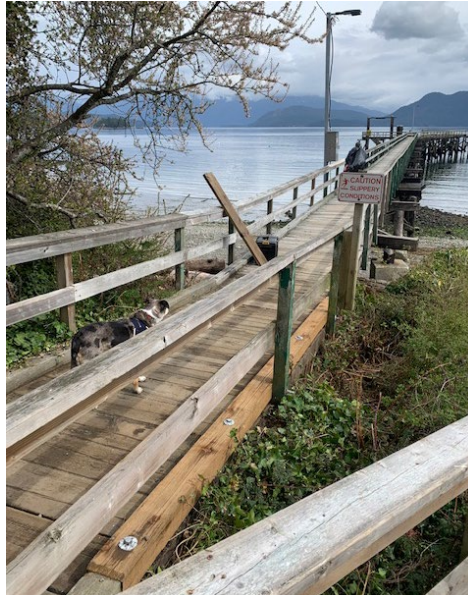
- (From previous inspection April 2019) Damaged near corner of the approach where it meets the gangway.
 - Condition stable, continue to monitor at future inspections.
- (From previous inspection April 2019) Curb rail buried under gravel deposits at the approach is showing significant rot. Recommend replacement of 16' - 4x6.
 - Curb rail on approach was replaced during round 9.
- Debris and vegetation were removed around approach.
- Curb should be installed by MOTI to divert water and debris and stop from flowing onto the approach.

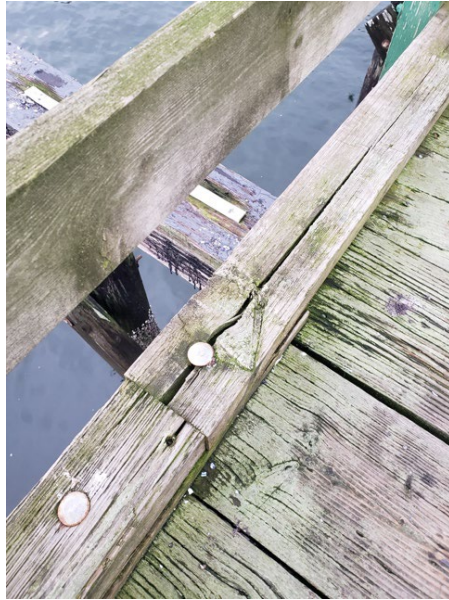
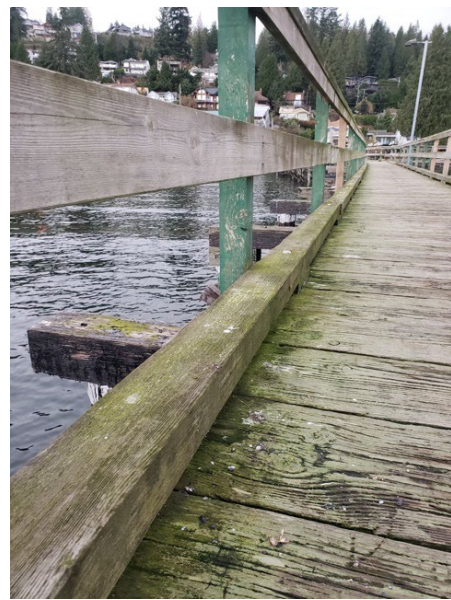
- (From Previous Inspection November 2021) Several other curb rails are showing signs of cracking and rotting.
 - Condition stable, continue to monitor at future inspections.

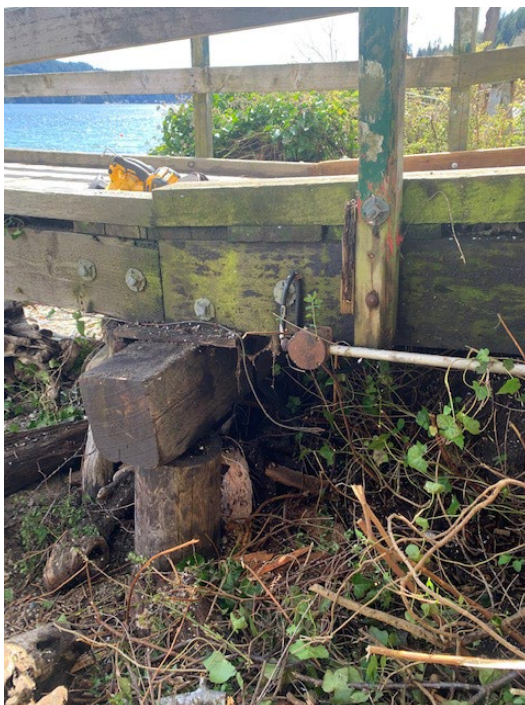
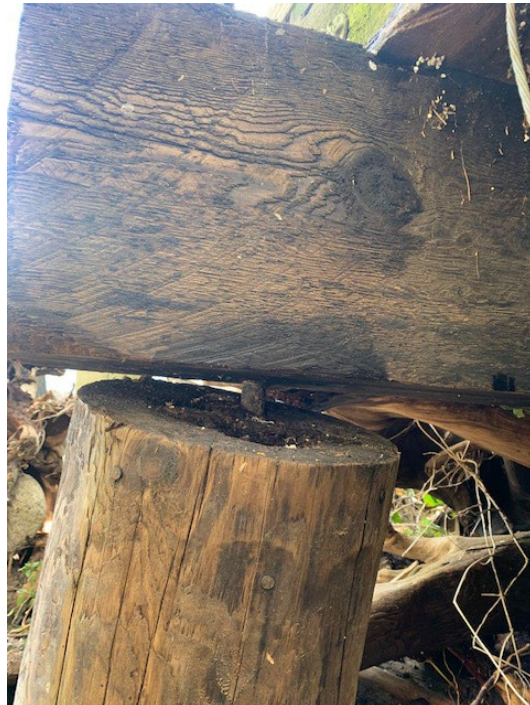
- **Bent 1** Log jammed under stringer, appears to not be properly supported.

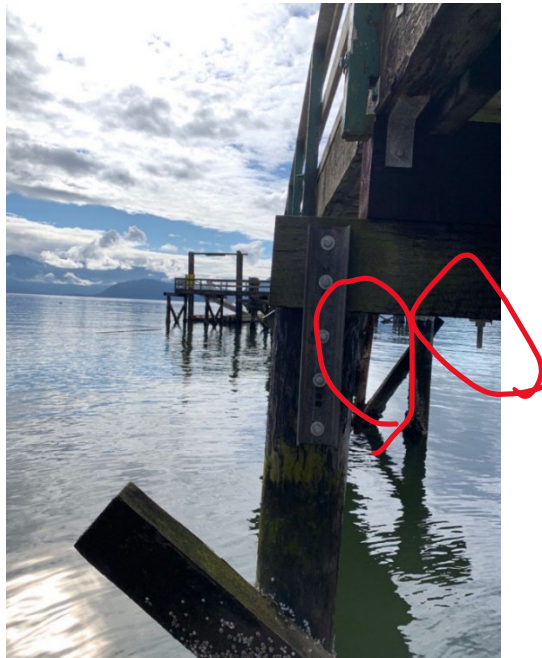
- **Bent 3** (From Previous inspection 2019) Recommend adding stainless steel banding at the top of pile *3D (no photo)
 - No action, condition stable, continue to monitor at future inspections.
- **Bent 4** (From previous inspection round) Concrete Pile 4D is cracked and warn, continue to monitor, consider future replacement.
- **Bent 5** (From previous inspection February 2020) Crack noted on pile *5E where cross brace bolts through.
 - Cap not fully bearing on pile *5E
- **Bent 9** (From previous inspection February 2020) Cross brace split at connection to pile 9E, recommend adding stainless steel strap. Monitor at future inspections.
 - Concrete Pile 9E leaning to the east

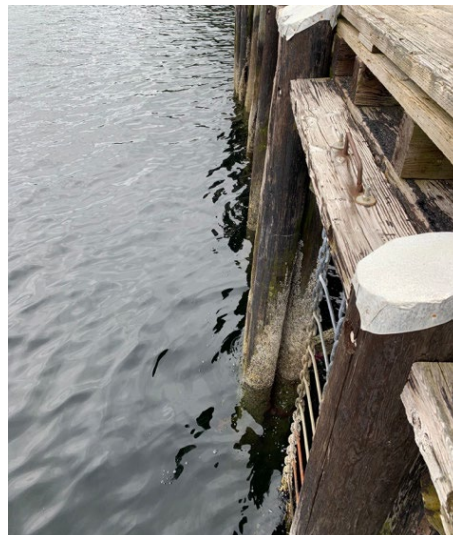
- (From previous inspection) Generally, in good condition although due to design, it is very challenging to climb up to the Wharfhead.

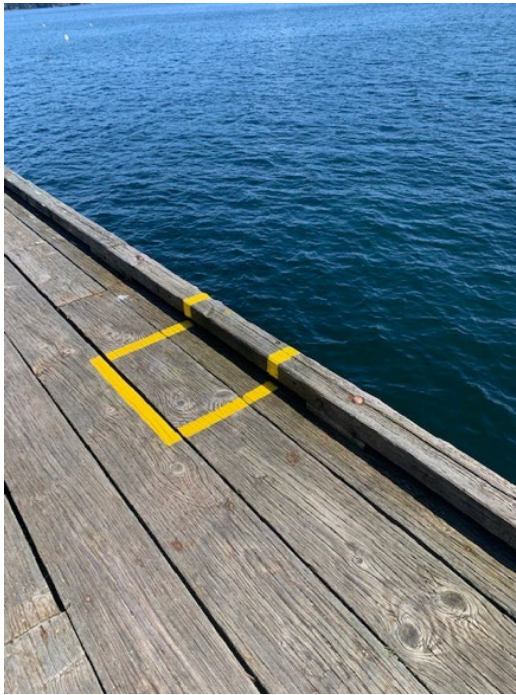
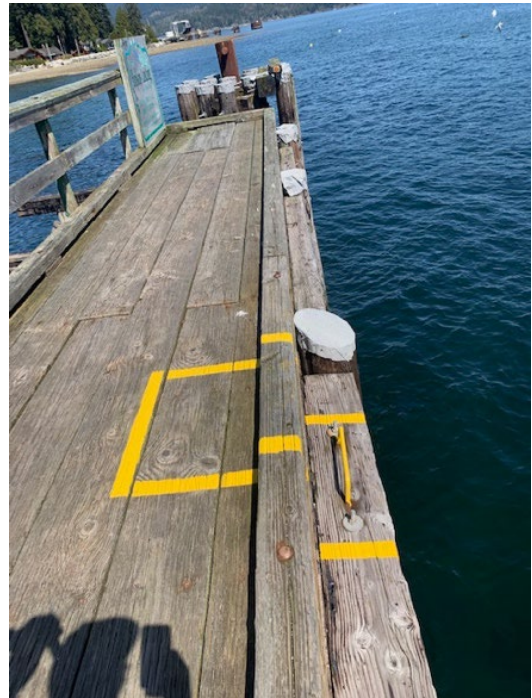
- Safety square added during round 9 to identify the ladder location.

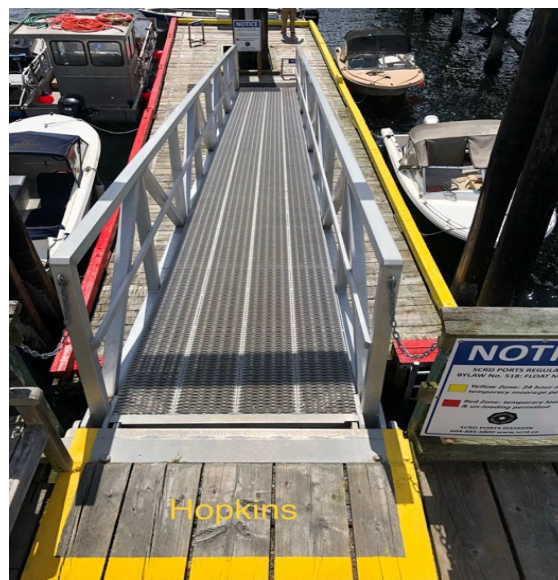
Observations: Generally in good condition

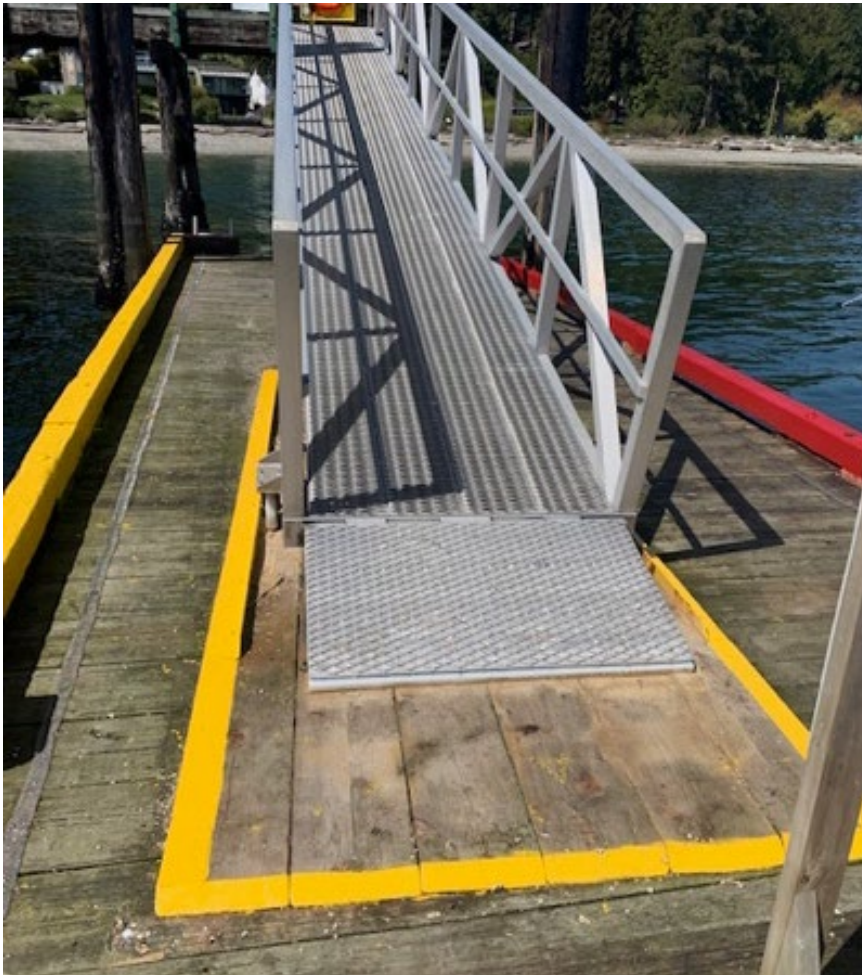
- New transition ramp and landing pad installed during round 8 appears to be holding up well.

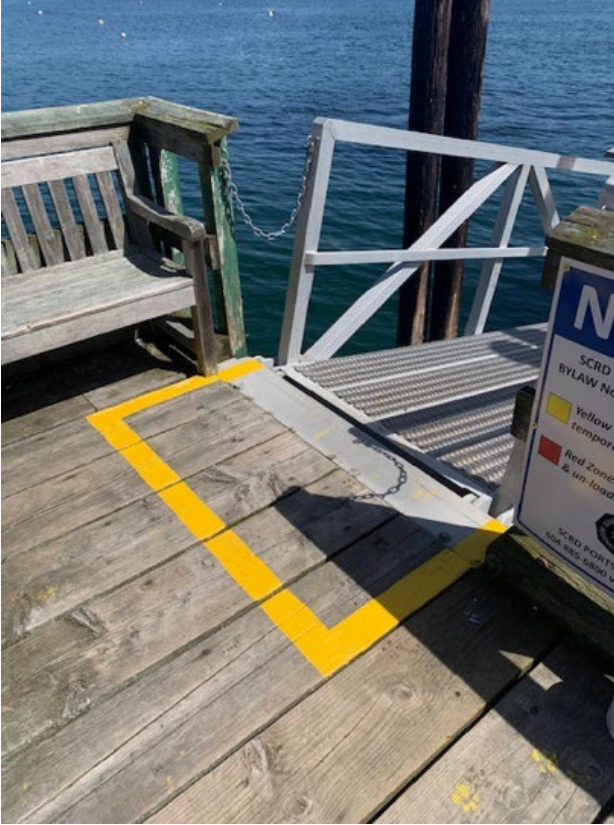
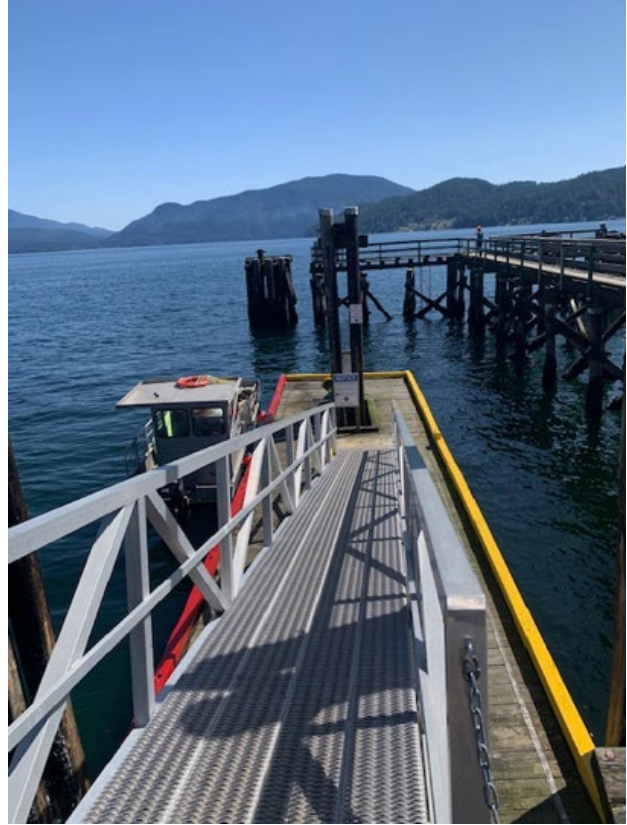
- Painting completed during, as per contract.
