Sunshine Coast 2017 Bridge Inspections

Structure Name: Metcalfe

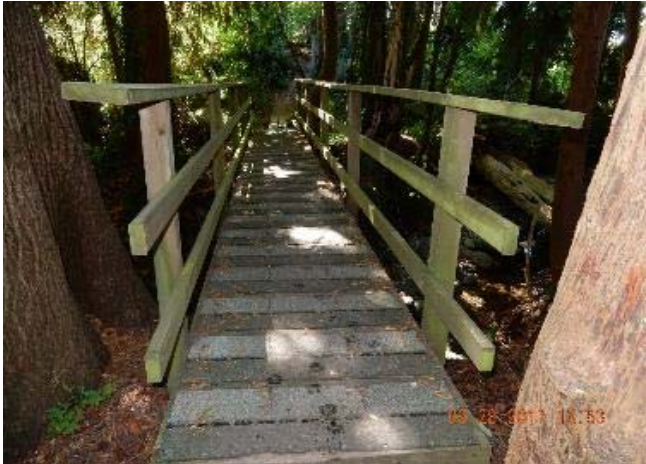
Parsons Waypoint #: 277	
Remaining Lifespan (Years): 15	
Replacement Cost: \$20,000	
Georeference: N 49°25'02" W 123°37'40"	
Deflection at Centre (mm): 0	
Weight Usage Restriction: 17 people, 1 horse, 2 ATVs	
Date Inspected: Sept. 28, 2017	
Inspected By: Grant Waldie, P. Eng., PE Michael Li, EIT	
Weather: 15°C, sunny	
Overall Rating of Bridge	Structure Description
POOR	8.4x1.04m beam bridge with timber deck and steel I girder.

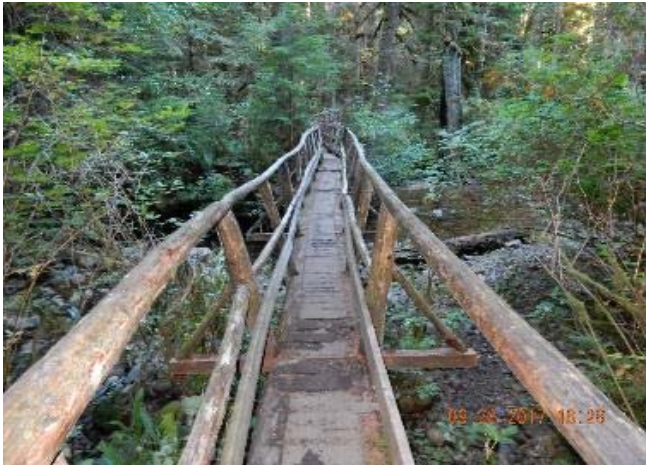
Parsons Waypoint #: 285	
Remaining Lifespan (Years): 15	
Replacement Cost: \$30,000	
Georeference: N 49°25'53" W 123°38'03"	
Deflection at Centre (mm): 0	
Weight Usage Restriction: 25 people, 1 horse, 2 ATVs	
Date Inspected: Sept. 28, 2017	
Inspected By: Grant Waldie, P. Eng., PE Michael Li, EIT	
Weather: 15°C, sunny	
Overall Rating of Bridge	Structure Description
FAIR	19.5x1.04m beam bridge with timber deck.

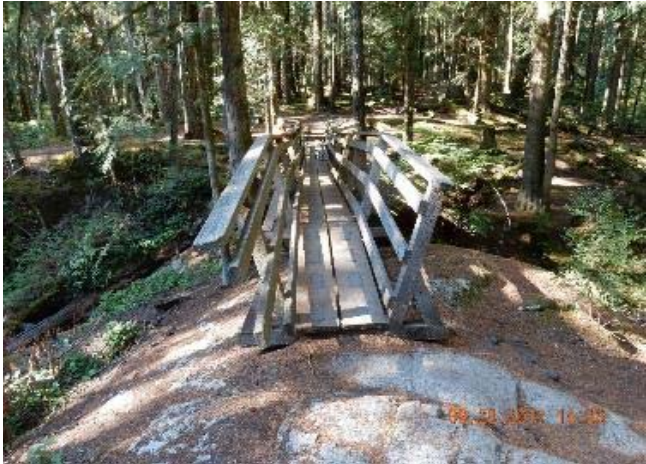
Parsons Waypoint #:	279	
Remaining Lifespan (Years):	25	
Replacement Cost:	\$30,000	
Georeference:	N 49°25'43" W 123°38'24"	
Deflection at Centre (mm):	350	
Weight Usage Restriction:	15 people, 1 horse, 2 ATVs	
Date Inspected:	Sept. 28, 2017	
Inspected By:	Grant Waldie, P. Eng., PE Michael Li, EIT	
Weather:	15°C, sunny	
Overall Rating of Bridge	GOOD	Structure Description
		16.3x0.64m beam bridge with timber deck.

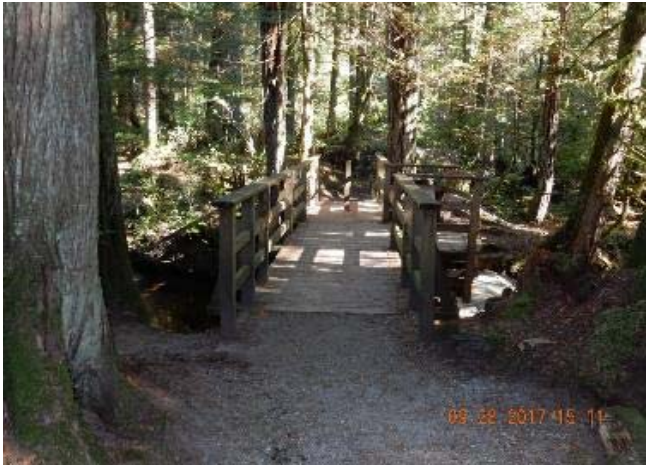
Parsons Waypoint #: 281	
Remaining Lifespan (Years): 40	
Replacement Cost: \$20,000	
Georeference: N 49°25'49" W 123°38'26"	
Deflection at Centre (mm): 0	
Weight Usage Restriction: 25 people, horse, 2 ATVs	
Date Inspected: Sept. 28, 2017	
Inspected By: Grant Waldie, P. Eng., PE Michael Li, EIT	
Weather: 15°C, sunny	
Overall Rating of Bridge	Structure Description
GOOD	9.2x1.52m beam bridge with timber deck.

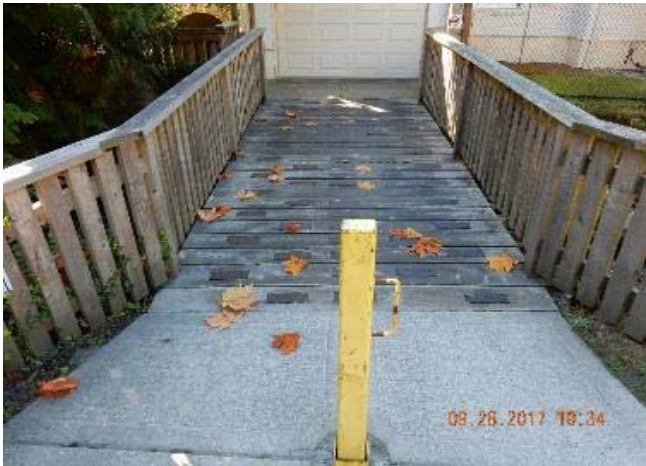
Parsons Waypoint #:	272	
Remaining Lifespan (Years):	40	
Replacement Cost:	\$30,000	
Georeference:	N 49°23'23" W 123°33'19"	
Deflection at Centre (mm):	0	
Weight Usage Restriction:	21 people, 1 horse, 2 ATVs	
Date Inspected:	Sept. 28, 2017	
Inspected By:	Grant Waldie, P. Eng., PE Michael Li, EIT	
Weather:	15°C, sunny	
Overall Rating of Bridge		Structure Description
VERY GOOD		4.7x2.29m beam bridge with timber deck and two steel I gider.

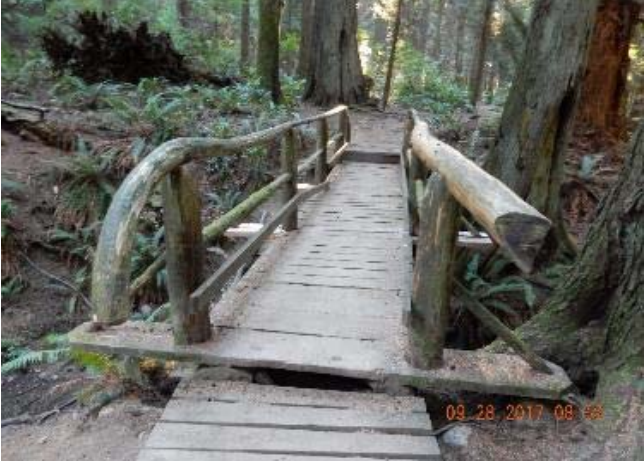
Parsons Waypoint #: 266	
Remaining Lifespan (Years): 15	
Replacement Cost: \$20,000	
Georeference: N 49°25'08" W 123°29'43"	
Deflection at Centre (mm): 0	
Weight Usage Restriction: 13 people, 1 horse, 2 ATVs	
Date Inspected: Sept. 28, 2017	
Inspected By: Grant Waldie, P. Eng., PE Michael Li, EIT	
Weather: 15°C, sunny	
Overall Rating of Bridge	Structure Description
GOOD	6.5x1.04m beam bridge with timber deck.

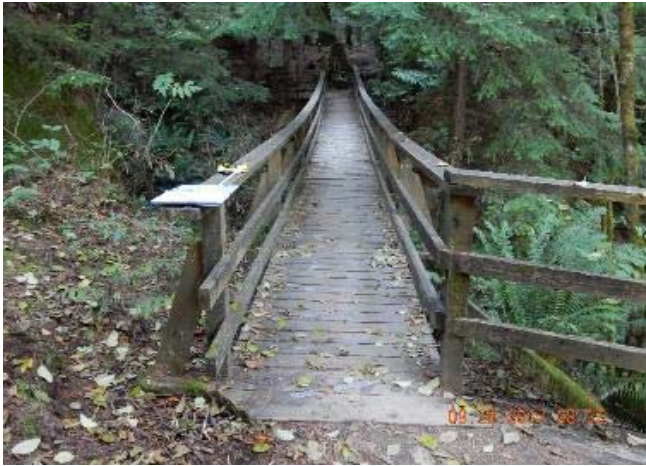
Parsons Waypoint #: 264	
Remaining Lifespan (Years): 5	
Replacement Cost: \$30,000	
Georeference: N 49°25'10" W 123°29'49"	
Deflection at Centre (mm): 350	
Weight Usage Restriction: 25 people, 1 horse, 2 ATVs	
Date Inspected: Sept. 28, 2017	
Inspected By: Grant Waldie, P. Eng., PE Michael Li, EIT	
Weather: 15°C, sunny	
Overall Rating of Bridge	Structure Description
POOR	20x1.07m beam bridge with timber deck.

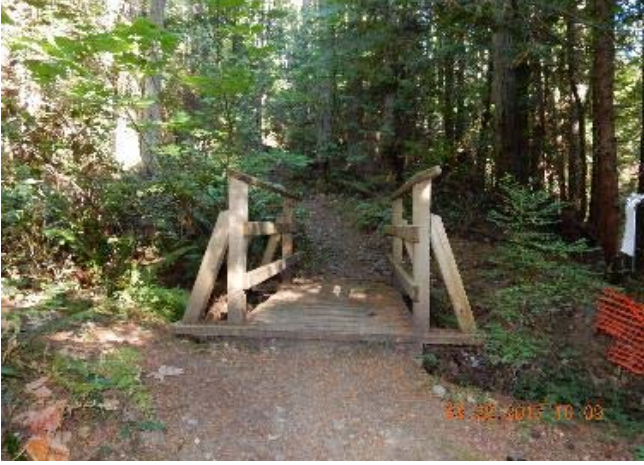
Parsons Waypoint #:	271	
Remaining Lifespan (Years):	25	
Replacement Cost:	\$5,000	
Georeference:	N 49°24'53" W 123°29'43"	
Deflection at Centre (mm):	0	
Weight Usage Restriction:	5 people, 1 horse, 1 ATV	
Date Inspected:	Sept. 28, 2017	
Inspected By:	Grant Waldie, P. Eng., PE Michael Li, EIT	
Weather:	15°C, sunny	
Overall Rating of Bridge		Structure Description
GOOD		2.1x1.07m beam bridge with timber deck.
