FINAL BUILDING CONDITION ASSESSMENT REPORT

Building Name	Coopers Green Hall
Address	5500 Fisherman Road, Halfmoon Bay, BC
Campus	Halfmoon Bay
Building Size (sq. Ft.)	1,320
Number of Storeys	1
Date of Construction	1983

Prepared by Facility Condition Assessment Portfolio eXperts Canada Ltd. May 19, 2017

Project No. C17002

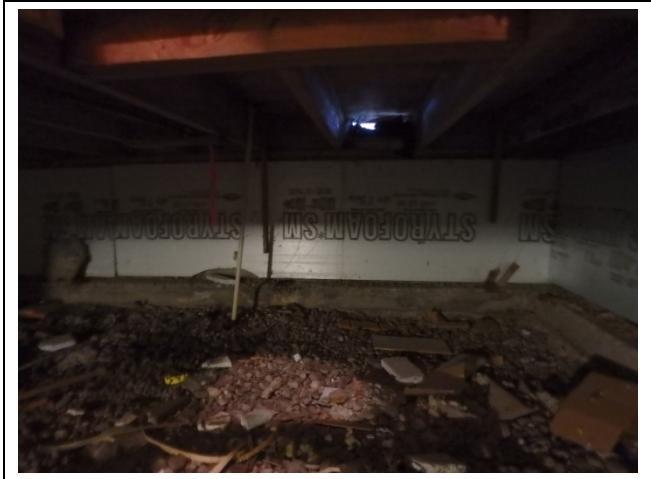
Photo 1: A1010 Standard Foundations **Concrete Footings**

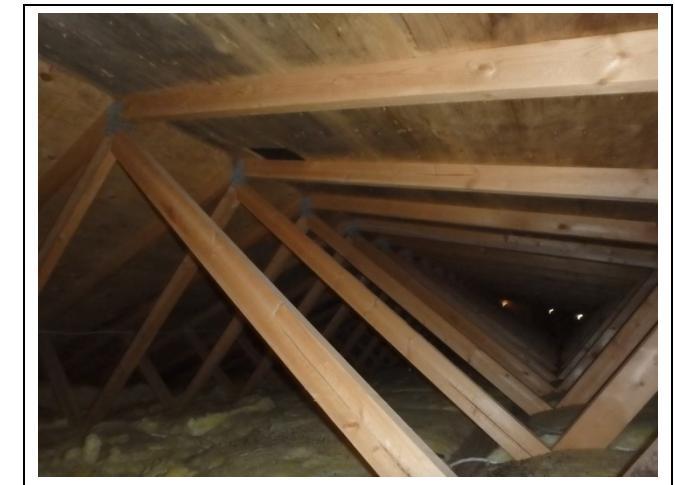
Photo 2: B1030 Structural Frame Roof Structural Frame.

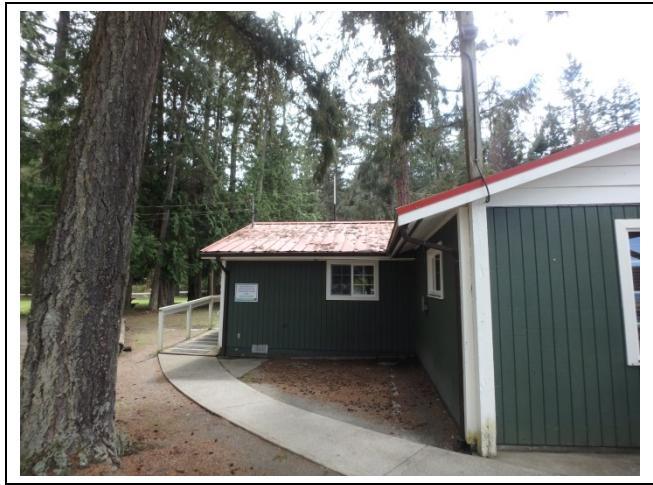
Photo 3: B2010 Exterior Walls General view of exterior walls

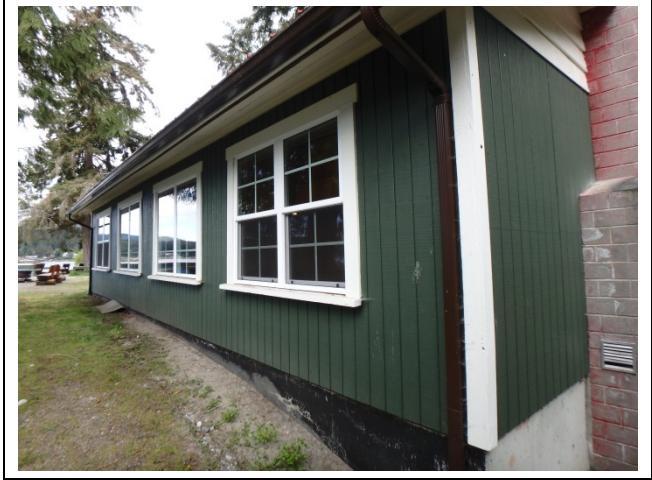
Photo 4: B2020 Exterior Windows Typical condition exterior windows

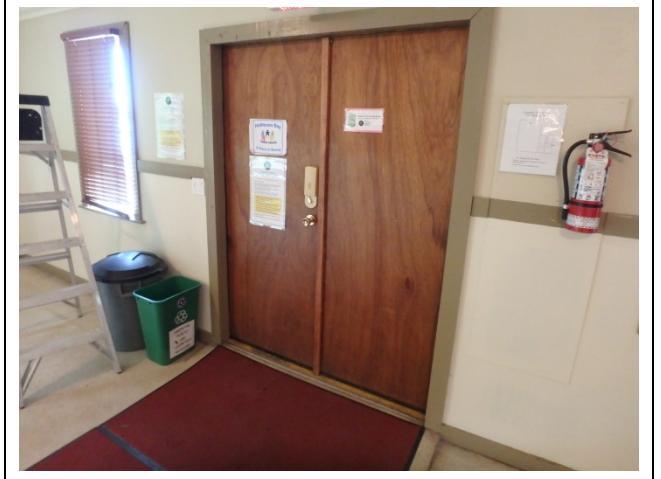
5	B - Shell	B20 - Exterior Enclosure	B2030 - Exterior Doors	B2031 - Exterior Doors - Wood/Aluminum Framed Glass Double Door	Two wood service doors, set in wood frames, are provided along the perimeter of the building, providing access to the facility.	No major deficiencies were observed or reported. However, current deterioration with usage is anticipated to progress, and the replacement of the exterior doors is within the evaluation period (2017 to 2021)	2 - Fair	Condition-Based Replacement	2	EA	\$3,000	\$6,000	1983	20	0	3	5	2020	\$0	\$0	\$0	\$6,000	\$0	\$0	\$6,000
6	B - Sheli	B30 - Roofing	B3010 - Roof Coverings	B3011 - Roof Coverings - Preformed/ standing seam metal roof	The gable roof structure is completed with a standing seam prefinished metal roof. At the roof edge, guiters connected to downspouts that discharge to grade are provided.	At the time of the assessment, no roof leaks were reported, and no corrosion or deteriorated metal roof panels were observed. The guiders were clogged and are in need of cleaning. Based on the current condition, and to ensure that roof anchieves its expected useful life, it is recommended that the roof and the stormwater discharge system be maintained in the short term.	1 - Poor	Major Repair	1	EA	\$1,450	\$1,450	1983	35	1	1	6	2018	\$0	\$1,450	\$0	\$0	\$0	\$0	\$1,450

Photo 5: B2030 Exterior Doors Main Entry Door.

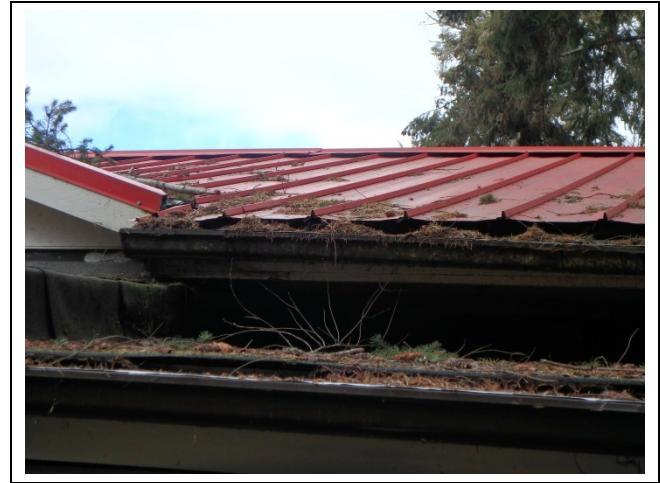
7	B - Shell	B30 - Roofing	B3010 - Roof Coverings	B3011 - Roof Coverings - Preformed/ standing seam metal roof	The gable roof structure is completed with a standing seam prefinished metal roof. At the roof edge, gutters connected to downspouts that discharge to grade.	At the time of the assessment, no roof leaks were reported, and no corrosion or deteriorated metal roof panels were observed. The gutters were clogged and are in need of cleaning.	3 - Good	Lifecycle Replacement	1450	SF	\$25	\$36,250	1983	35	1	7	6	2024	\$0	\$0	\$0	\$0	\$0	\$36,250	\$36,250
8	C - Interiors	C10 - Interior Construction	C1010 - Partitions	C1011 - Fixed Partitions	Fixed partitions are comprised gypsum board over wood framed wall assemblies.	No major deficiencies were observed or reported.	3 - Good		2190	SF	\$9	\$18,615	1983	75	41	41		2058	\$0	\$0	\$0	\$0	\$0	\$18,615	\$18,615
9	C - Interiors	C10 - Interior Construction	C1020 - Interior Doors	C1021 - Interior Doors	The interior doors consist of wood doors in wood frames.	No major deficiencies were observed or reported. The component is expected to reach the end of its useful life within the evaluation period.	3 - Good	Lifecycle Replacement	5	EA	\$3,000	\$15,000	1983	40	6	6		2023	\$0	\$0	\$0	\$0	\$0	\$15,000	\$15,000

Photo 6: B3010 Roof Covering View of Roof Drains in Need of Cleaning

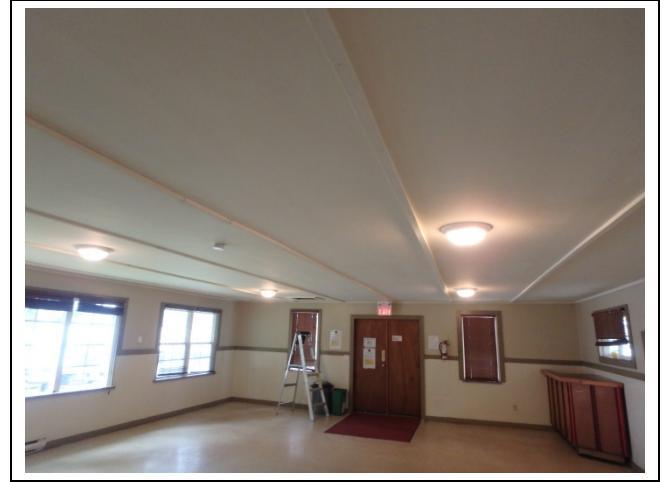
Photo 7: C30 Interior Finishes Typical Interior Finishes

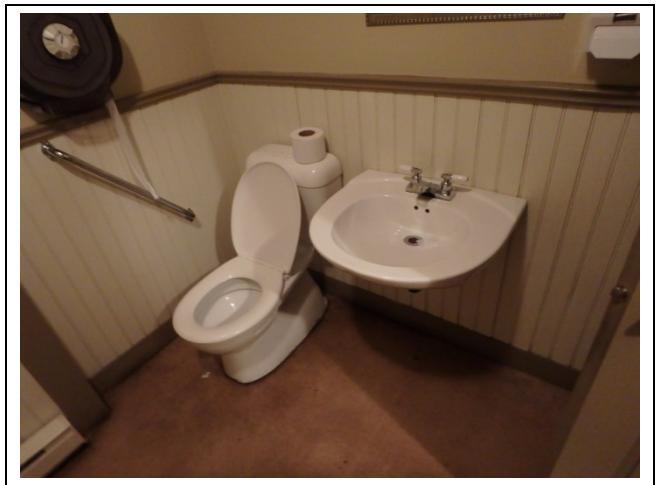
Photo 8: D2010 Plumbing Fixtures Typical Fixtures

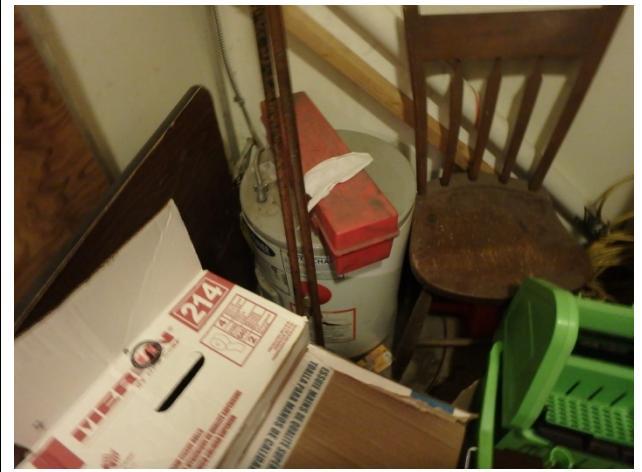
Photo 9: D2020 Domestic Water Distribution Domestic Water Heater.

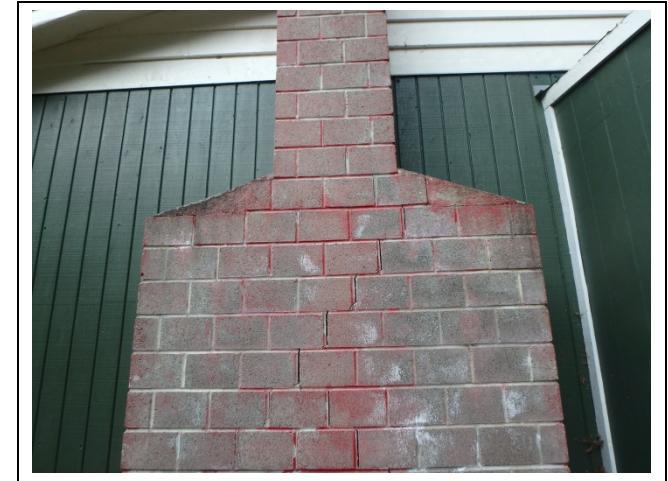
19	D - Services	D30 - HVAC	D3020 - Heat Generation Systems	D3023.5 - Aux Stacks	There is a brick fireplace with a brick chimney.	The fireplace has been blocked off and is no longer in use. The exterior chimney is cracked which is why it is no longer in use. The crack should be sealed to prevent any potential water infiltration.	1 - Poor	Major Repair	1	EA	\$2,000	\$2,000	1983	40	6	0	10	2017	\$2,000	\$0	\$0	\$0	\$0	\$0	\$2,000
Copyright	2017 Facility Condition Assessment Por erved	tfolio eXperts Canada Ltd.																			F	-(C/		⊃·X

Photo 10: D3020 Heat Generation Systems Cracked Fireplace Chimney.

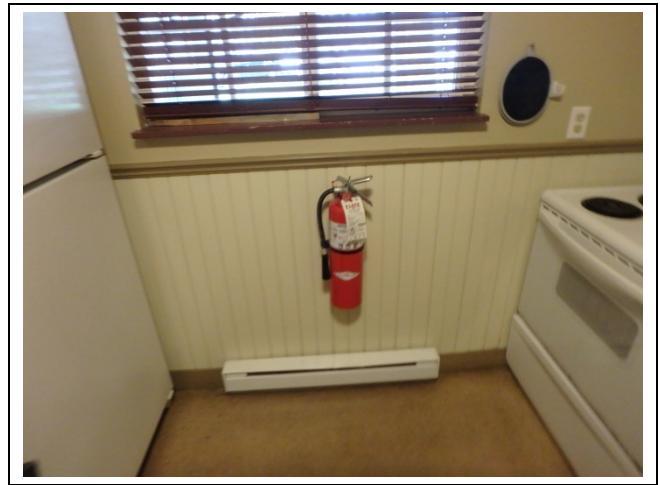
Photo 11: D3050 Heat Transfer Terminal Units Typical Electric Baseboard Heater

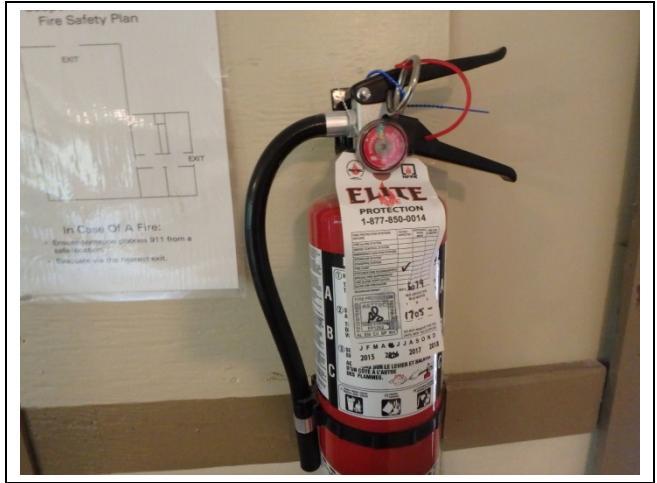
Photo 12: D4030 Fire Protection Specialties Fire Extinguisher

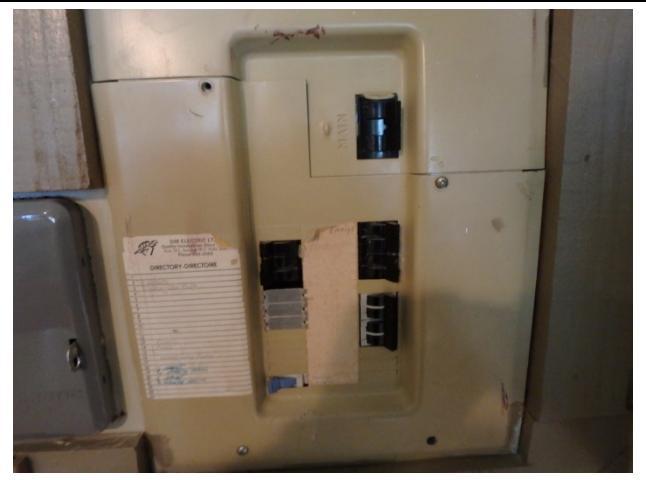
22	D - Services	D50 - Electrical Systems	D5010 - Electrical Service and Distribution	D5012 - Electrical Panels	The electrical panel, which was manufactured by Federal Pioneer, is installed in the building.	It is apparent that the electrical panels are likely original, dating to the construction of the building in 1983.	2 - Fair	Lifecycle Replacement	2	EA	\$3,000	\$6,000	1983	40	6	4	13	2021	\$0	\$0	\$0	\$0	\$6,000	\$0	\$6,000
23	D - Services	D50 - Electrical Systems	D5020 - Lighting and Branch Wiring	D5021 - Branch Wiring Devices	Building wiring consists of surface and concealed conduit and cabling.	No major deficiencies were observed or reported.	3 - Good	Lifecycle Replacement	1320	SF of Building	\$15	\$19,140	1983	40	6	10		2027	\$0	\$0	\$0	\$0	\$0	\$19,140	\$19,140
24	D - Services	D50 - Electrical Systems	D5020 - Lighting and Branch Wiring	D5022.1 - Internal Lighting	Interior lighting consists of ceiling mounted fixtures with compact fluorescent lamps.	No major deficiencies were observed or reported.	3 - Good	Lifecycle Replacement	12	EA	\$300	\$3,600	2000	30	13	13	14	2030	\$0	\$0	\$0	\$0	\$0	\$3,600	\$3,600

Photo 13: D5010 Electrical Service and Distribution Electrical Panel

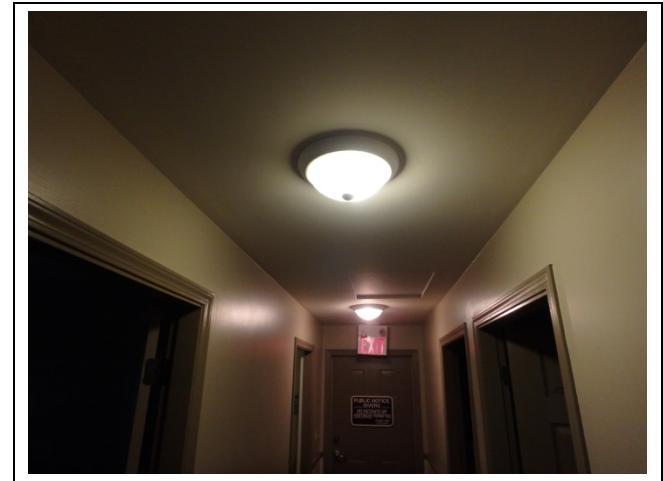
Photo 14: 5020 Lighting and Branch Wiring Typical Lighting

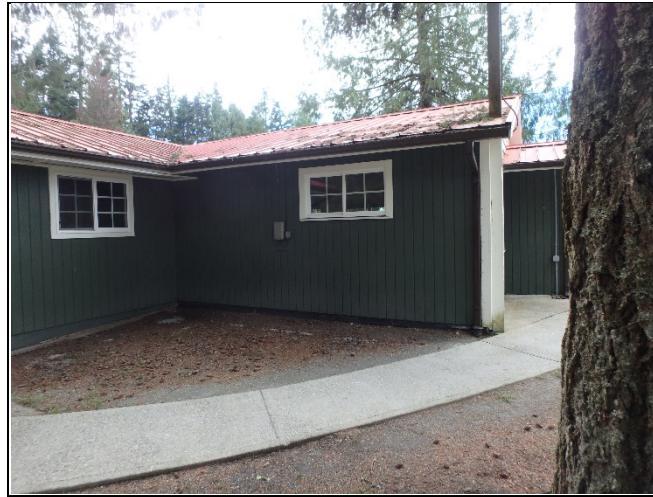
Photo 15: G2032 Concrete Paved Walkway

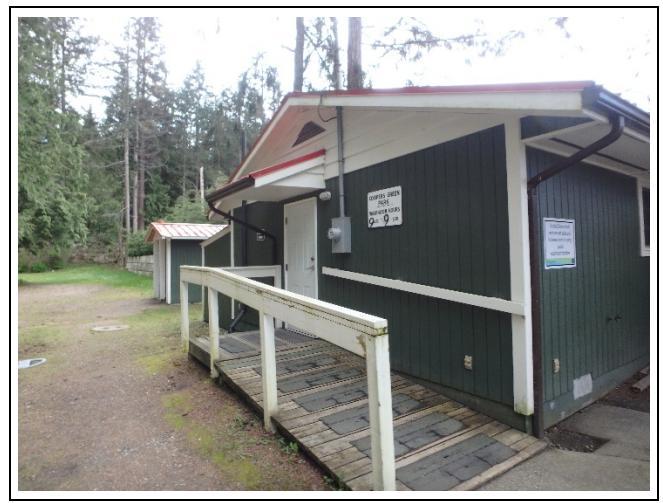
Photo 16: G2030 - Wood framed exterior Ramp
