COMMITTEE OF THE WHOLE

Thursday, March 23, 2023

2. Pierre Aubin, RPF, Practice Forester, BC Timber Sales Chinook /
Sunshine Coast, Ministry of Forests
Regarding BC Timber Sales Mt. Elphinstone South
Watershed Assessment: Phase 1 and 2

The following letter is to accompany the release of the final draft of the Mt. Elphinstone South Watershed Assessment: Phase 1 & 2 report. The purpose of this letter is to provide an overview as to the scope of this report. This report does not contain site specific assessments associated with planned BC Timber Sales developments but rather provides an evaluation of the current condition of the watersheds within the assessment area.

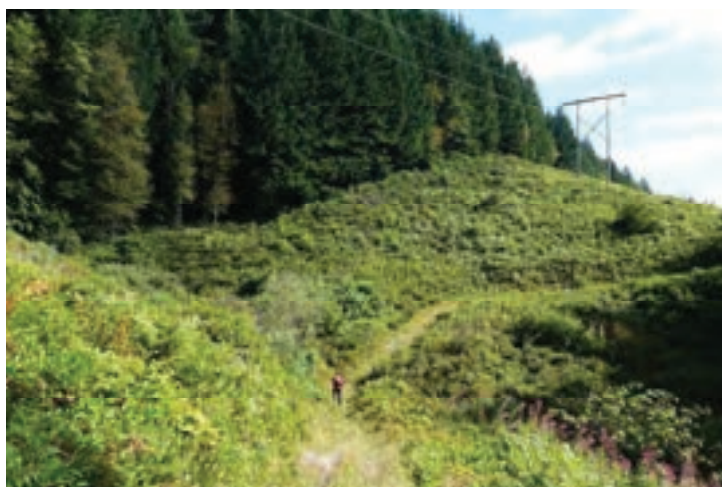
FIGURE 4.1 View eastward along the BC Hydro ROW, near a tributary to Chaster Creek at an elevation of 295 m. Photo DSC09916, August 27, 2020.

The assessment area is located approximately 4 to 6 km northwest of Gibsons Town Centre on the southwest slopes of Mt. Elphinstone. Access to the upper portions of assessment area is via Largo Road northbound from the Sunshine Coast Highway (101), then by the Sechelt-Roberts Creek Forest Service Road (FSR) (7575) and several branch roads. Lower portions of the assessment area are accessed via several local roads between Gibsons and Roberts Creek. A BC Hydro Transmission Line right of way (ROW), which has a gated access road and trail for much of its length also crosses the assessment area between elevations of 200 and 400 m (FIGURE 4.1).

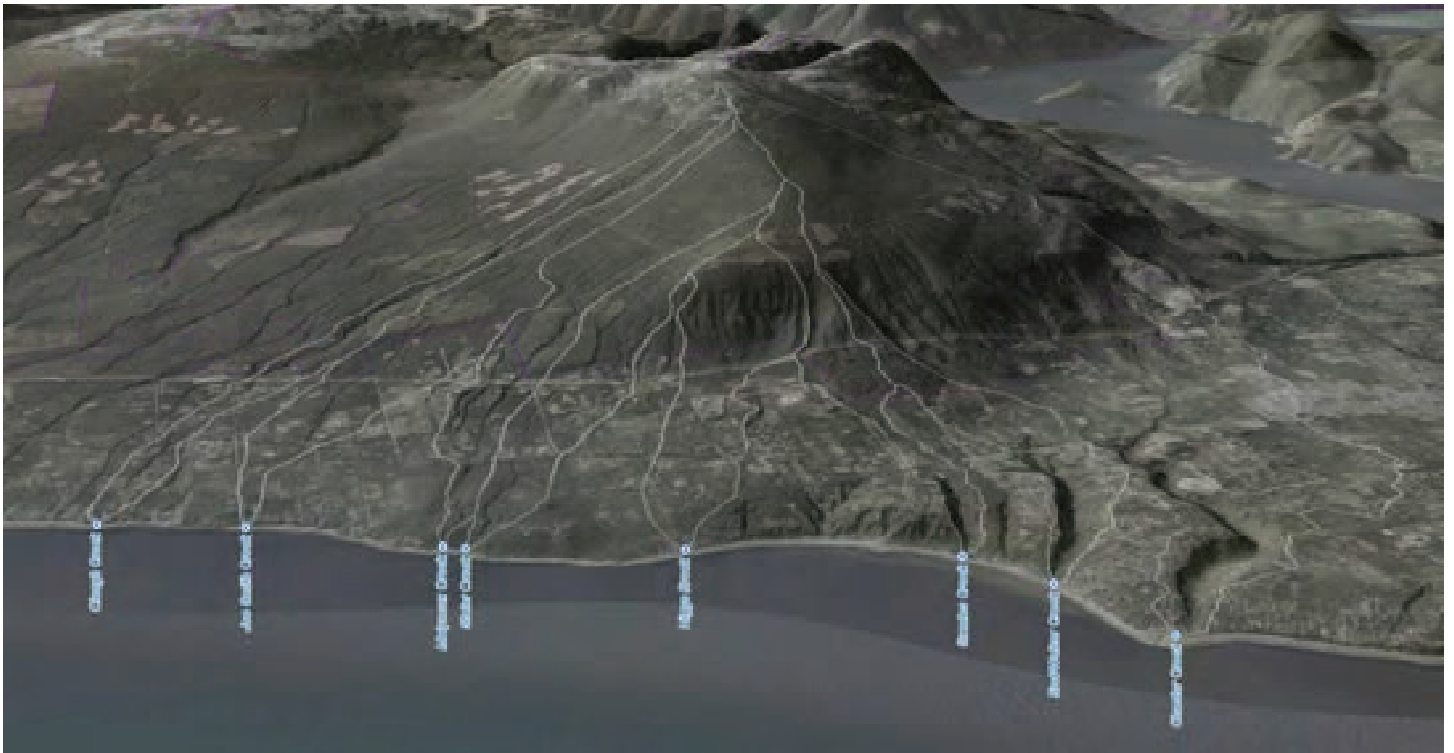
FIGURE 4.4 3D perspective view of the southwestern slopes of Mt. Elphinstone and the eight stream catchments of the assessment area (outlined in white). Vertical exaggeration 1.25x. DEM source: Province of BC and SCRDC; Imagery source: ESRI (2021).

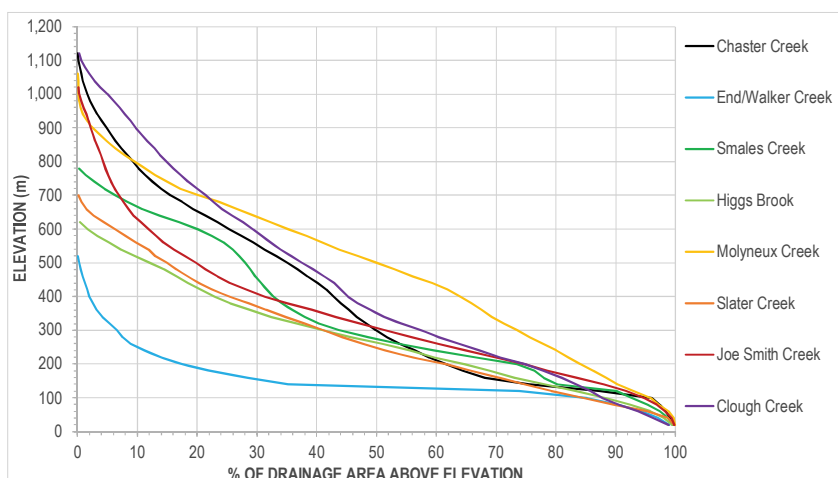
FIGURE 4.5 *Hypsometric (area-elevation) curves for the watersheds of interest in the assessment area.*

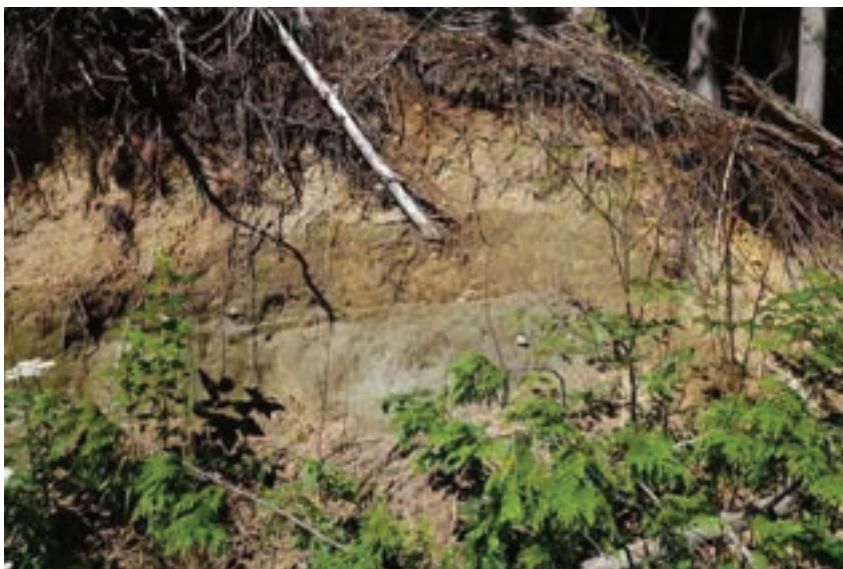
FIGURE 4.8 *View of till exposed in a roadcut near one of the western tributary gullies to Chaster Creek near an elevation of 650 m. Photo DSC00256, August 27, 2020.*

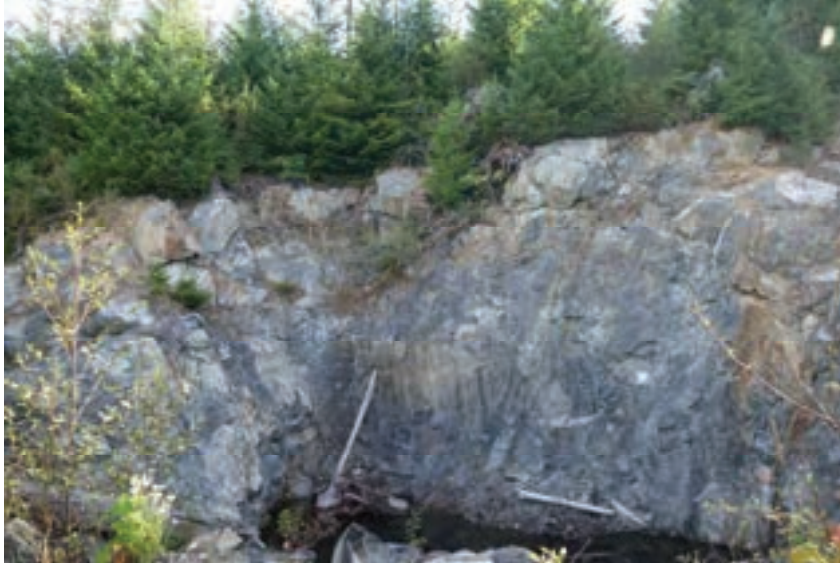
FIGURE 4.9 *Example of thin soil over bedrock at this aggregate pit near the watershed divide between Higgs Brook and Slater Creek at an elevation of 560 m. Photo DSC00134, August 27, 2020.*

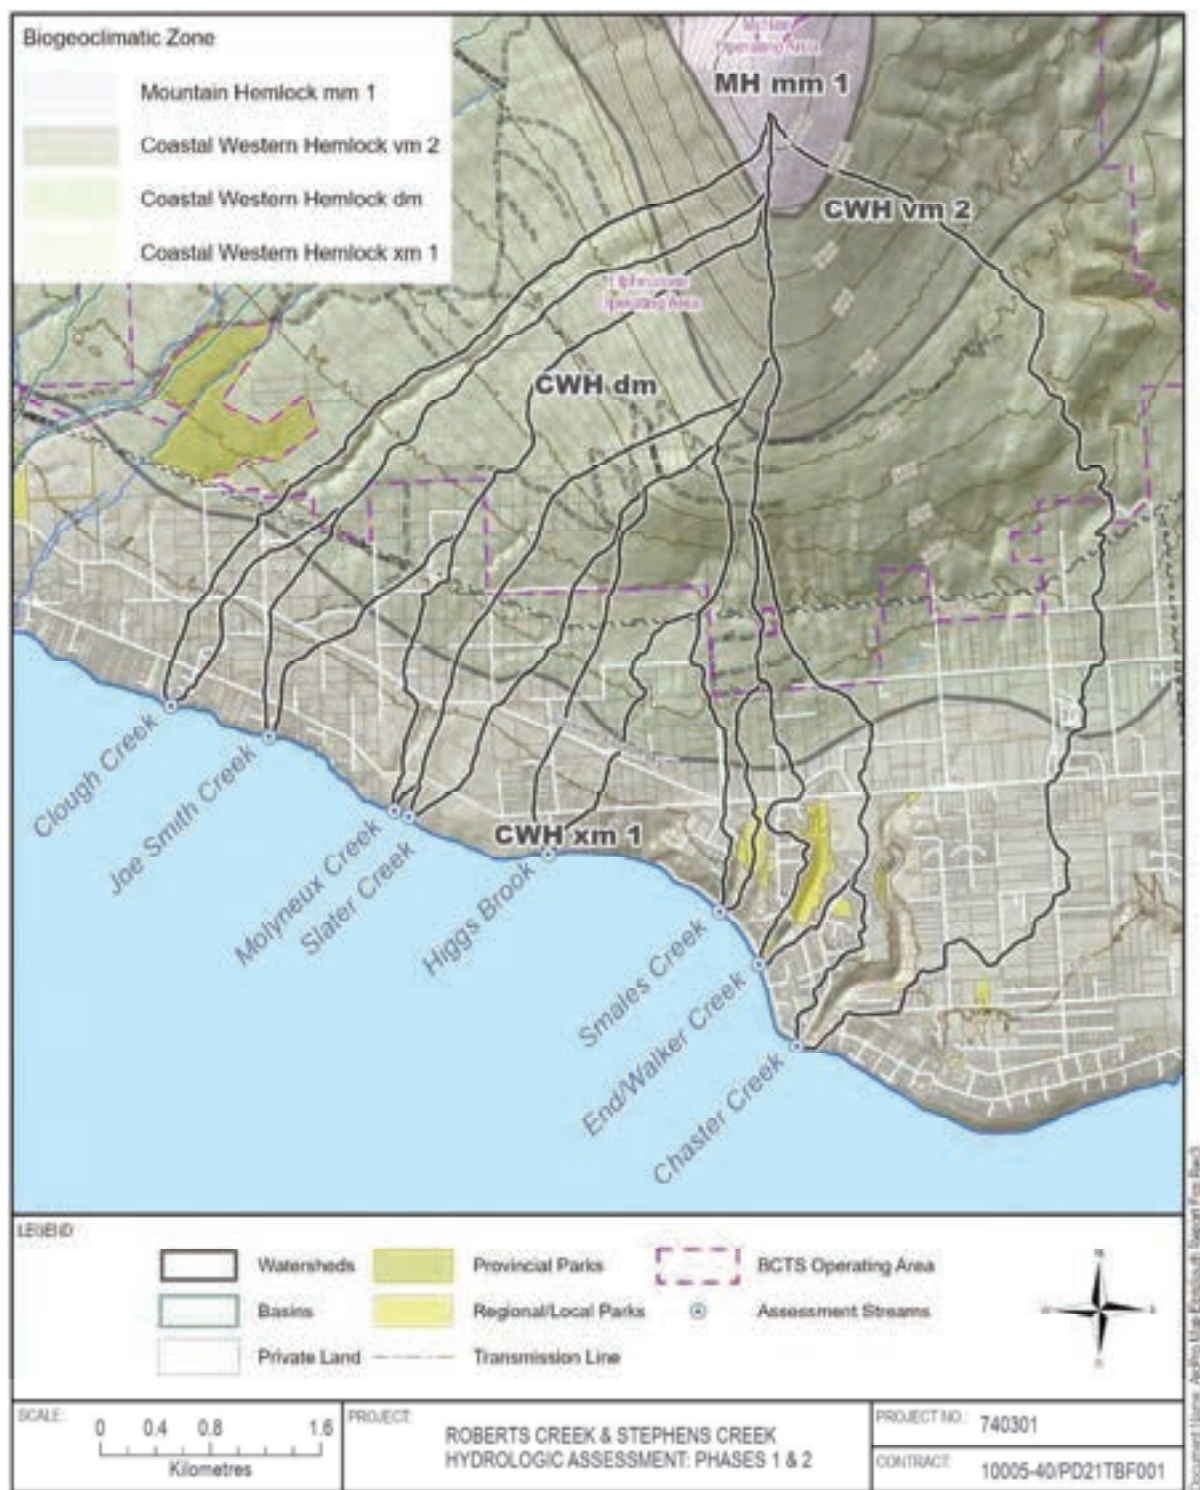
FIGURE 4.11 *Biogeoclimatic zones in the assessment area.*

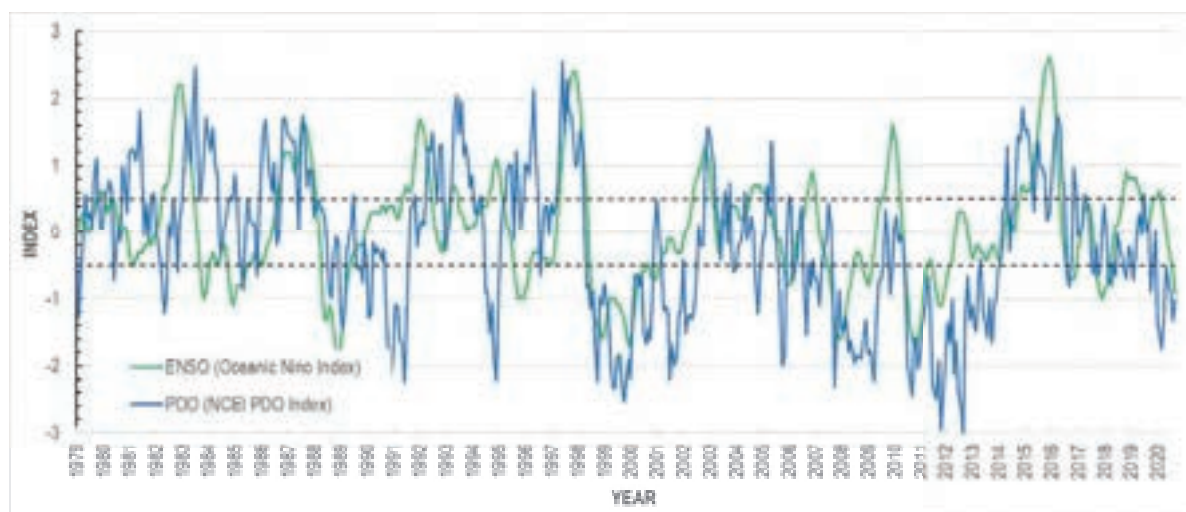
FIGURE 4.17 ENSO and PDO Index patterns from 1979 – 2020. Horizontal lines roughly indicate boundaries between warm (> 0.5), neutral (0.5 to -0.5), and cool (< -0.5) phases. ENSO data from NOAA (2020a) and PDO data from NOAA (2020b).

There are six combinations of the PDO (cool and warm) and ENSO (cool, neutral, warm) phases that have been historically observed that affects regional climate. The potential for precipitation and temperature extremes tends to be greater when PDO and ENSO are in-phase. For example, when both PDO and ENSO are experiencing a cool phase more snow tends to accumulate, and conversely, when both PDO and ENSO are in the warm phase there tends to be a thinner snowpack. There is relatively poor predictive ability when PDO and ENSO are in opposite phases (e.g., cool-warm or warm-cool) (Wang et al., 2014). Patterns of ENSO and PDO between 1979 and 2020 are shown in FIGURE 4.17.

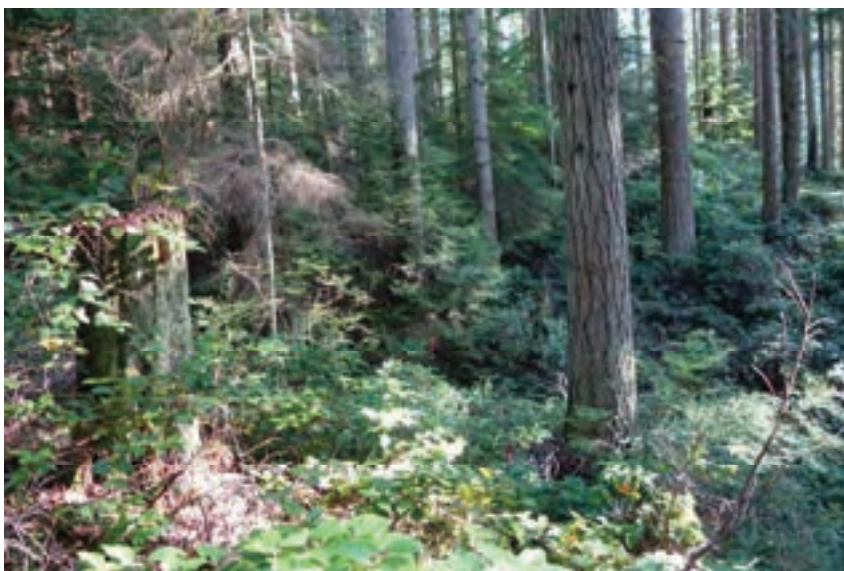
FIGURE 4.19 *Example of mature second growth stands near Reed Road. The location is approximately 50 m north of the west end of Reed Road. Photo DSC09810, August 26, 2020.*

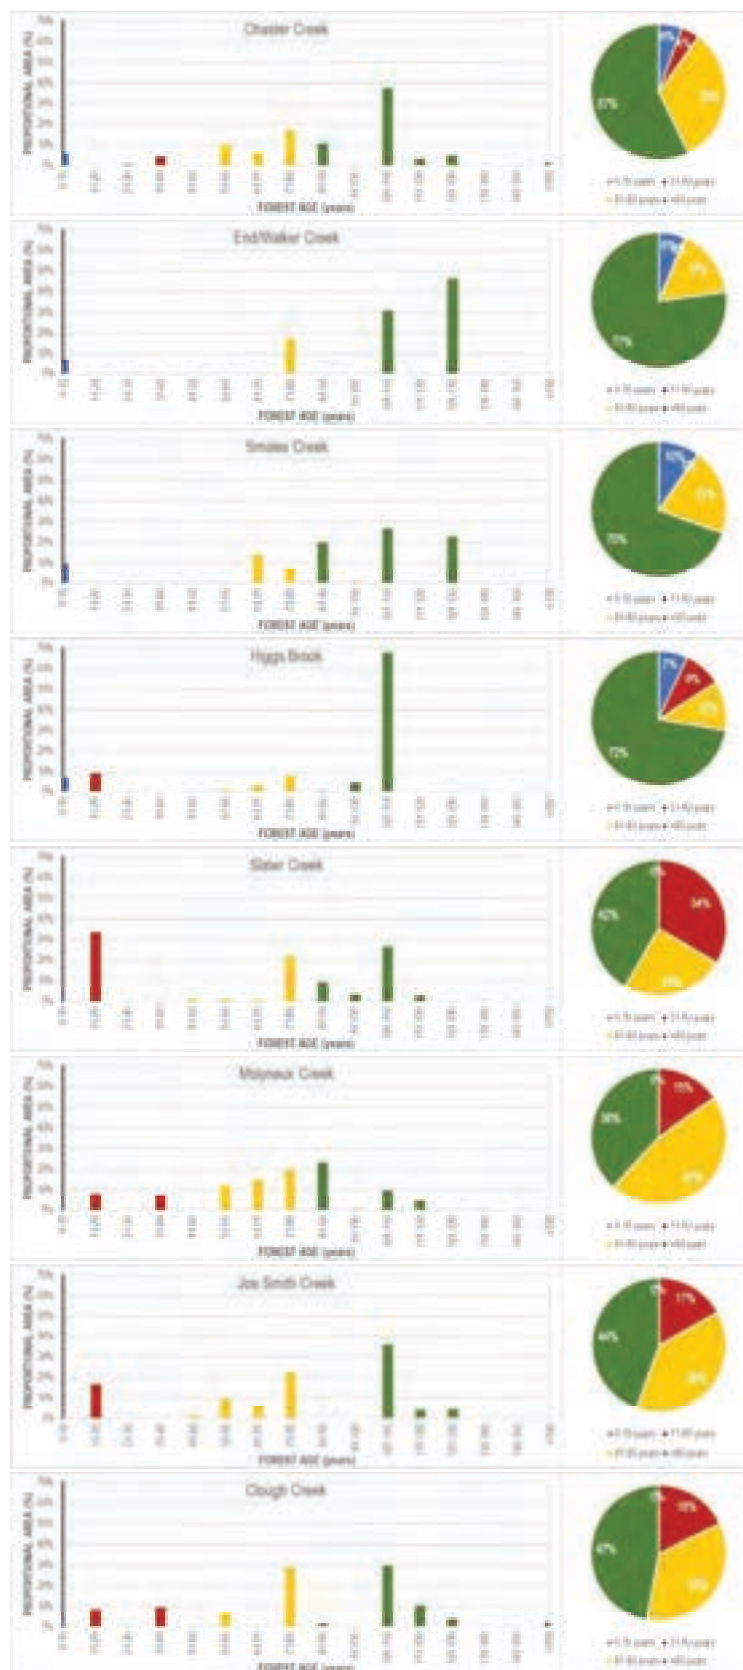
FIGURE 6.5 Distribution of forest ages within BCTS Chart by watershed. The histogram presents age classes by decade. The pie chart shows stand age distribution for four age classes based on water consumption (i.e., evapotranspiration rates) relative to mature (i.e., >80-year-old) stands. Stands 0-10 years old are expected to have relatively low water consumption, stands 11-40 years are expected to have relatively high water consumption, stands 41-80 years are expected to have relatively moderate water consumption and stands >80-years are expected to have normal water consumption (i.e., baseline).

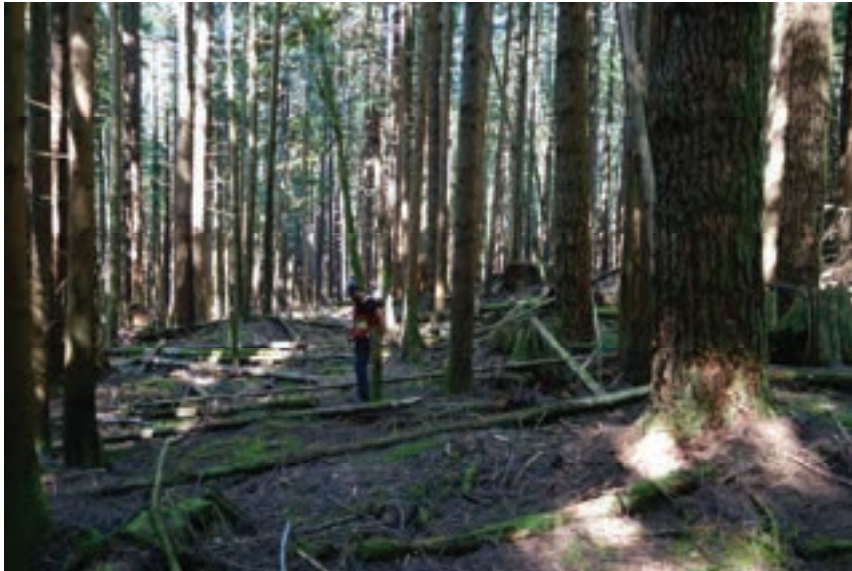
FIGURE 6.6 View of gentle terrain near 600 m elevation in the Molyneux Creek watershed. Photo DSC00206, August 27, 2020.

BCTS' Chart within the assessment watersheds is largely characterized as gentle to moderate terrain (MAP 1, FIGURE 6.6). Sediment risks associated with forest development are primarily associated with the construction (including reactivation), maintenance, and use of new and existing roads and trails. Fine-textured soils may be susceptible to rutting, compaction and erosion if subject to mechanical disturbance or excessive traffic during wet weather or wet ground conditions. Sediment risks can, however, be mitigated with a number of control measures, depending on site-conditions. Several of these measures are outlined in Section 9. Assuming that these (or equivalent) control measures are documented in site-specific erosion control plans and are incorporated into road and harvest planning and construction, sediment yields and the risks associated with future forest development can be maintained at low levels.

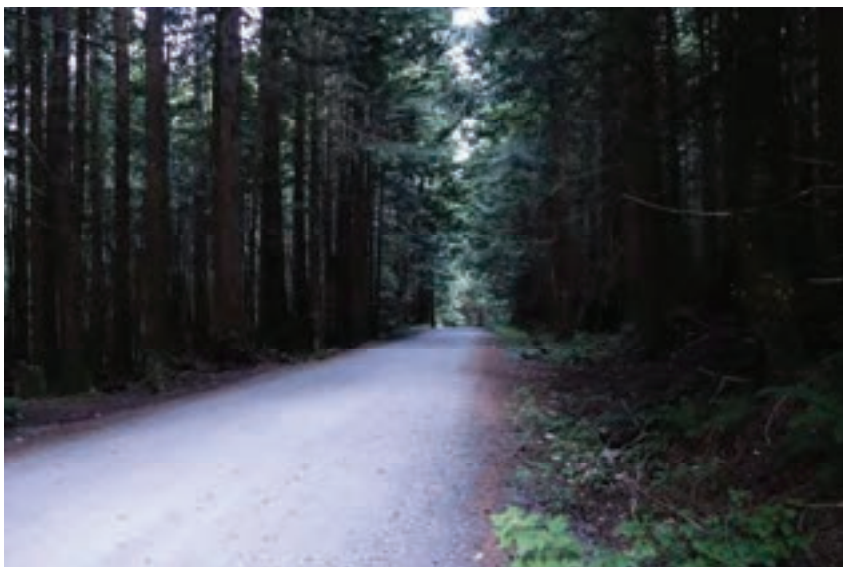
FIGURE 6.8 View of the Sechelt Roberts FSR (7575 Br 3) within the Molyneux Creek watershed at an elevation of 545 m. This example shows a stable road surface with low erosion potential. Photo DSC00079, August 27, 2020.

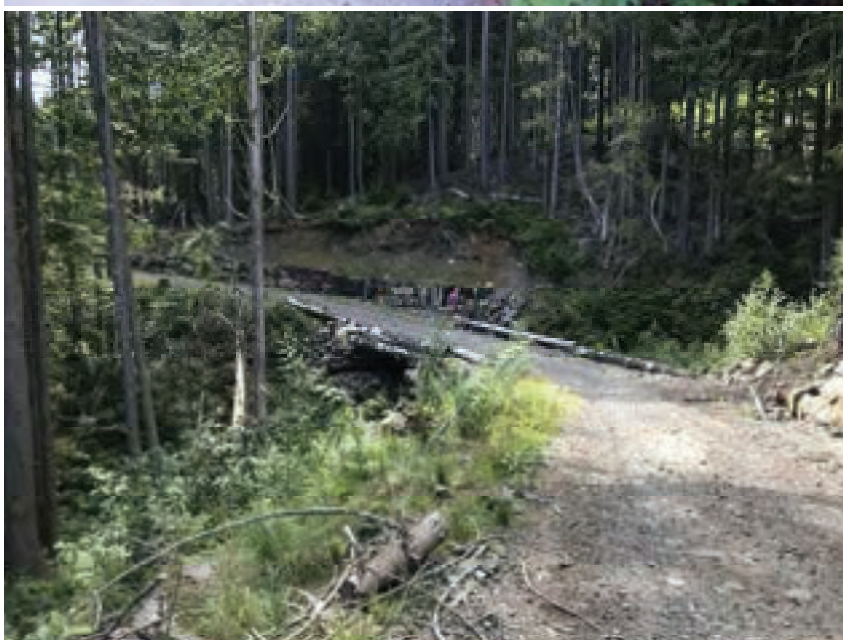
FIGURE 6.9 View of the Sechelt Roberts FSR (7575 Br 23) crossing of a tributary to Chaster Creek at an elevation of 620 m. This example shows a retaining wall that was constructed to stabilize the cutslope and minimize sediment delivery to the stream below. Photo IMG_3093 (Placemark 36), August 24, 2020.

and functional drainage infrastructures were noted along all reviewed active roads (FIGURE 6.8). Consequently, the erosion potential from active roads is low. Erosion potential does marginally increase in the vicinity of crossings of incised gullies, due to the increased height of road cuts that are typically required; however, these site-level risks appear to have been effectively mitigated where necessary (FIGURE 6.9), and sediment risks are low.

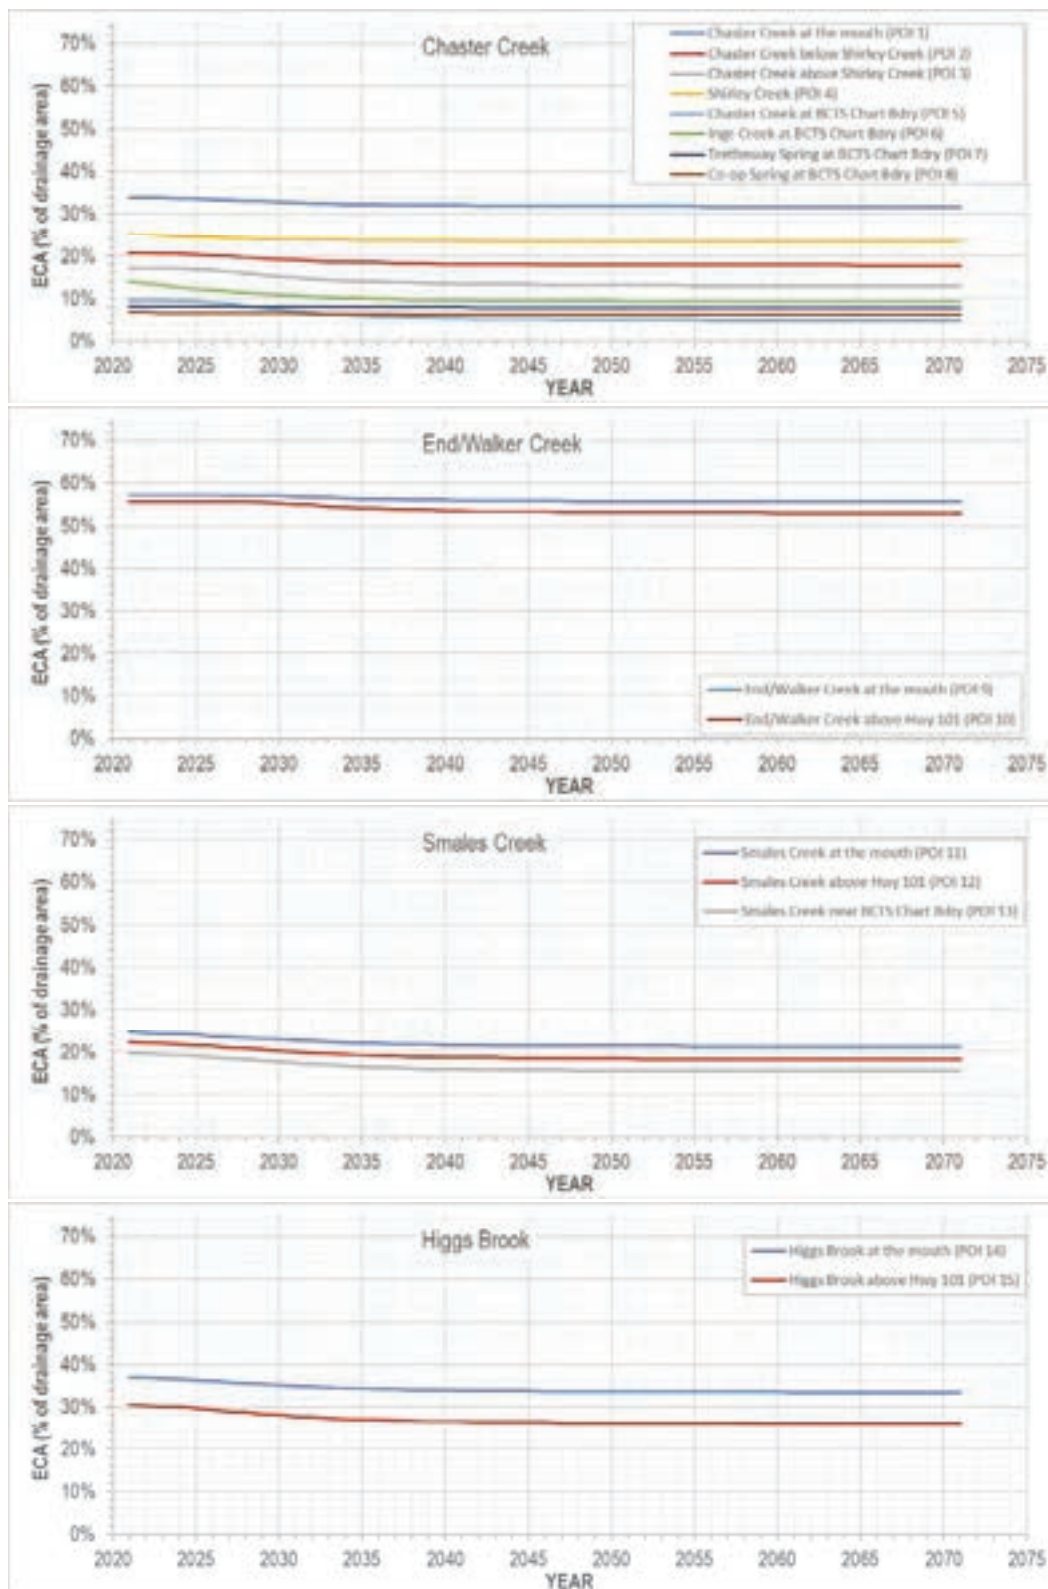
FIGURE E.1 ECA projections over the next 50-years for points-of-interest in the assessment area. Relatively slow hydrologic recovery is noted for most of the assessment watersheds given the portion of residential and commercial area, where recovery does not occur.

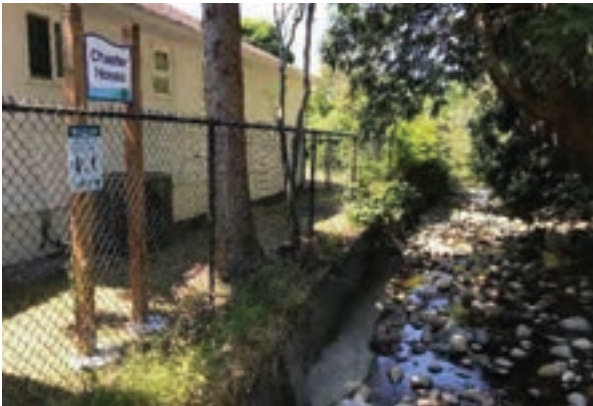
FIGURE 002

Photo: DSC09983
Date (YYYY MM DD): 2021 07 12
Location: **Chaster Cr, km 0.02**
View direction: Downstream
Description:
Retaining wall along Chaster House near mouth.

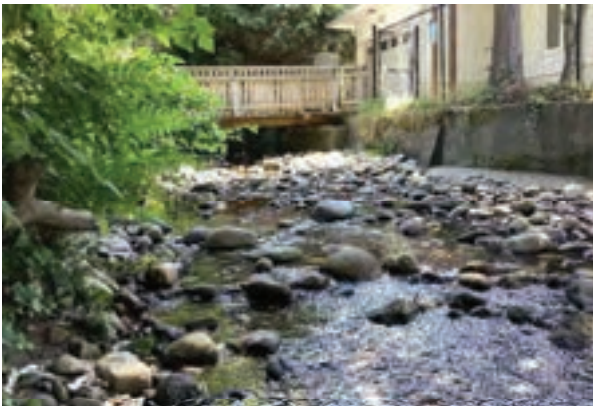
FIGURE 003

Photo: IMG_4496
Date (YYYY MM DD): 2021 07 12
Location: **Chaster Cr, km 0.02**
View direction: Upstream
Description:
Bridge across Chaster Creek near mouth to Chaster House.

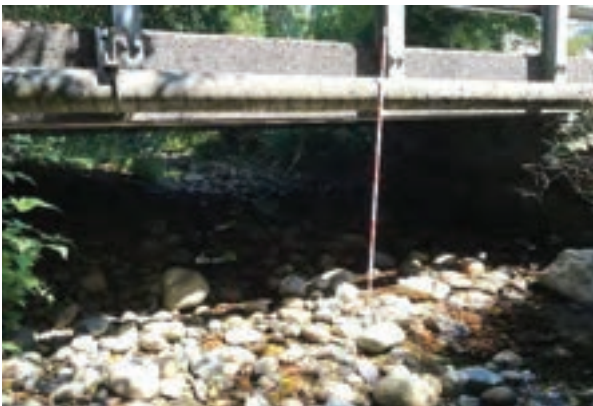
FIGURE 004

Photo: IMG_3926
Date (YYYY MM DD): 2021 07 12
Location: **Chaster Cr, km 0.04**
View direction: Upstream
Description:
Ocean Beach Esplanade bridge over Chaster Creek.

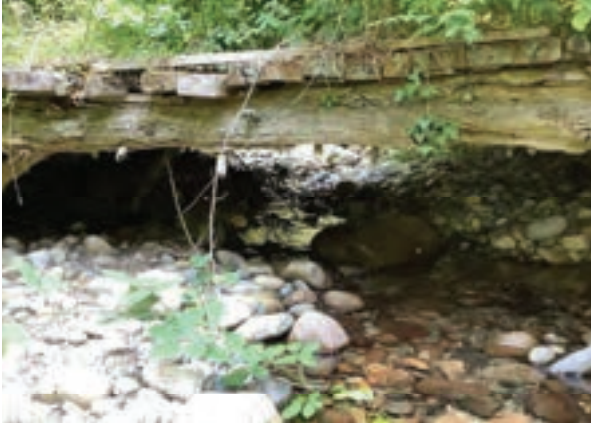
FIGURE 005

Photo: IMG_3931
Date (YYYY MM DD): 2021 07 12
Location: **Chaster Cr, km 0.10**
View direction: Upstream
Description:
 Old private bridge over Chaster Creek.

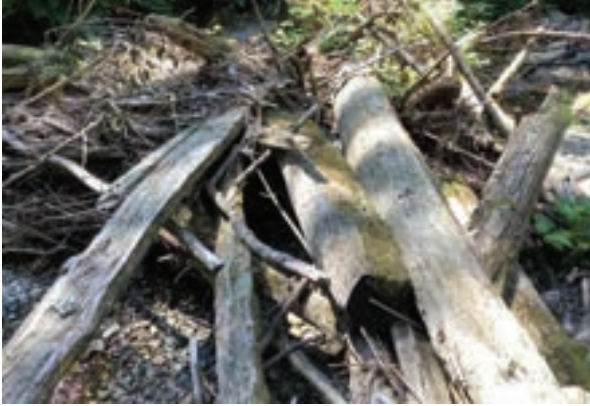
FIGURE 009

Photo: IMG_4512
Date (YYYY MM DD): 2021 07 12
Location: **Chaster Cr, km 0.9**
View direction: Upstream
Description:
 Log jam

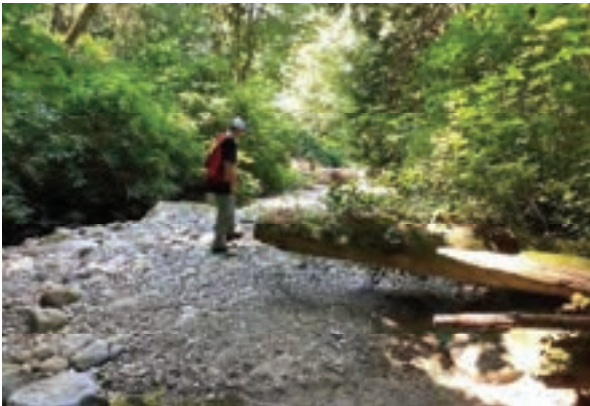
FIGURE 010

Photo: IMG_4510
Date (YYYY MM DD): 2021 07 12
Location: **Chaster Cr, km 0.9**
View direction: Downstream
Description:
 Sediment wedge above log jam.

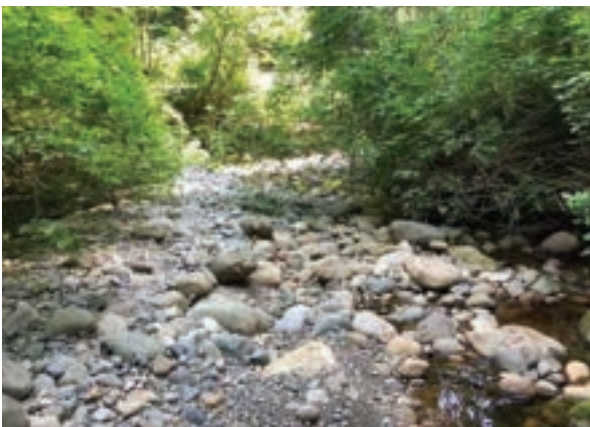
FIGURE 012

Photo: IMG_4520
Date (YYYY MM DD): 2021 07 12
Location: **Chaster Cr, km 1.6**
View direction: Downstream
Description:
 Sediment wedge

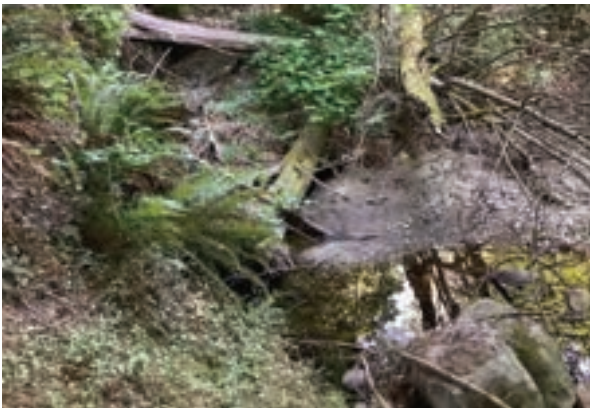
FIGURE 014

Photo: IMG_4532
Date (YYYY MM DD): 2021 07 12
Location: **Chaster Cr, km 2.6**
View direction: Upstream
Description:
 Log jam and sediment wedge

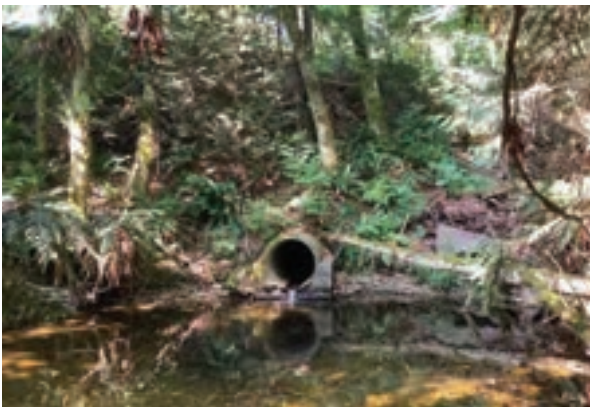
FIGURE 015

Photo: IMG_4527
Date (YYYY MM DD): 2021 07 12
Location: **Chaster Cr, km 2.6**
View direction: Upstream
Description:
 900 mm diameter concrete culvert beneath Sunshine Coast Highway.

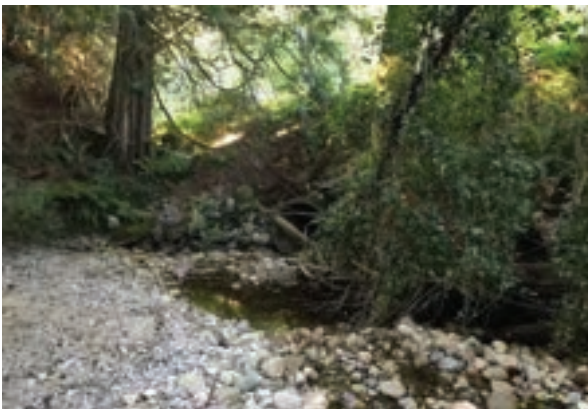
FIGURE 019

Photo: IMG_2008
Date (YYYY MM DD): 2021 07 13
Location: **Chaster Cr, km 2.9**
View direction: Downstream
Description:
 Henry Road culvert.

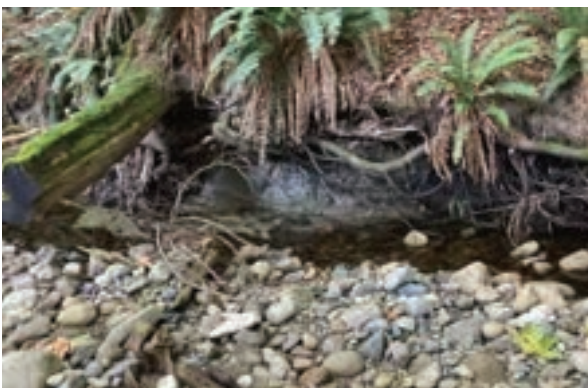
FIGURE 020

Photo: IMG_4563
Date (YYYY MM DD): 2021 07 13
Location: **Chaster Cr, km 2.9**
View direction: South
Description:
 Clay layer on streambank.

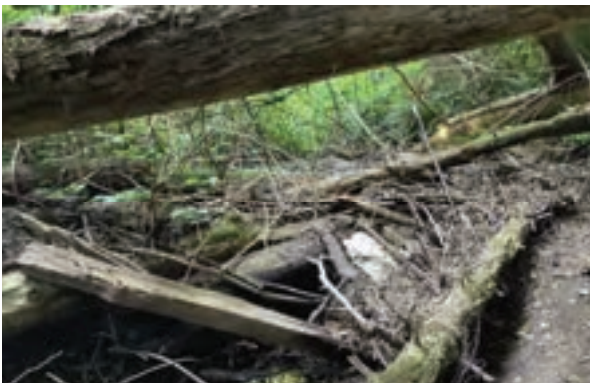
FIGURE 033

Photo: Placemark 33
Date (YYYY MM DD): 2021 07 16
Location: **Chaster Tributary 4.1 (Shirley Cr), km 2.4**
View direction: Downstream
Description:
 Log jam with sediment wedge.

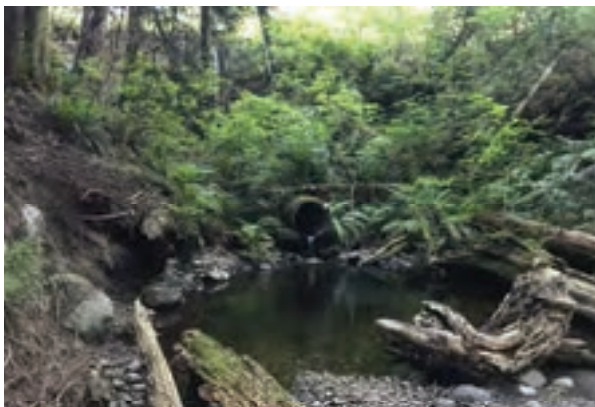
FIGURE 034

Photo: Placemark 2
Date (YYYY MM DD): 2021 07 16
Location: **Chaster Tributary 4.1 (Shirley Cr), km 2.55**
View direction: Upstream
Description:
 900 mm diameter concrete culvert beneath Sunshine Coast Highway.

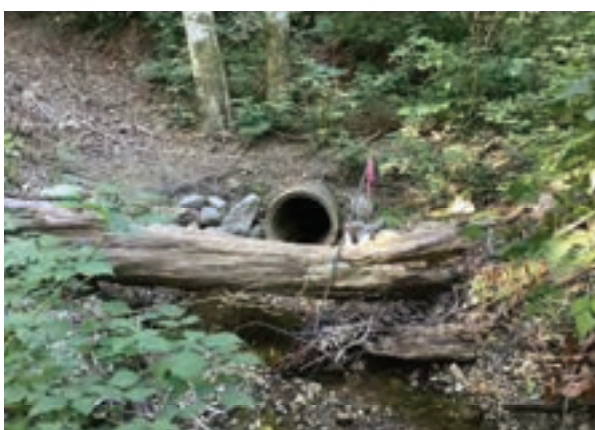
FIGURE 037

Photo: Placemark 34
Date (YYYY MM DD): 2021 07 16
Location: **Chaster Tributary 4.1 (Shirley Cr), km 2.6**
View direction: Downstream
Description:
 900 mm diameter concrete culvert beneath Sunshine Coast Highway.

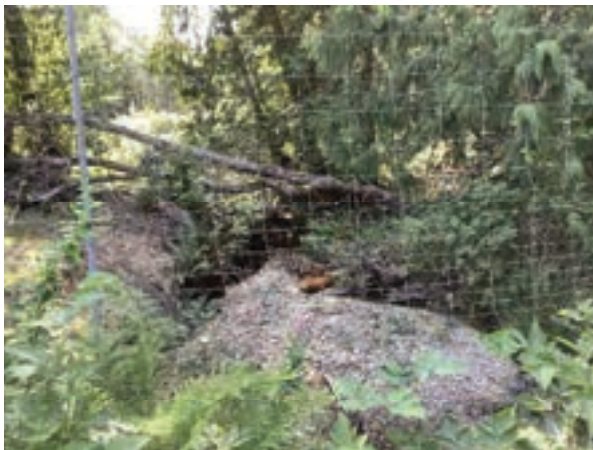
FIGURE 044

Photo: Placemark XX
Date (YYYY MM DD): 2021 07 16
Location: **Chaster Tributary 4.1.2.2 (Tretheway Spring), km 3.5**
View direction: Upstream
Description:
 View from Henry Road cuvlert crossing.

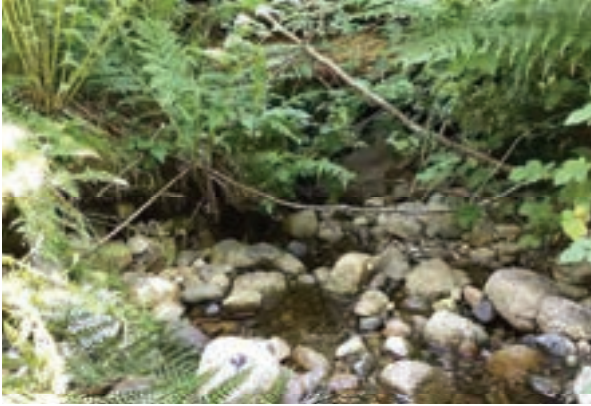
FIGURE 045

Photo: Placemark XX
Date (YYYY MM DD): 2021 07 16
Location: **Chaster Tributary 4.1.2.2 (Tretheway Spring), km 3.9**
View direction: Upstream
Description:
 Near residence at 1216 Reed Road.

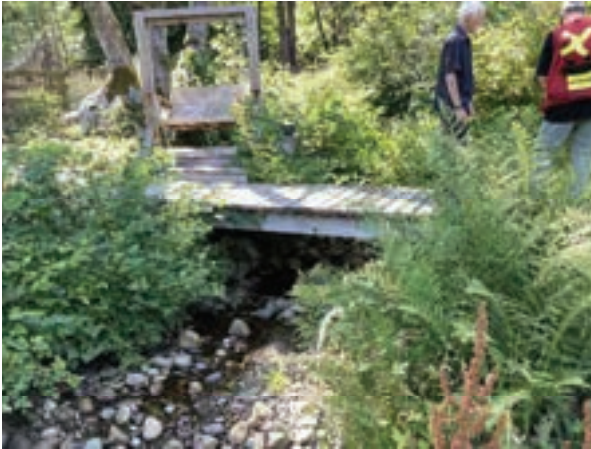
FIGURE 046

Photo: Placemark XX
Date (YYYY MM DD): 2021 07 16
Location: **Chaster Tributary
 4.1.2.2 (Tretheway
 Spring), km 3.8**
View direction: Downstream
Description:
 Private bridge near residence at 1216 Reed
 Road.

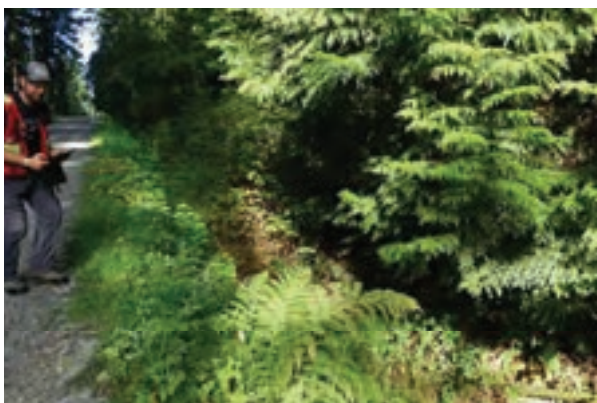
FIGURE 051

Photo: DSC09835
Date (YYYY MM DD): 2020 08 16
Location: **Chaster Tributary
 4.1.1.1, km 3.55**
View direction: Upstream
Description:
 Dry channel above Reed Road.

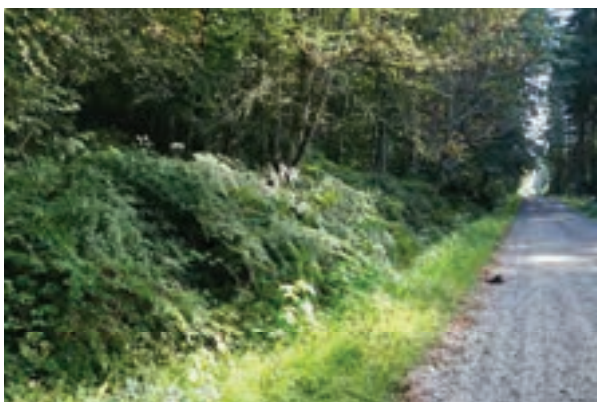
FIGURE 052

Photo: DSC09831
Date (YYYY MM DD): 2020 08 16
Location: **Chaster Tributary
 4.1.1.1.1 (Inge Creek),
 km 3.6**
View direction: Upstream
Description:
 Ditch along Reed Road that conveys runoff
 from north side of Reed Road.

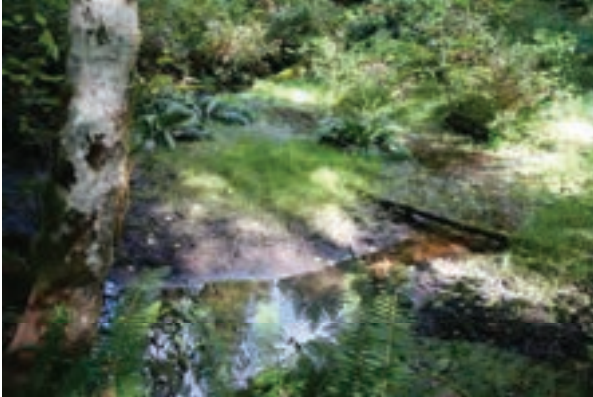
FIGURE 053

Photo: DSC09819
Date (YYYY MM DD): 2020 08 16
Location: **Chaster Tributary
 4.1.1.1.1 (Inge Creek),
 km 3.8**
View direction: Downstream
Description:
 Ditch along Reed Road that seasonally conveys
 runoff from north side of Reed Road.

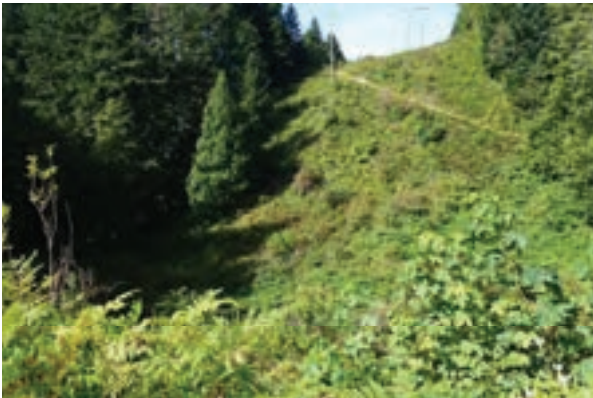
FIGURE 054

Photo: DSC09885
Date (YYYY MM DD): 2020 08 16
Location: **Chaster Tributary
 4.1.1.1.1 (Inge Creek),
 km 4.2**
View direction: Upstream
Description:
 Small pond and water intake (water licence C015414). Sedimentation has all but eliminated storage capacity of the pond.

Co-op Springs (Chaster Trib 4.1.4.2)	3.6	C019935	PD45949	19410915	00A - Waterworks: Local Provider	199118.74	m ³ /yr	Yes	Mapped POD is located on crown land. Reviewed Chaster Trib 4.1.1.2 (Co-op Spring) in vicinity of mapped POD. No water supply infrastructure noted.
	Co-op Springs (Chaster Trib 4.1.4.2)	3.6	C019935	PD45950	19410915	00A - Waterworks: Local Provider	-	-	No	Reviewed small stream downslope near Reed Road.
	Co-op Springs (Chaster Trib 4.1.4.2)	3.6	C019935	PD45951	19410915	00A - Waterworks: Local Provider	-	-	No	Reviewed small stream downslope near Reed Road.
	Inge Creek (Chaster Trib 4.1.1.1.1)	4.3	C015414	PD45077	19410915	00A - Waterworks: Local Provider	82966.143	m ³ /yr	Yes	Mapped POD located on Crown land. Chaster Trib 4.1.1.1.1 (Inge Creek) reviewed near mapped POD. Old berm/weir across channel noted with vertical culvert riser. The former pond is all but filled with sediment (APPENDIX E, Figure 54), and the system appears abandoned and non-functional.

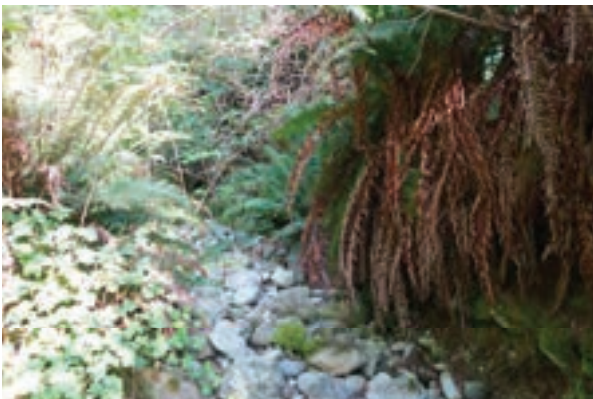
FIGURE 055

Photo: DSC09928
Date (YYYY MM DD): 2020 08 16
Location: **Chaster Tributary
 4.1.1.1.1 (Inge Creek),
 km 4.6**
View direction: West
Description:
 Ravine at hydro right-of-way.

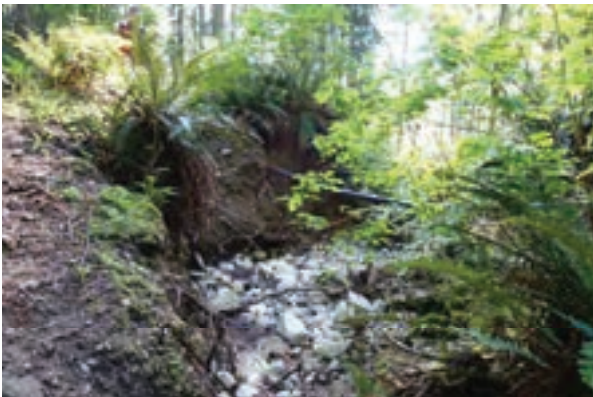
FIGURE 056

Photo: DSC09835
Date (YYYY MM DD): 2020 08 16
Location: **Chaster Tributary
 4.1.1.1.2, km 3.6**
View direction: Upstream
Description:
 Well-incised channel.

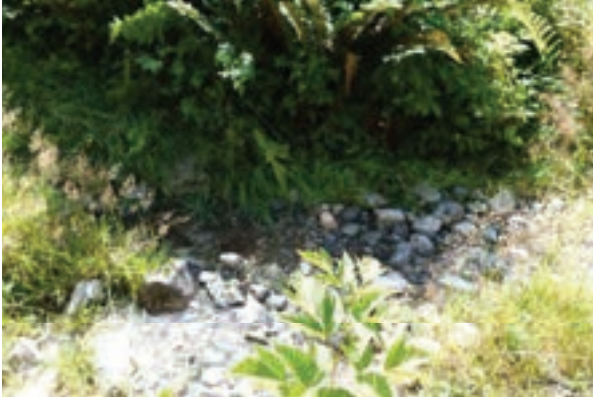
FIGURE 058

Photo: DSC09863
Date (YYYY MM DD): 2020 08 16
Location: **Chaster Tributary
 4.1.1.1.2, km 3.65**
View direction: Downstream
Description:
 Trail and water supply line crossing. Near-vertical eroding banks noted.

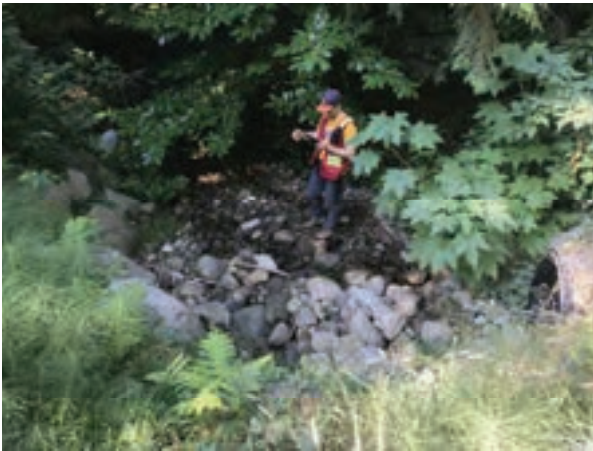
Photo: DSC09919
Date (YYYY MM DD): 2020 08 16
Location: **Chaster Tributary
 4.1.1.1.2, km 4.3**
View direction: Downstream
Description:
 At hydro right-of-way.

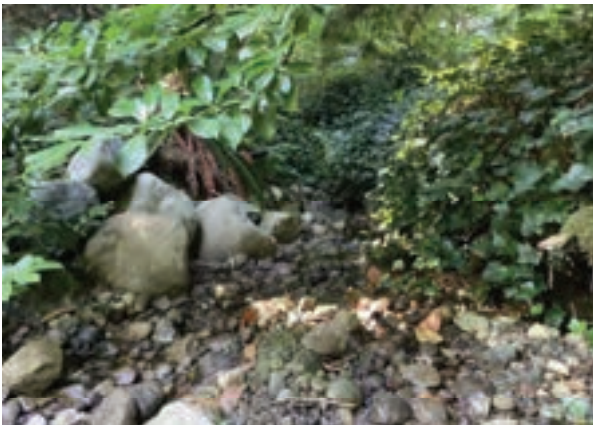
FIGURE 059

Photo: Placemark 8
Date (YYYY MM DD): 2021 07 16
Location: **Chaster Tributary
 4.1.1.2 (Co-op Spring),
 km 3.5**
View direction: Downstream
Description:
 Below Reed Road.

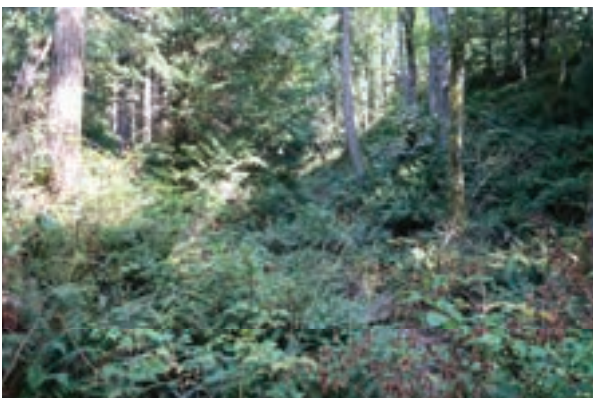
FIGURE 060

Photo: Placemark 41
Date (YYYY MM DD): 2021 07 16
Location: **Chaster Tributary
 4.1.1.2 (Co-op Spring),
 km 3.5**
View direction: Upstream
Description:
 Above Reed Road.

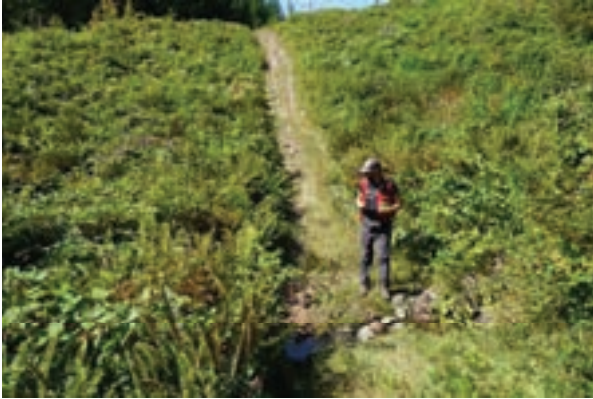
FIGURE 062

Photo: DSC09851
Date (YYYY MM DD): 2020 08 26
Location: **Chaster Tributary
 4.1.1.2 (Co-op Spring),
 km 3.6**
View direction: Upstream
Description:
 Deep ravine near location of water licence
 C019935 (no point of diversion noted).

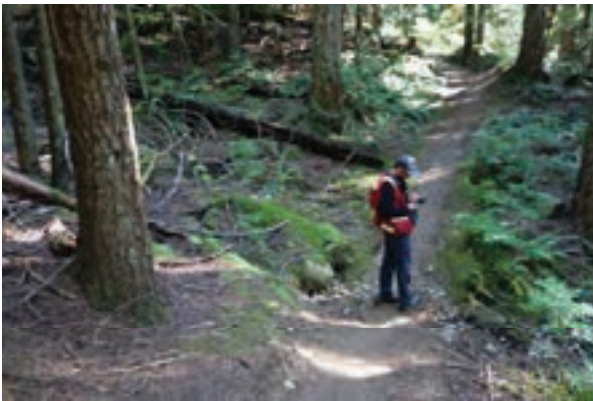
Photo: DSC09851
Date (YYYY MM DD): 2020 08 26
Location: **Chaster Tributary
 4.1.1.2 (Co-op Spring),
 km 4.1**
View direction: West
Description:
 At hydro right-of-way

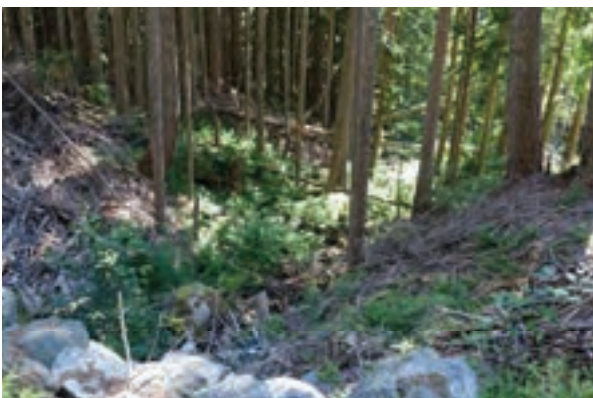
FIGURE 072

Photo: DSC00273
Date (YYYY MM DD): 2020 08 27
Location: **Chaster Tributary 9.1,**
km 6.3
View direction: Upstream
Description:
 Non classified channel in draw.

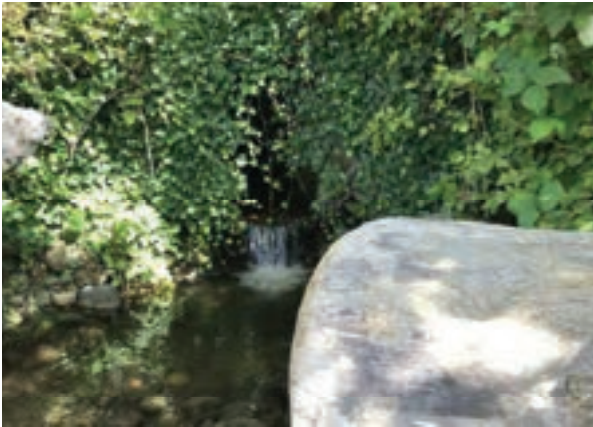
FIGURE 074

Photo: DSC09997
Date (YYYY MM DD): 2021 07 16
Location: **End/Walker Cr, km 0.0**
View direction: South
Description: Mouth of creek.

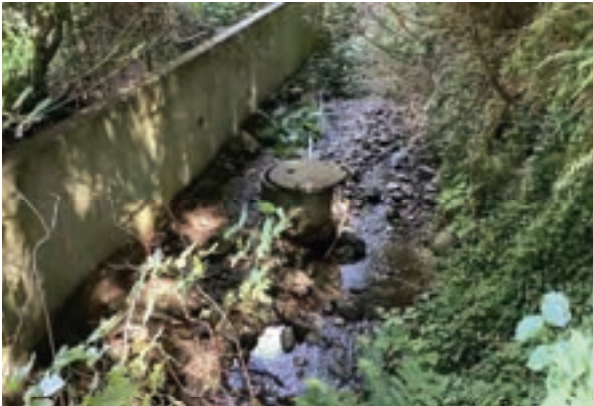
FIGURE 075

Photo: Placemark 138
Date (YYYY MM DD): 2020 08 24
Location: **End/Walker Cr, km 0.0**
View direction: Upstream
Description: Culvert at Ocean Beach Esplanade.

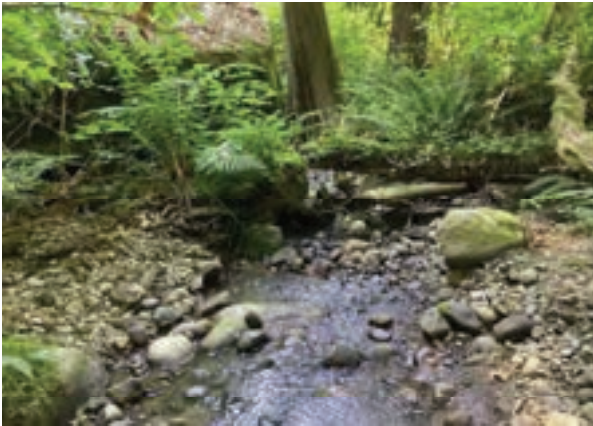
FIGURE 079

Photo: Placemark 56
Date (YYYY MM DD): 2021 07 16
Location: **End/Walker Cr, km 0.5**
View direction: Upstream
Description:
 In 50 m deep ravine. Turbid water noted.

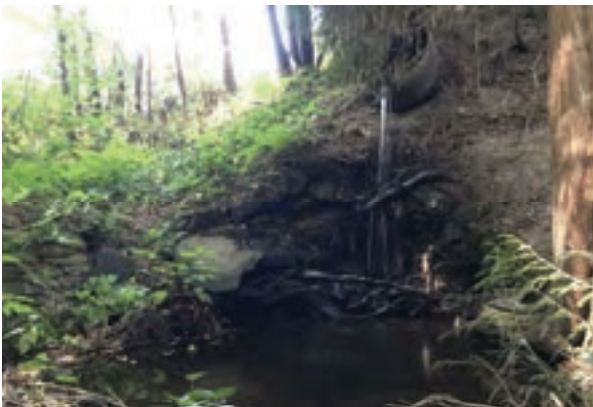
FIGURE 080

Photo: Placemark 56
Date (YYYY MM DD): 2021 07 16
Location: **End/Walker Cr, km 0.5**
View direction: Downstream
Description:
 In 50 m deep ravine. Turbid water noted.

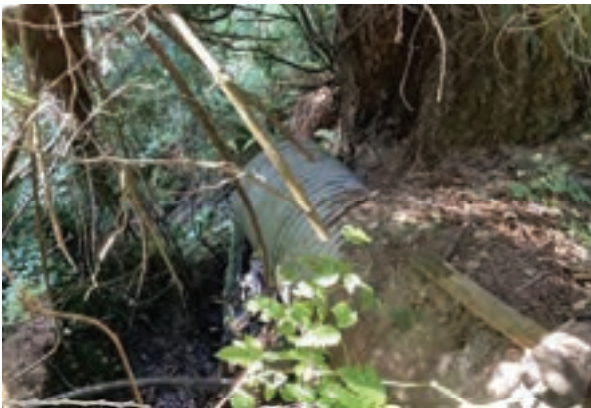
FIGURE 082

Photo: Placemark 53
Date (YYYY MM DD): 2021 07 16
Location: **End/Walker Cr, km 1.4**
View direction: Upstream
Description:
 1200 mm culvert at Sunshine Coast Highway.

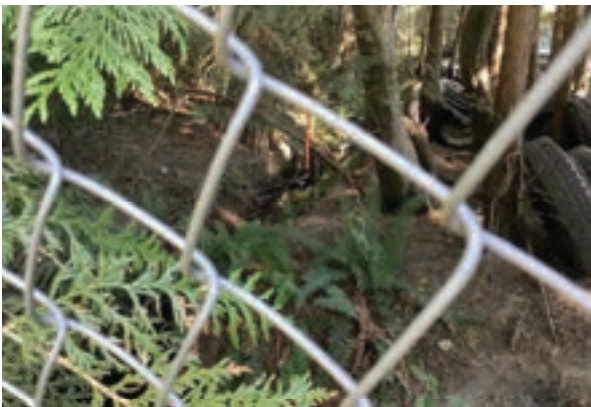
FIGURE 083

Photo: Placemark 51
Date (YYYY MM DD): 2021 07 16
Location: **End/Walker Cr, km 1.6**
View direction: Downstream
Description:
 View below Russell Road 900 mm diameter hanging culvert.

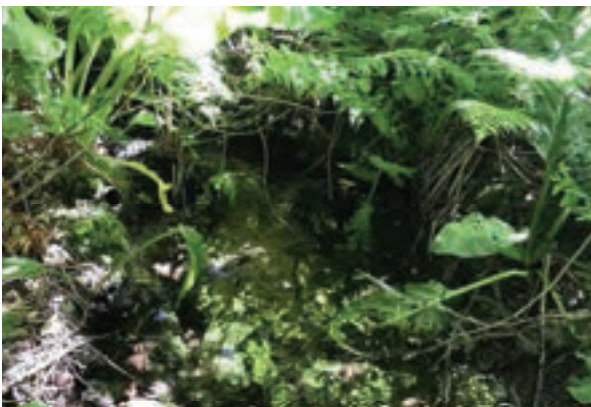
FIGURE 084

Photo: Placemark 50
Date (YYYY MM DD): 2021 07 16
Location: **End/Walker Cr, km 1.6**
View direction: Upstream
Description:
 View above Russell Road to Coastal Tire property.
