COMMITTEE OF THE WHOLE

Thursday, March 23, 2023

2. Pierre Aubin, RPF, Practice Forester, BC Timber Sales Chinook /
Sunshine Coast, Ministry of Forests
Regarding BC Timber Sales Mt. Elphinstone South
Watershed Assessment: Phase 1 and 2

The following letter is to accompany the release of the final draft of the Mt. Elphinstone South Watershed Assessment: Phase 1 & 2 report. The purpose of this letter is to provide an overview as to the scope of this report. This report does not contain site specific assessments associated with planned BC Timber Sales developments but rather provides an evaluation of the current condition of the watersheds within the assessment area.

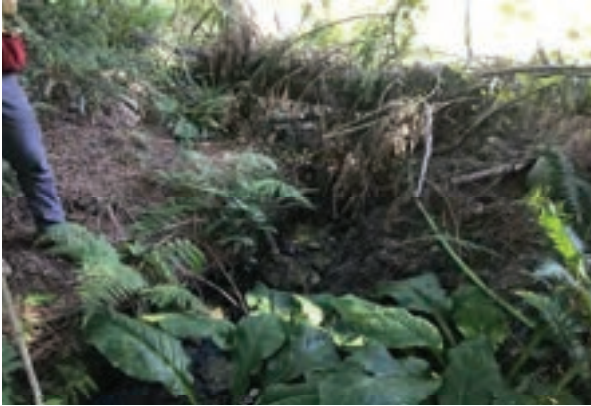
FIGURE 085

Photo: Placemark 9
Date (YYYY MM DD): 2021 07 16
Location: **End/Walker Cr, km 1.75**
View direction: Upstream
Description:
 Fine-grained streambed with brushy riparian zone.

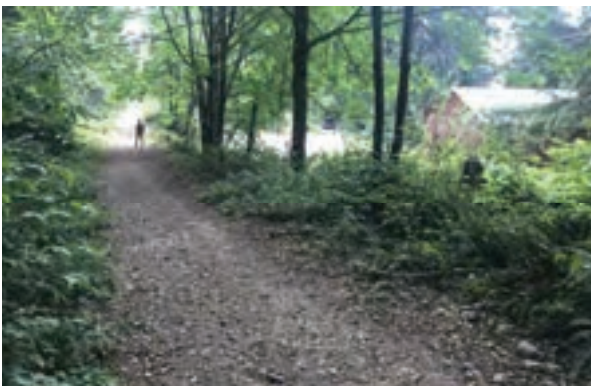
FIGURE 088

Photo: Placemark 222
Date (YYYY MM DD): 2021 07 16
Location: **End/Walker Cr watershed north of Reed Road**
View direction: West
Description: Top of ditch that flows seasonally to the west along road.

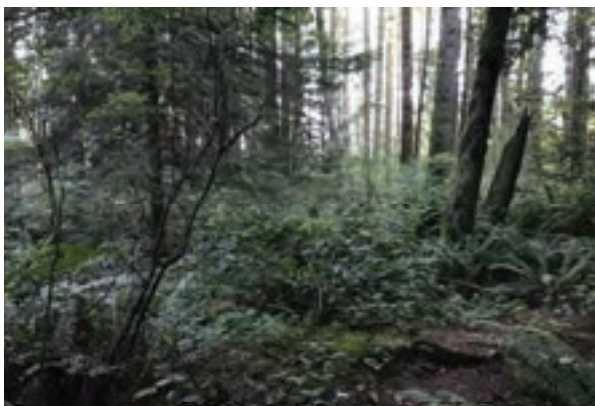
FIGURE 090

Photo: Placemark 218
Date (YYYY MM DD): 2021 07 16
Location: **End/Walker Cr watershed north of Reed Road**
View direction: West
Description: Low point along road/trail where seasonally, runoff may cross the road.

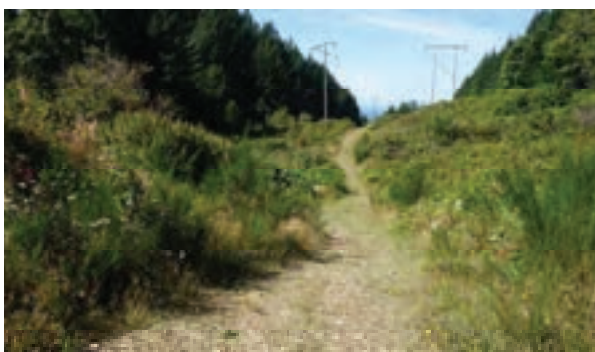
FIGURE 090

Photo: Placemark 110
Date (YYYY MM DD): 2021 07 16
Location: **End/Walker Cr watershed north of Reed Road**
View direction: South
Description:

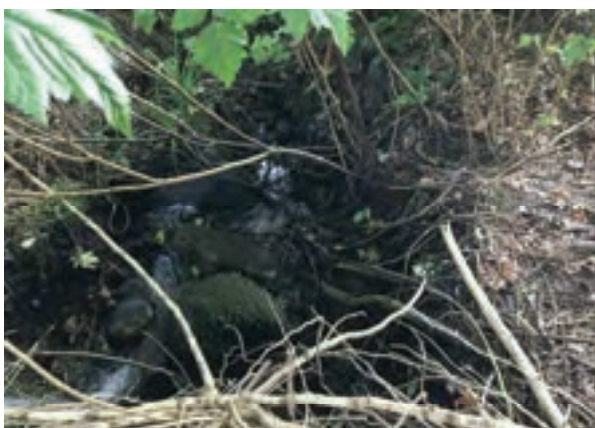
FIGURE 092

Photo: Placemark 139
Date (YYYY MM DD): 2021 07 16
Location: **Smales Cr, km 0.0**
View direction: Upstream
Description: View above Ocean Beach Esplanade.

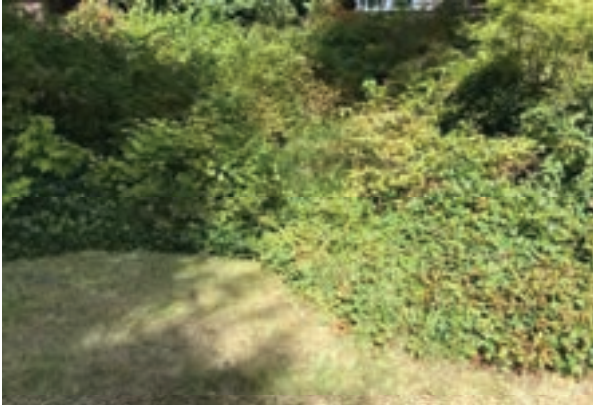
FIGURE 093

Photo: Placemark 139
Date (YYYY MM DD): 2021 07 16
Location: **Smales Cr, km 0.0**
View direction: Upstream
Description:
 View above Ocean Beach Esplanade. Heavy brush along private property. Less than 1 L/s of flow noted.

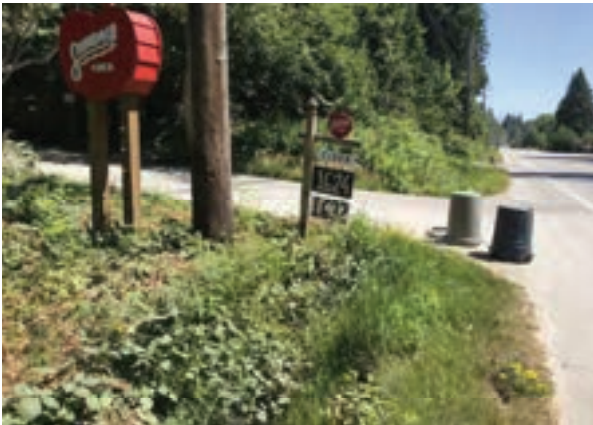
FIGURE 095

Photo: Placemark 24
Date (YYYY MM DD): 2021 07 16
Location: **Smales Cr, km 0.8**
View direction: West
Description:
 Ditch along Sunshine Coast Highway that conveys Smales Creek runoff (from above the highway) to the east towards End/Walker Creek. No flow in Smales Creek above the highway appears to cross the highway.

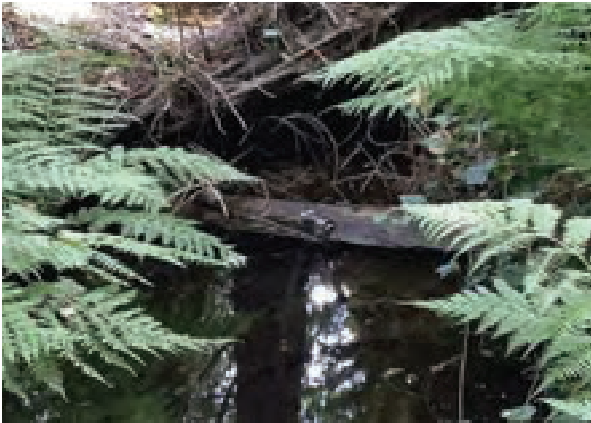
FIGURE 098

Photo: Placemark 226
Date (YYYY MM DD): 2021 07 16
Location: **Smales Cr, km 1.1**
View direction: Upstream
Description:
 Water line along creek.

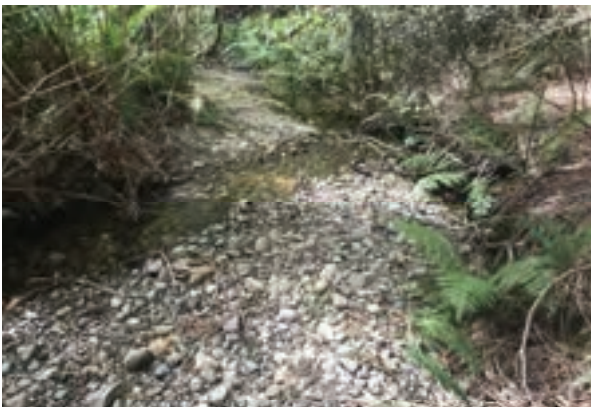
FIGURE 099

Photo: Placemark 212
Date (YYYY MM DD): 2021 07 16
Location: **Smales Cr, km 1.15**
View direction: Upstream
Description:
 Aggraded stream channel.

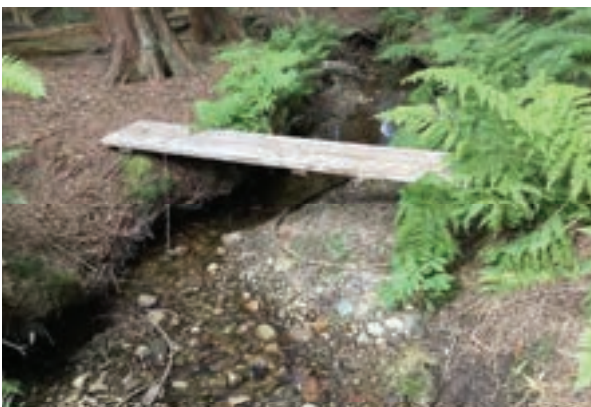
FIGURE 100

Photo: Placemark 224
Date (YYYY MM DD): 2021 07 16
Location: **Smales Cr, km 1.15**
View direction: Downstream
Description:
 Foot bridge on Sunday Cider property.

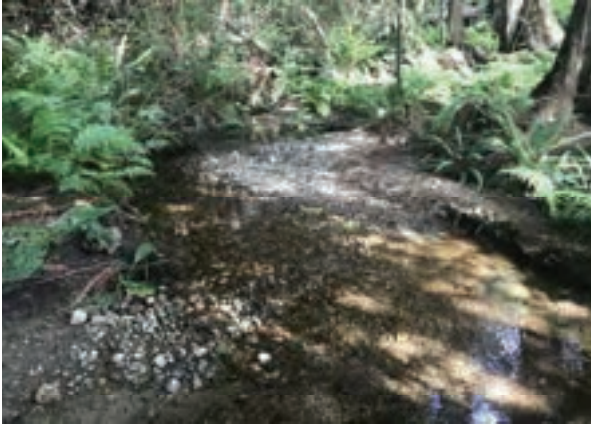
FIGURE 101

Photo: Placemark 211
Date (YYYY MM DD): 2021 07 16
Location: **Smales Cr, km 1.2**
View direction: Downstream
Description:
 Aggraded stream channel.

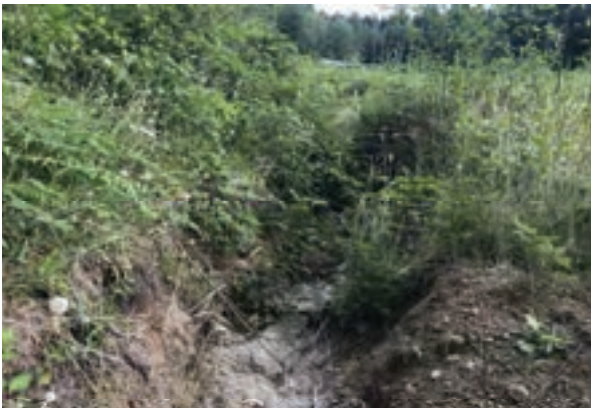
FIGURE 102

Photo: Placemark 178
Date (YYYY MM DD): 2021 07 16
Location: **Tributary to Smales Cr that joins at km 1.3**
View direction: Upstream
Description:
 Dry channel.

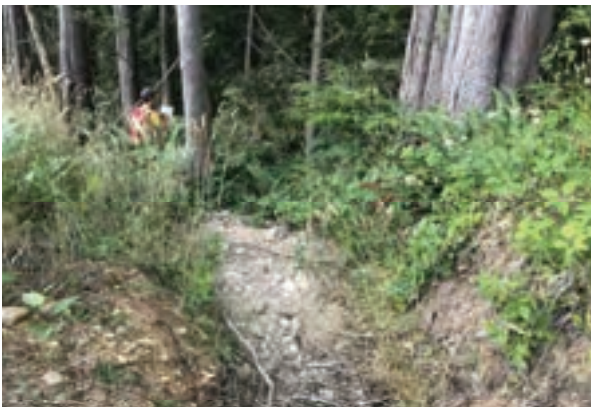
FIGURE 103

Photo: Placemark 178
Date (YYYY MM DD): 2021 07 16
Location: **Tributary to Smales Cr that joins at km 1.3 (km 1.3)**
View direction: Downstream
Description:
 Dry channel.

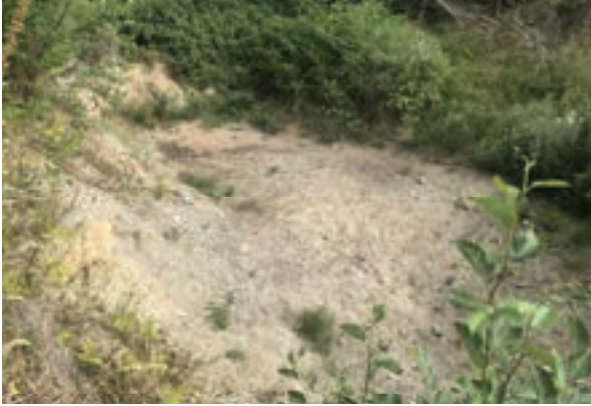
FIGURE 105

Photo: Placemark 209
Date (YYYY MM DD): 2021 07 16
Location: **Tributary to Smales Cr that joins at km 1.3 (km 1.4)**
View direction: Upstream
Description:
 Small sump/pond (dry).

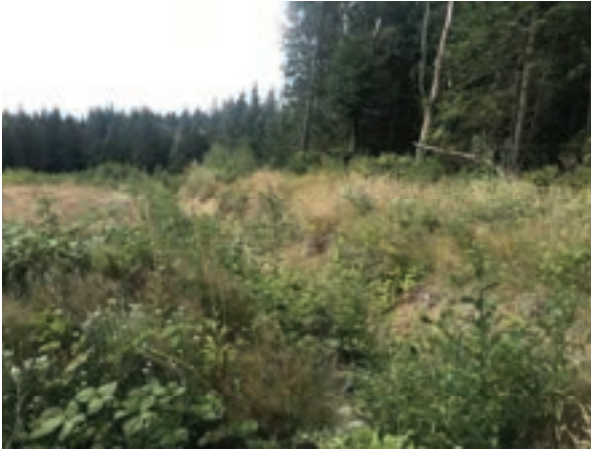
FIGURE 106

Photo: Placemark 209
Date (YYYY MM DD): 2021 07 16
Location: **Tributary to Smales Cr that joins at km 1.3 (km 1.4)**
View direction: Downstream
Description:
 Eroded channel below small sump/pond (dry).

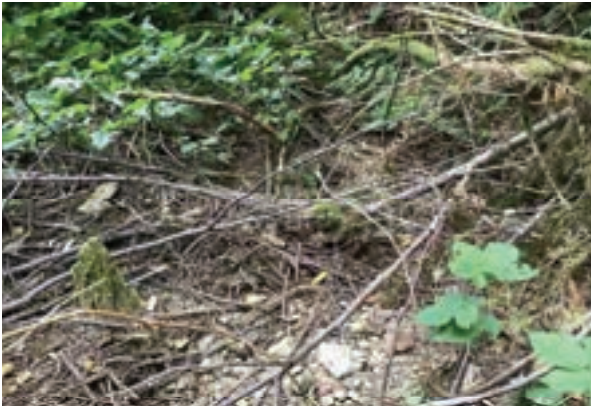
FIGURE 107

Photo: Placemark 222
Date (YYYY MM DD): 2021 07 16
Location: **Tributary to Smales Cr that joins at km 1.3 (km 1.5)**
View direction: Downstream
Description:
 Heavy brush.

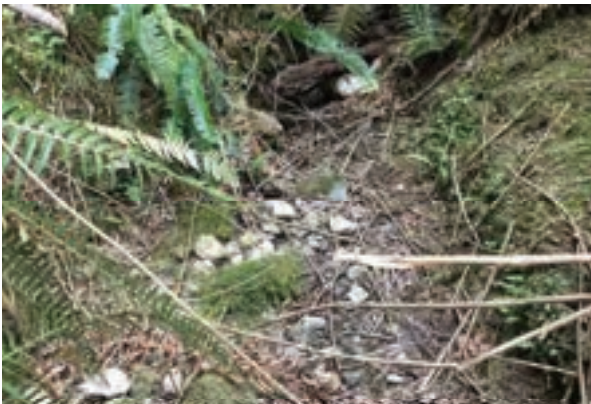
FIGURE 108

Photo: Placemark 220
Date (YYYY MM DD): 2021 07 16
Location: **Tributary to Smales Cr that joins at km 1.3 (km 1.6)**
View direction: Downstream
Description:
 Upstream extent of gravel. NCD above this point.

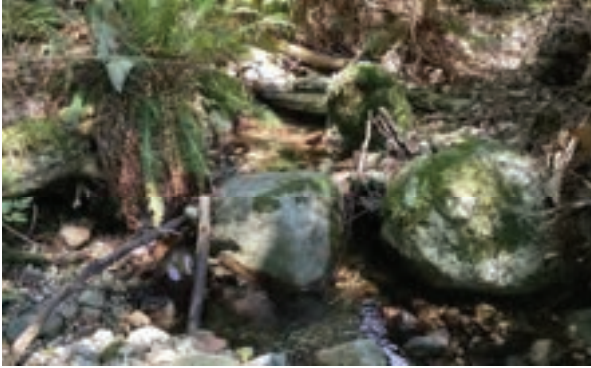
FIGURE 109

Photo: Placemark 64
Date (YYYY MM DD): 2021 07 16
Location: **Smales Cr, km 1.3**
View direction: Upstream
Description:
 In 8 m deep ravine.

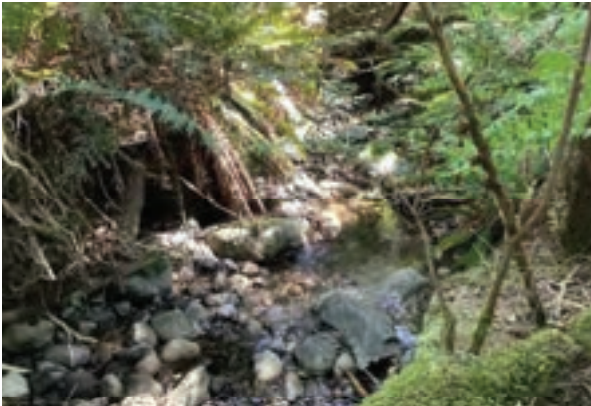
FIGURE 110

Photo: Placemark 64
Date (YYYY MM DD): 2021 07 16
Location: **Smales Cr, km 1.3**
View direction: Downstream
Description:
 In 8 m deep ravine.

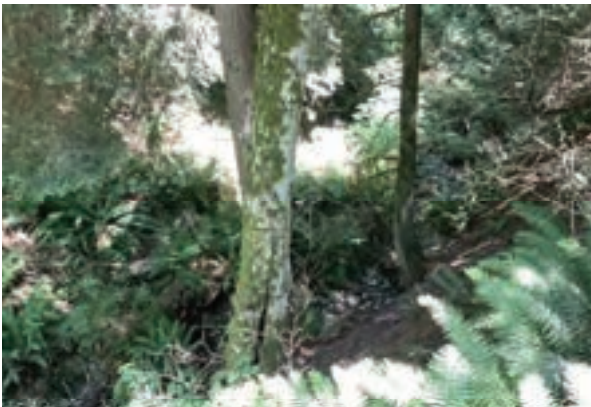
FIGURE 111

Photo: Placemark 67
Date (YYYY MM DD): 2021 07 16
Location: **Smales Cr, km 2.5**
View direction: Downstream
Description:
 View from Highland Road on west side of 10 m deep ravine.

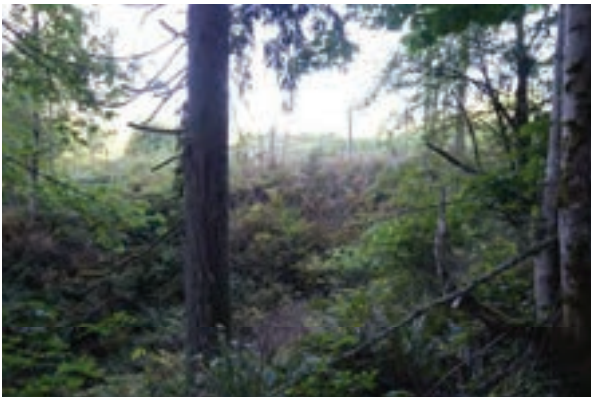
FIGURE 112

Photo: DSC09732
Date (YYYY MM DD): 2020 08 24
Location: **Smales Cr, km 1.7**
View direction: West
Description:
 View across ravine to residential development.

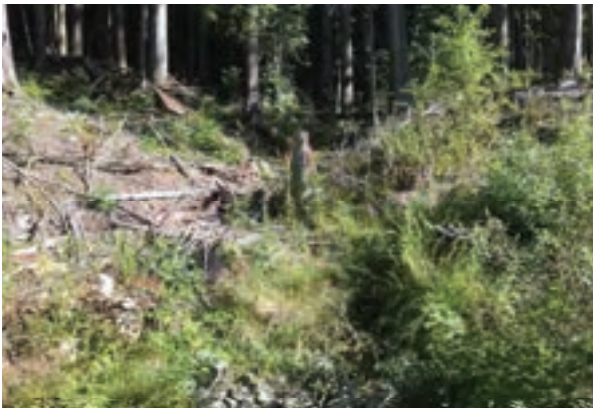
FIGURE 114

Photo: Placemark 161
Date (YYYY MM DD): 2021 07 16
Location: **Smales Cr Tributary 2, km 3.4**
View direction: Upstream
Description:
 View above 900 mm culvert.

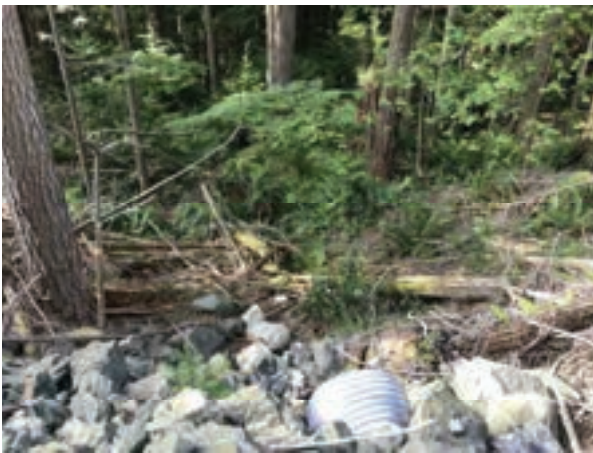
FIGURE 115

Photo: Placemark 161
Date (YYYY MM DD): 2021 07 16
Location: **Smales Cr Tributary 2, km 3.4**
View direction: Downstream
Description:
 View below 900 mm culvert.

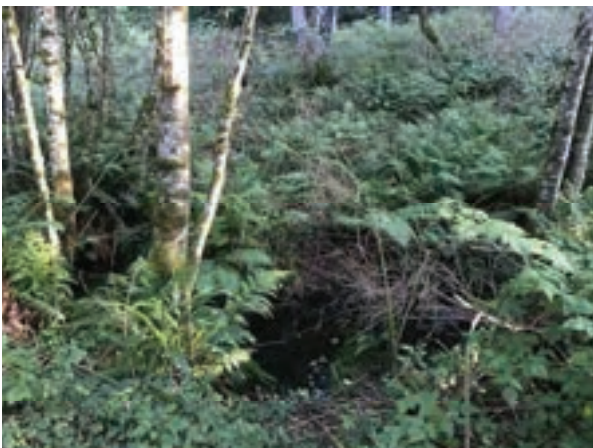
FIGURE 116

Photo: Placemark 102
Date (YYYY MM DD): 2021 07 16
Location: **Smales Cr watershed, north side of trail west of end of Reed Road.**
View direction: North
Description:
 Standing water along 100 m of ditch.

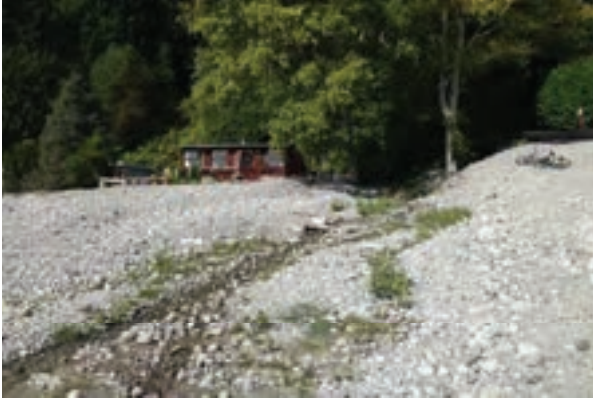
FIGURE 117

Photo: DSC00026
Date (YYYY MM DD): 2020 08 26
Location: **Whittaker Cr, km 0.0**
View direction: Upstream
Description:
Widespread aggradation near the mouth of Whittaker Creek following a washout of Lower Road.

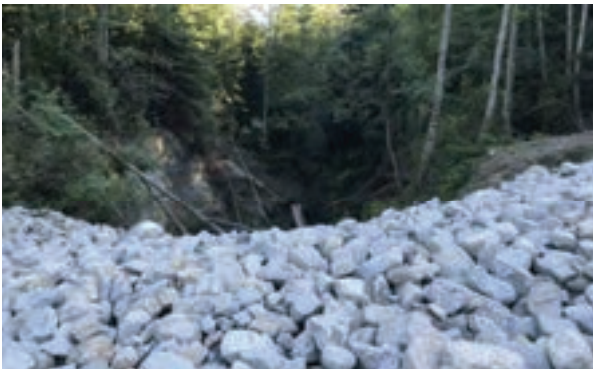
FIGURE 119

Photo: Placemark 140
Date (YYYY MM DD): 2021 07 16
Location: **Whittaker Cr, km 0.1**
View direction: Downstream
Description:
Stream conditions post-flood and road washout.

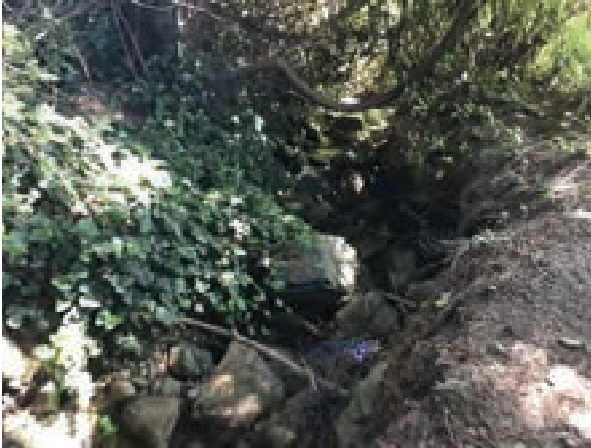
FIGURE 121

Photo: Placemark 36
Date (YYYY MM DD): 2021 07 16
Location: **Higgs Br, km 0.05**
View direction: Upstream
Description:
 Incised channel with eroding banks near trail.

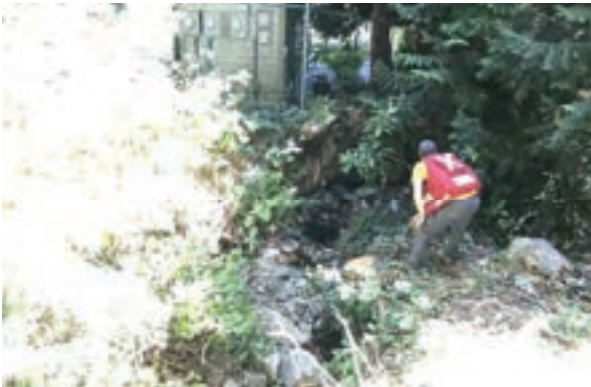
FIGURE 123

Photo: Placemark 34
Date (YYYY MM DD): 2021 07 16
Location: **Higgs Br, km 0.1**
View direction: Downstream
Description:
 Undercut bank poses a risk to utility building adjacent to channel.

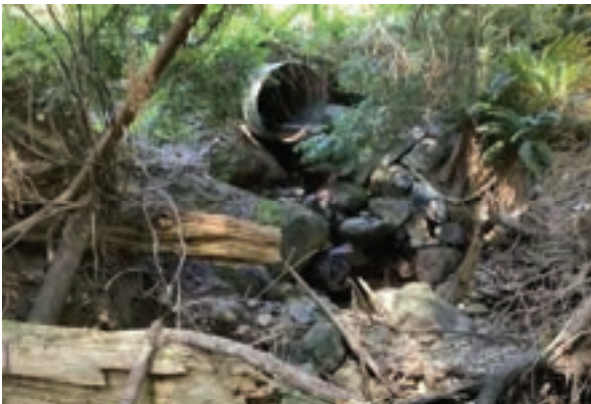
FIGURE 124

Photo: Placemark 72
Date (YYYY MM DD): 2021 07 16
Location: **Higgs Br, km 0.1**
View direction: Upstream
Description:
 1,000 mm diameter culvert at Lower Road. Incised channel below road.

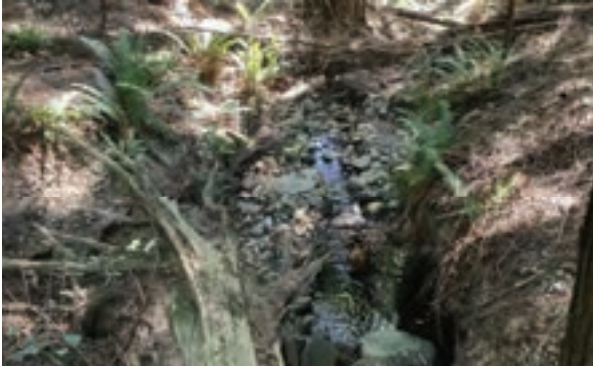
FIGURE 125

Photo: Placemark 72
Date (YYYY MM DD): 2021 07 16
Location: **Higgs Br, km 0.3**
View direction: Downstream
Description:
 View below Lower Road.

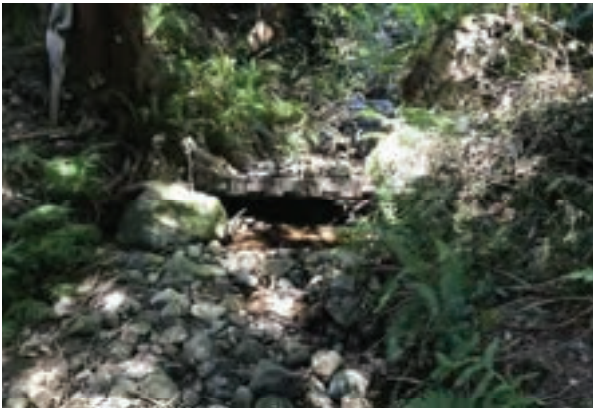
FIGURE 126

Photo: Placemark 38
Date (YYYY MM DD): 2021 07 16
Location: **Higgs Br, km 0.3**
View direction: Upstream
Description:
 View above Lower Road.

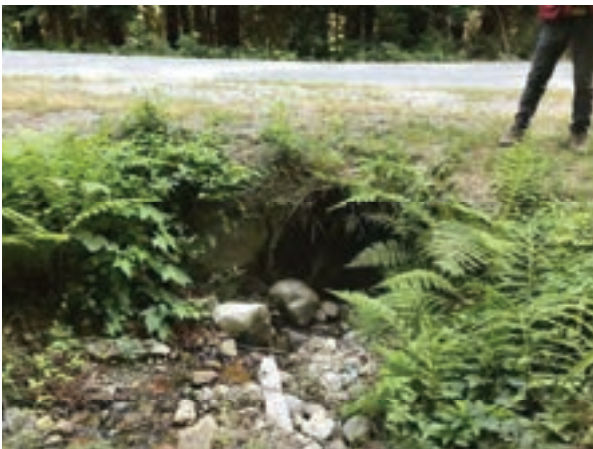
FIGURE 127

Photo: Placemark 38
Date (YYYY MM DD): 2021 07 16
Location: **Higgs Br, km 0.3**
View direction: Downstream
Description:
 Lower Road culvert inlet.

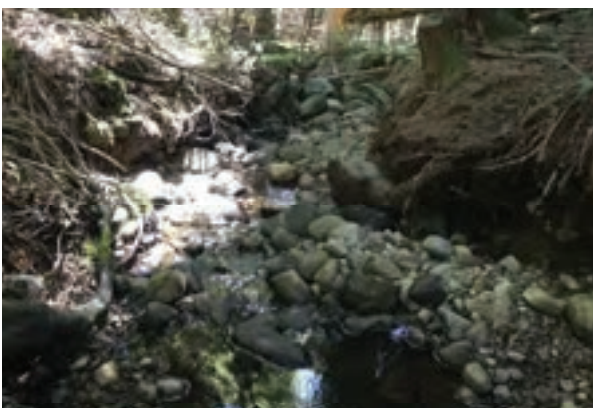
FIGURE 128

Photo: Placemark 41
Date (YYYY MM DD): 2021 07 16
Location: **Higgs Br, km 0.75**
View direction: Upstream
Description:
 Incised channel near farm.

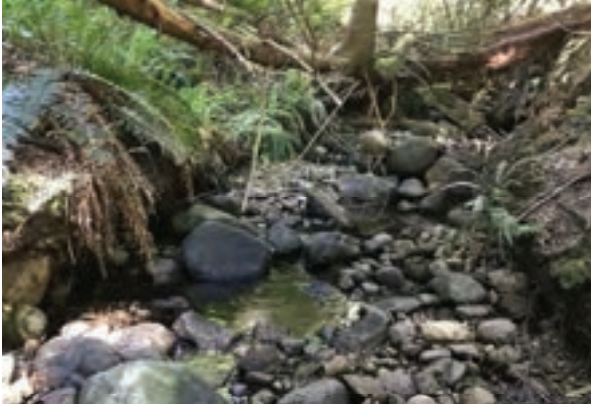
FIGURE 129

Photo: Placemark 41
Date (YYYY MM DD): 2021 07 16
Location: **Higgs Br, km 0.75**
View direction: Downstream
Description:
 Incised channel near farm.

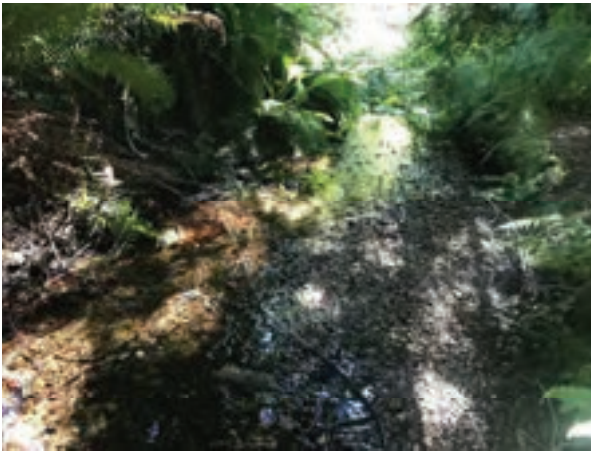
FIGURE 130

Photo: Placemark 49
Date (YYYY MM DD): 2021 07 16
Location: **Higgs Br, km 1.3**
View direction: Downstream
Description:
 Weir and pond infilled with sediment.

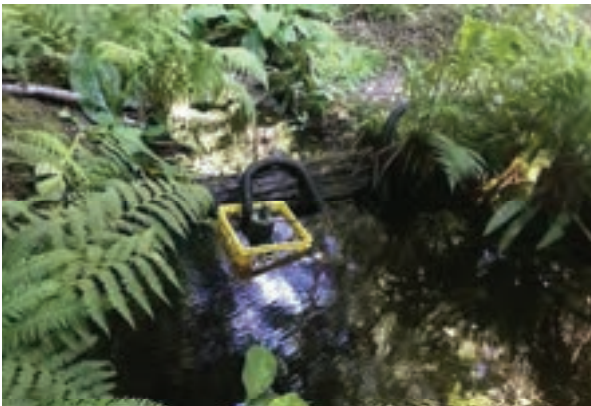
FIGURE 131

Photo: Placemark 49
Date (YYYY MM DD): 2021 07 16
Location: **Higgs Br, km 1.3**
View direction: Upstream
Description:
 Submersible pump in milk crate at location of weir and pond infilled with sediment. Water licence C070726.

Higgs Brook	0.76	C069016	PD45103	19781107	02D - Comm. Enterprise: Enterprise	4.54609	m ³ /day	No	See above.
	Higgs Brook	1.1	C107917	PD69089	19940323	01A - Domestic	2.27305	m ³ /day	No	Mapped POD located on Crown land. Did not obtain permission to visit property. Observed channel above and below property.
	Higgs Brook	1.23	C070726	PD45105	19620720	01A - Domestic	2.27305	m ³ /day	Yes	Polar visited property. Owners used to have an intake when they first moved here 20 years ago but they don't currently use it. Higgs Brook typically dry in summer but there are wet areas due to springs in area. Currently there is a well near the stream adjacent to the property. Owner noted that recently there is less water in well partially due to larger development above which he says has altered natural drainage patterns. Skid trails and roads may have altered drainage. Noted a submersible pump in milk crate in infilled pond above old concrete weir. Low energy stream conditions.

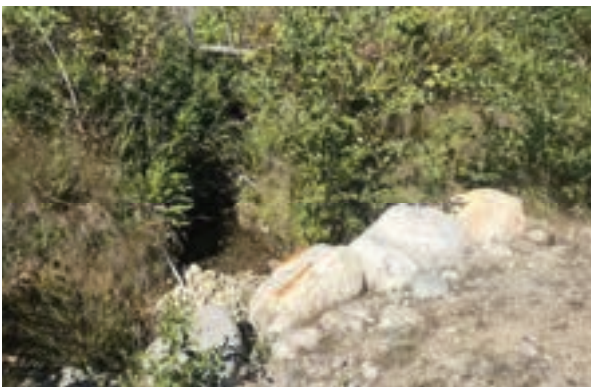
FIGURE 132

Photo: Placemark 46
Date (YYYY MM DD): 2021 07 16
Location: **Higgs Br, km 1.6**
View direction: Upstream
Description:
 View below Harman Road culvert.

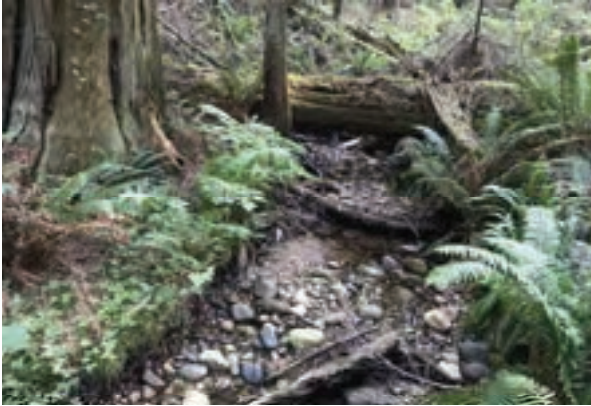
FIGURE 133

Photo: Placemark 62
Date (YYYY MM DD): 2021 07 16
Location: **Slater Cr, km 0.4**
View direction: Upstream
Description:
Above Lower Road.

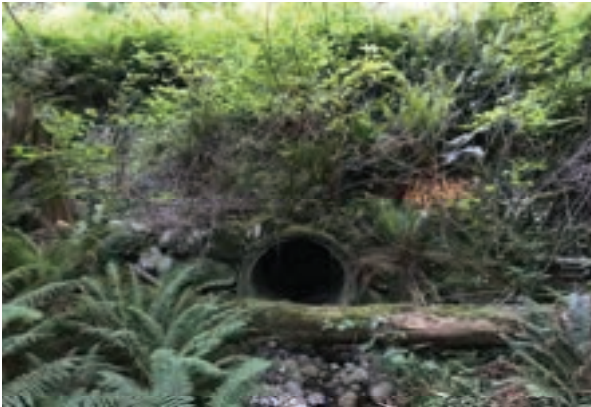
FIGURE 134

Photo: Placemark 62
Date (YYYY MM DD): 2021 07 16
Location: **Slater Cr, km 0.4**
View direction: Downstream
Description:
Lower Road 1200 mm diameter concrete culvert.

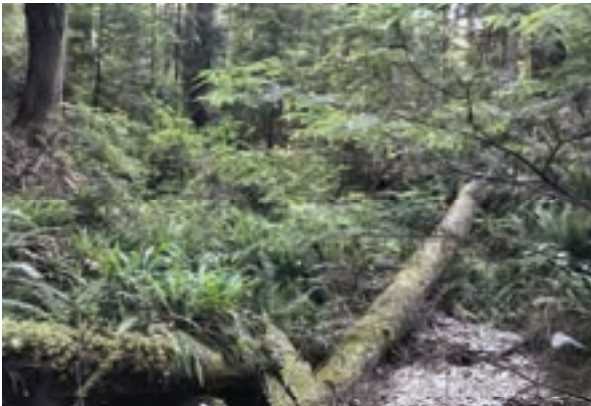
FIGURE 135

Photo: Placemark 62
Date (YYYY MM DD): 2021 07 16
Location: **Slater Cr, km 0.45**
View direction: Upstream
Description:
Bedrock along channel noted.

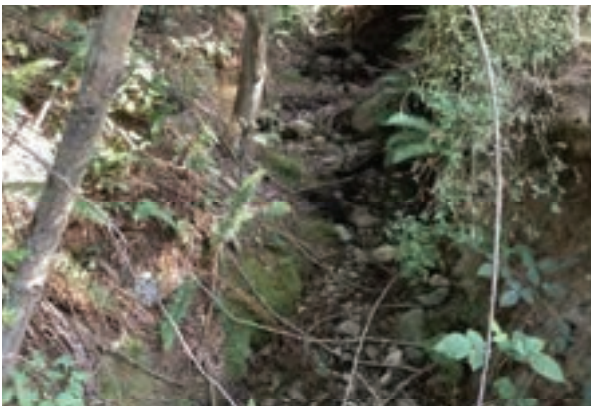
FIGURE 136

Photo: Placemark 101
Date (YYYY MM DD): 2021 07 16
Location: **Slater Cr, km 1.0**
View direction: Upstream
Description:
Incised channel above Sunshine Coast Highway and 900 mm diameter culvert.

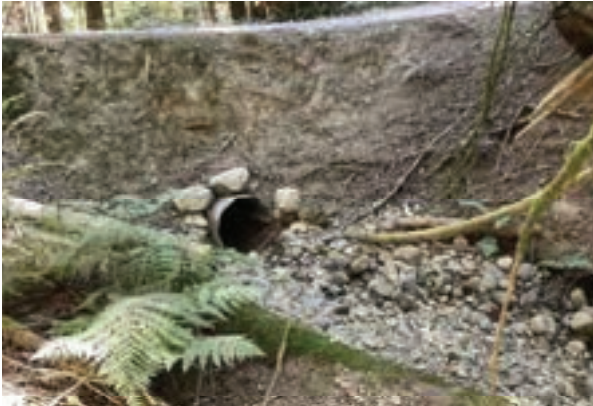
FIGURE 138

Photo: Placemark 124
Date (YYYY MM DD): 2021 07 16
Location: **Slater Cr, km 1.4**
View direction: Downstream
Description:
 600 mm diameter culvert at Porter Road.

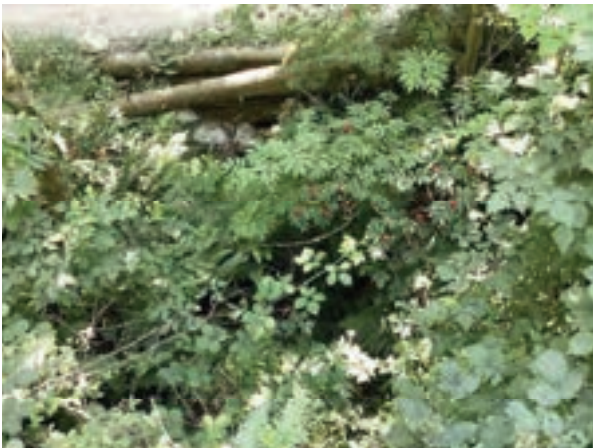
FIGURE 140

Photo: Placemark 137
Date (YYYY MM DD): 2021 07 16
Location: **Slater Cr, km 2.1**
View direction: Upstream
Description:
 Wood bridge near driveway on Pixton Road.

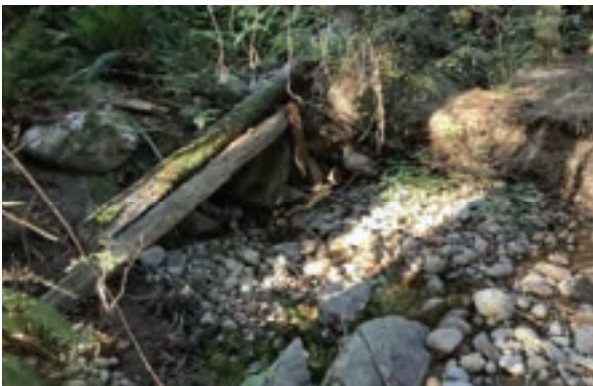
FIGURE 144

Photo: Placemark 95
Date (YYYY MM DD): 2021 07 16
Location: **Slater Cr, km 0.3**
View direction: Downstream
Description:
 1,200 mm diameter concrete culvert with log at inlet. Evidence of sediment accumulation at inlet.

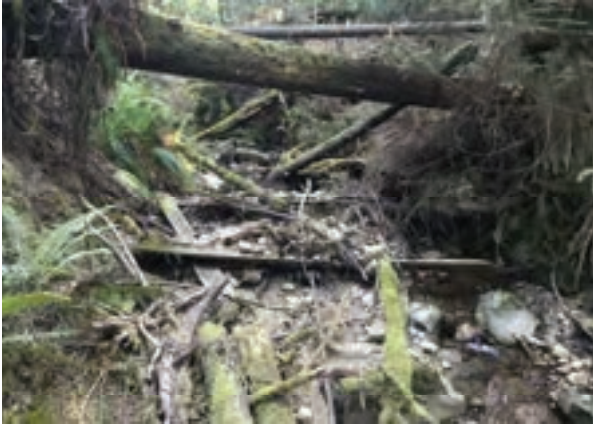
FIGURE 145

Photo: Placemark 56
Date (YYYY MM DD): 2021 07 16
Location: **Molyneux Cr, km 0.35**
View direction: Upstream
Description:
 Incised channel above Lower Road. Heavy wood load.

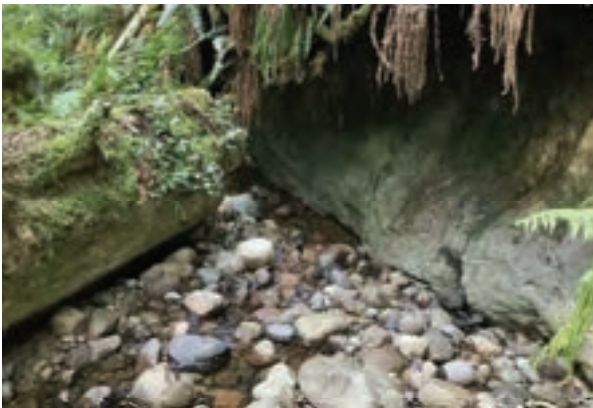
FIGURE 146

Photo: Placemark 97
Date (YYYY MM DD): 2021 07 16
Location: **Molyneux Cr, km 0.5**
View direction: Upstream
Description:
 Exposed clay till along stream bank.

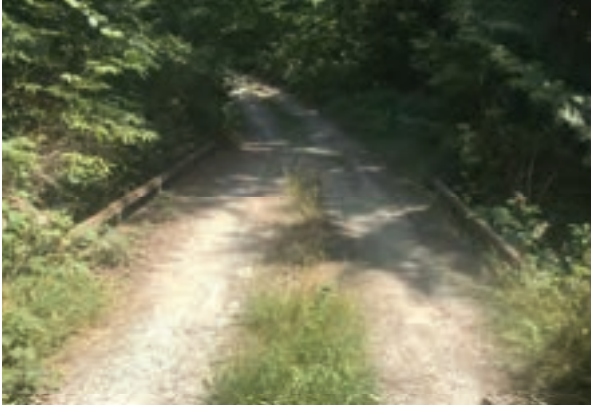
FIGURE 149

Photo: Placemark 60
Date (YYYY MM DD): 2021 07 16
Location: **Molyneux Cr**
Tributary 1.1, km 1.4
View direction: East.
Description:
 Private bridge near end of Porter Road. No flow in stream.

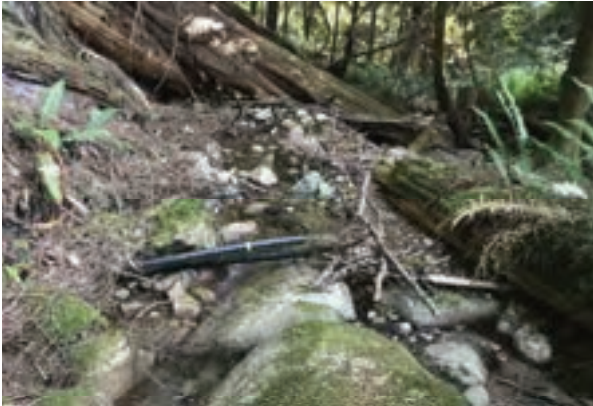
FIGURE 154

Photo: Placemark 111
Date (YYYY MM DD): 2021 07 16
Location: **Molyneux Cr
 Tributary 1.2, km 1.75**
View direction: Downstream
Description:
 Exposed water line in channel.

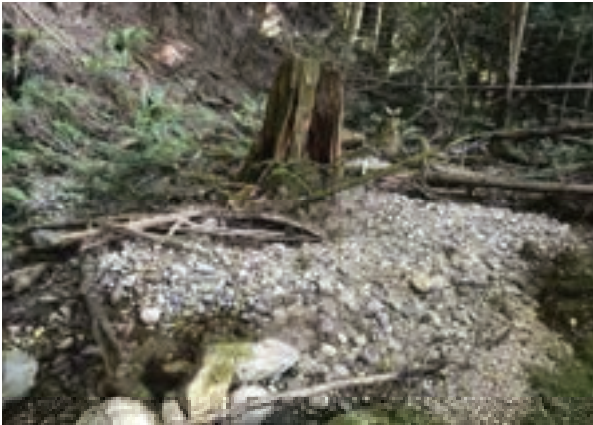
FIGURE 156

Photo: Placemark 112
Date (YYYY MM DD): 2021 07 16
Location: **Molyneux Cr
 Tributary 1.2, km 1.7**
View direction: Downstream
Description:
 Location of former water intake above log jam and buried by gravel. Various pipes and barrel noted in area.

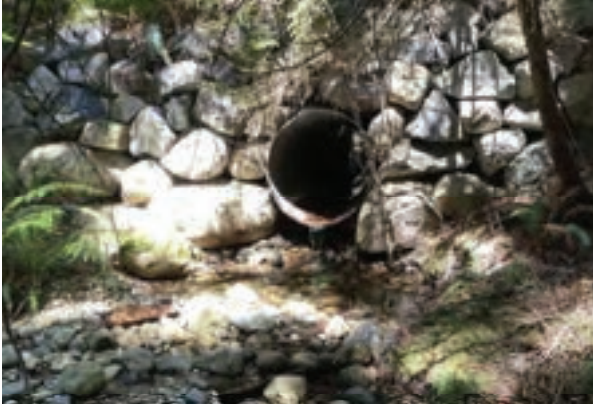
FIGURE 157

Photo: Placemark 125
Date (YYYY MM DD): 2021 07 16
Location: **Molyneux Cr
 Tributary 2, km 1.3**
View direction: Upstream
Description:
 1,200 mm diameter culvert.

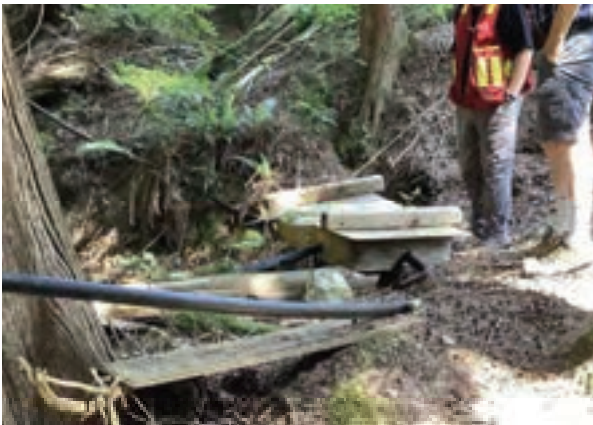
FIGURE 160

Photo: Placemark 93
Date (YYYY MM DD): 2021 07 16
Location: **Molyneux Cr
 Tributary 2, km 1.35**
View direction: Downstream
Description:
 Water supply infrastructure along creek.
 Licence C114609.

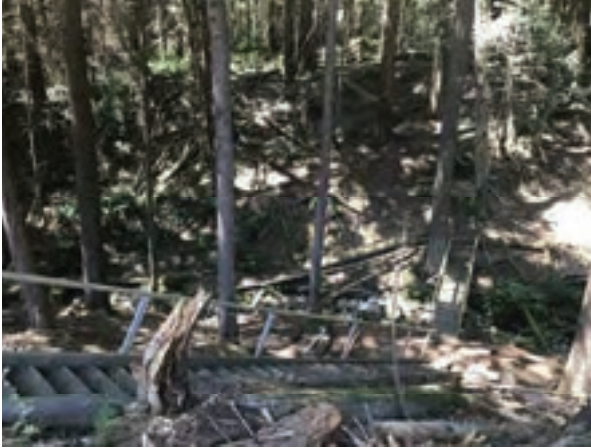
FIGURE 161

Photo: Placemark 94
Date (YYYY MM DD): 2021 07 16
Location: **Molyneux Cr
 Tributary 2, km 1.5**
View direction: West
Description:
 Private stairs and bridge across creek.

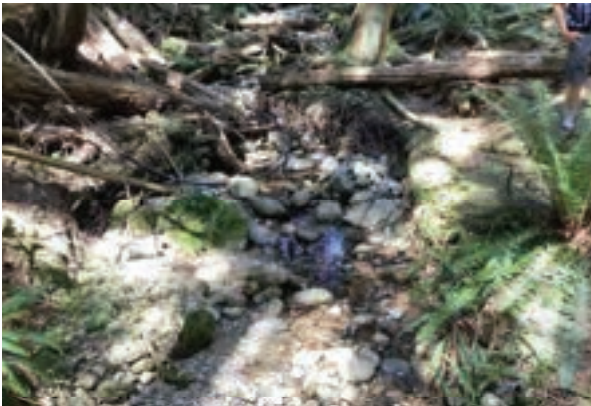
FIGURE 163

Photo: Placemark 132
Date (YYYY MM DD): 2021 07 16
Location: **Molyneux Cr
 Tributary 2, km 1.55**
View direction: Upstream
Description:
 Water line along creek.

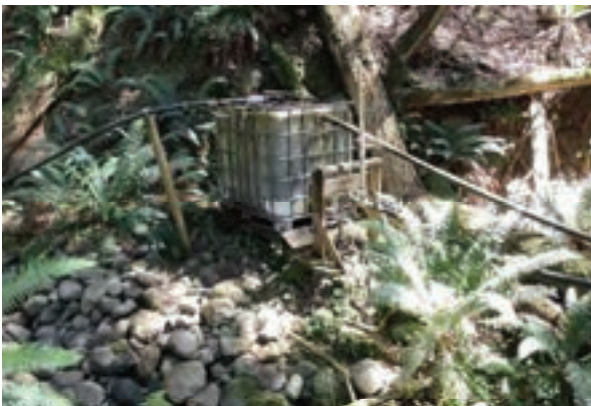
FIGURE 164

Photo: Placemark 133
Date (YYYY MM DD): 2021 07 16
Location: **Molyneux Cr
 Tributary 2, km 1.6**
View direction: Upstream
Description:
 Water supply infrastructure along creek.

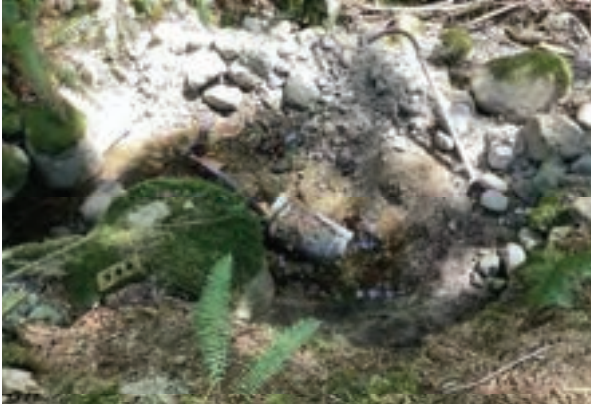
FIGURE 165

Photo: Placemark 134
Date (YYYY MM DD): 2021 07 16
Location: **Molyneux Cr
 Tributary 2, km 1.6**
View direction: Downstream
Description:
 Intake in small pool. Licence C118817.

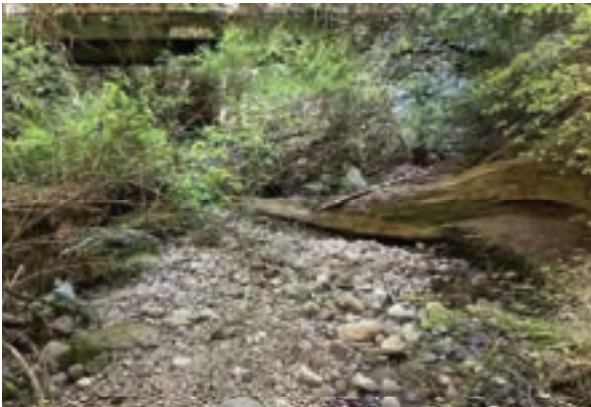
FIGURE 167

Photo: Placemark 122
Date (YYYY MM DD): 2021 07 16
Location: **Molyneux Cr
 Tributary 2, km 1.7**
View direction: Downstream
Description:
 Bridge constructed from railcar.

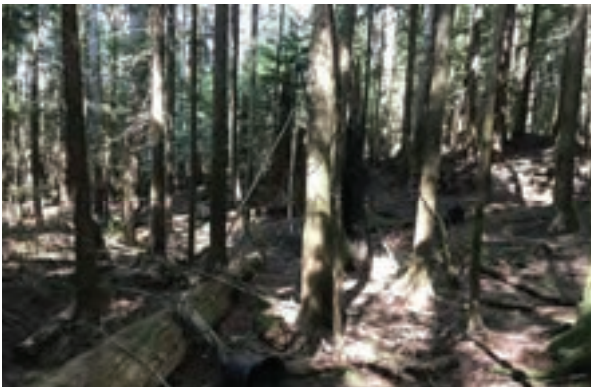
FIGURE 168

Photo: Placemark 81
Date (YYYY MM DD): 2021 07 16
Location: **Molyneux Cr
 Tributary 1.1, km 2.8**
View direction: Downstream
Description:
 Subtle draw with no evidence of surface flow.

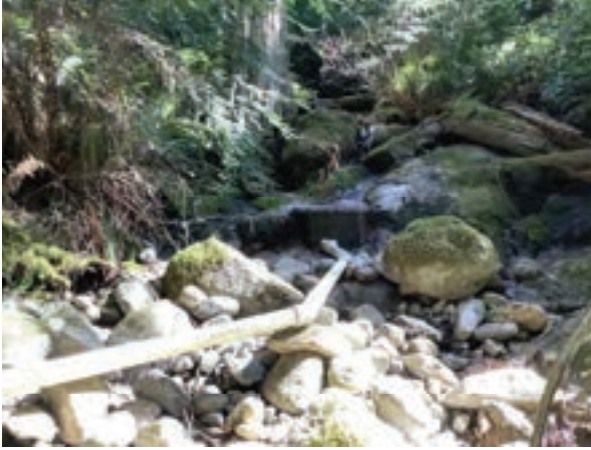
FIGURE 169

Photo: Placemark XX
Date (YYYY MM DD): 2021 07 16
Location: **Molyneux Cr
 Tributary 1.2, km 2.5**
View direction: Upstream
Description:
 Concrete intake in channel with pvc distribution pipe below. Intake may be vulnerable to sediment loading.

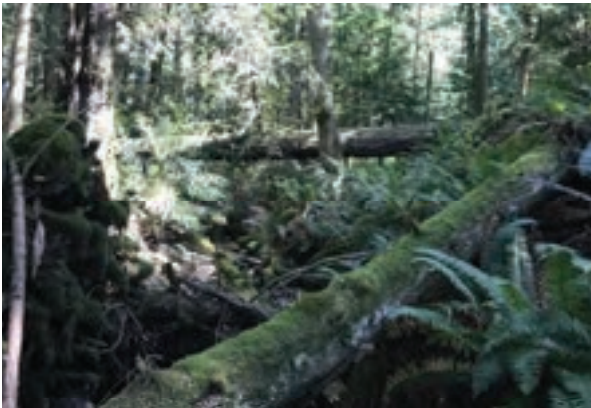
FIGURE 171

Photo: Placemark 74
Date (YYYY MM DD): 2021 07 16
Location: **Molyneux Cr
 Tributary 1.2, km 2.6**
View direction: Upstream
Description:
 Heavy blowdown from edge of harvested block to the east.

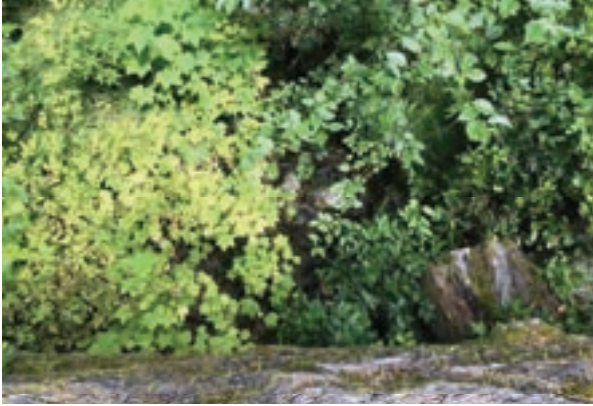
FIGURE 173

Photo: Placemark 33
Date (YYYY MM DD): 2021 07 16
Location: **Molyneux Cr
 Tributary 1.2, km 2.8**
View direction: Upstream
Description:
 Bouldery channel above log bridge.

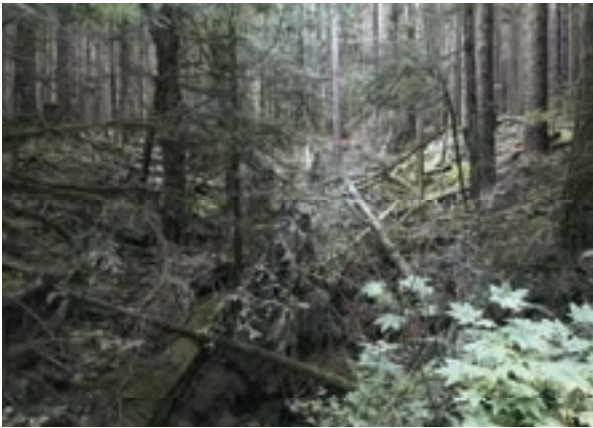
FIGURE 175

Photo: Placemark 148
Date (YYYY MM DD): 2021 07 16
Location: **Molyneux Cr
 Tributary 1.2.7, km 4.1**
View direction: Upstream
Description:
 S6 channel above 900 mm culvert.

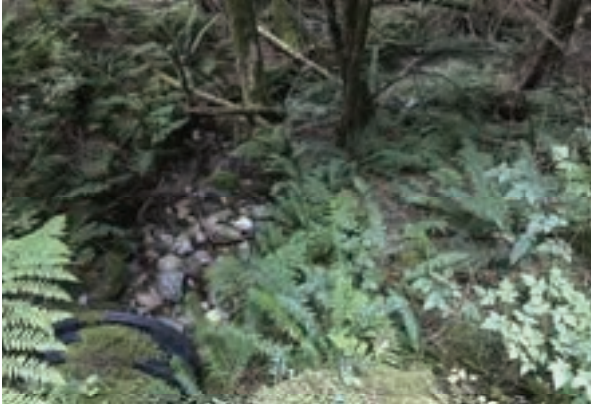
FIGURE 176

Photo: Placemark 147
Date (YYYY MM DD): 2021 07 16
Location: **Molyneux Cr
 Tributary 1.2.8.1, km
 4.1**
View direction: Upstream
Description:
 S6 channel above 900 mm culvert.

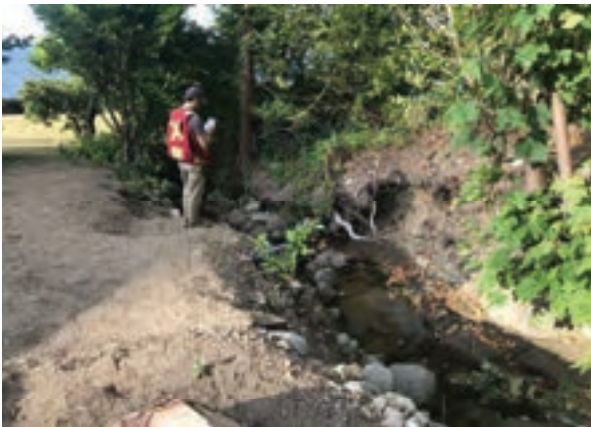
FIGURE 181

Photo: Placemark 149
Date (YYYY MM DD): 2021 07 16
Location: **Joe Smith Cr, km 0.05**
View direction: Upstream
Description:
 Eroding channel along private property.

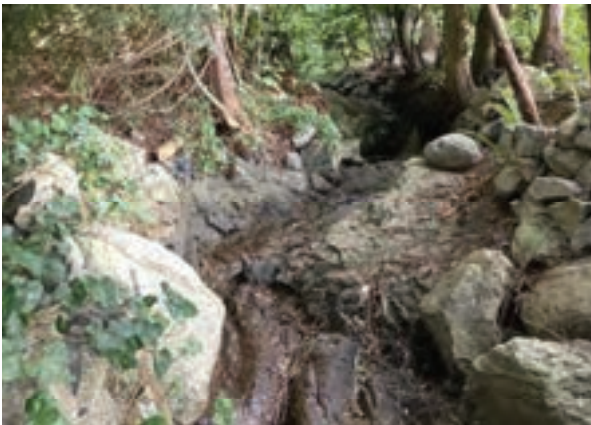
FIGURE 182

Photo: Placemark 115
Date (YYYY MM DD): 2021 07 16
Location: **Joe Smith Cr, km 0.05**
View direction: Downstream
Description:
 Eroding channel along private property.

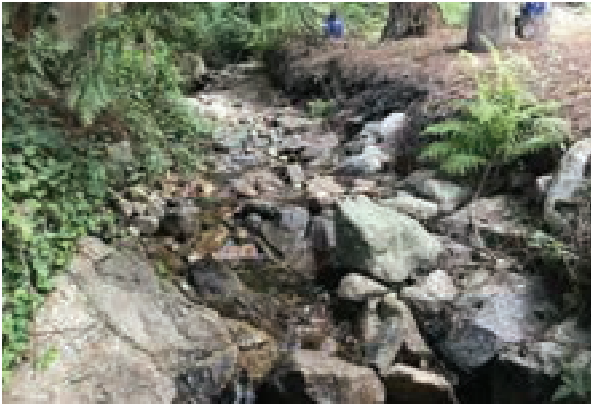
FIGURE 185

Photo: Placemark 117
Date (YYYY MM DD): 2021 07 16
Location: **Joe Smith Cr, km 0.2**
View direction: Upstream
Description:
 Exposed bedrock along channel.

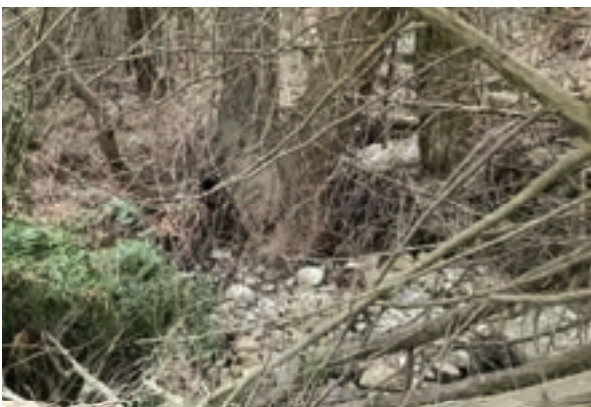
FIGURE 187

Photo: Placemark 153
Date (YYYY MM DD): 2021 07 16
Location: **Joe Smith Cr, km 0.25**
View direction: Downstream
Description:
 Undercut banks may pose blowdown risk.

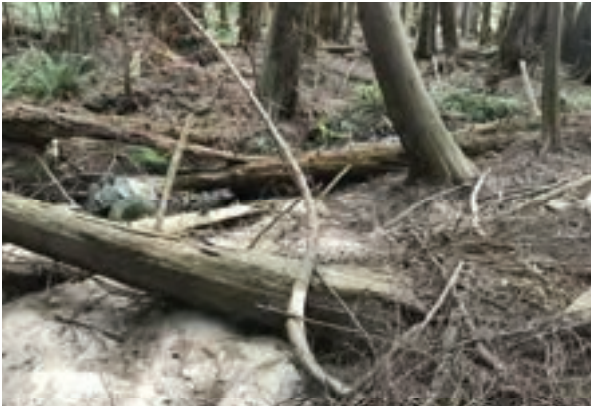
FIGURE 190

Photo: Placemark 131
Date (YYYY MM DD): 2021 07 16
Location: **Joe Smith Cr, km 0.3**
View direction: Downstream

Below Lower Road channel partially flows across bedrock. Water distribution line along channel. Does not appear to be in use.

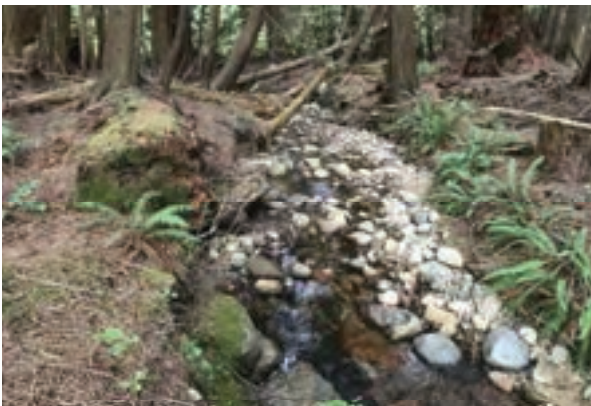
FIGURE 191

Photo: Placemark 121
Date (YYYY MM DD): 2021 07 16
Location: **Joe Smith Cr, km 0.35**
View direction: Upstream

Sediment trapped by debris above Lower Road.

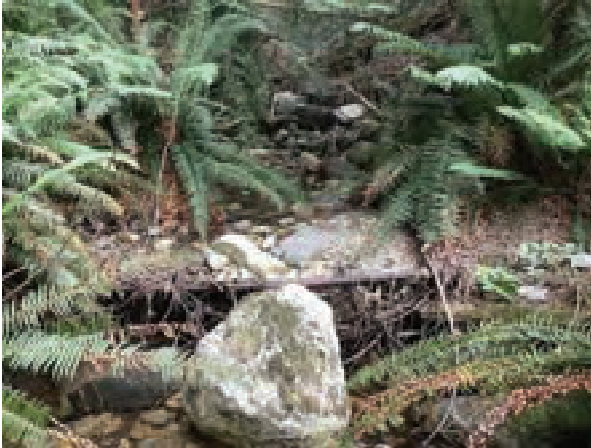
FIGURE 200

Photo: Placemark 160
Date (YYYY MM DD): 2021 07 16
Location: **Joe Smith Cr, km 0.85**
View direction: Upstream
Description:
 View below Sunshine Coast Highway.

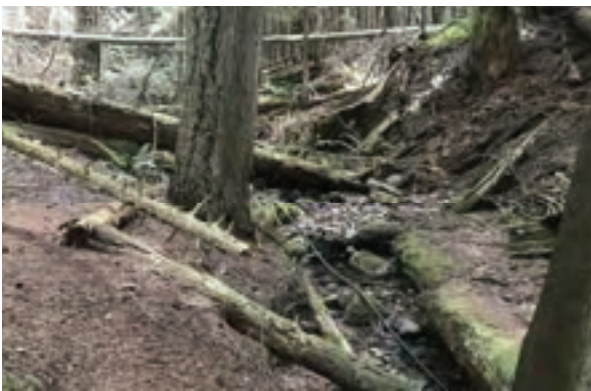
FIGURE 201

Joe Smith Creek	1.16	C121536	PD45927	19520124	01A - Domestic	2.27305	m ³ /day	No	Did not gain permission to access property. Reviewed stream conditions above Pixton Road near mapped POD (APPENDIX E, Figure 201).
	Joe Smith Creek	1.16	C121544	PD45927	19600408	01A - Domestic	2.27305	m ³ /day	No	Did not obtain permission to access property. Reviewed stream conditions above Pixton Road near mapped POD (APPENDIX E, Figure 201).
	Joe Smith Creek	1.36	C050117	PD45928	19770815	01A - Domestic	2.27305	m ³ /day	Yes	Mapped POD on Crown land. Polar reviewed stream near stream km 1.5. PVC distribution line runs along channel and is exposed to flows. Pipe appears to go up to intake above hydro right-of-way, presumably where summer flows are reliable. Mapped POD appears 350 m below actual intake location.

Photo: Placemark 163
Date (YYYY MM DD): 2021 07 16
Location: **Joe Smith Cr, km 1.10**
View direction: Upstream
Description:
 View above Pixton Road culvert.

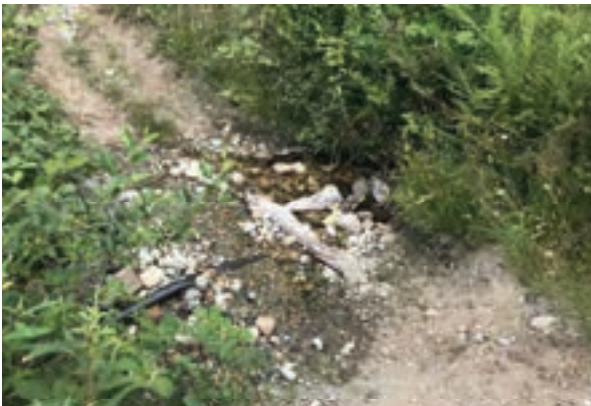
FIGURE 202

Photo: Placemark 224
Date (YYYY MM DD): 2021 07 16
Location: **Joe Smith Cr, km 1.50**
View direction: Upstream
Description:
 Water distribution line along channel.

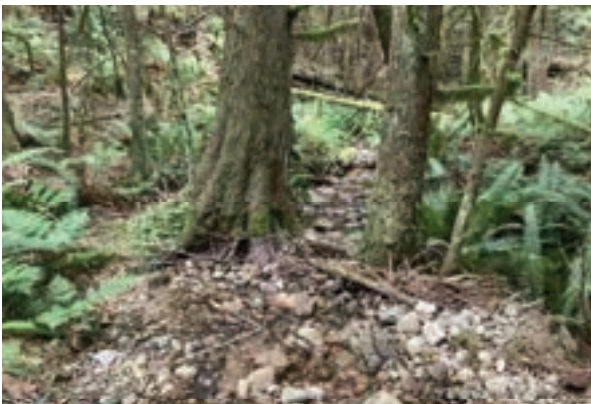
FIGURE 203

Photo: Placemark 134
Date (YYYY MM DD): 2021 07 16
Location: **Joe Smith Cr, km 1.70**
View direction: West
Description:
 Water distribution line along stream at hydro right-of-way.

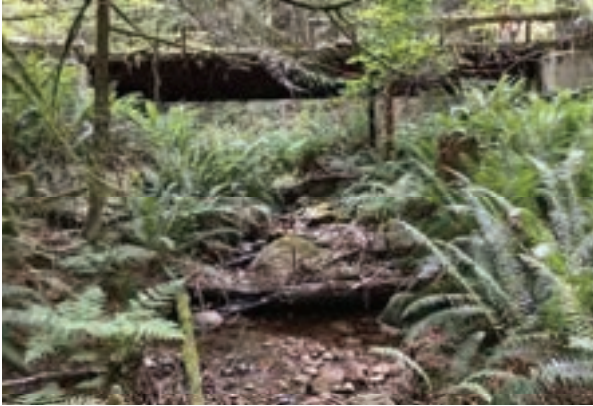
FIGURE 204

Photo: Placemark XX
Date (YYYY MM DD): 2021 07 16
Location: **Joe Smith Cr, km 1.80**
View direction: Upstream
Description:
 Aggraded channel.

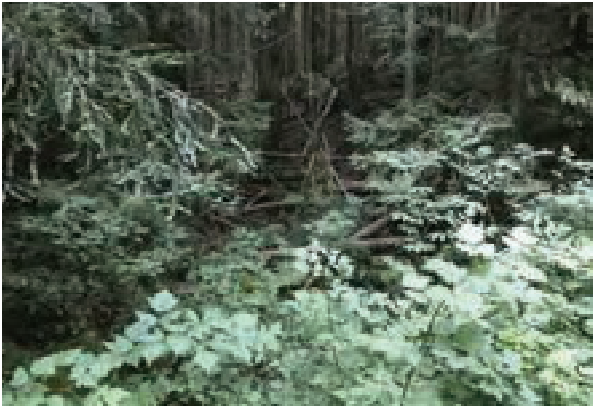
FIGURE 205

Photo: Placemark 160
Date (YYYY MM DD): 2021 07 16
Location: **Joe Smith Cr, km 1.8**
View direction: Downstream
Description:
 Private bridge.

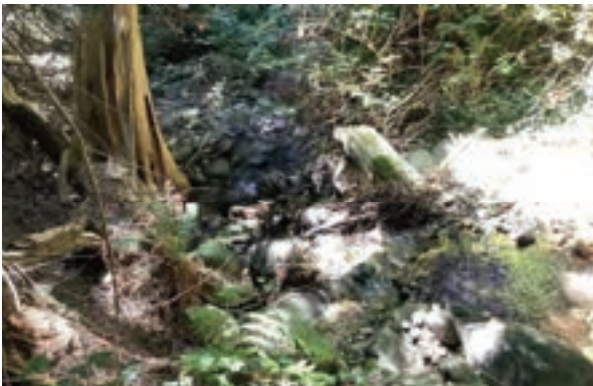
FIGURE 207

Photo: Placemark 160
Date (YYYY MM DD): 2021 07 16
Location: **Clough Cr, km 0.0**
View direction: West
Description:
 Mouth of creek.
