COMMITTEE OF THE WHOLE

Thursday, March 23, 2023

2. Pierre Aubin, RPF, Practice Forester, BC Timber Sales Chinook /
Sunshine Coast, Ministry of Forests
Regarding BC Timber Sales Mt. Elphinstone South
Watershed Assessment: Phase 1 and 2

The following letter is to accompany the release of the final draft of the Mt. Elphinstone South Watershed Assessment: Phase 1 & 2 report. The purpose of this letter is to provide an overview as to the scope of this report. This report does not contain site specific assessments associated with planned BC Timber Sales developments but rather provides an evaluation of the current condition of the watersheds within the assessment area.

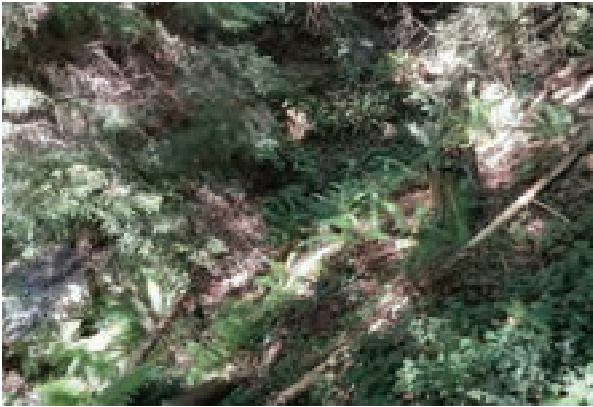
FIGURE 213

Photo: Placemark 162
Date (YYYY MM DD): 2021 07 16
Location: **Clough Cr, km 0.35**
View direction: Upstream
Description:
 View above Lower Road to private foot bridge.

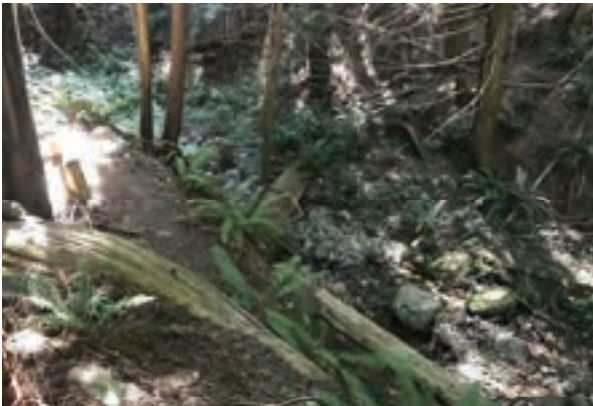
FIGURE 214

Photo: Placemark 192
Date (YYYY MM DD): 2021 07 16
Location: **Clough Cr, km 0.6**
View direction: West
Description:
 10 m deep ravine.

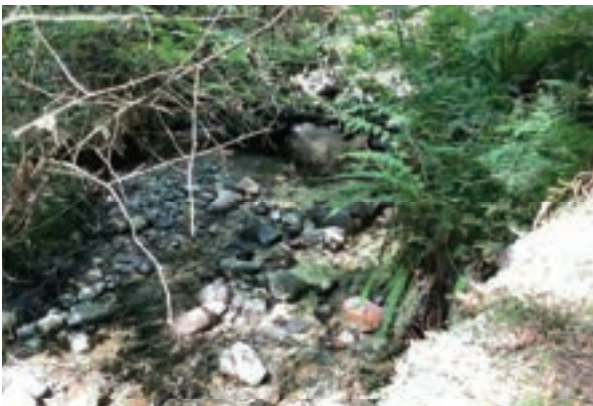
FIGURE 215

Photo: Placemark 164
Date (YYYY MM DD): 2021 07 16
Location: **Clough Cr, km 0.65**
View direction: Downstream
Description:
 Ravine.

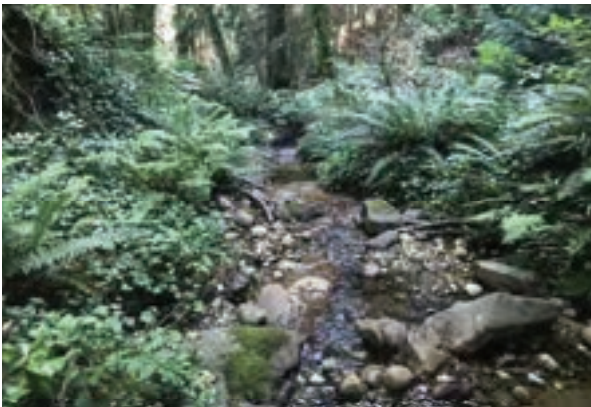
FIGURE 217

Photo: Placemark 166
Date (YYYY MM DD): 2021 07 16
Location: **Clough Cr, km 0.85**
View direction: Upstream
Description:

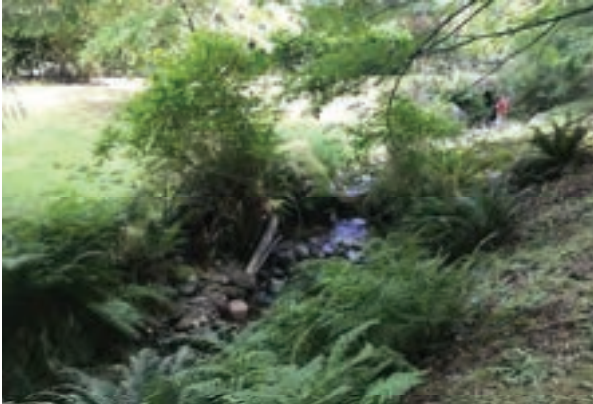
FIGURE 221

Suspected scar on tree associated with the 1983 debris flow. Scar is up to 3 m above current streambed.

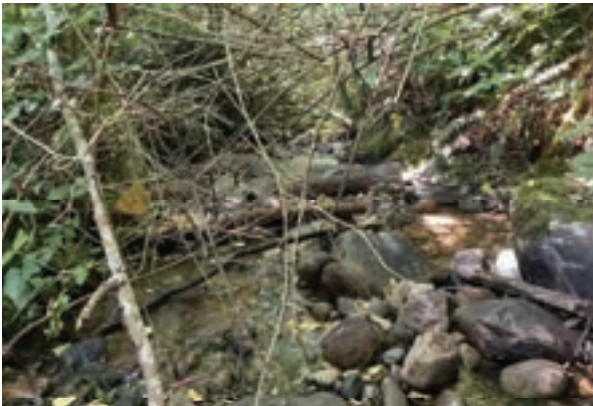
FIGURE 222

View across property affected by the 1983 debris flow.

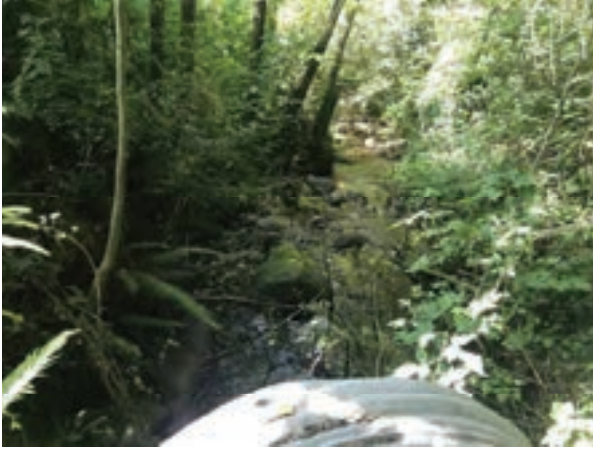
View above Orange Road culvert.

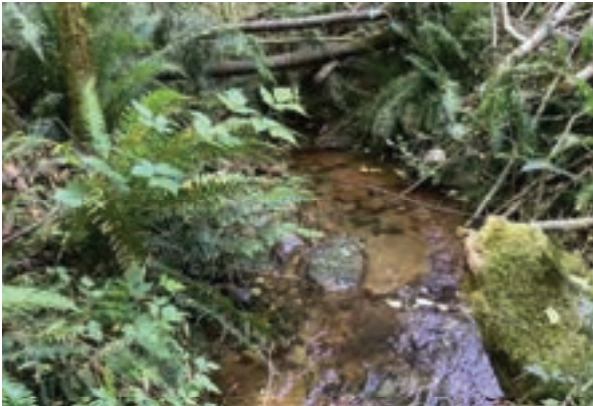
FIGURE 226

Photo: Placemark 177
Date (YYYY MM DD): 2021 07 16
Location: **Clough Cr, km 1.5**
View direction: Upstream
Description:
 Water pump principally used by property owner for fire protection.

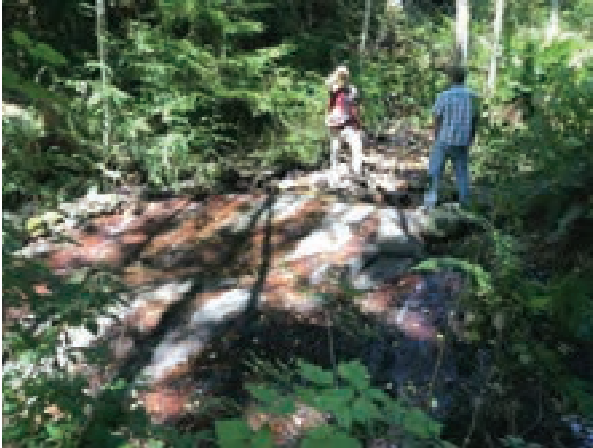
FIGURE 228

Photo: Placemark 178
Date (YYYY MM DD): 2021 07 16
Location: **Clough Cr, km 1.6**
View direction: Downstream
Description:
 Localized riparian clearing along private property.

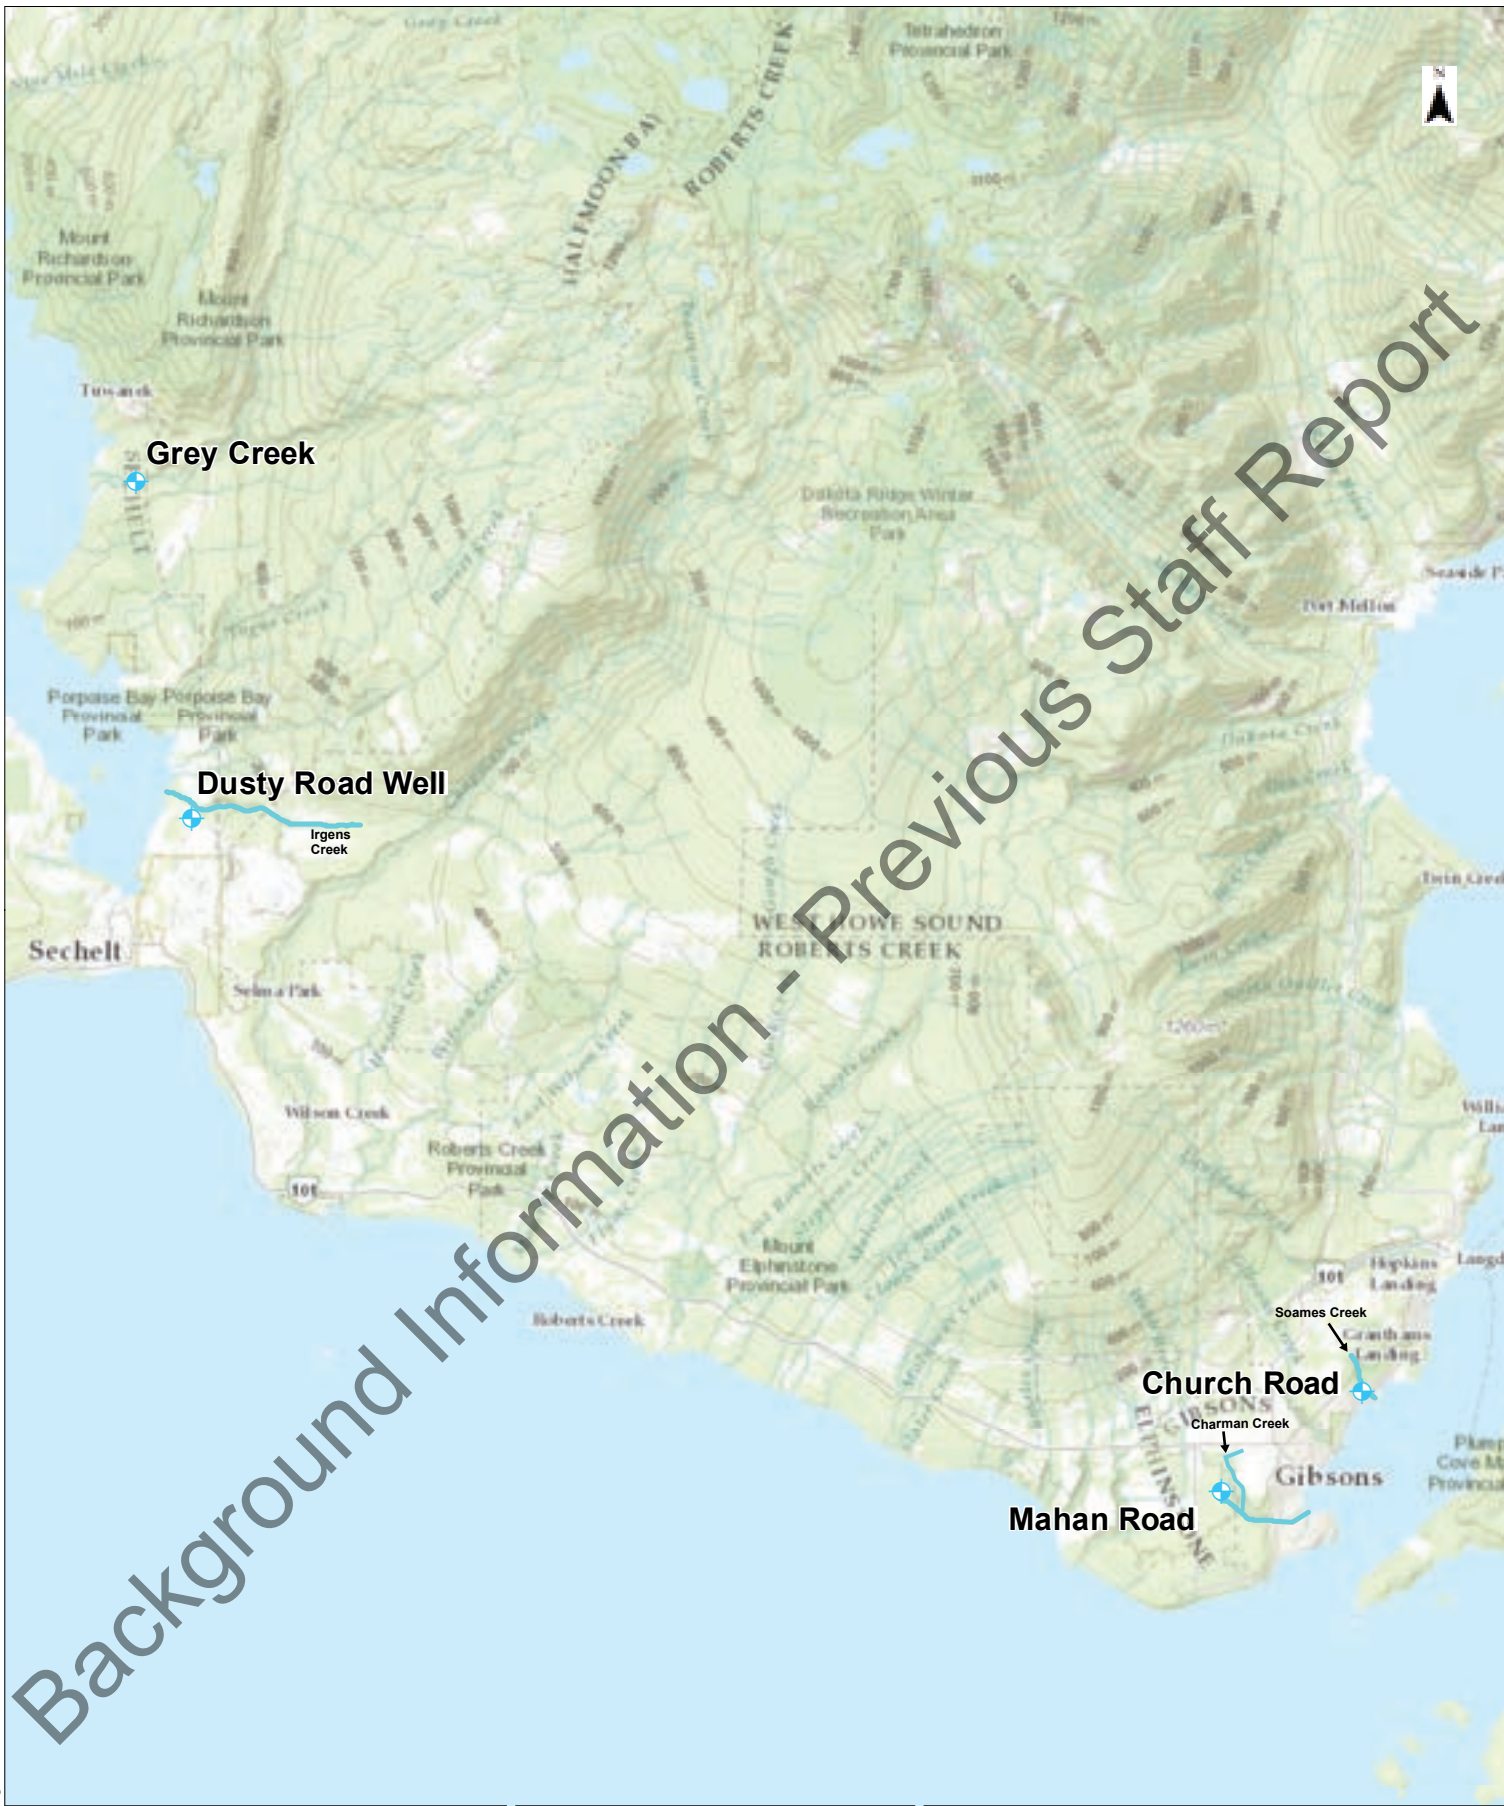
The location of the four well sites – Gray Creek, Dusty Road, Mahan Road and Church Road (formerly known as Elphinstone Avenue) are shown on Figure 2-1. The well sites are located near the coast, close to the urbanised areas of the District of Sechelt and the Town of Gibsons, and are situated relatively close to existing SCRD water mains infrastructure.

As detailed above, numerous creeks drain the mountain range flowing down to the coast. Additional details for the creeks located closest to the three completed wells is provided below. The location of these are shown on Figure 2-1.

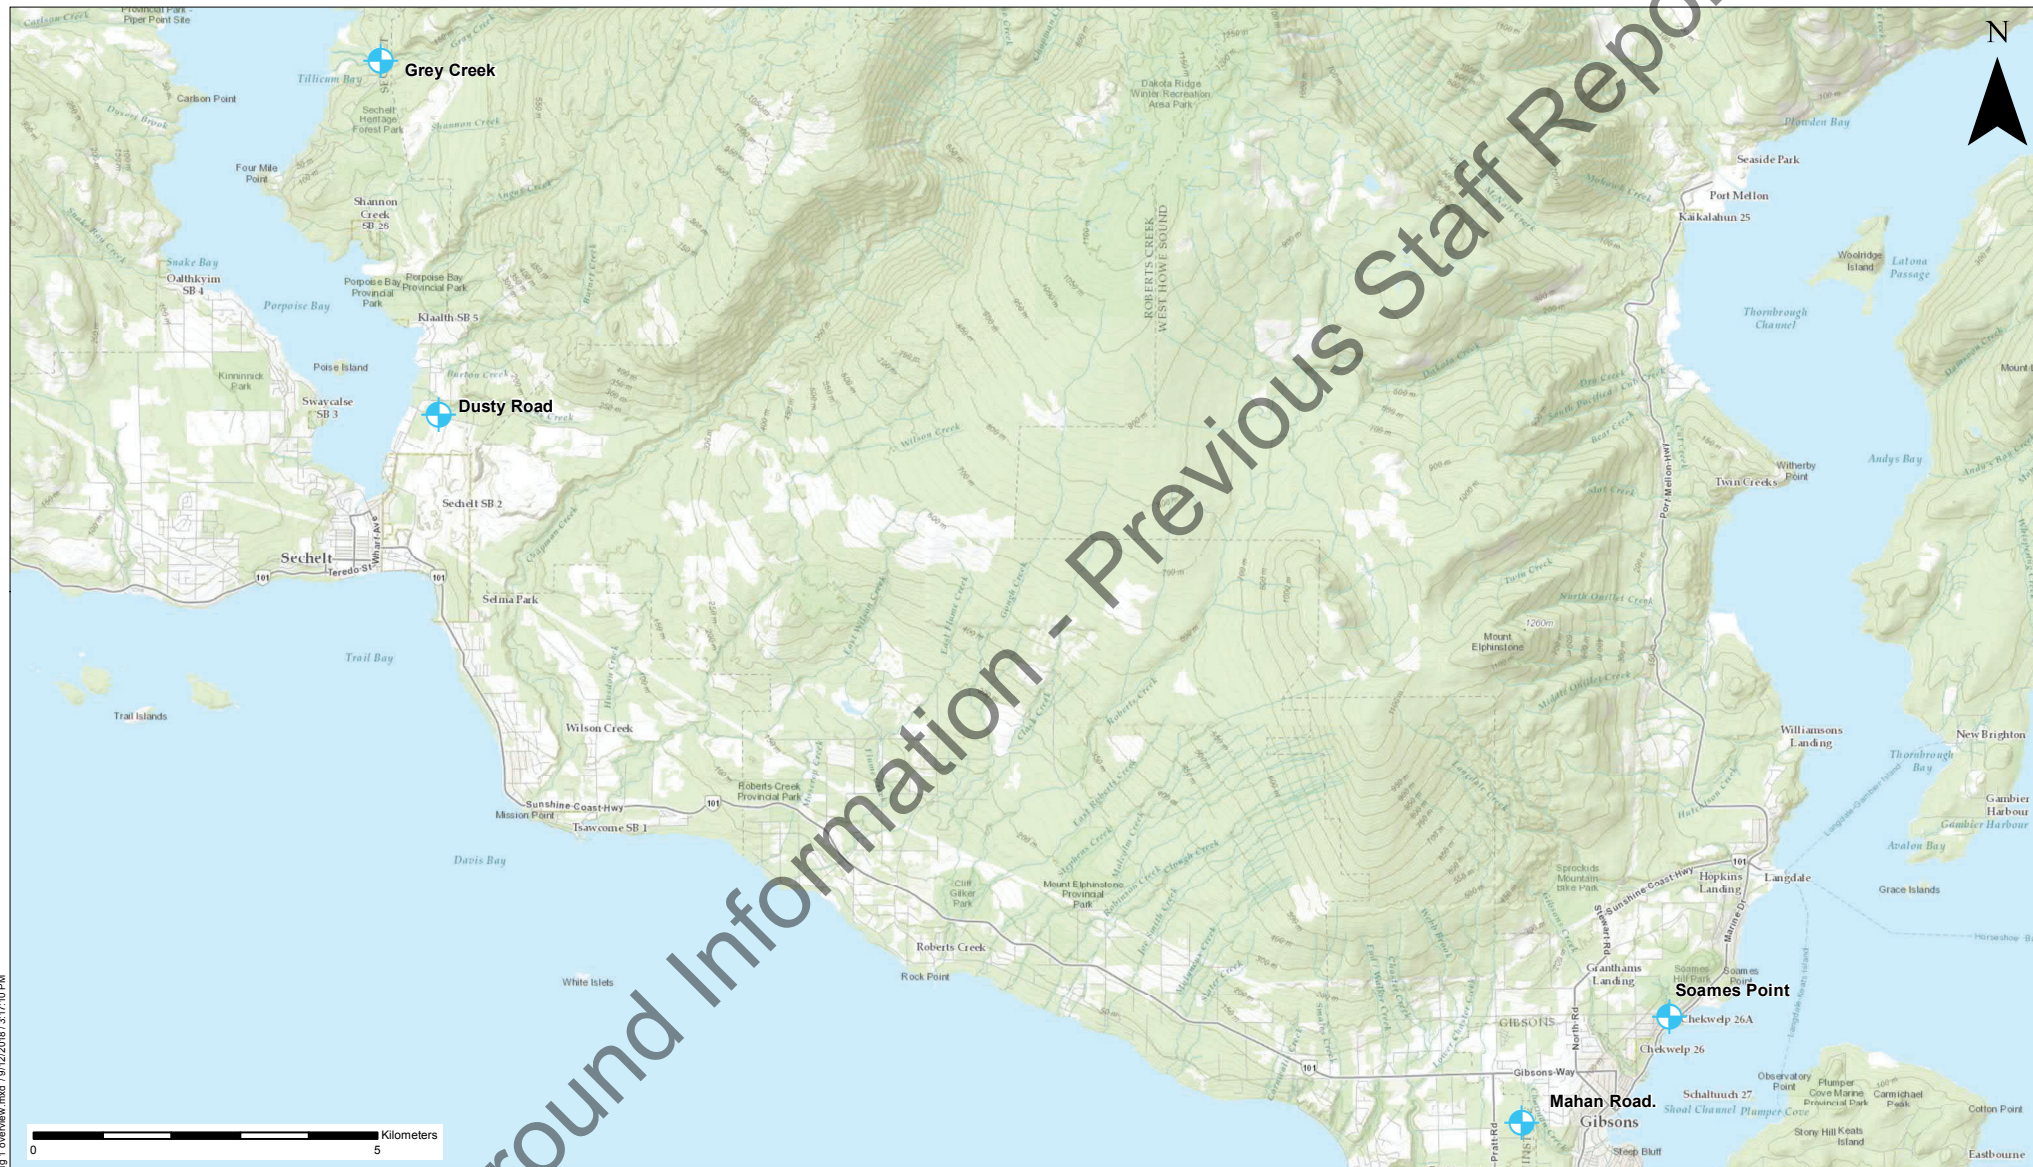
Figure C2

Dusty Road Well and monitoring well location
