# Proposed Seaview Cemetery Expansion and Infill

**1706 Lower Road – Roberts Creek, SCR D, BC**

Prepared by: **Ryzuk Geotechnical Ltd.**  
#100-771 Vernon Avenue  
Victoria, BC V8X 5A7

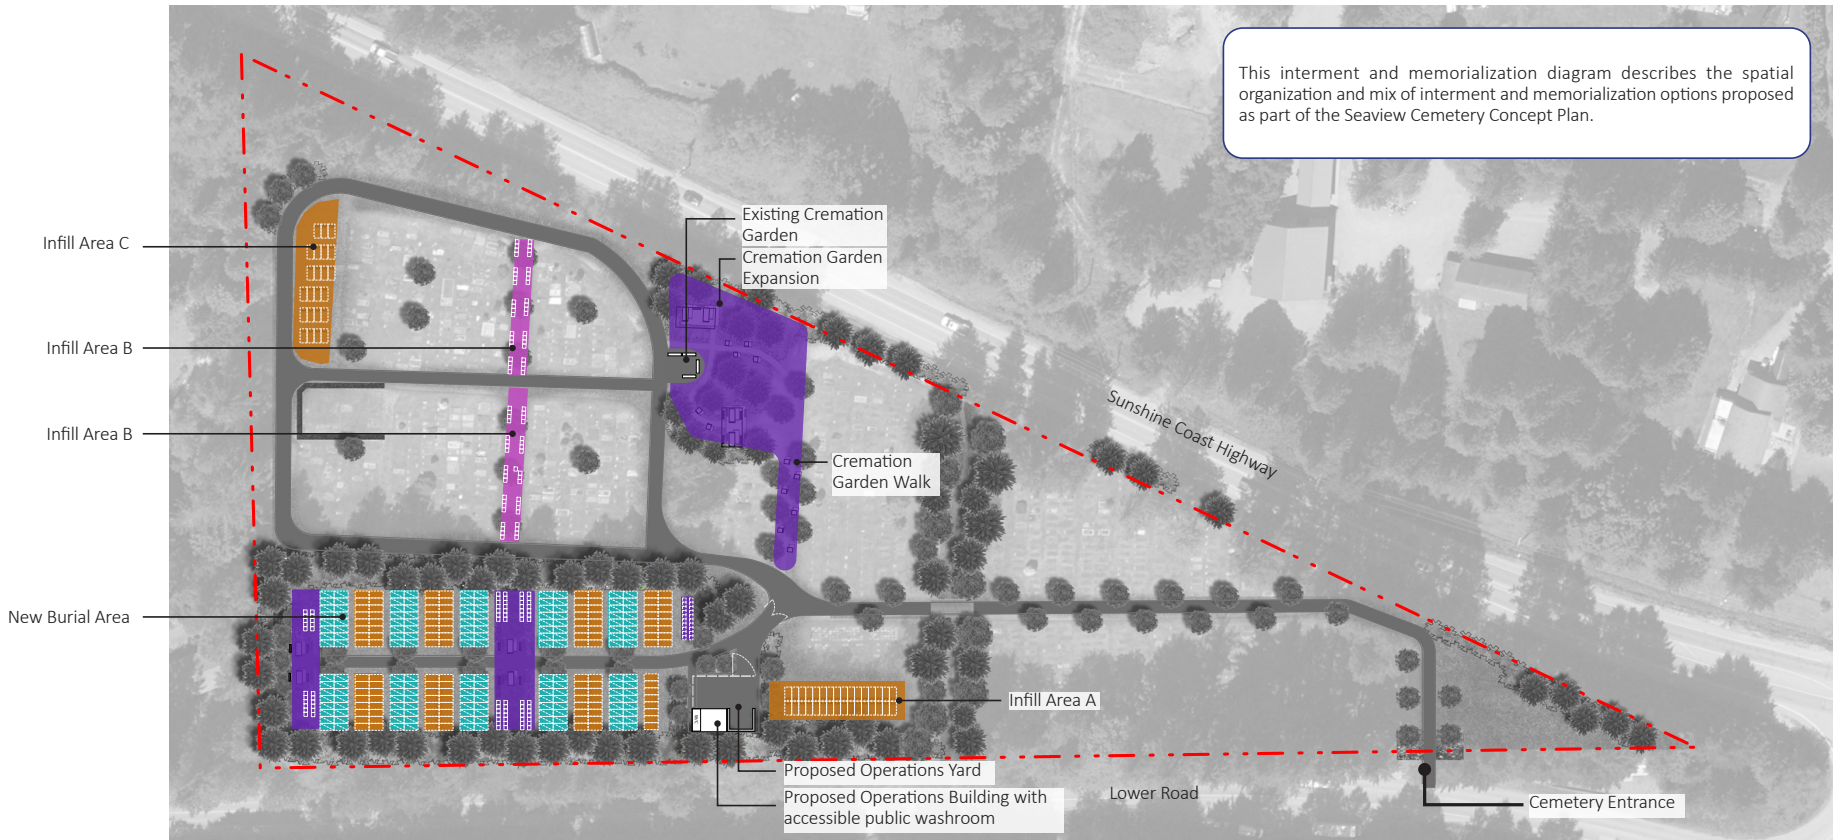
# Seaview Cemetery Interment and Memorialization Diagram

This interment and memorialization diagram describes the spatial organization and mix of interment and memorialization options proposed as part of the Seaview Cemetery Concept Plan.

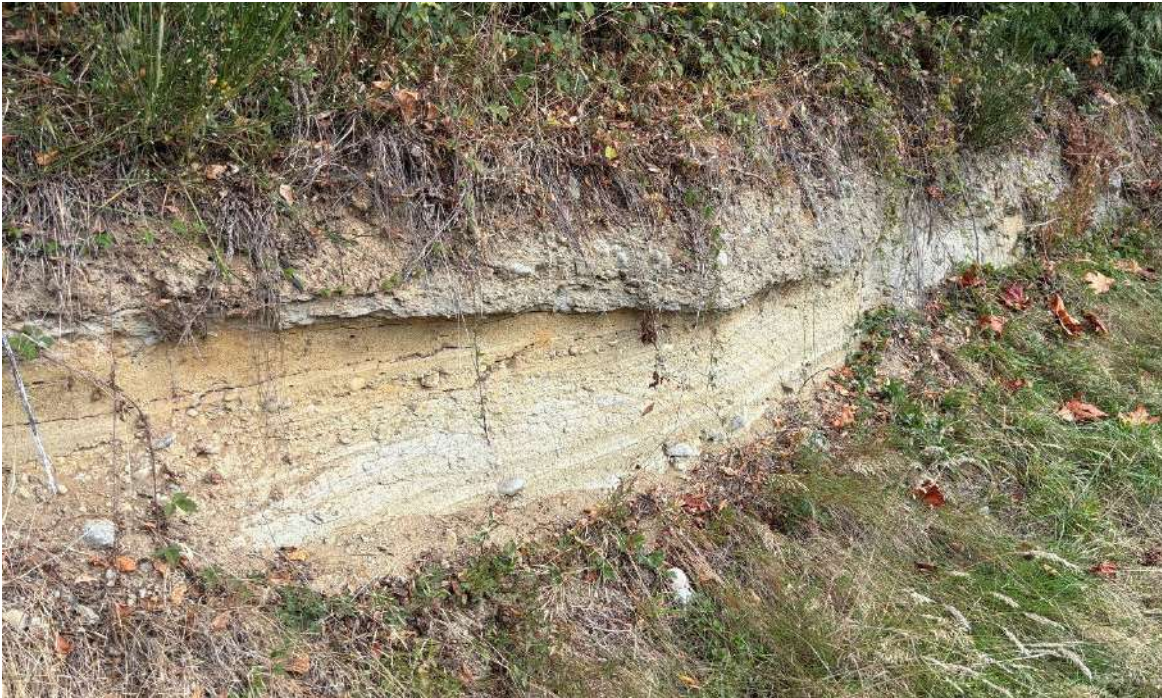
Photo 1: Soil cutbank along west end of north edge of cemetery.

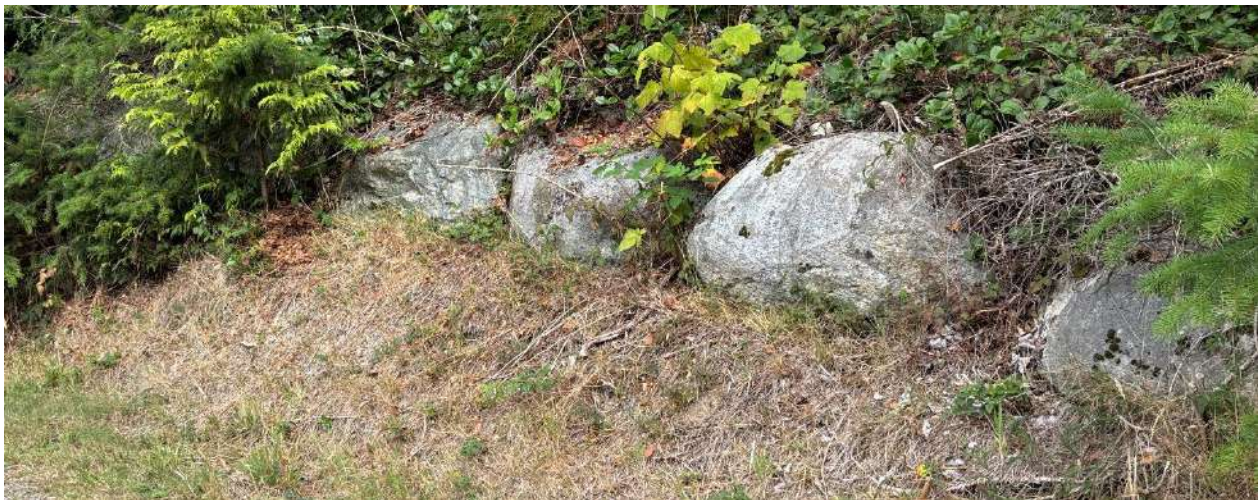
Photo 2: Row of large glacial boulders along north edge of cemetery.

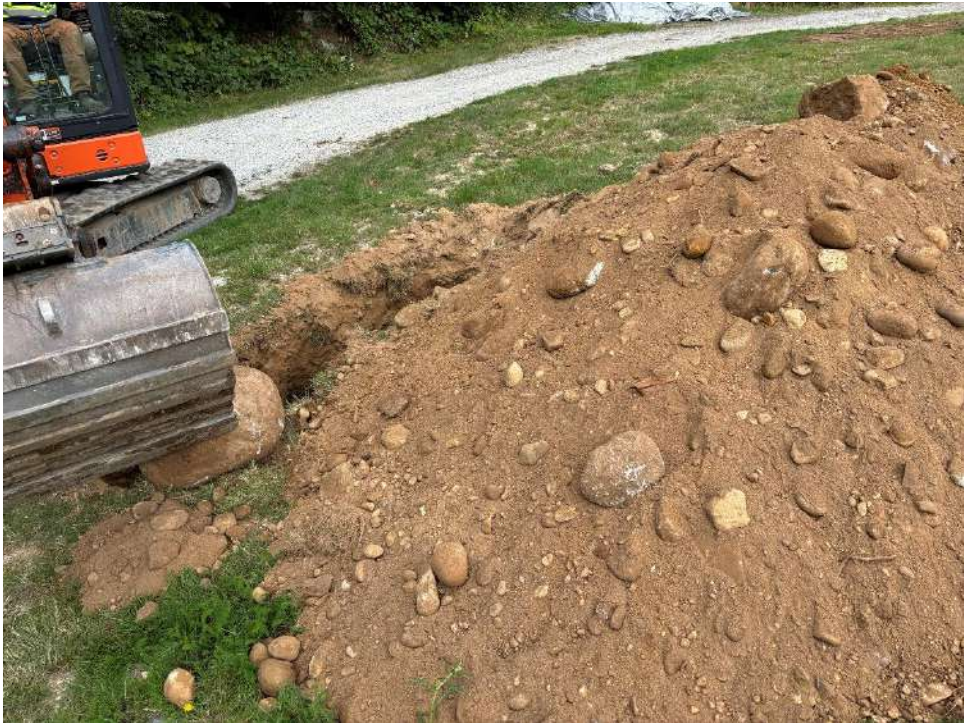
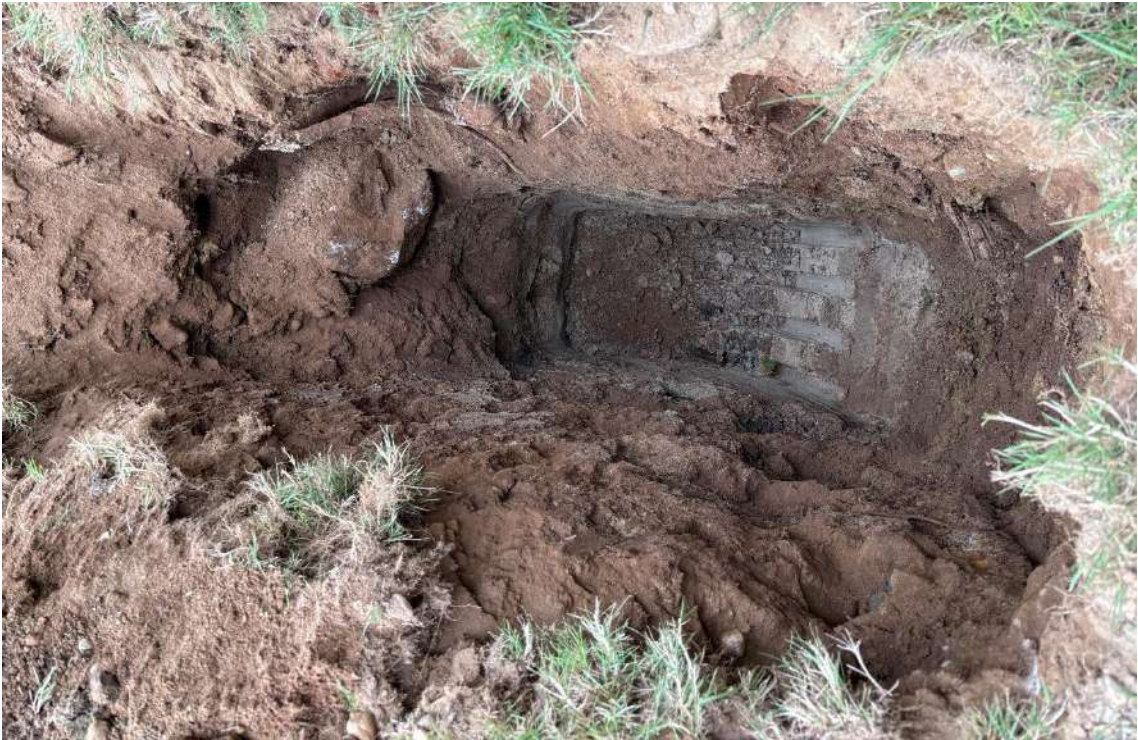
Our test pits in this area (Photos 3, 4, 5 & 6) did encounter trace boulders in some soil layers up to approximately 450-600 mm in size, and we understand from anecdotal evidence that larger boulders, some up to 1 to 1.5 m in size have been encountered within burial site excavations in this area (Photo 2). We understand these larger boulders can cause issues during the excavation process for full depth burial sites as they are difficult to remove and can cause cave ins/destabilization of neighbouring burial sites. While our test pits did not encounter any of the larger boulders, and only trace amounts of smaller boulders (up to 450-600 mm), we understand the project team desires to know what the process of removing the boulders from the soil in advance of burial site excavations in this area would entail. To remove problematic large boulders from the Phase 1 infill burial areas, these areas would need to be bulk excavated to full burial depth (approx. 2 to 2.4 m) and the soil material would need to be screened through a heavy-duty steel screen (perhaps set to 300 to 450 mm spacing). Once screened the soil material could then be replaced in lifts and well compacted (so that future excavation cutslopes can be cut steeper).

0.0	to	0.1 m	FILL – fine sand, silty, loose
0.1	to	1.8 m	FILL – gravelly, cobbly, some silt, trace boulders (<300 mm), trace organics, rootlets and wood fragments, compact, light brown, dry
1.8	to	2.4 m	SAND and GRAVEL – some cobbles, trace boulders (<600 mm), medium to coarse sand, dense, damp
	at	2.4 m	End of test pit – desired depth

Photo 3: TP24-02.

Photo 4: TP24-02.

Recommended lift thickness would vary between 300 to 600 mm depending on the size and energy of the compaction equipment available. If the soil material is dry, moisture conditioning each lift prior to compaction may be necessary to achieve higher levels of compaction. We remain somewhat uncertain of the frequency and probability of encountering problematic large boulders within burial excavations in this area, and we recommend the project team weigh the financial aspect of advanced boulder removal vs. doing nothing.

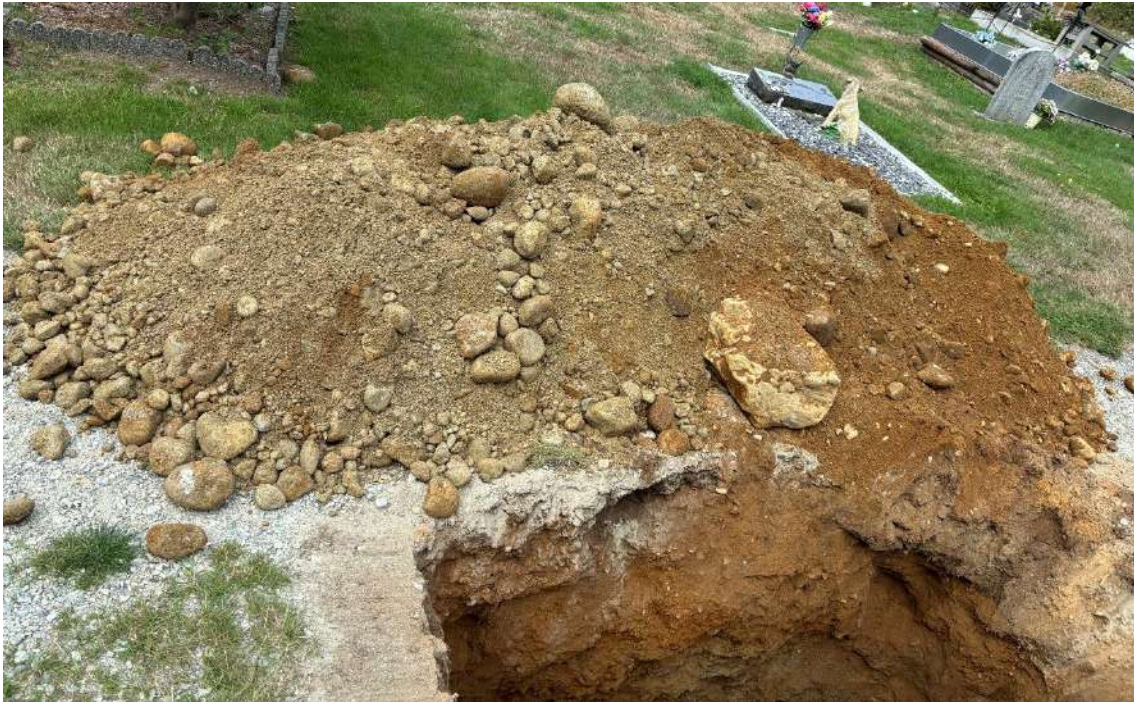
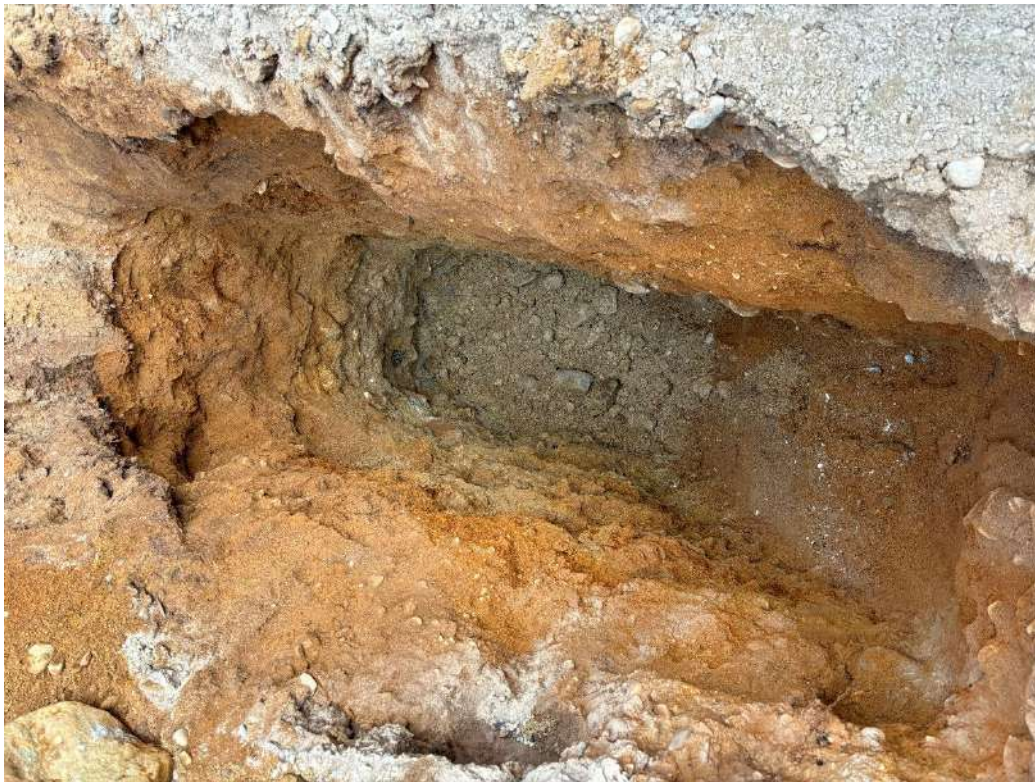
0.0	to	0.1 m	ROADBASE
0.1	to	0.8 m	SAND – gravelly, some cobbles, dense, rusty brown with grey lenses, dry
0.8	to	2.2 m	COBBLES – sandy, gravelly, trace to no silt and clay, very dense, grey, damp to moist
	at	2.2 m	End of test pit – desired depth

Photo 5: TP24-04.

Photo 6: TP24-04.

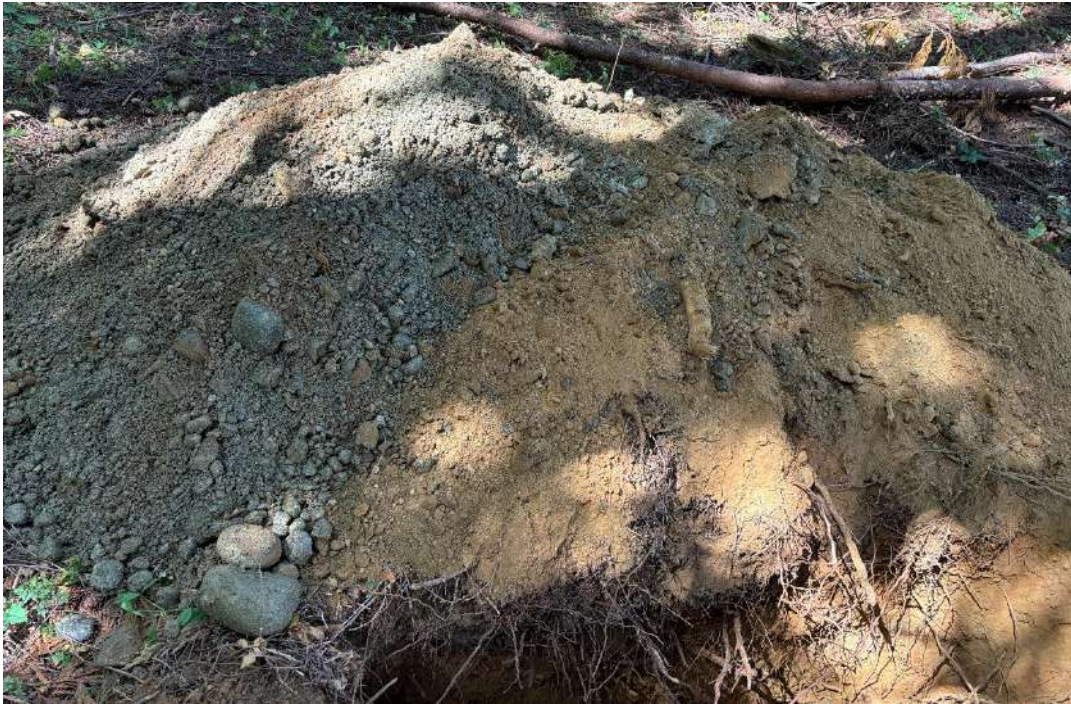
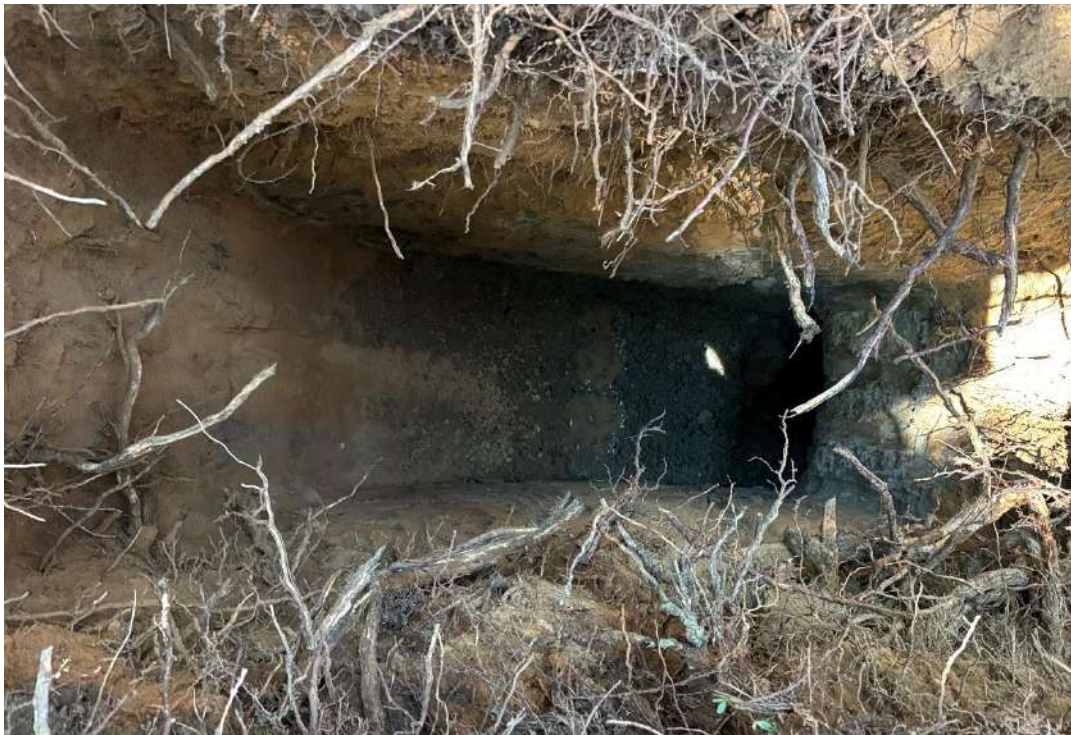
Photo 7: TP24-09.

Photo 8: TP24-09.

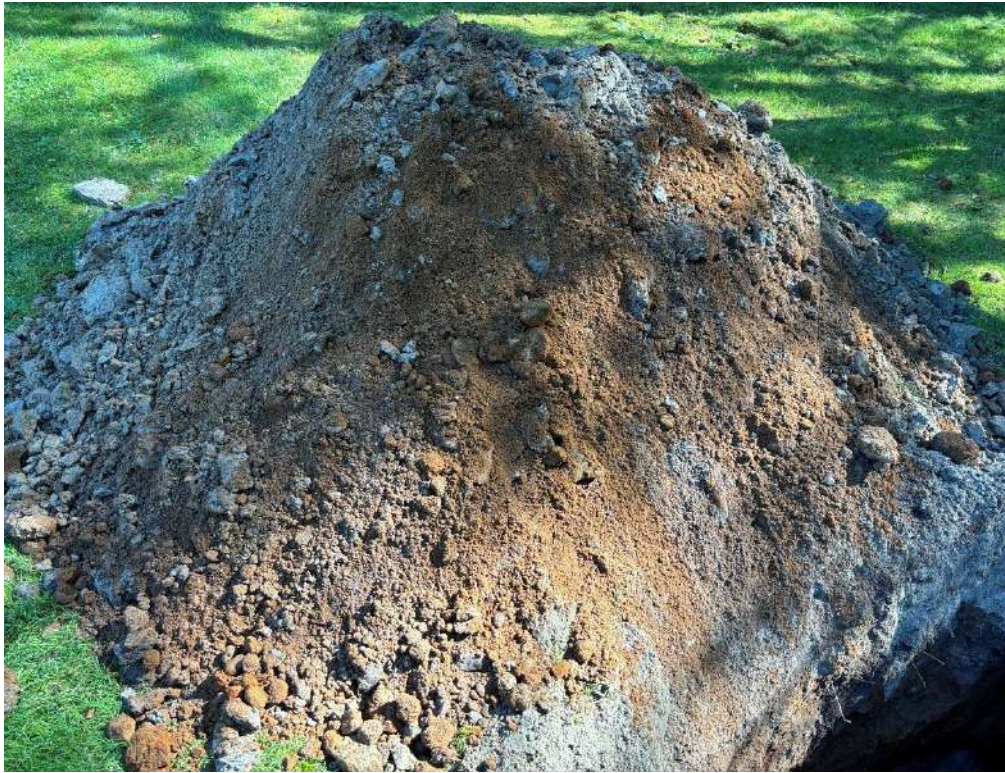
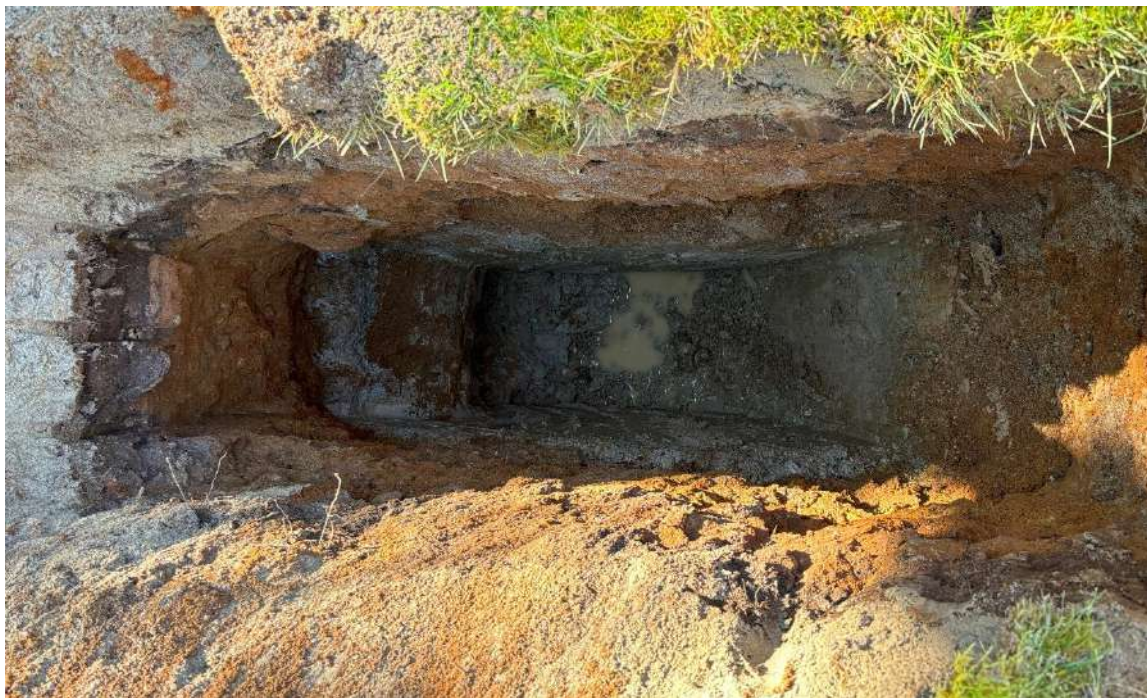
Photo 9: TP24-11.

Photo 10: TP24-11.

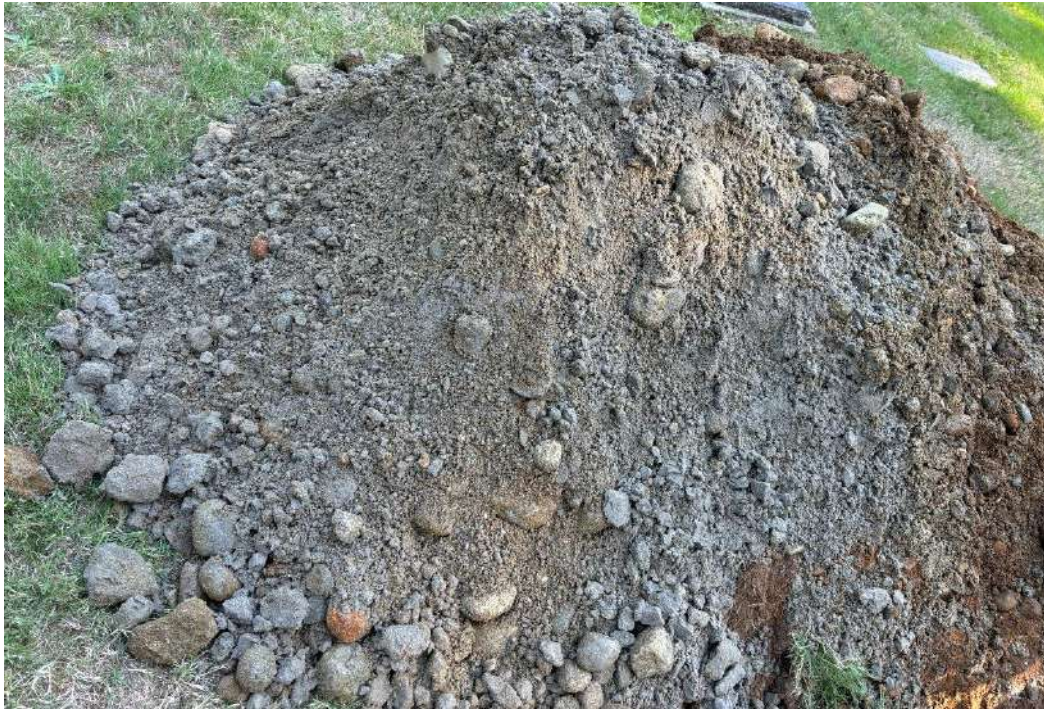
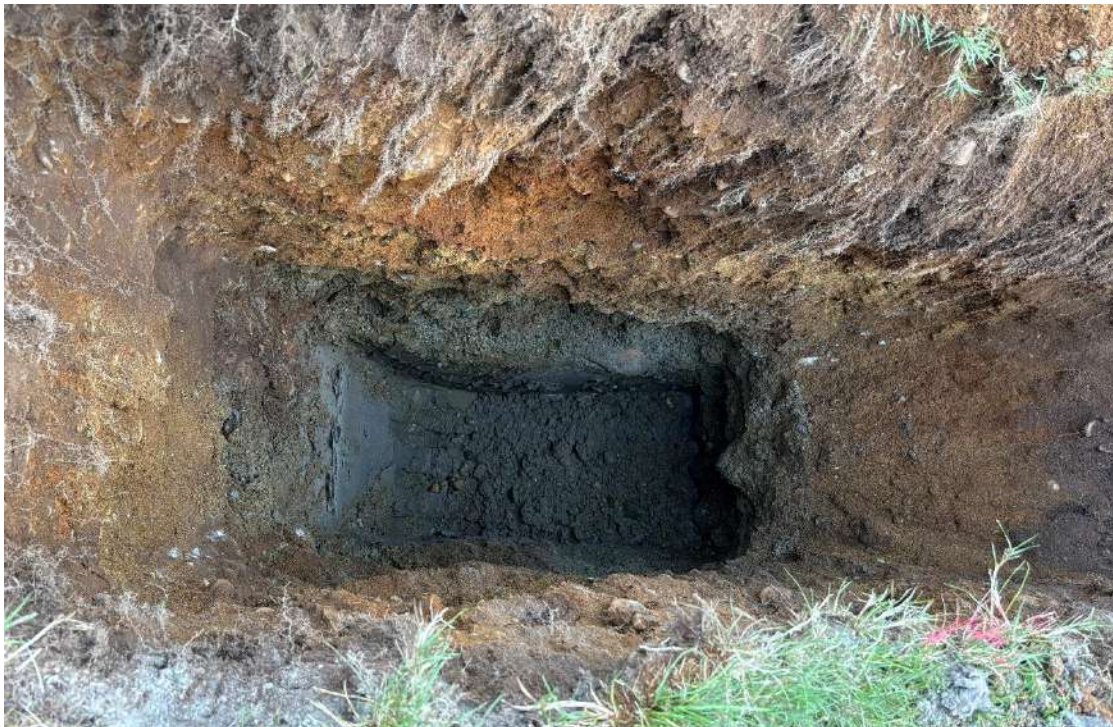
Subsurface conditions between the watercourse and Phase 1 Area are anticipated to consist of very dense sand, gravel, cobbles and boulders with a high groundwater table, encountered at a depth of 1 m bgs within TP24-13.

Photo 11: TP24-13.

Photo 12: TP24-13.

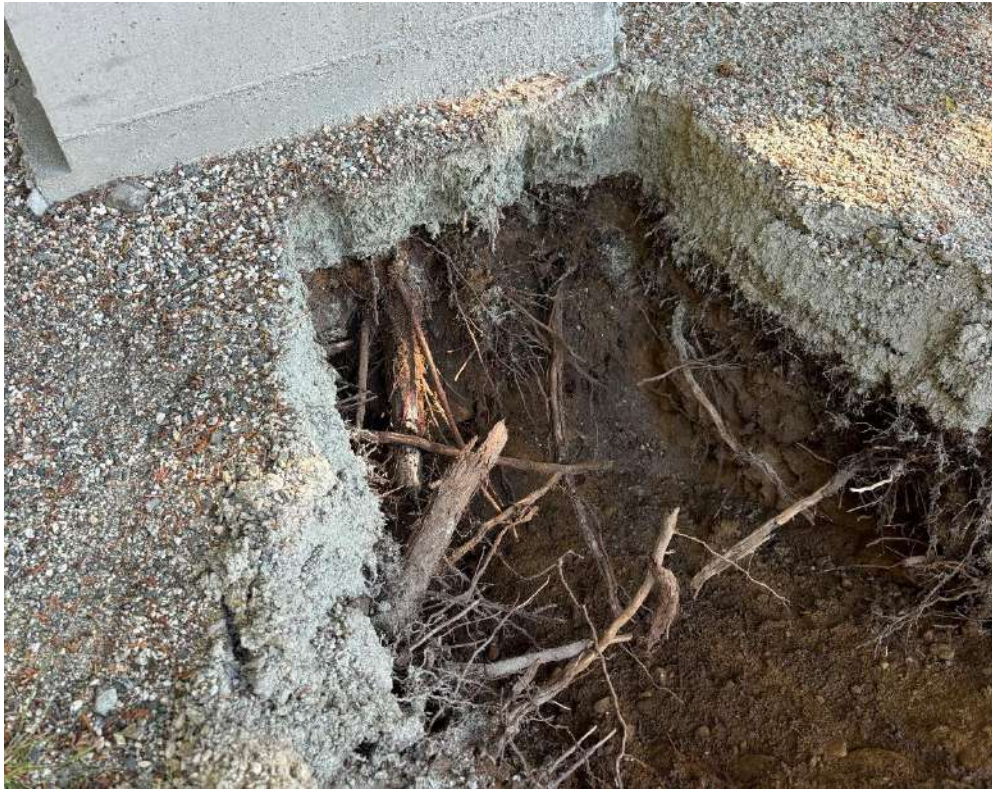
cremation garden. We conducted one test pit, TP24-15, at the west edge of the concrete foundation (Photo 13), and discovered the concrete foundation had been constructed at the ground surface (no frost cover protection) atop a skim of dense crusher dust (fine gravel and sand) atop 200 mm of native loamy sand with some organics and roots, atop native dense sand and gravel. The concrete foundation appeared nearly level and no cracks were observed. While the lack of frost cover and presence of roots and loamy organic sand are certainly not aligned with best practices for foundation subgrade preparation, we consider the underlying soils to be capable of providing adequate bearing support to the existing columbaria concrete foundation, although some differential settlement or tilting may occur over the lifespan of the structure.

Photo 13: TP24-15.

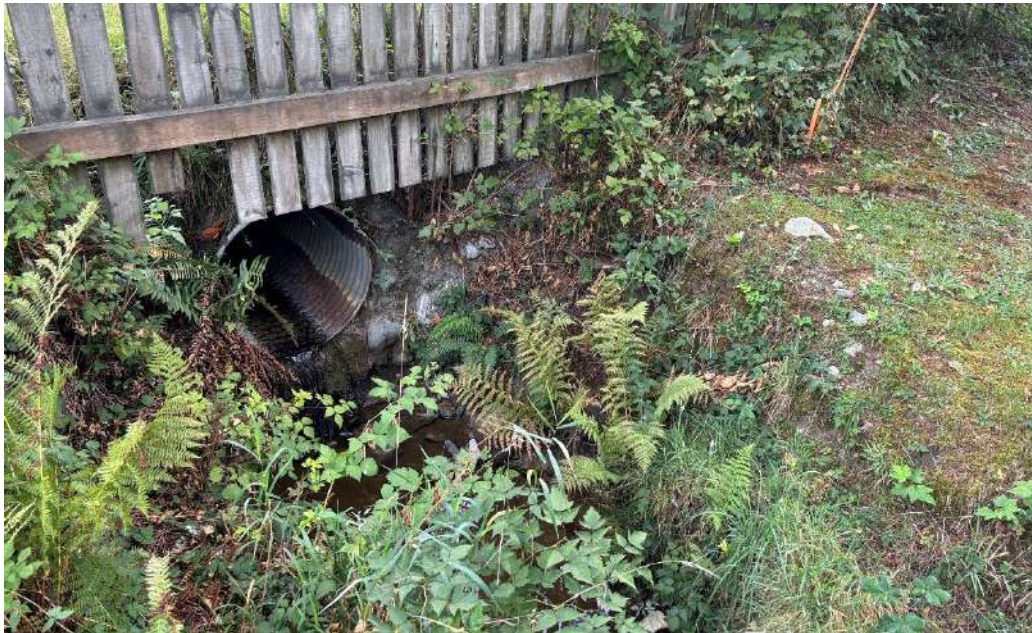
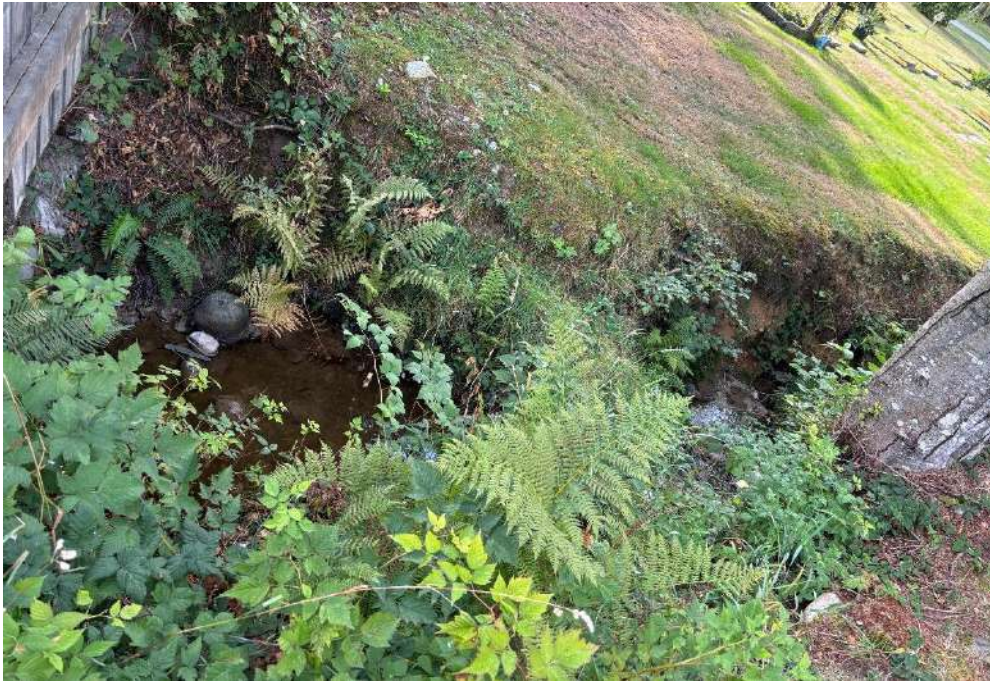
**Phase E Watercourse Bank Erosion and Infill Burial Area:** The watercourse enters the property through a 914 mm (36 in) diameter corrugated steel culvert from below the Sunshine Coast Highway (Photos 14 & 15). The channel is approximately 0.6 to 1.5 m wide typically, although some wider and thinner segments are also present. The channel is cut into the terrain approximately 1 to 1.5 m below the surrounding cemetery lawn, and we noted the channel bed was comprised of glacial till. The banks were generally sandy where soils were exposed. We noted two stretches of the east bank where relatively recent bank erosion is actively eroding into the cemetery and approaching existing burial sites (Photos 16, 17 & 18). The erosion appears to have advanced up to approximately 0.6 m beyond the natural boundary of the watercourse and into the cemetery. No trees or major vegetation were noted in these two areas, and the soils were sandy and would be considered easily erodible.

Photo 14: 914 mm (36 in) corrugated steel culvert at upstream end of Cornwallis Creek tributary.

Photo 15: 914 mm (36 in) corrugated steel culvert at upstream end of Cornwallis Creek.

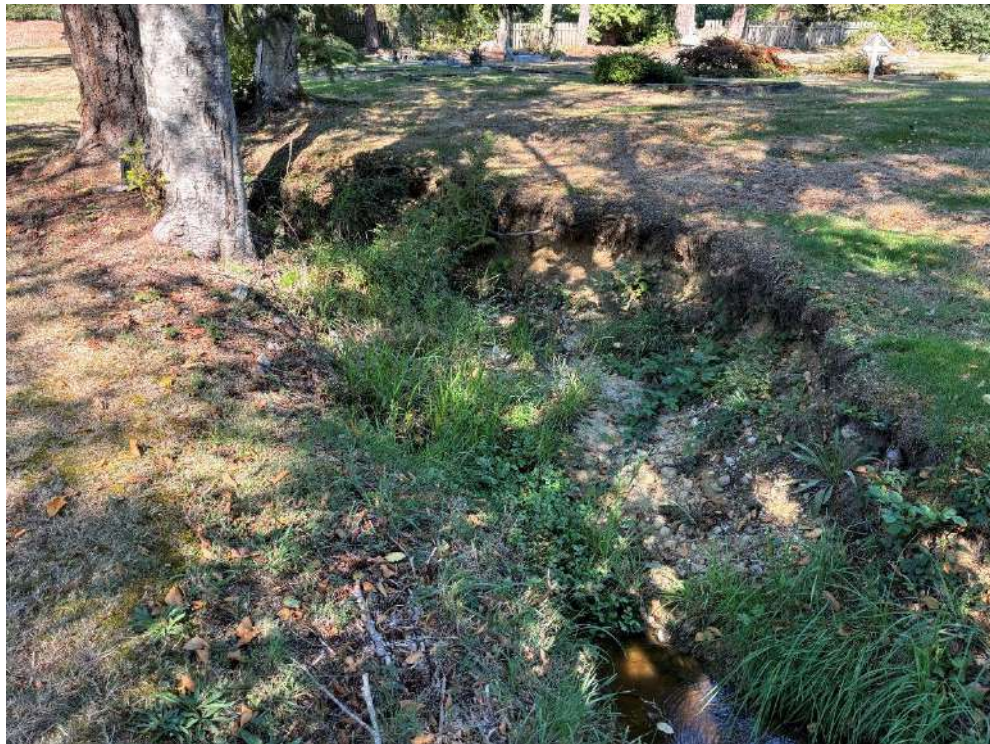
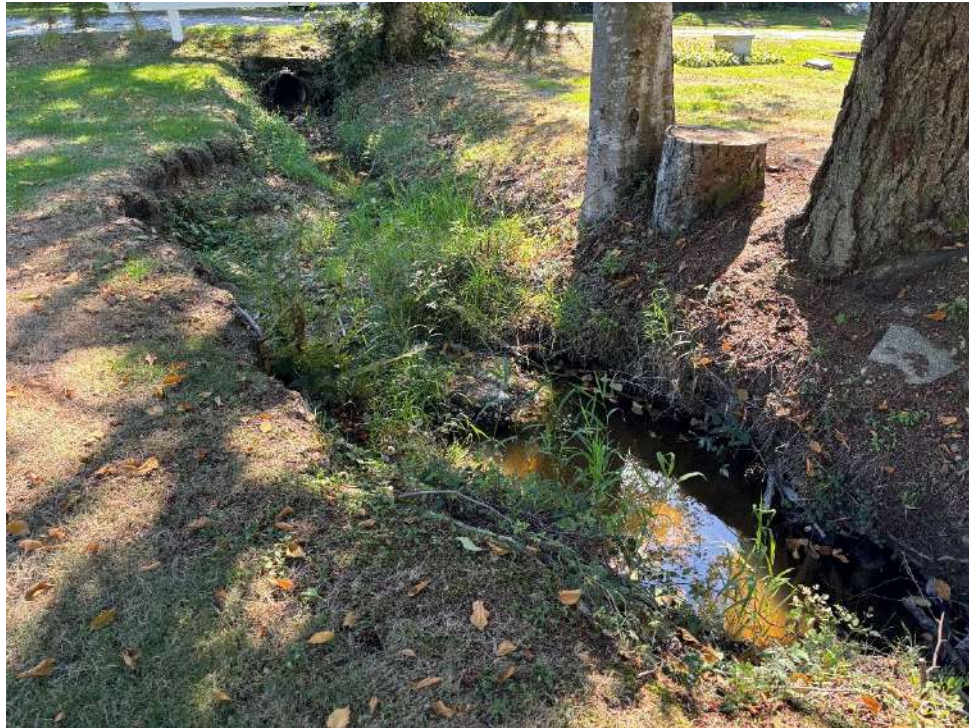
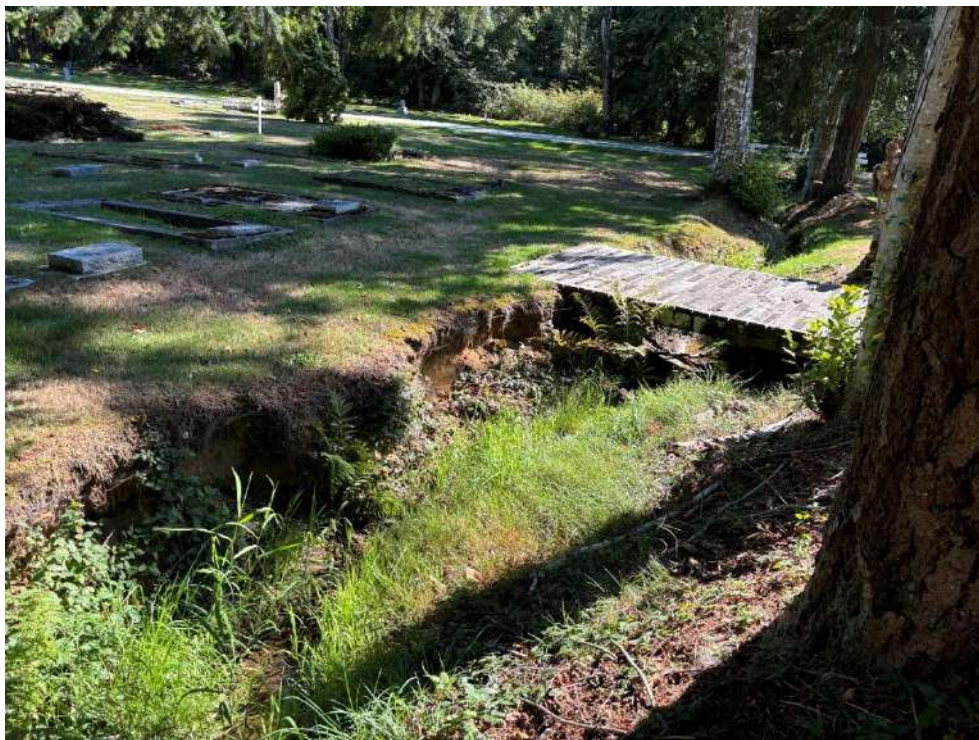
Photo 16: Erosion along west bank of Cornwallis Creek.

Photo 17: Erosion along west bank of Cornwallis Creek (same as Photo 16)

Photo 18: Erosion along west bank of Cornwallis Creek.

Given the erosion appears to be progressing towards existing grave sites, we recommend the team consider restoring some or all of the land lost to erosion, and increasing the erosion resistance of the bank in eroding areas by installing one or a combination of the following: medium sized rock rip-rap, gabion baskets filled with gravel and cobbles, or perhaps a 'bag wall' (heavy weight filter fabric bags filled with soil material and stacked on

top of each other). Once restored and protected as above, erosion resistant shrubs and trees could also be planted along the affected banks to increase the natural erosion resistance of the bank. Selection of the most suitable option should also involve input from the project biologist/environmental consultant and civil engineer.
