<b>Issue Date:</b>	September 21, 2020	<b>File:</b>	2019-8525.010.803
<b>To:</b>	Frew Azene	<b>Previous Issue Date:</b>	
<b>From:</b>	Marta Green, P.Geo.		
<b>Client:</b>	Sunshine Coast Regional District		
<b>Project Name:</b>	Phase 4a Detailed Design Church Road Well Field Project	<b>Project No.:</b>	2019-8525.010
<b>Subject:</b>	Supplemental Information to Support Licence Application Amendment

#### Phase 4a

#### Church Road Well 3 & Soames Well

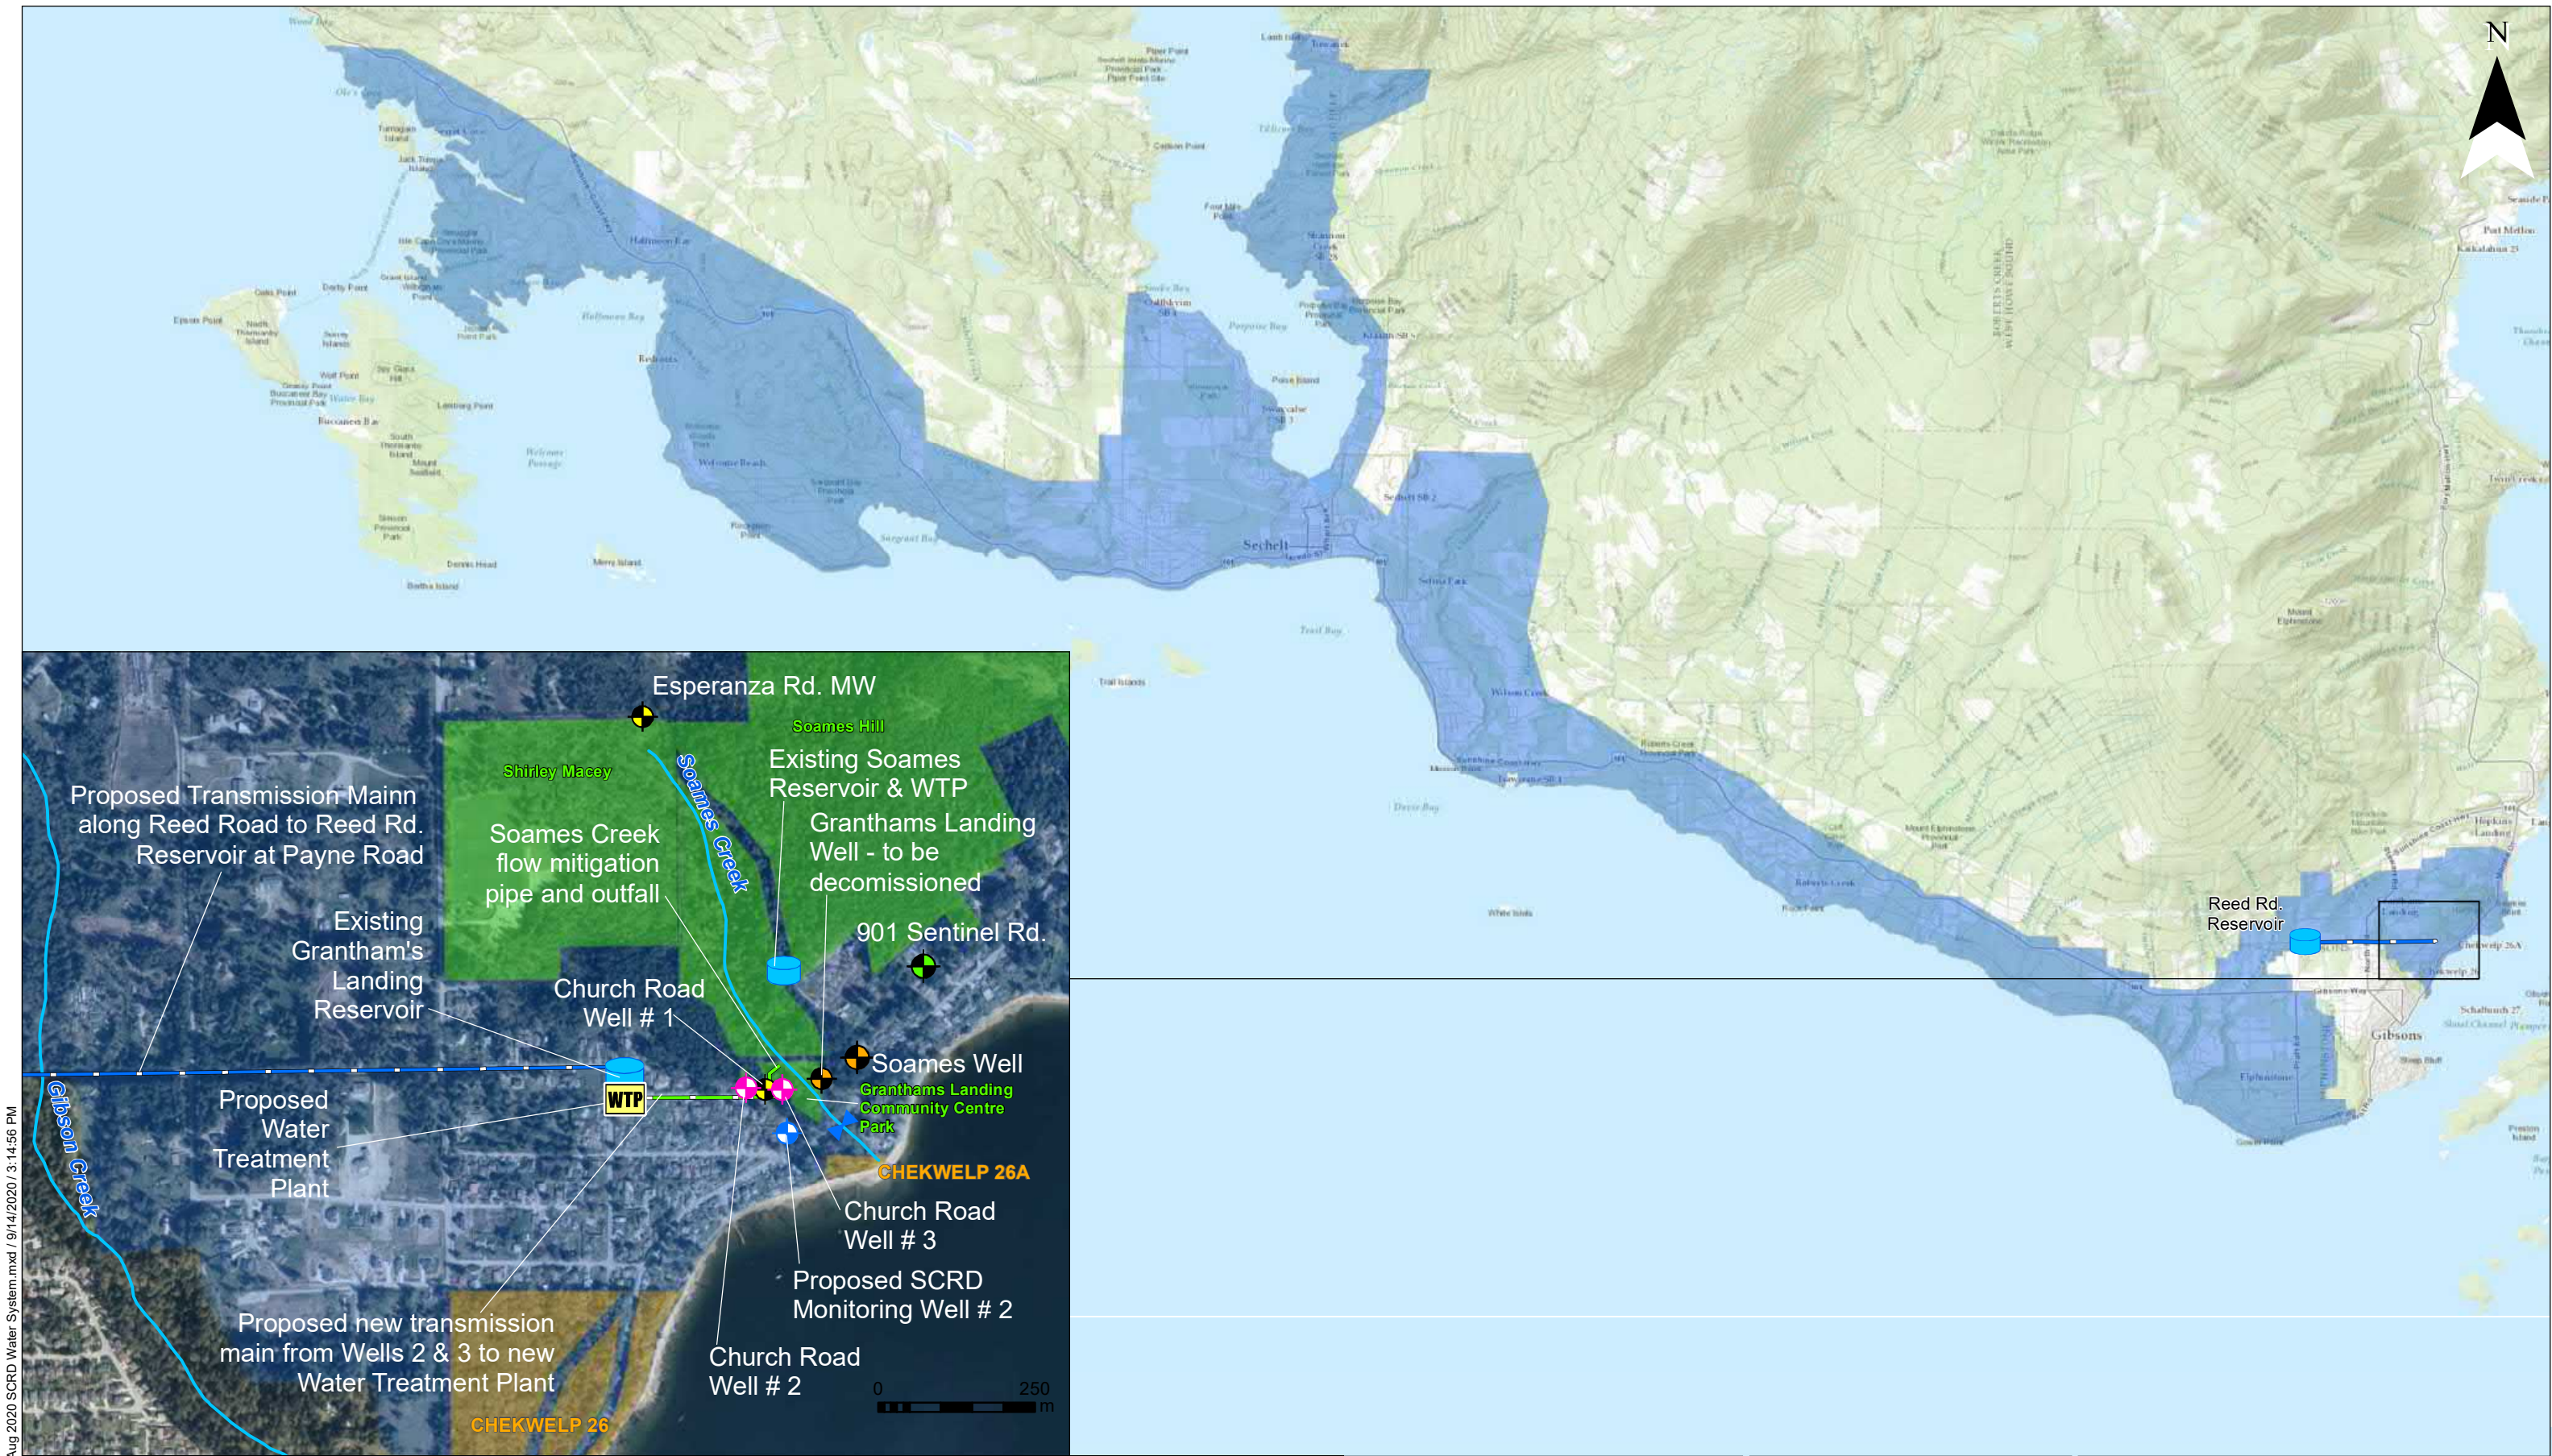
At the end of September 2019, the SCRD submitted a new groundwater use licence application and technical assessment report to FLNRORD for the future extraction of groundwater from two production wells located at Church Road/Elphinstone Avenue in Granthams Landing, Gibsons, BC, in what is now known as Aquifer 560<sup>2</sup>. At the time of the application submission, only one production well (Church Road Well 2) had been constructed and tested and the licence application was based on the results of this test. It was noted in the application that a second production well (Church Road Well 3) would be drilled and tested in 2020, the results of which would be provided as supplementary information (this memo) to the technical assessment report. Church Road Well 3 was constructed and tested in June/July 2020. The two Church Road production wells are together known as the Church Road Wellfield. Their location, together with all other nearby wells and features of interest are provided on Figure 2-1.

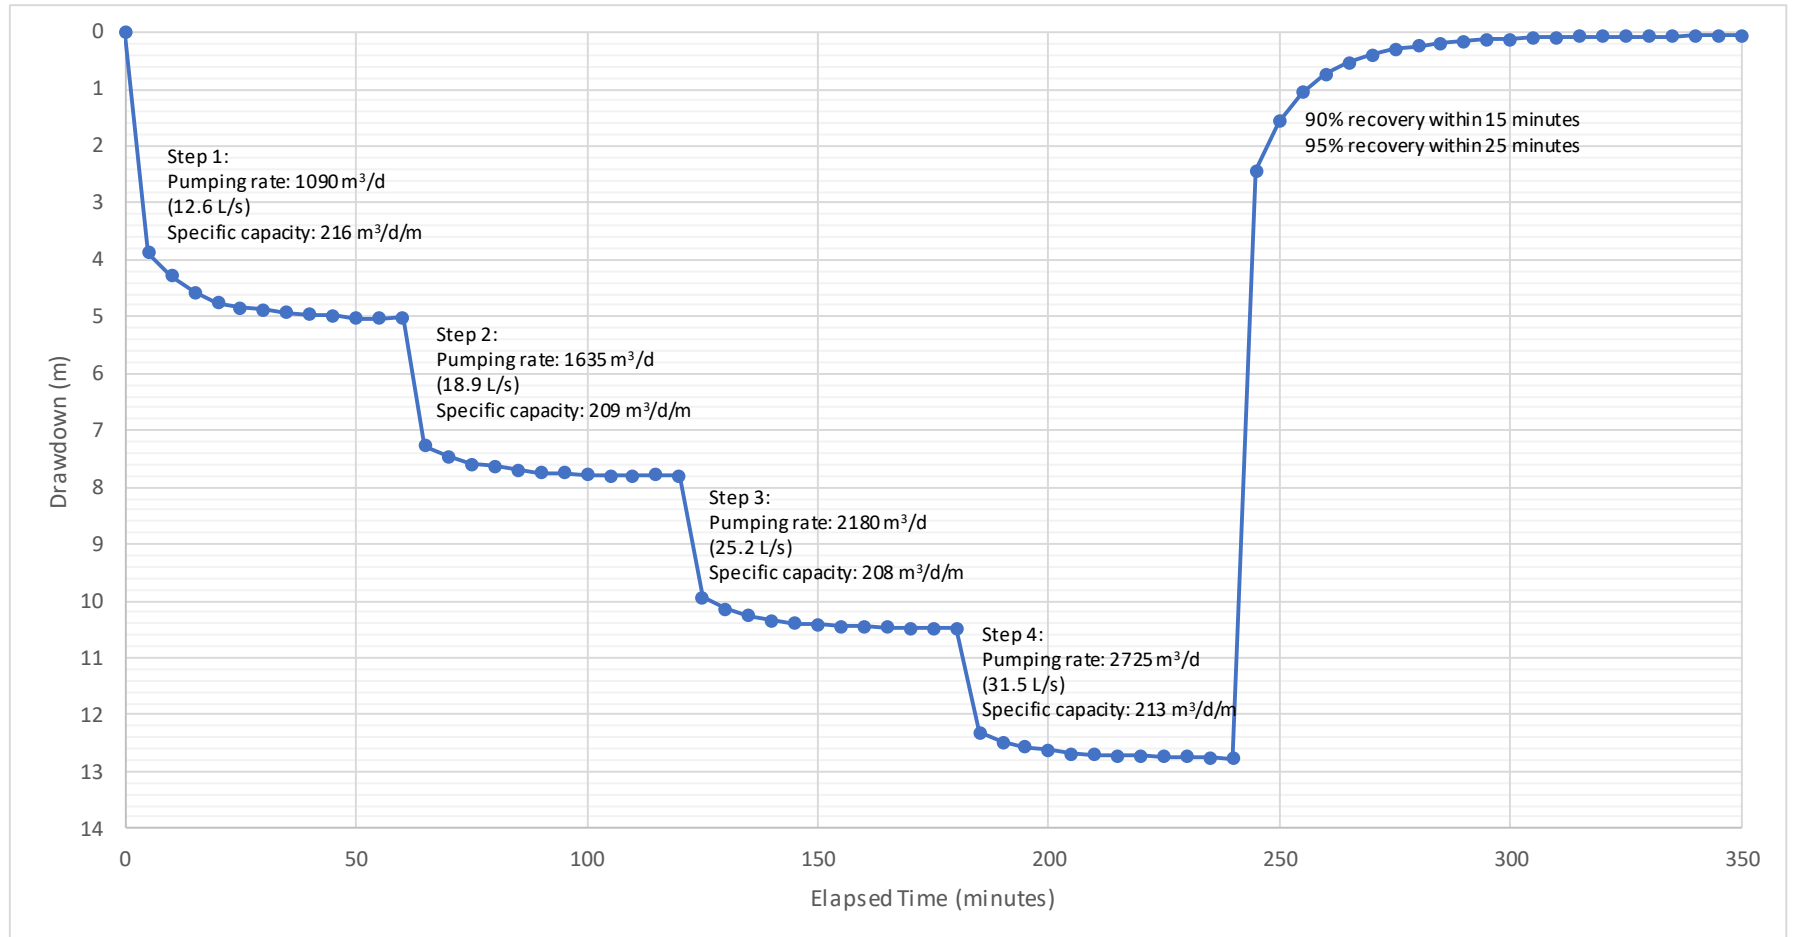
**Figure 3-1**  
Results of the Church Road Well 3 step test

Step testing commenced at 08:00 on 28 July 2020; each step was conducted for 60 minutes with a total of four steps. During each step an initial rapid drawdown in water level was recorded followed by relatively static water levels (Figure 3-1). Water levels recovered rapidly following the end of the step test with 90% recovery achieved within 15 minutes, and 95% recovery within 25 minutes. The results of the step test show a specific capacity of approximately 210 m<sup>3</sup>/d/m throughout the test, the final step was slightly higher than the two middle steps at 213 m<sup>3</sup>/d/m, indicating no drop in well efficiency, even though the pumping rate was above the manufacturers theoretical screening capacity of the well screen installed. This increase in specific capacity may reflect additional well development caused by the step tests.

A rate of 29.0 L/s (460 USgpm) was selected for the constant rate test. This rate was chosen based on the drawdown observed during the step tests and because this rate is just below the manufacturers theoretical transmitting capacity of the well screen (467 USgpm).

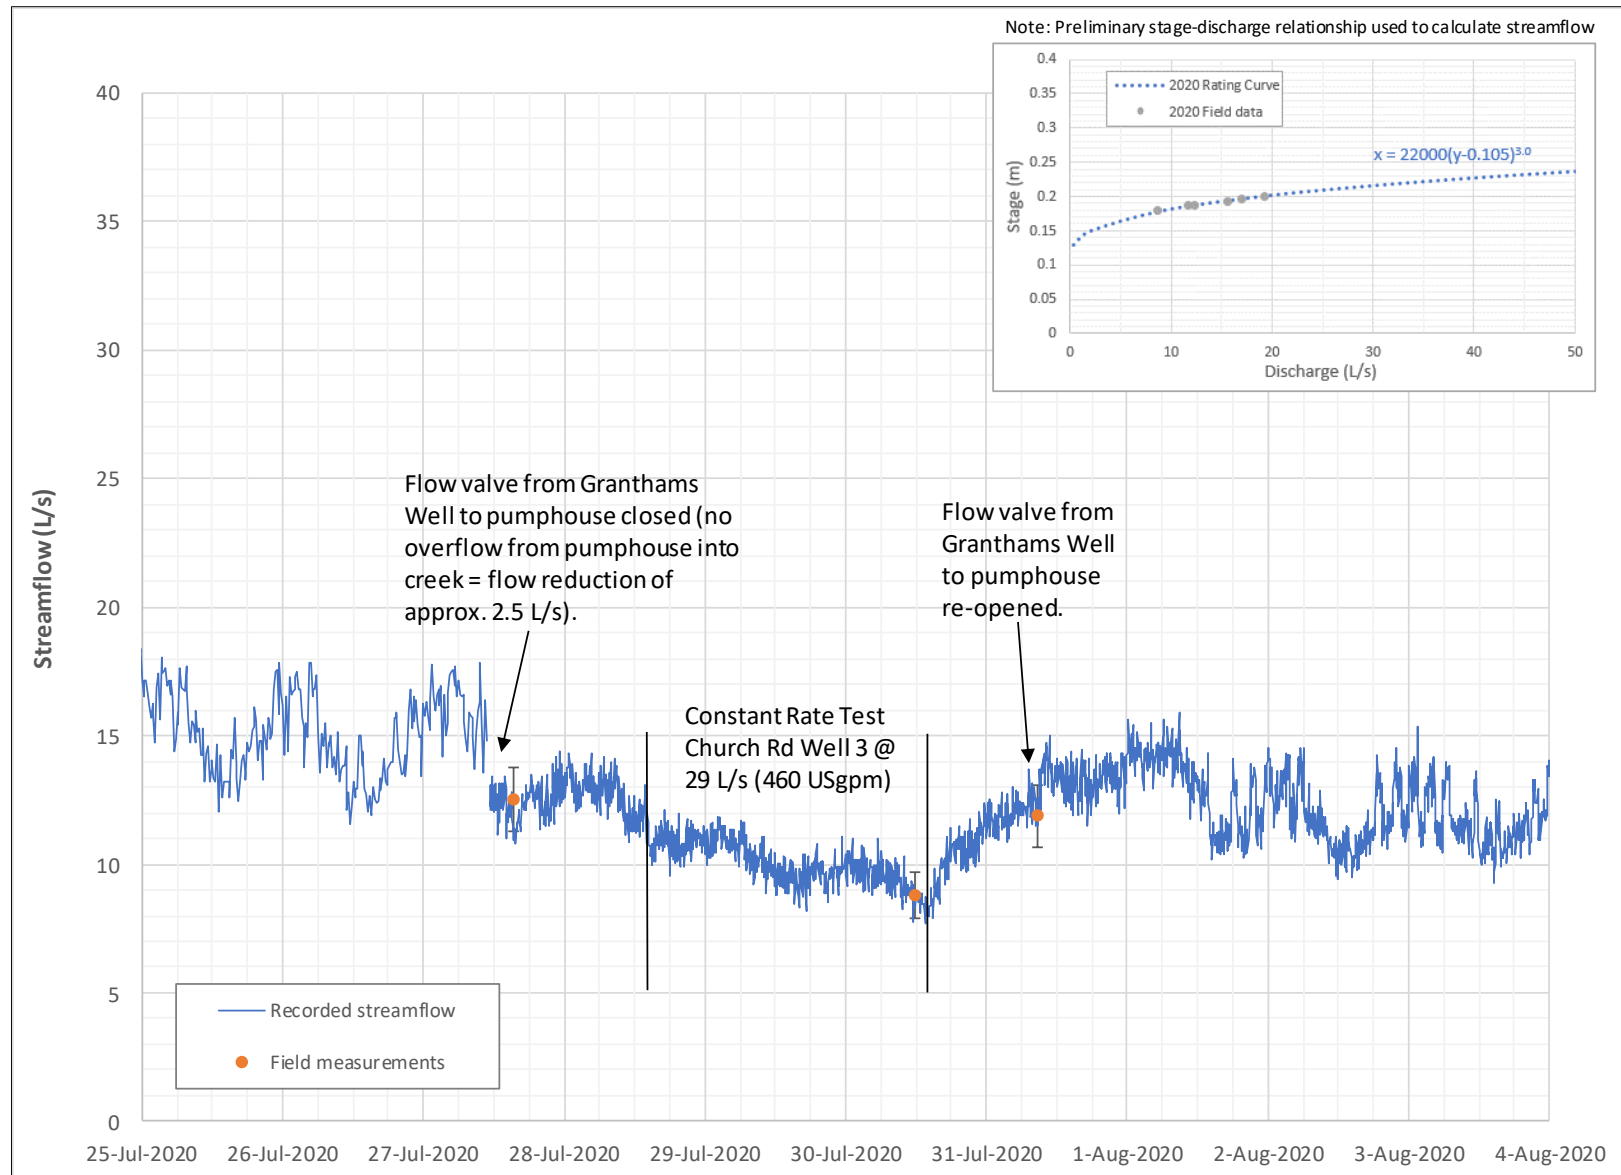
**Figure 3-2**  
**Soames Creek streamflow during Church Road Well 3 constant rate test**

Figure 3-2 illustrates how pumping from Church Road Well 3 reduces streamflow in the creek. It should be noted that prior to the start of the tests, flow from the artesian flowing Granthams Landing Well to Granthams Pumphouse (from where it overflows into the creek) was stopped, so the only flow from this well discharging to the creek was from the flow emerging around the outside of the well casing. In other words, no flow from inside of the well casing was discharging to the creek via the Granthams Landing pumphouse during the pumping tests. This resulted in a reduction in streamflow in the creek of approximately 2.5 L/s. Following the start of the constant rate test, a further reduction in creek streamflow is recorded. At the start of the constant rate test creek streamflow was approximately 12 L/s but after 2 days of pumping the streamflow had reduced to approximately 8 L/s, a decrease of 4 L/s.

The data indicates that streamflow in the creek was higher in the days prior to the pumping test than it was in the days following the test. July was a very dry month with just 29 mm rain recorded at Gower Point rainfall station (4.7 km to the south-west of the wells), of which 27.6 mm was recorded before 12 July 2020. No additional rainfall was recorded until 05 August 2020. The reduction in flow observed before and after the pumping test could therefore be reflecting a natural seasonal decline in creek streamflow so the 4 L/s reduction in creek streamflow recorded during the pumping test may not all be attributed to the groundwater extraction. Streamflow recorded after the test are similar to the low flows observed in 2019.

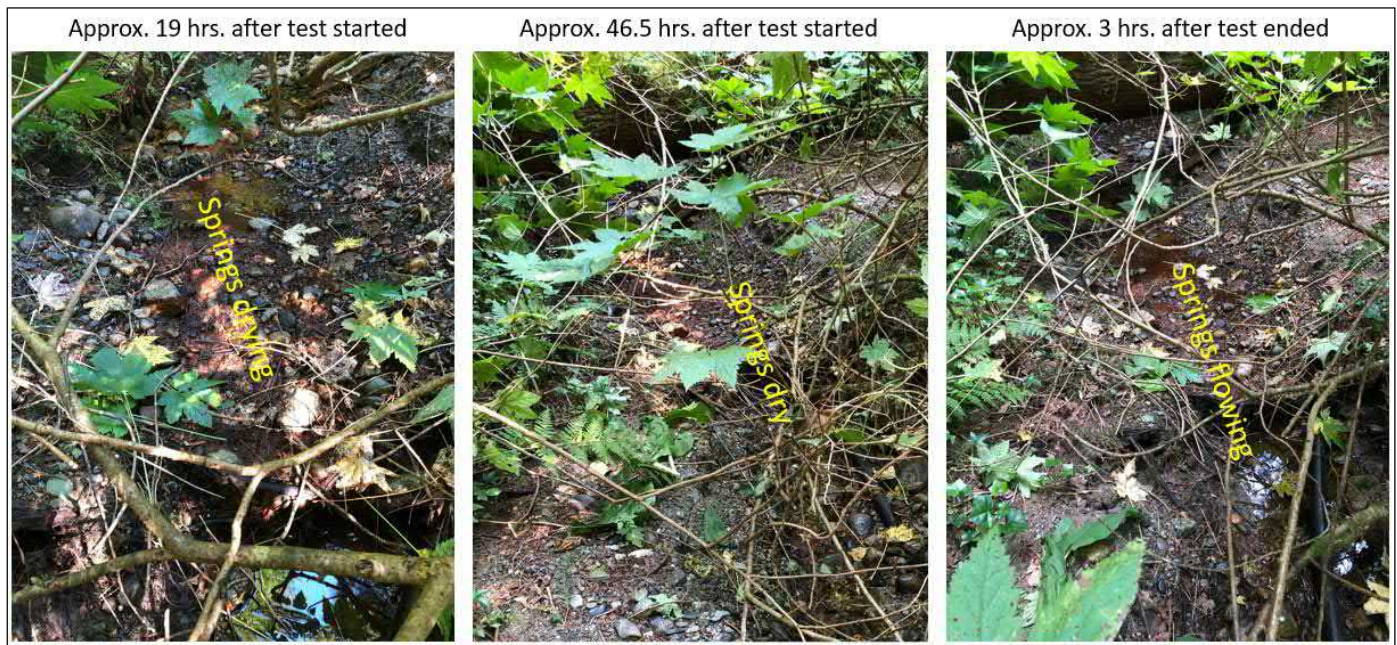
Figure 3-3  
Visual spring observations

In addition to the continuous flow measurements recorded at the D/S Soames Creek hydrometric station, visual observations were made at the springheads, and field flow measurements were taken in the most southerly channel draining the springs. Based on these, the flow at the springheads had reduced and the head of the springs had moved a short distance downstream (Figure 3-3). Current meter flow gauging (using a Swoffer 2100 flow meter) on the southern channel, approximately 20 m downstream of the springhead also indicated a reduction in flow (from approximately 4 L/s before the pumping test started to 1.4 L/s near the end of the pumping test); although caution should be given to this data due to the low flow, narrow stream channel, and shallow depth of water, potentially decreasing the gauging accuracy. This reduction in flow is however relatively consistent with the reduction in flow recorded by the hydrometric station

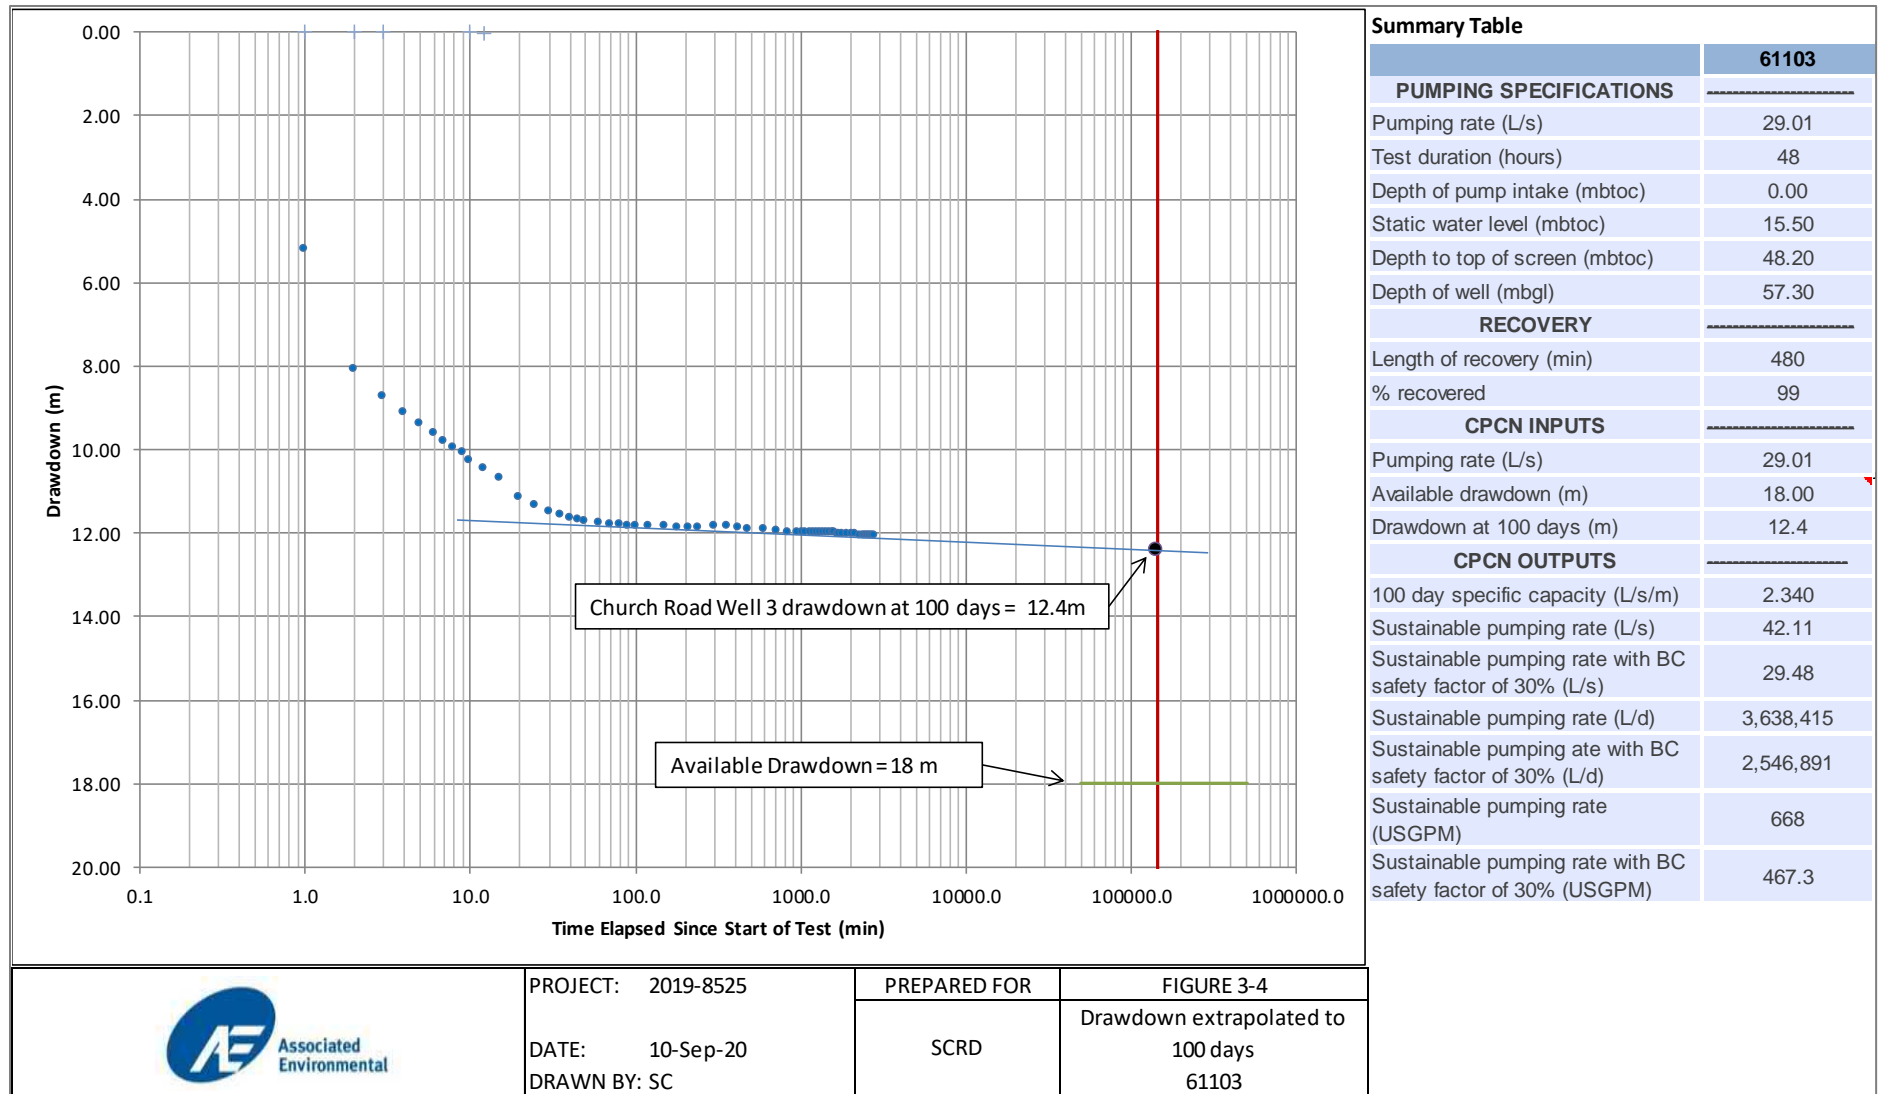
Figure 3-4  
Church Road Well 3: 100-day sustainable well yield

The calculated sustainable long-term pumping rate for Church Road Well 3 using the CPCN 100-day method (MOE 2007) is 29.5 L/s (467.3 USgpm). Figure 3-4 shows the extrapolated drawdown curve on a linear-logarithmic chart and provides a summary of the calculation inputs and resulting 100-day sustainable well yield.

In determining the 18 m of available drawdown (i.e., which affects the 100-day sustainable well yield), the following was considered:

1. Although the well is technically confined under non-pumping conditions, pumping of the aquifer over time will locally at the well draw the water below the confining unit, therefore, we calculated available drawdown assuming it is an unconfined aquifer. Available drawdown in an unconfined aquifer is the distance from the static water level to the top of the screen. The static groundwater level is 24.5 masl. To maintain the aquifer water level above sea level and therefore maintain a hydraulic gradient to the ocean, we used a minimum allowable groundwater level of 2 masl, rather than using the elevation of the top of the screen (at an elevation of -8.5 masl). This equals 22.5 m of available drawdown.

2. Next, we extended the well interference observed on nearby wells during constant rate pumping tests to 100 days. Using the calculated aquifer characteristics and the extrapolated drawdown curves, we added 4 m of additional drawdown which could be expected from Church Road Well 2 pumping at a rate of 25.4 L/s (403 USgpm), plus 0.5 m well interference from Soames Well pumping at a rate of 16.0 L/s (254 USgpm) continuously.

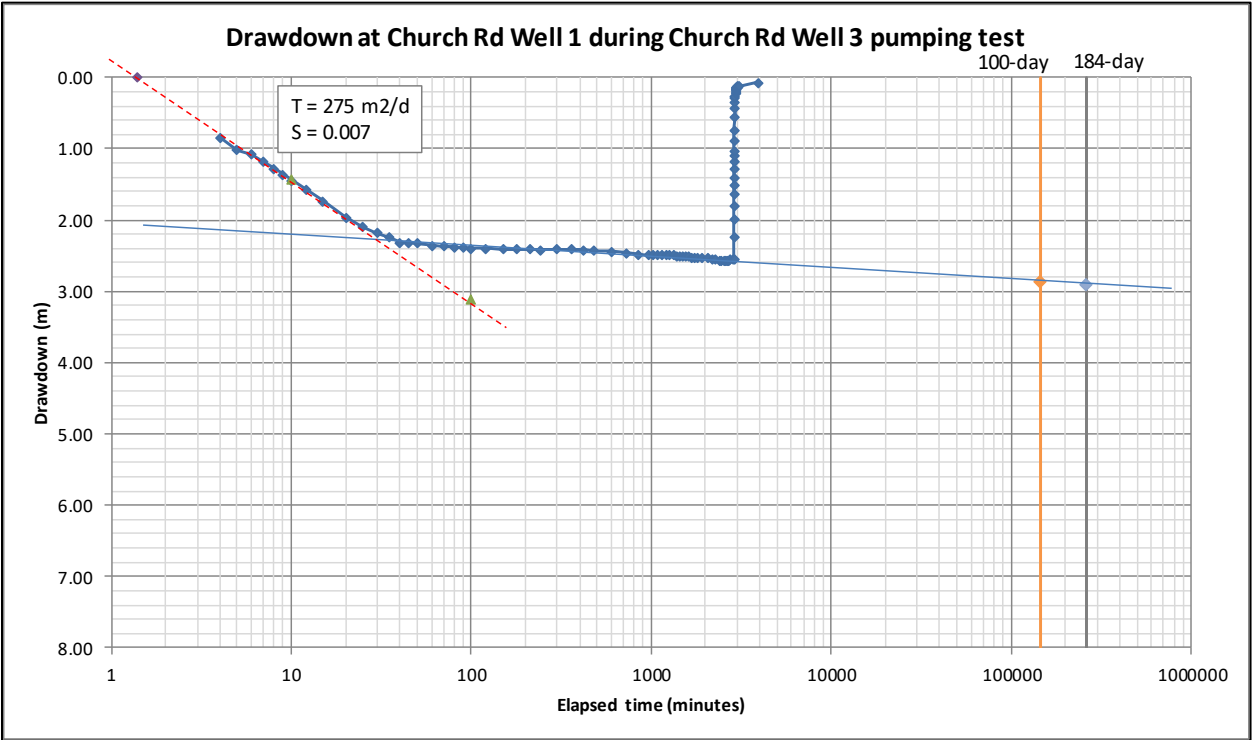
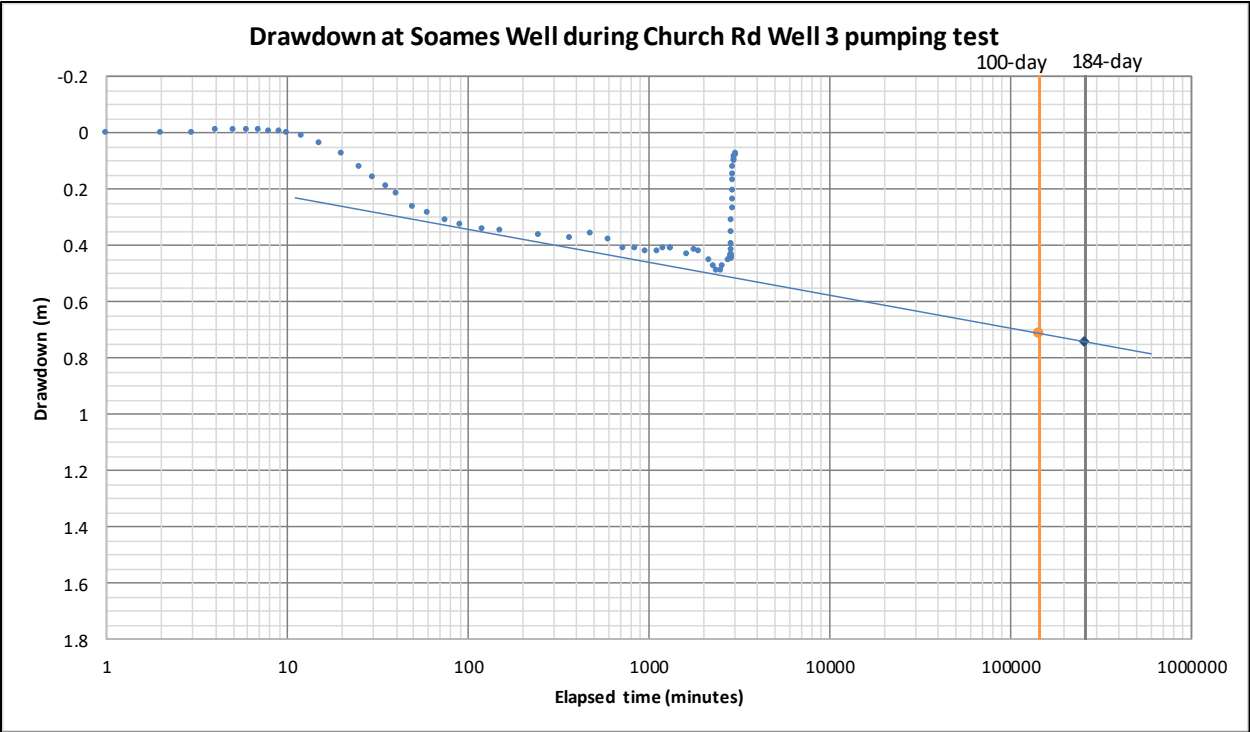
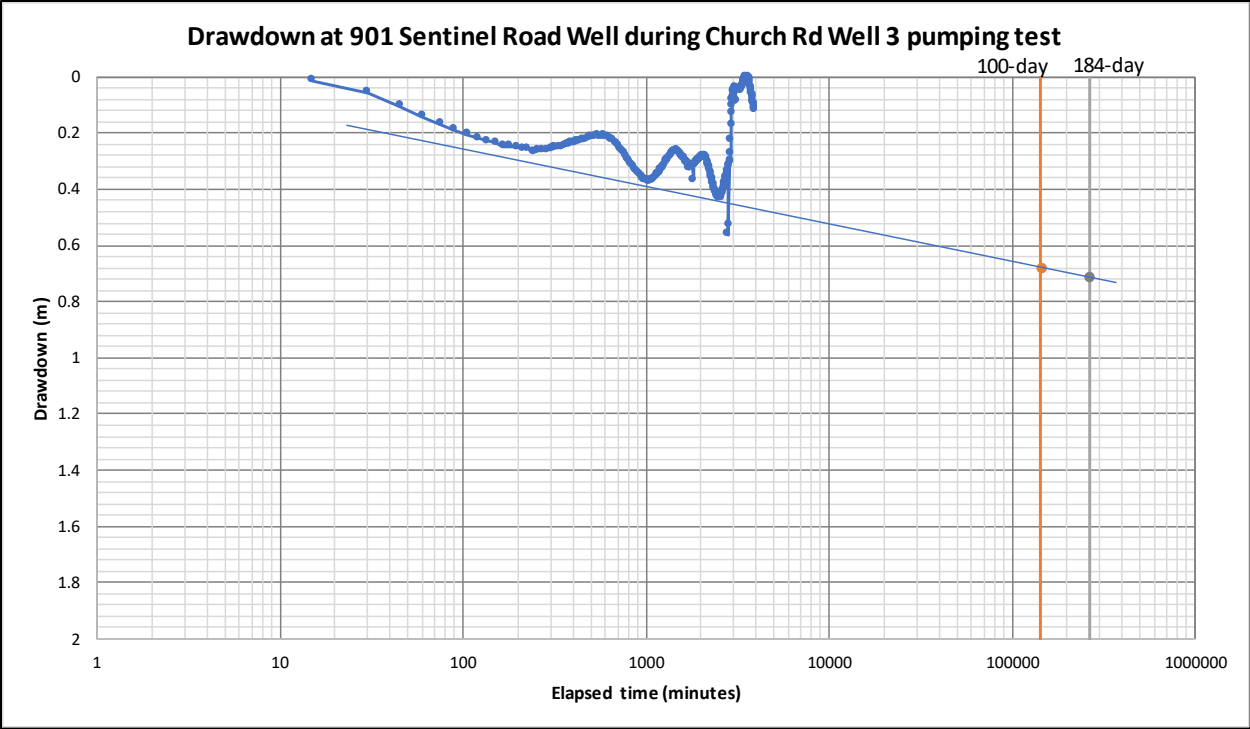
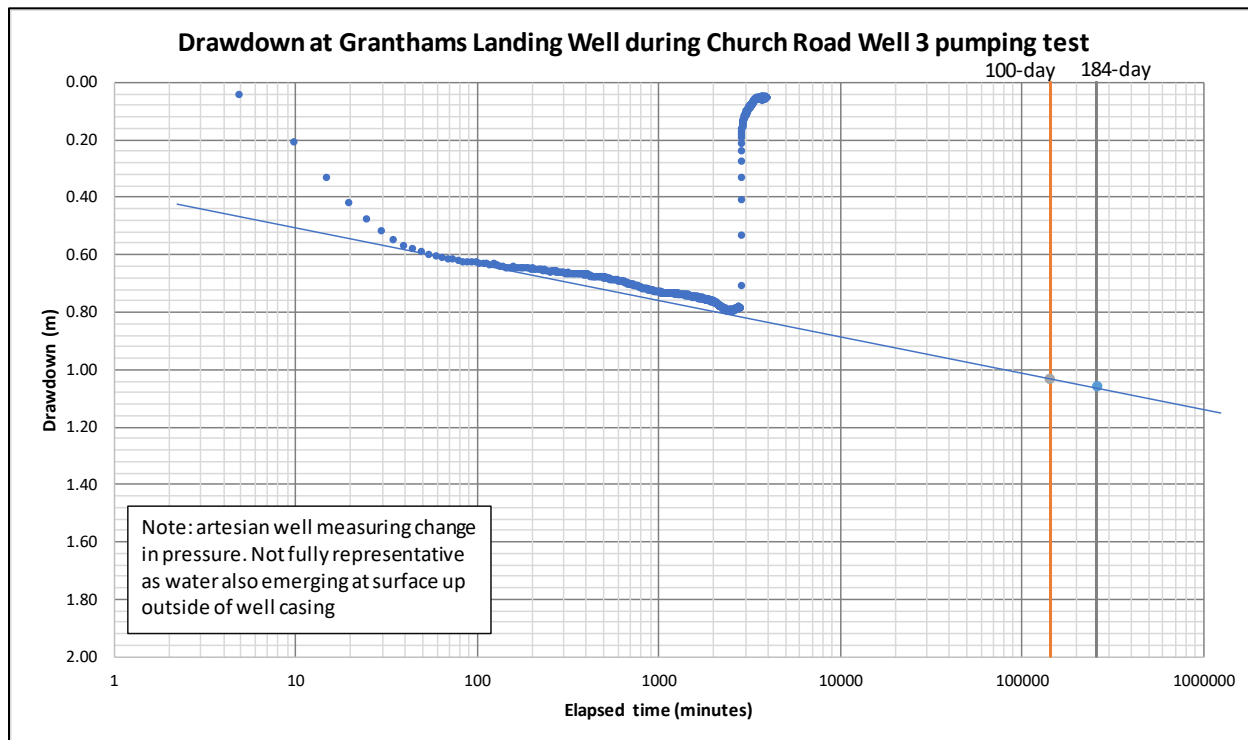
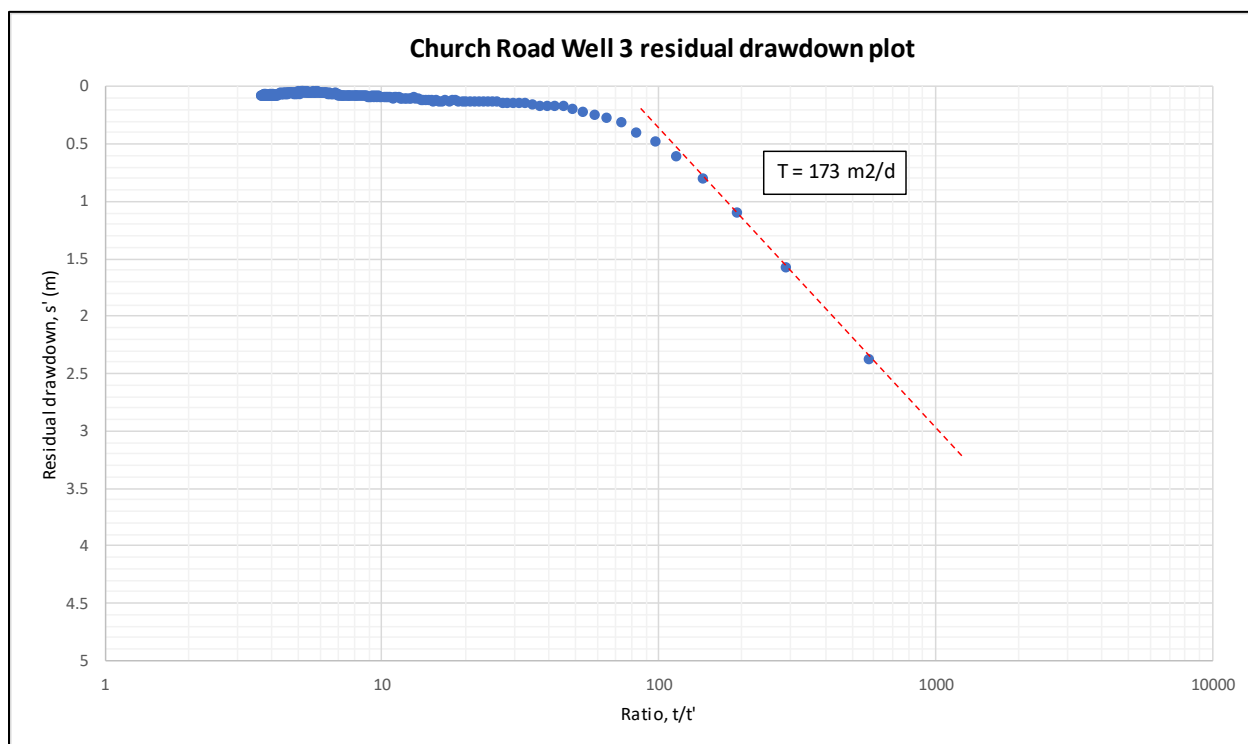
APPENDIX B – Observation well water drawdown during Church Road Well 3 Pumping Tests

Six observation wells were monitored during the Church Road Well 3 48-hour constant rate test. The impacts noted on each well are presented in Table 3-5. Figures showing the drawdown in each monitoring well during the test and extrapolated to 100 days and 184 days are provided in Appendix B. The 184-day drawdown values correspond to a possible 'worst-case' drought and was the period used in drought demand modelling for the SCRD by Integrated

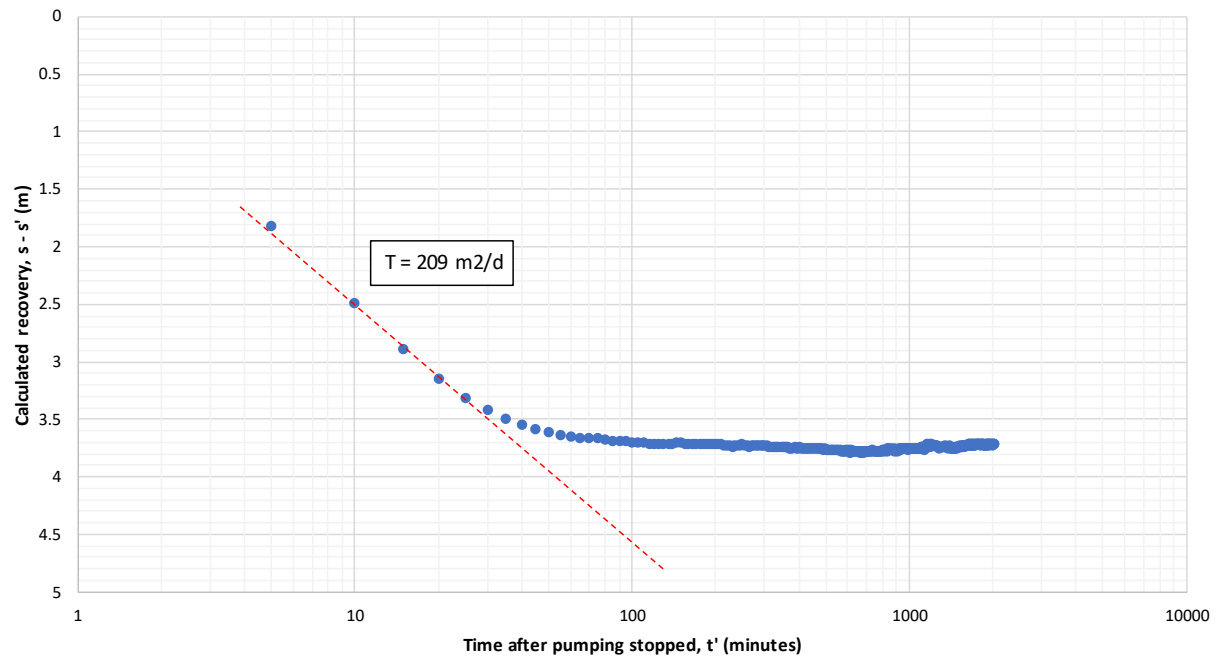
Time-recovery plot Church Road Well 2 following Church Road Well 3 pumping test

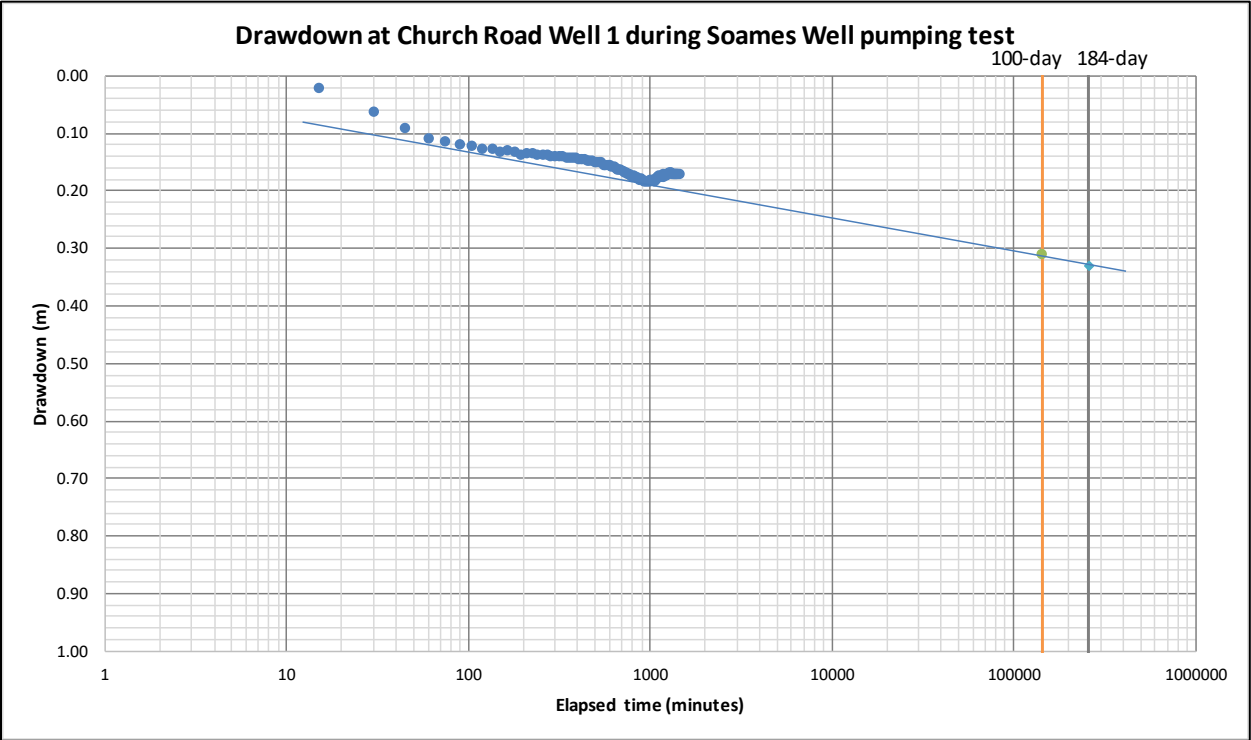
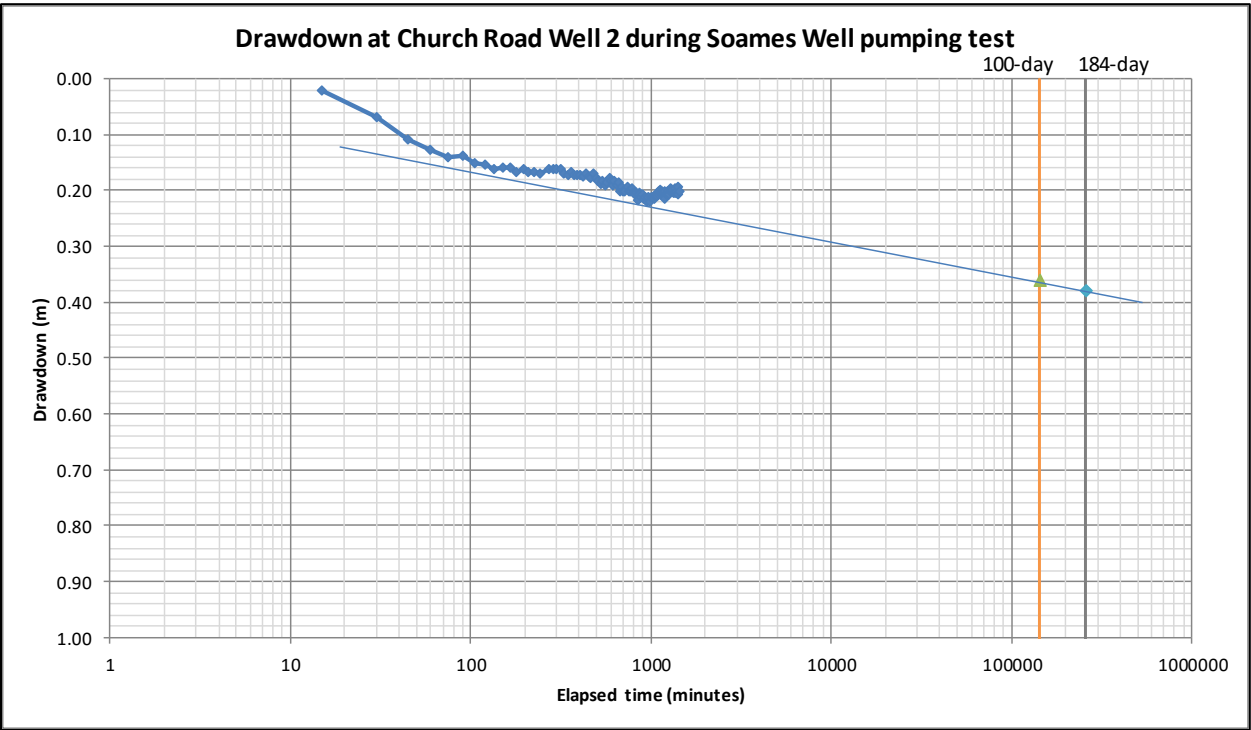
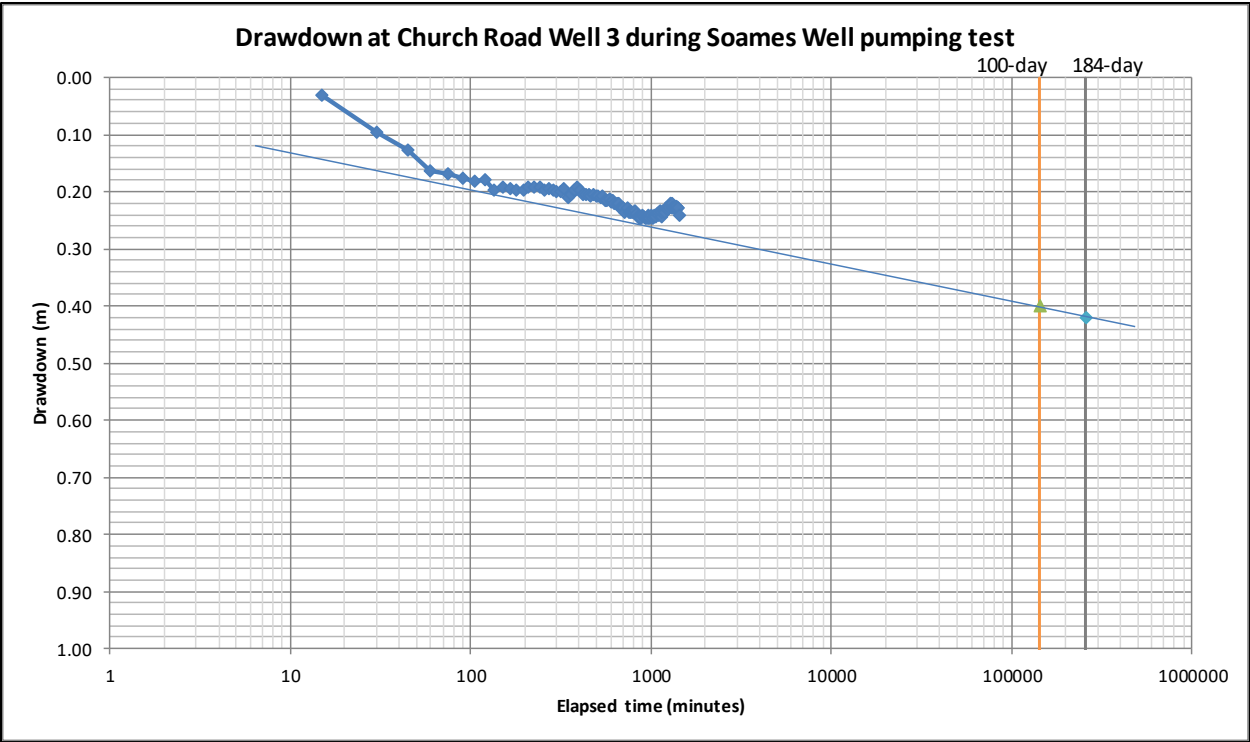
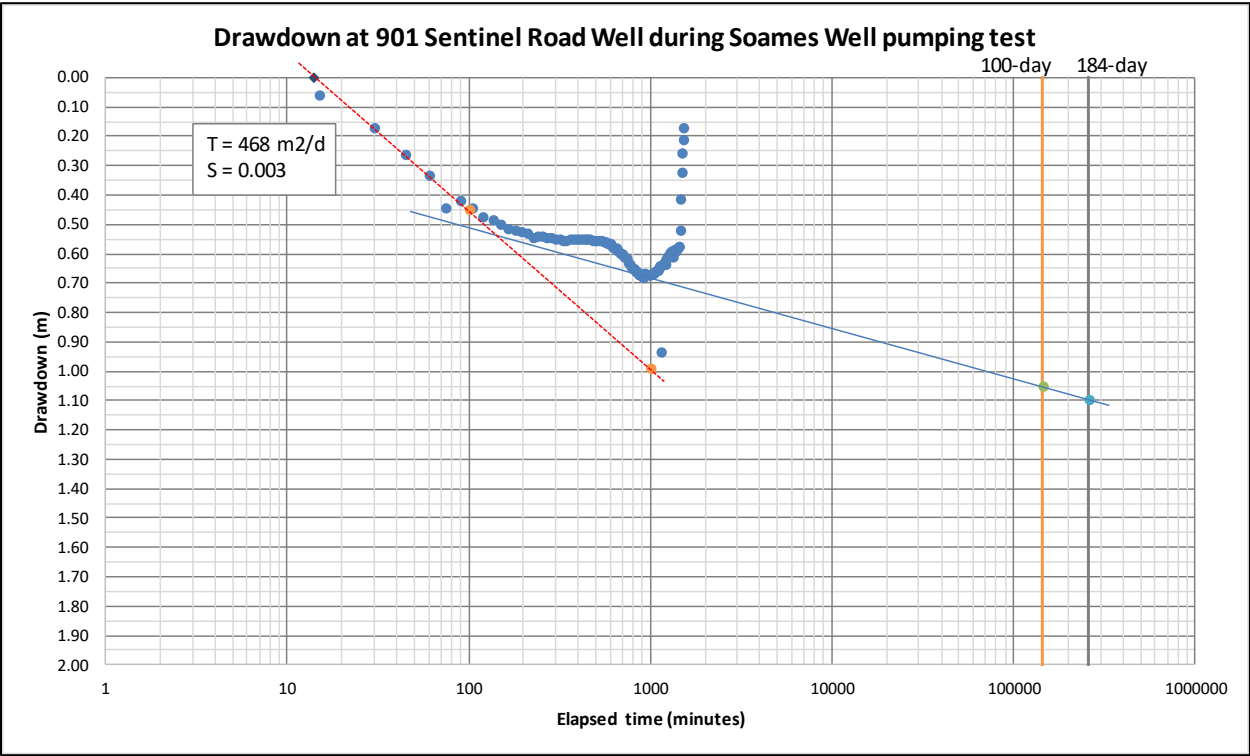
APPENDIX C – Observation well water drawdown during Soames Well Pumping Tests

As detailed in Section 4-1 and Table 4-1, five observation wells were monitored during the Soames Well 24-hour constant rate test. The impacts noted on each well are presented in Table 4-2. Figures showing the drawdown in each monitoring well during the test and extrapolated to 100 days and 184 days are provided in Appendix C. The findings are discussed below in Section 4.2.1.1.
