# Sunshine Coast Regional District

# Request for Proposal

**Number: 2337009**

## **Exposed Watermain Rehabilitation**

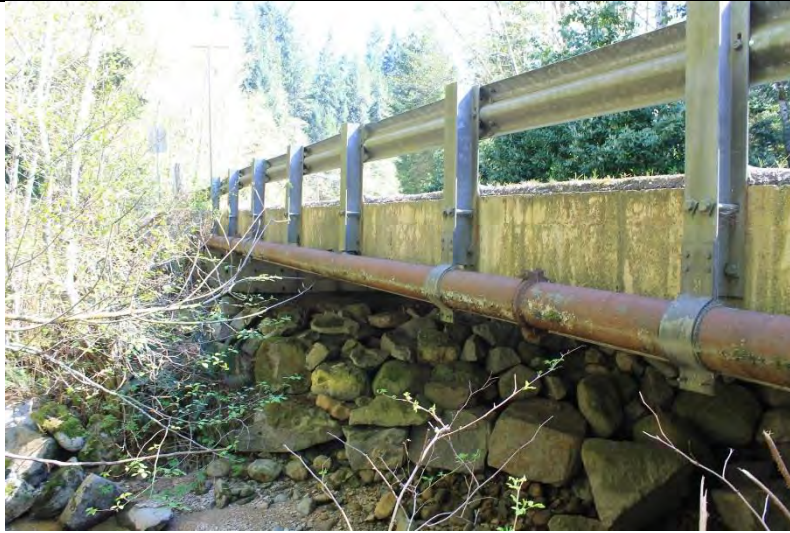
Additional view from the western stream embankment showing widespread surface corrosion throughout the length of the water main. Note the support brackets and connections are in a good condition.

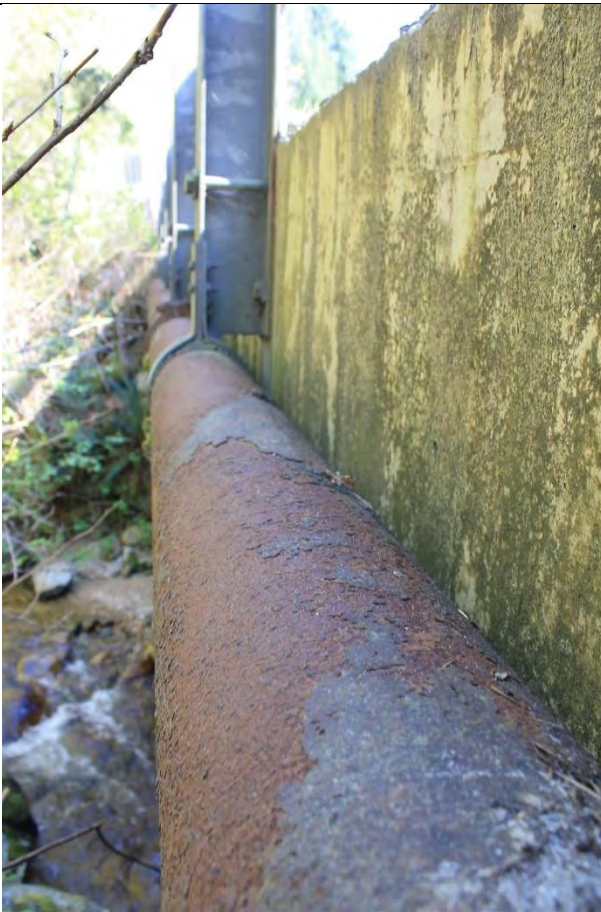
Close up view showing wide spread failure of the paint system and surface corrosion to the water main looking east.

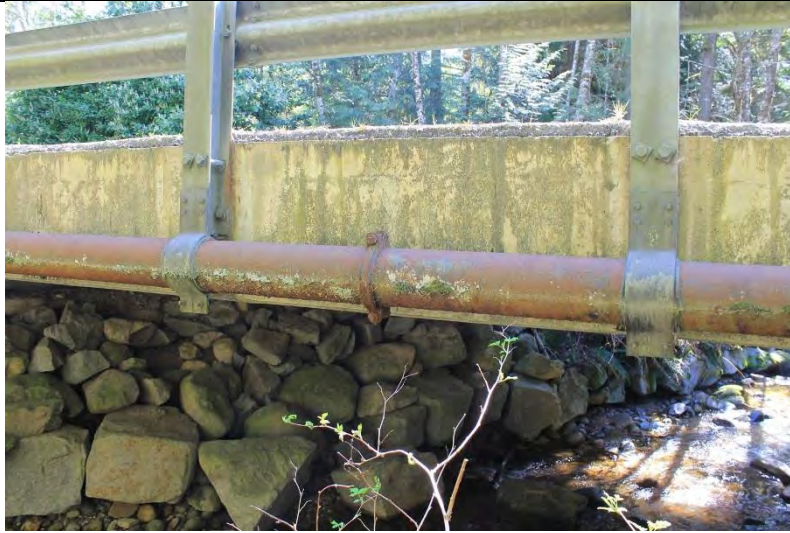
View of the western-most support brackets and flange connection. The two water main flange connections are showing typical surface corrosion. Note the support brackets are in a good condition.

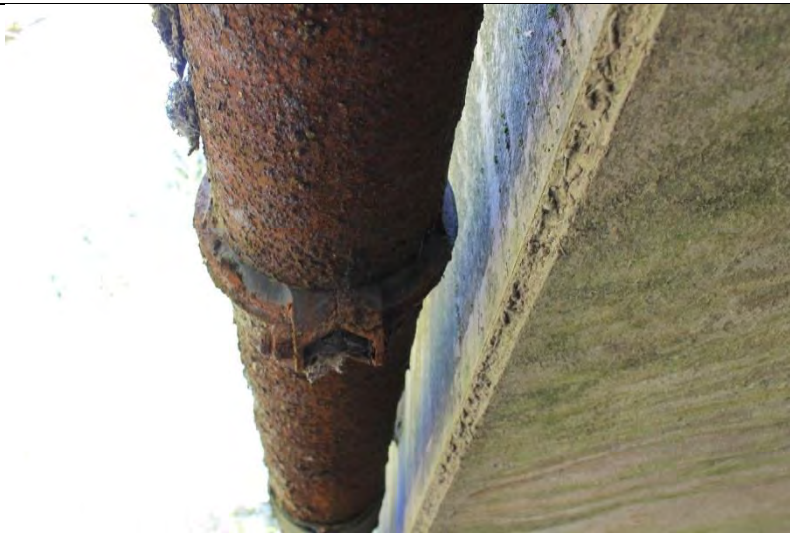
Close up view of the western flange connection from the underside showing minor pitting to the underside of the water main and grooved coupling.

Recommend that the water main is cleaned and painted throughout its length within 12-24 months to prevent further deterioration.

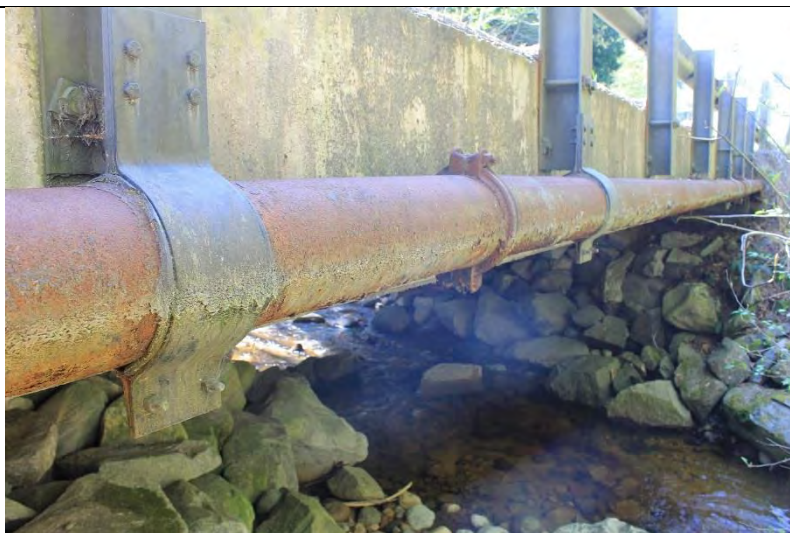
View of the water main from the eastern stream embankment showing failure of the paint system and surface corrosion throughout, with the support brackets in good condition.

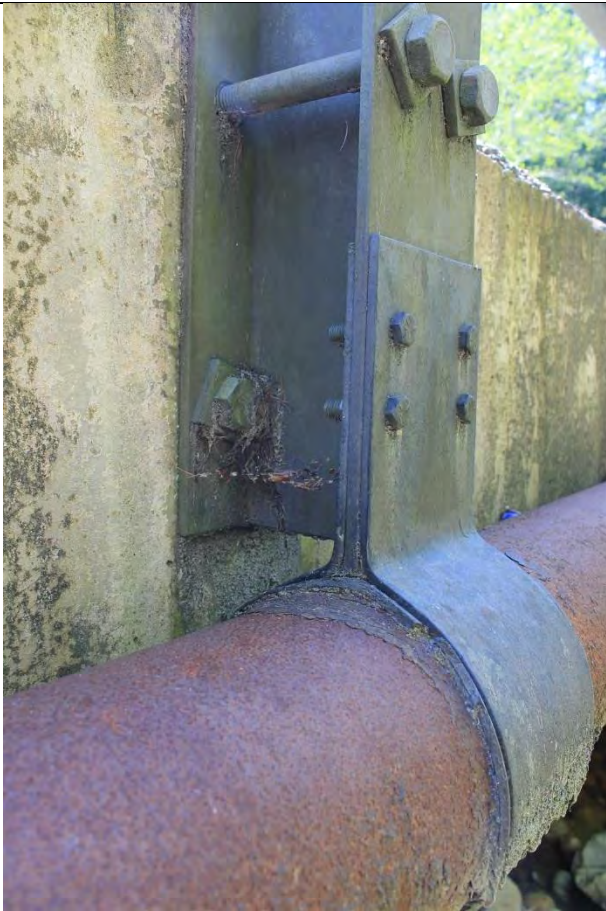
<p>Close up view of a support bracket where it connects to the bridge guardrail post showing it to be in a good condition.</p>
------------------------------------------------------------------------------------	--------------------------------------------------------------------------------------------------------------------------------

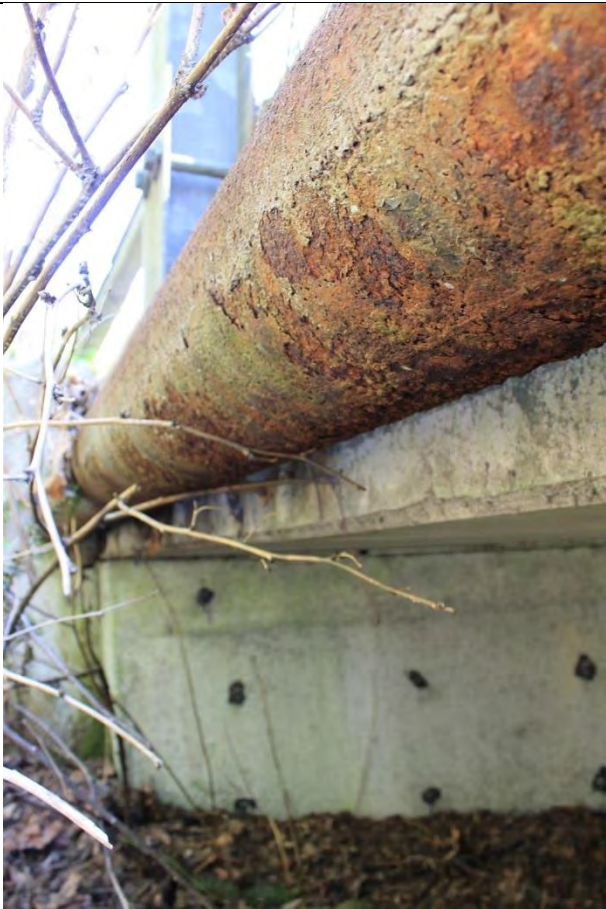
<p>View of water main passing through the eastern bridge abutment with typical failure of the paint system and surface corrosion.</p>
------------------------------------------------------------------------------------	---------------------------------------------------------------------------------------------------------------------------------------

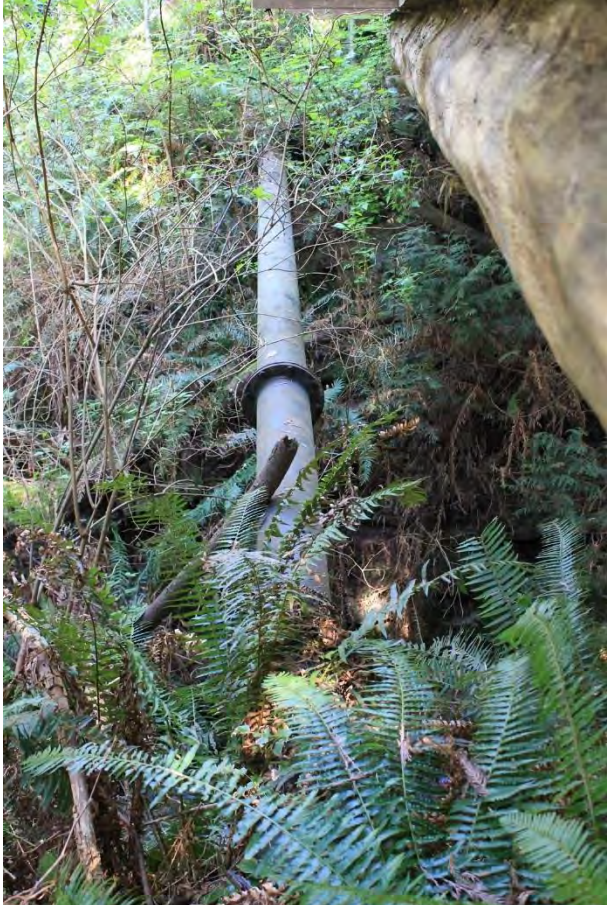
<p>View of the exposed water main from the eastern embankment showing a bolted flange connection to the east of mid span.</p>

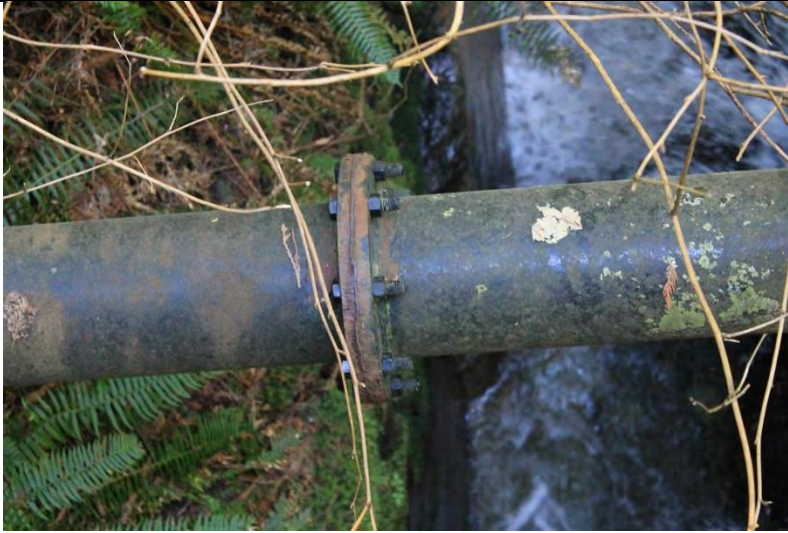
Close up view of the bolted flange showing minor surface corrosion to the flange edges and bolts in good condition. No immediate action required.

Pipe coating in good condition with very minor areas of breakdown.

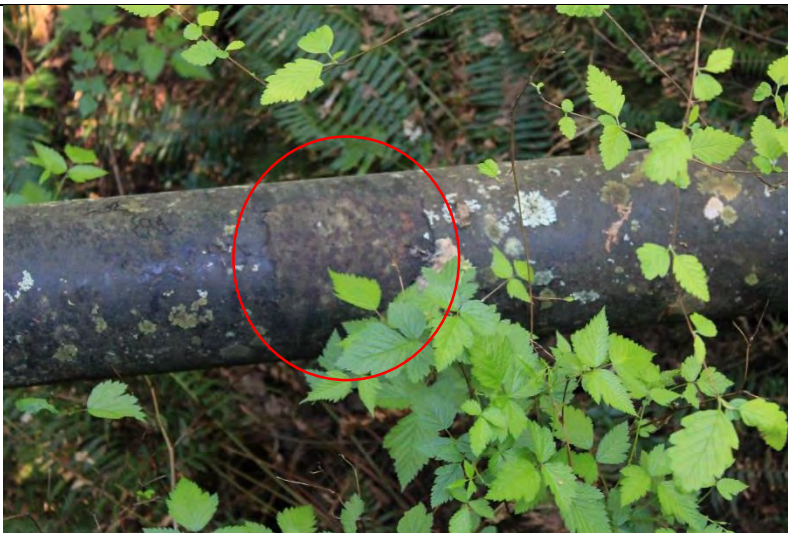
View of area of coating inconsistency, possibly due to past strapping. No action required.

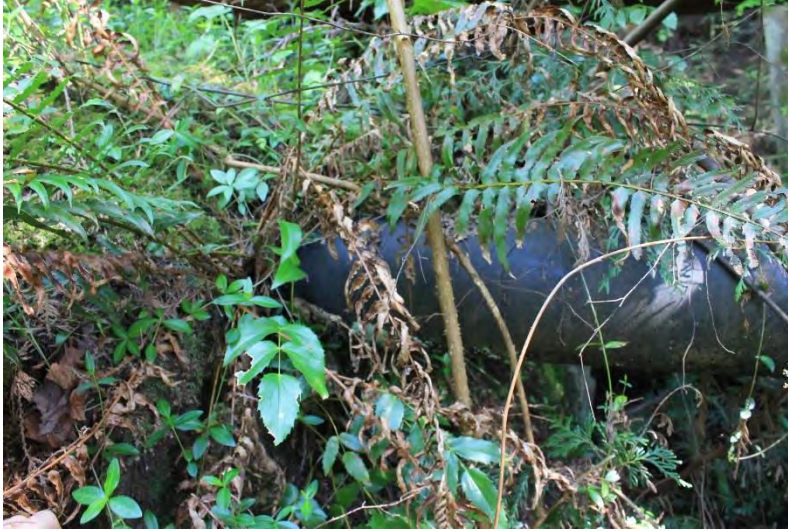
View of western end of water main partially obscured by vegetation.

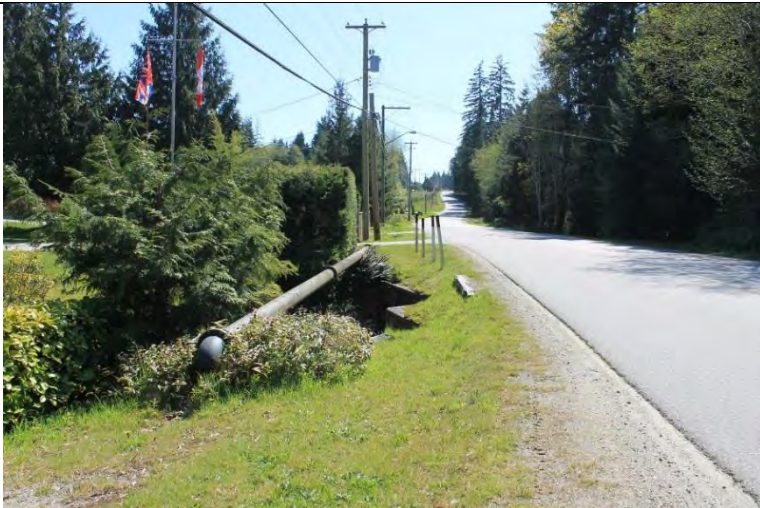
General view of the water main to the western side of Sechelt Inlet Road, looking south.
	View of the northern end of the water main showing all components to generally be in good condition, with minor surface corrosion present to the upper surface of the water main.

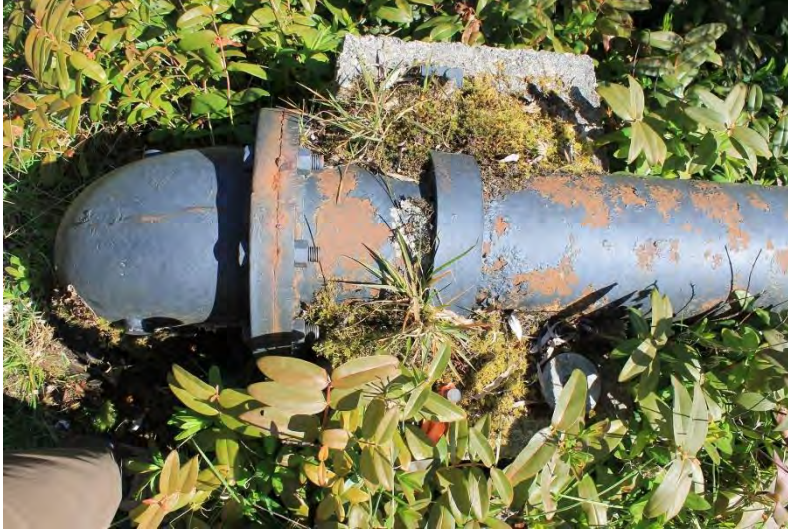
Further view of surface corrosion to the upper surface of the water main at the northern end.

Note the concrete footing and holding down bolts are in good condition.

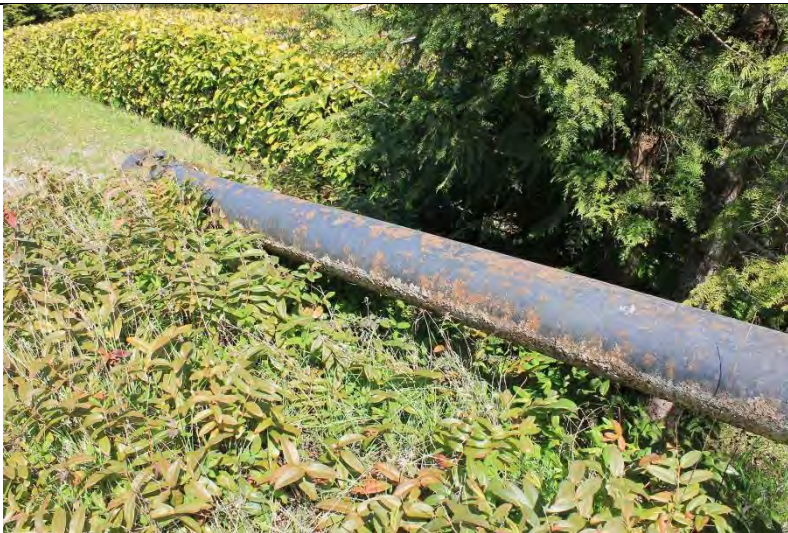
View of the northern quarter of the water main showing minor patches of surface corrosion where the paint system has failed.

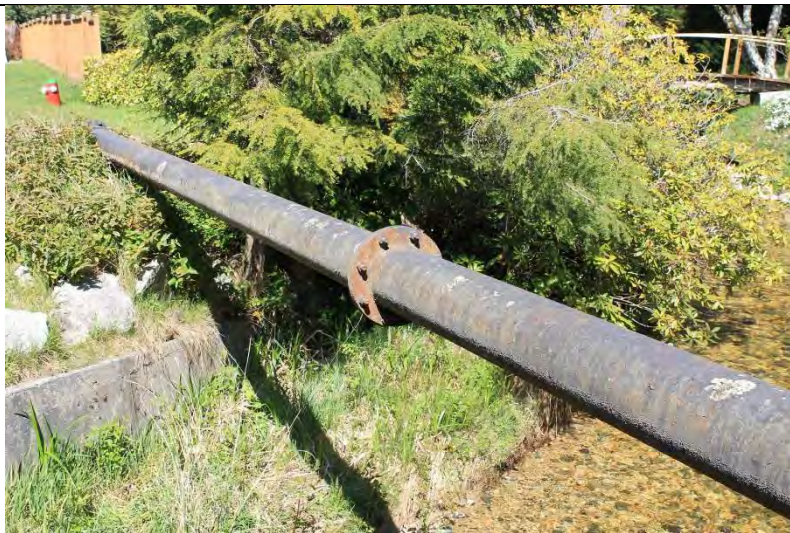
View of the flange connection approximately at mid-span of the exposed water main, showing minor surface corrosion to the flange plates.

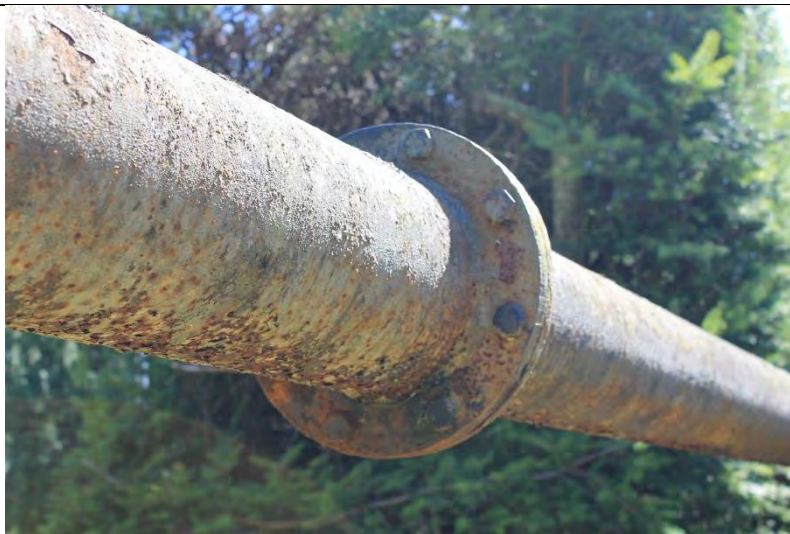
Close up view of the flange connection showing it to be generally in a condition with minor surface corrosion.

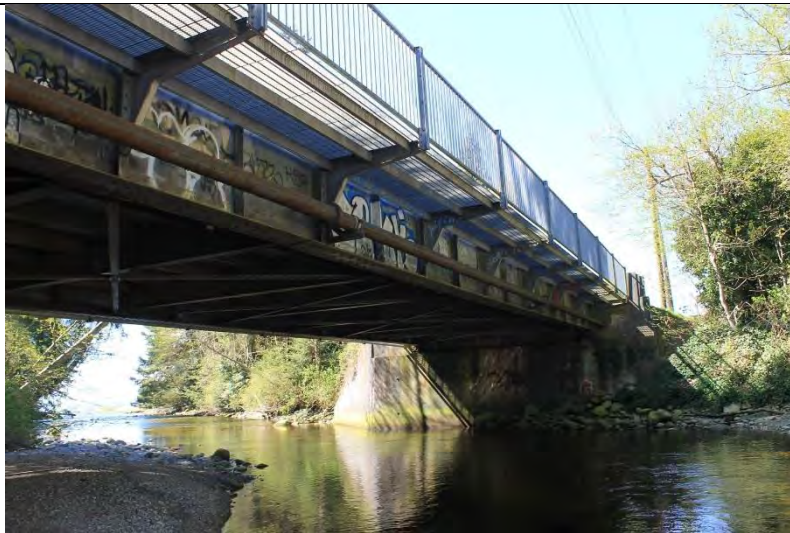
General view of the northern side of Chapman Creek Bridge from the eastern embankment, showing the water main supported by the outer girder below the bridge sidewalk.

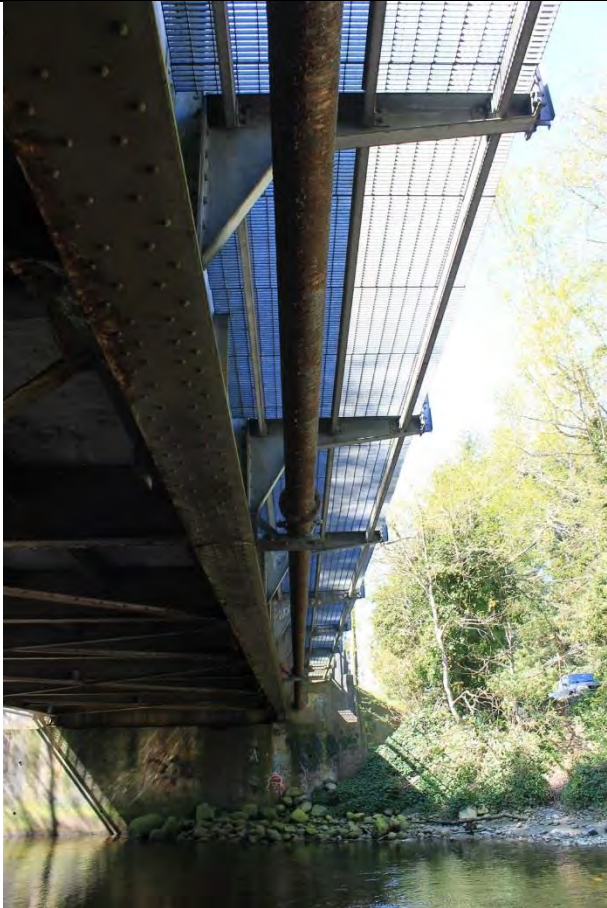
<p>General view of the water main from the eastern embankment, showing failure of the coating system and widespread surface corrosion to the underside of the water main.</p>

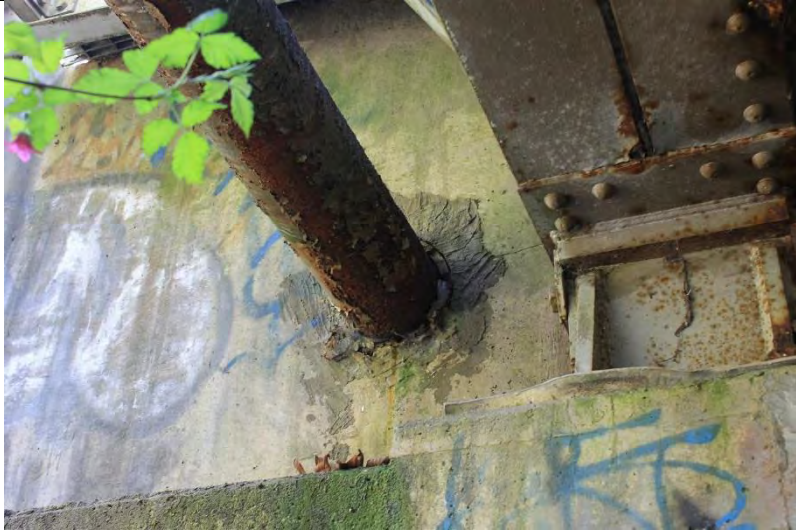
<p>View of the underside of the water main where it passes through the eastern bridge abutment.</p> <p>Note moderate loss of steel section depth has occurred to the water main in this area due to corrosion. Recommend clean and paint within 12 months to prevent further loss of section depth.</p>

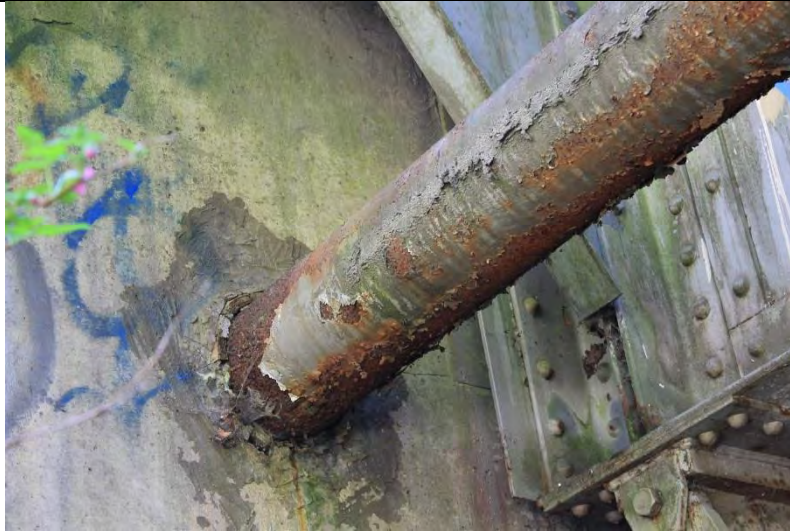
Additional view of the water main where it passes through the eastern bridge abutment showing moderate corrosion and loss of steel section depth at the abutment interface, with less severe surface corrosion the remainder of the water main.

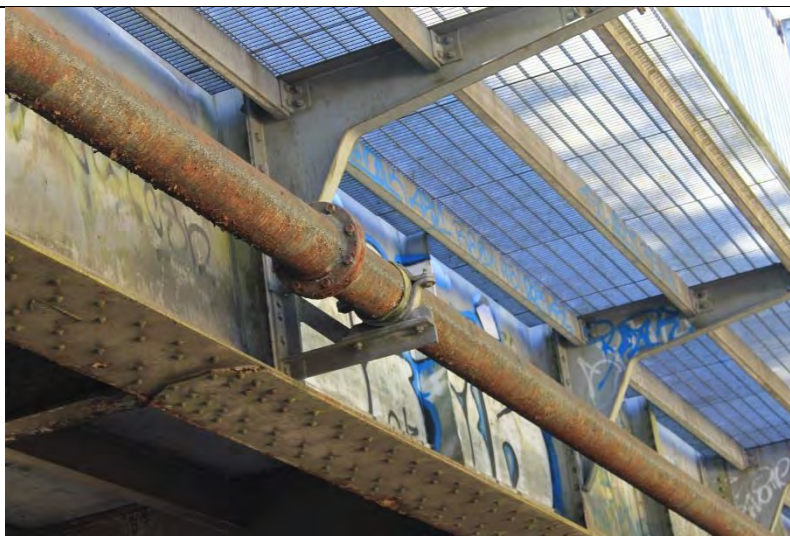
View of the eastern-most support bracket and flange water main flange connection showing widespread surface corrosion throughout.

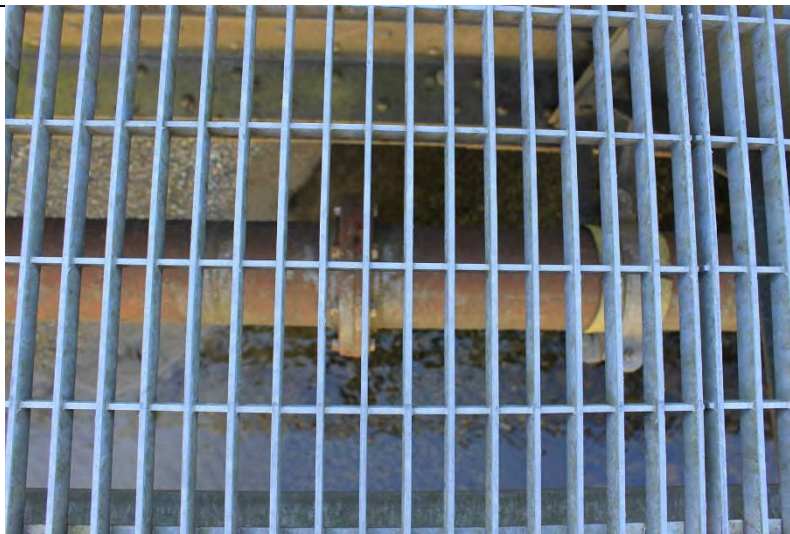
View of the topside of the eastern-most support bracket and flange connection through the sidewalk grating.

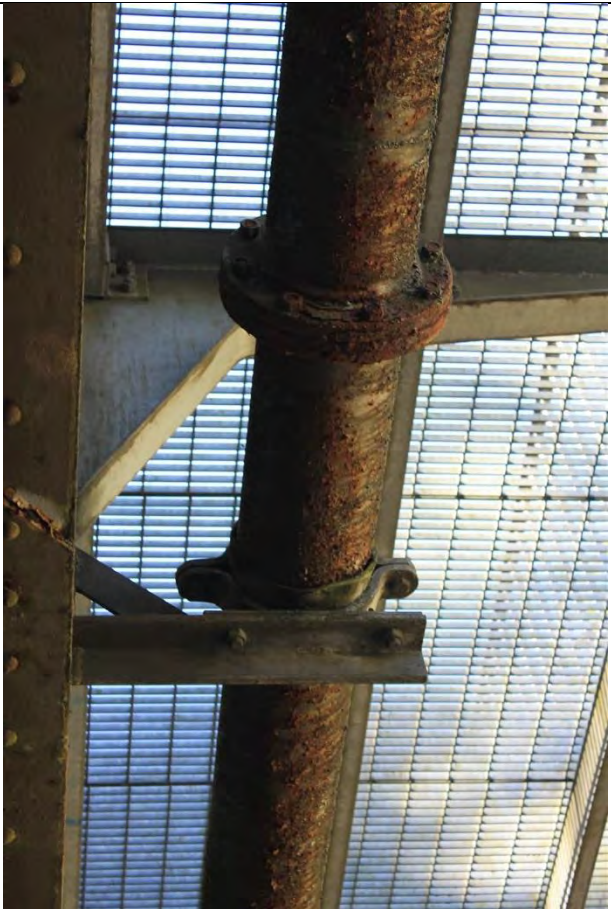
<p>Close up view of the eastern-most support bracket and flange connection showing widespread surface corrosion.</p>

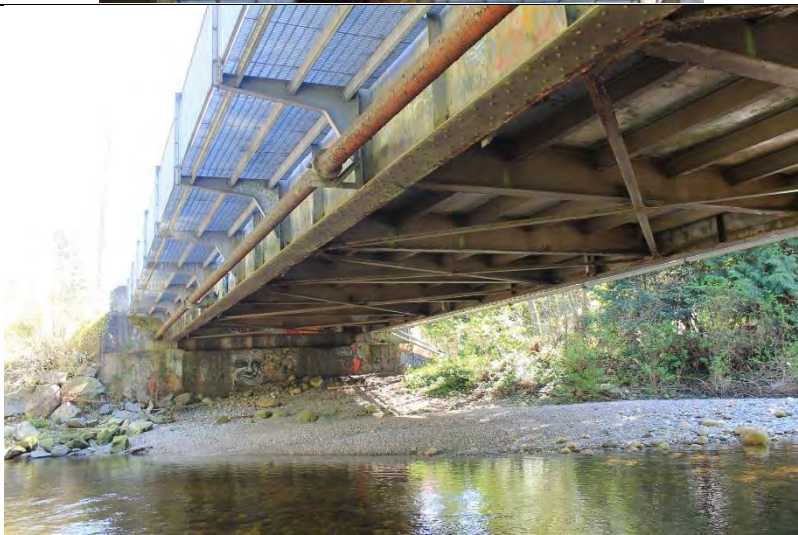
<p>General view of the water main from the western stream embankment showing widespread surface corrosion.</p>

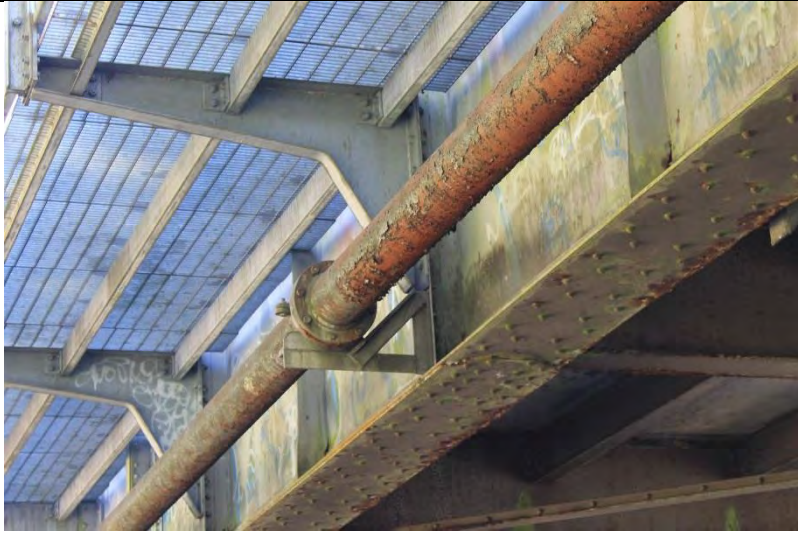
<p>Close up view of the western-most support bracket and flange connection showing widespread failure of the coating system and surface corrosion to the water main.</p> <p>Note the support brackets are in a good condition with no signs of corrosion.</p>
 	<p>View of the topside of the western-most support bracket and flange connection through the sidewalk grating.</p>
 	<p>View of the western end of the water main where it passes through the western bridge abutment showing surface corrosion to the underside of the water main throughout.</p>

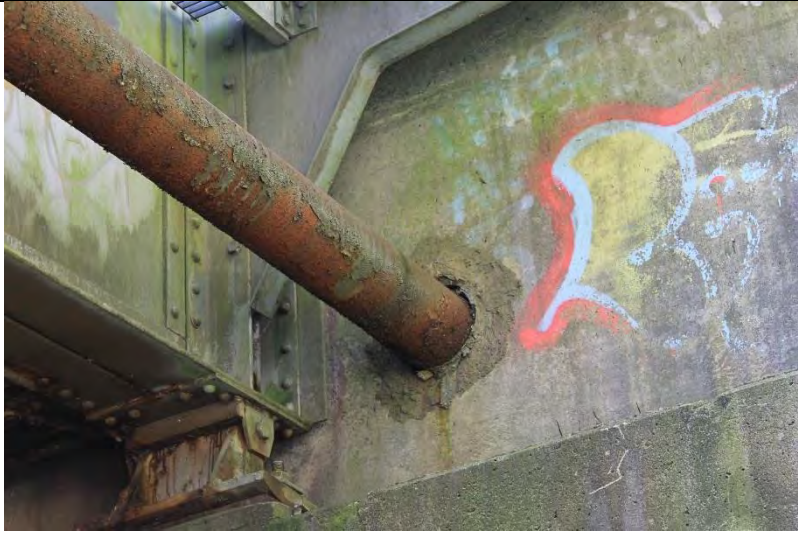
<p>Close up view of the interface between the water main and western bridge abutment. Note there is a small gap between the water main and cored hole through the abutment where the repair mortar has shrunk.</p>
------------------------------------------------------------------------------------	--------------------------------------------------------------------------------------------------------------------------------------------------------------------------------------------------------------------

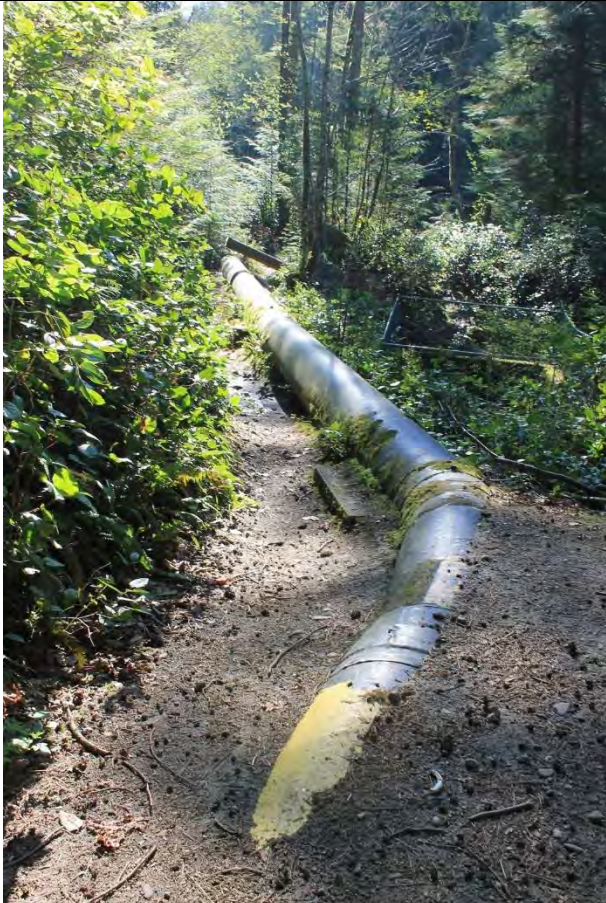
<p>General view of the water main looking east, where it becomes partially exposed to the east of the Trestle and Pipe #2 structure, before the existing Sed. Box (see right hand side of photo).</p>
	<p>Note yellow section of main where the protective jacket has been abraded by pedestrian traffic on the trail – no action required.</p>

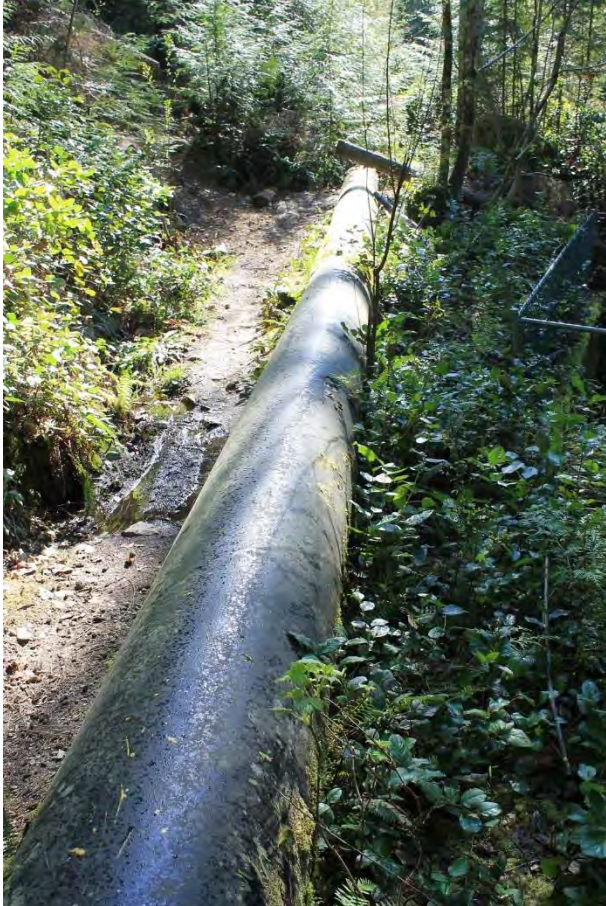
<p>View of the partially buried water main to the north of the existing Sed. Box (right hand side of photograph). Note the water main is generally in good condition, with minor abrasion to the outside face of the protective jacket requiring no action.</p>

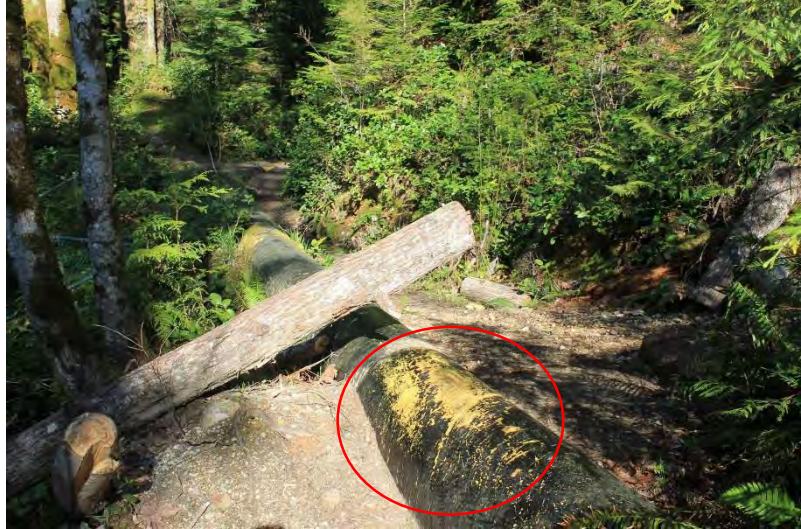
<p>View of the water main looking west where the trail crosses over it, with abrasion to the outer surface of the protective jacket due to pedestrian traffic. No action required.</p>

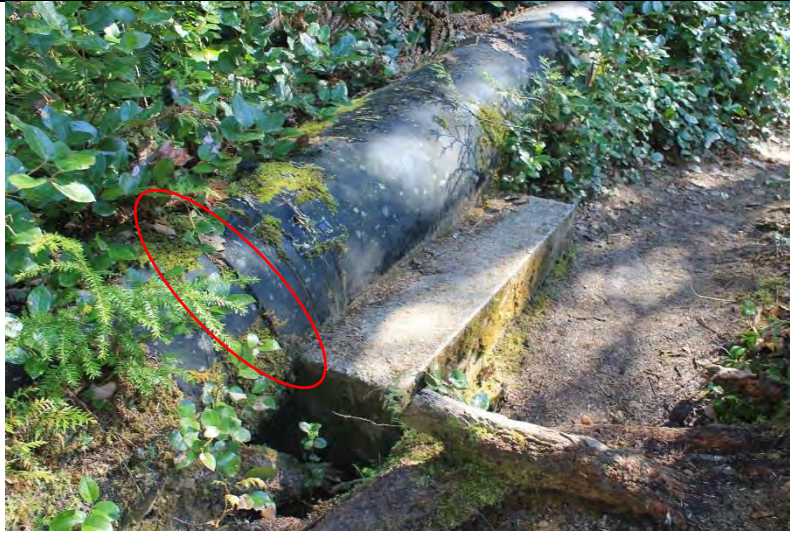
Close up view of the shallow concrete footing support. Note typical minor surface corrosion at the pipe joint between sections of protective jacket – no action required.

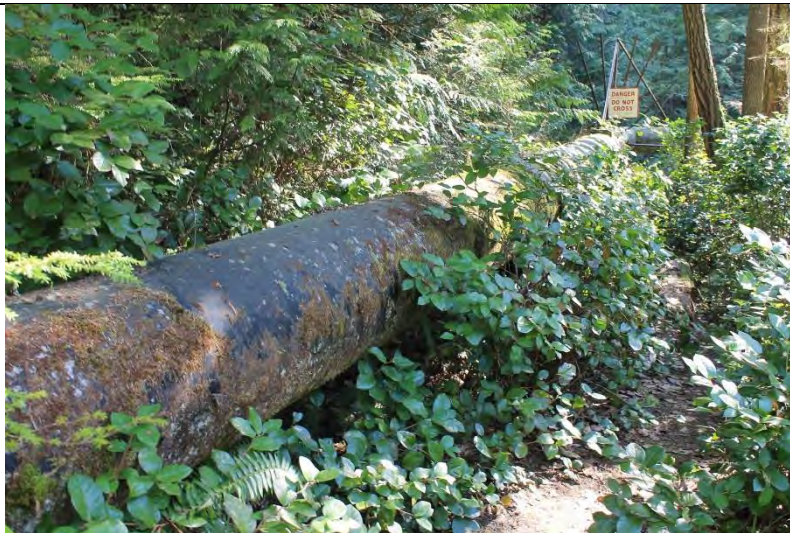
View of the water main where it rises above ground level on approach to the creek crossing. Water main is in a good condition where visible.

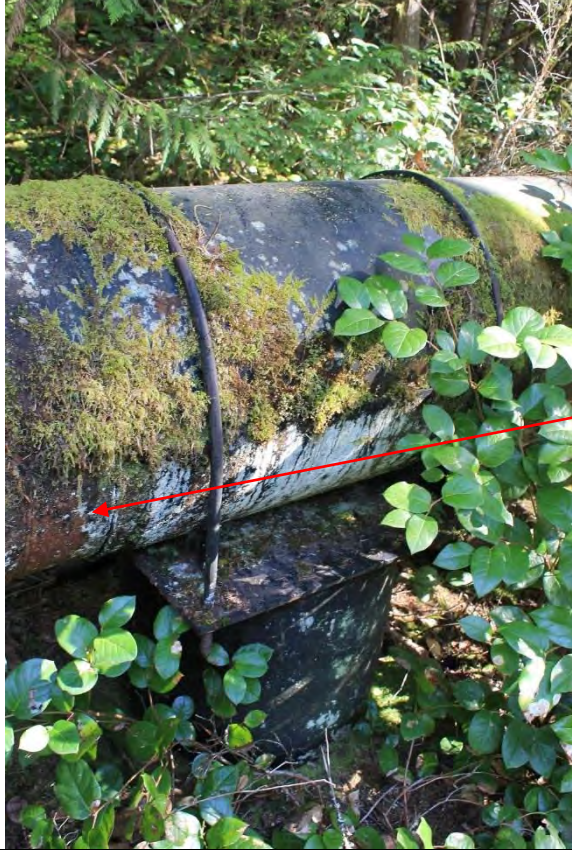
<p>View of the first water main support column on the western approach to the Chapman Creek crossing. Note the different support type to previous trestles with a pipe column, steel base plate, bearing plate and U-bolt connections.</p> <p>There is minor surface corrosion near the water main joint to the west of the support as seen in the following photograph.</p>

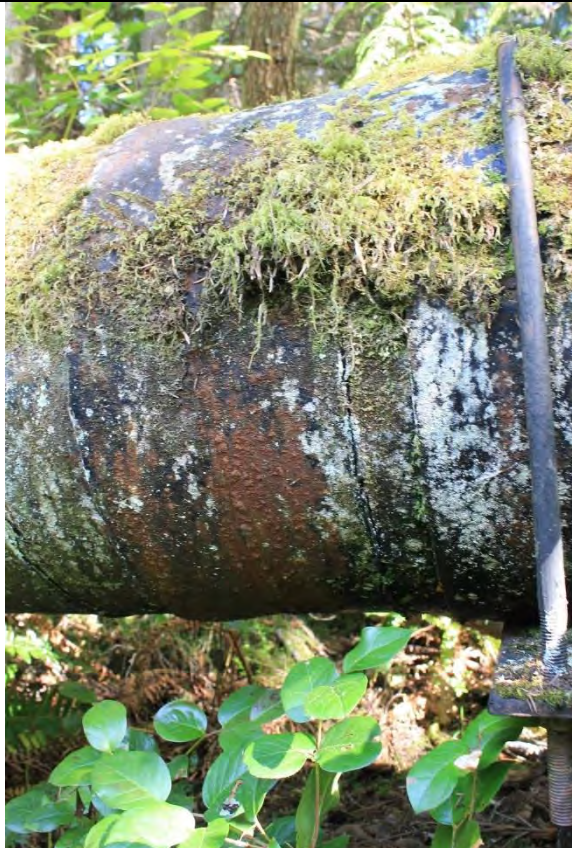
<p>Close up view of surface corrosion to the water main joint, isolated to the underside of the water main.</p> <p>It is recommended that this area is cleaned and painted within 36 months to limit further deterioration of this section of the water main.</p>

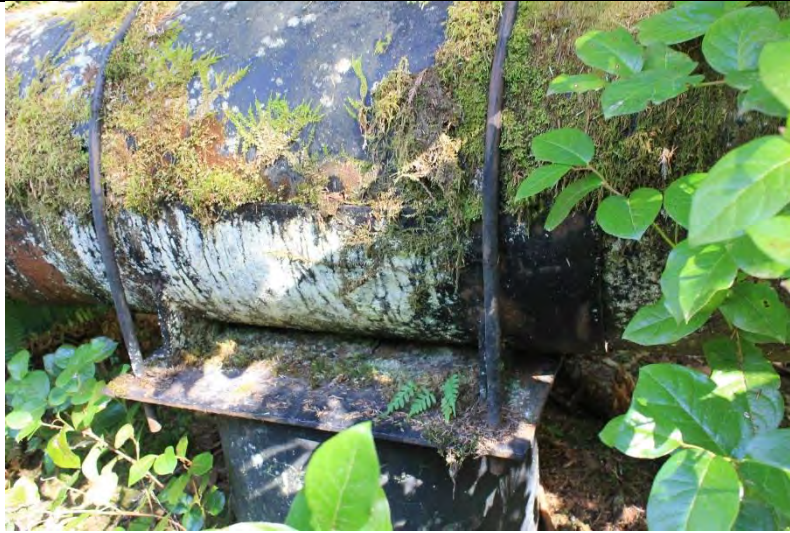
Close up view of the southern side of the support structure showing the base plate and U-bolt connections to be generally in good condition, with very minor surface corrosion to the plate edge. Monitor.

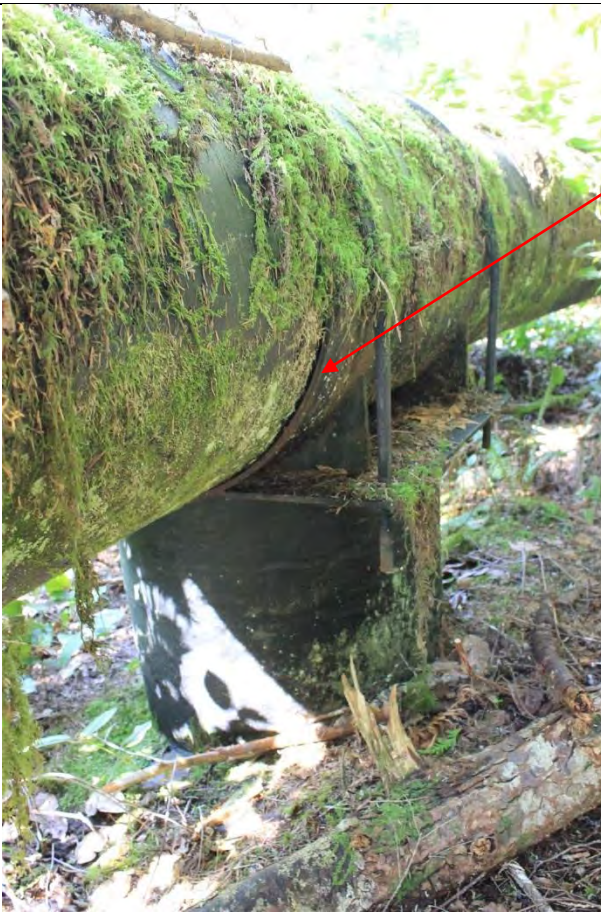
View of the northern side of the first water main support showing surface corrosion to the edge of the water main bearing plate. Monitor.

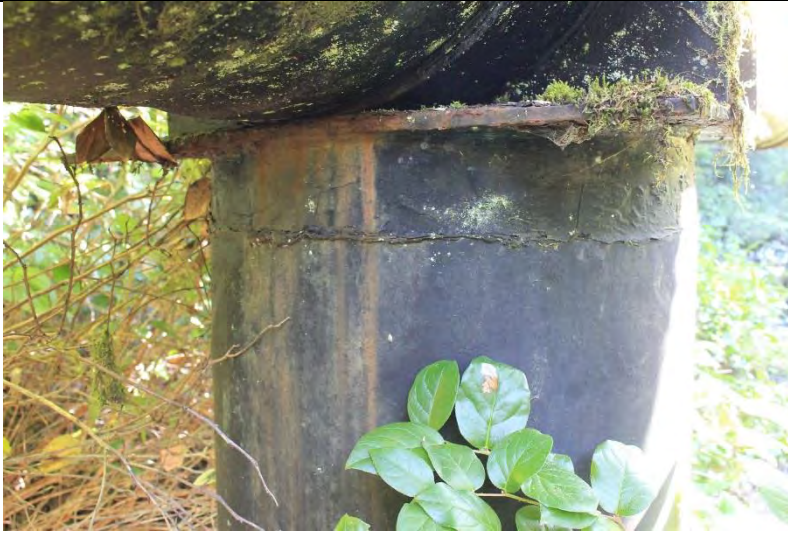
Close up view of the water main support column and base plate of the second support. The western edge of the base plate has minor surface corrosion, staining the face of the column. Monitor during future inspections.

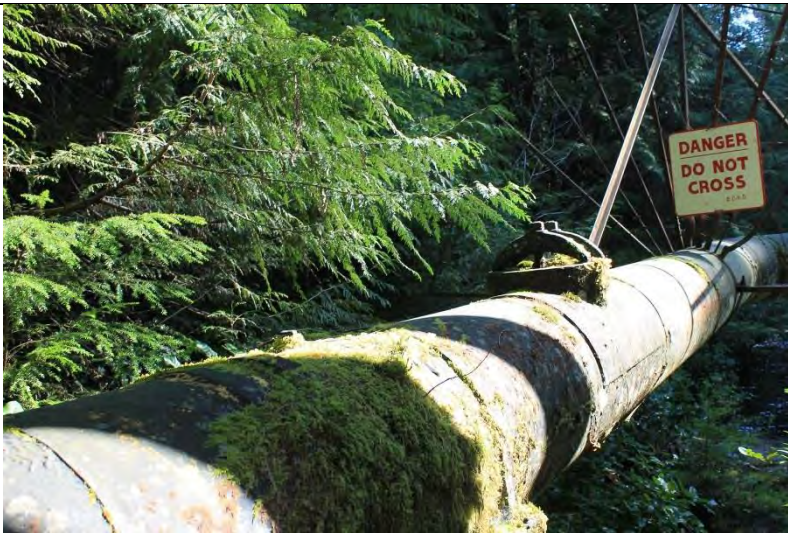
View of the water main on the western approach to the Chapman Creek crossing. Note the inspection hatch to the east of the second support.

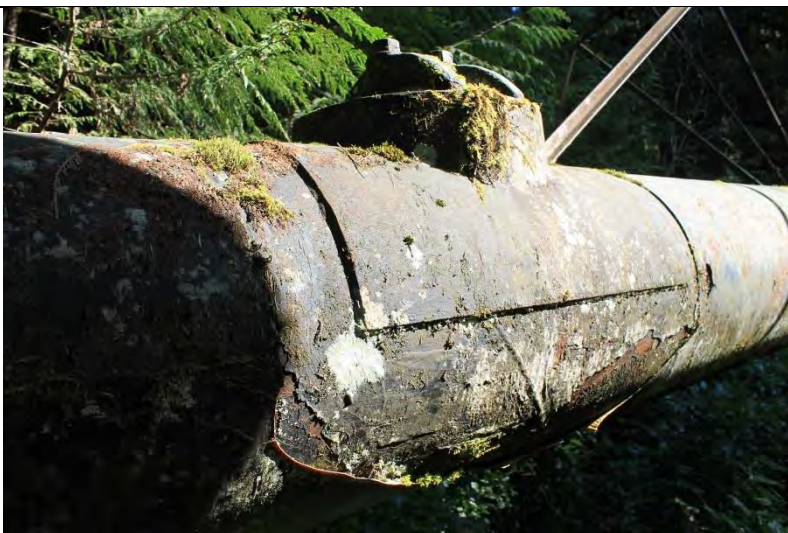
Close up view of the inspection hatch. Note the water main protective jacket has been shaped to accommodate the inspection hatch and has peeled away from the bottom half of the water main.

<p>Close up view of the area where the protective jacket has peeled away from the water main resulting in minor surface corrosion. The corrosion is not severe however it is recommended that the protective jacket and underlying section of water main is repaired within 24 months to limit further deterioration.</p>
 	<p>View of minor surface corrosion to the northern side of the water main below the inspection hatch. As per above recommendation for the southern side of the water main, repair protective jacket and underlying water main within 24 months to limit further deterioration.</p>

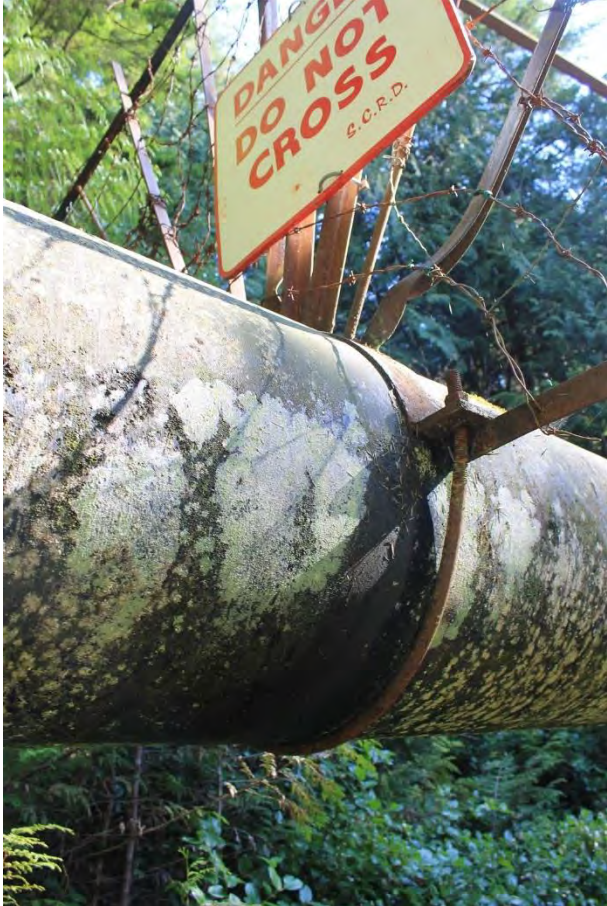
<p>View of the U-bolt and strap connection of the barbed wire climbing protection on approach to Chapman Creek. Note minor surface corrosion throughout however the barbed wire and posts remain sound and intact therefore no action required.</p>

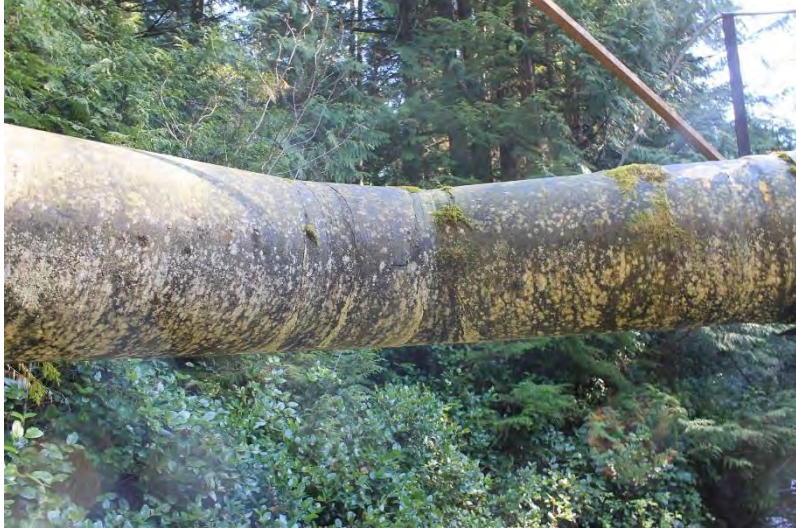
<p>View of the inside section of the elbow joint where the water main approaches Chapman Creek on the northern embankment. This section is in good condition.</p>

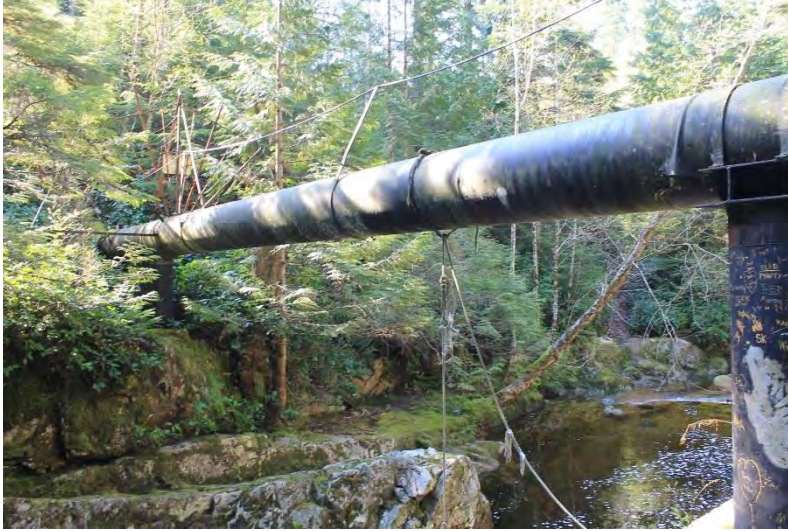
General view of the Chapman Creek crossing portion of the water main. The southern portion of the structure was inaccessible but from available vantage points appeared to be in a similar condition to the remainder of the water main.

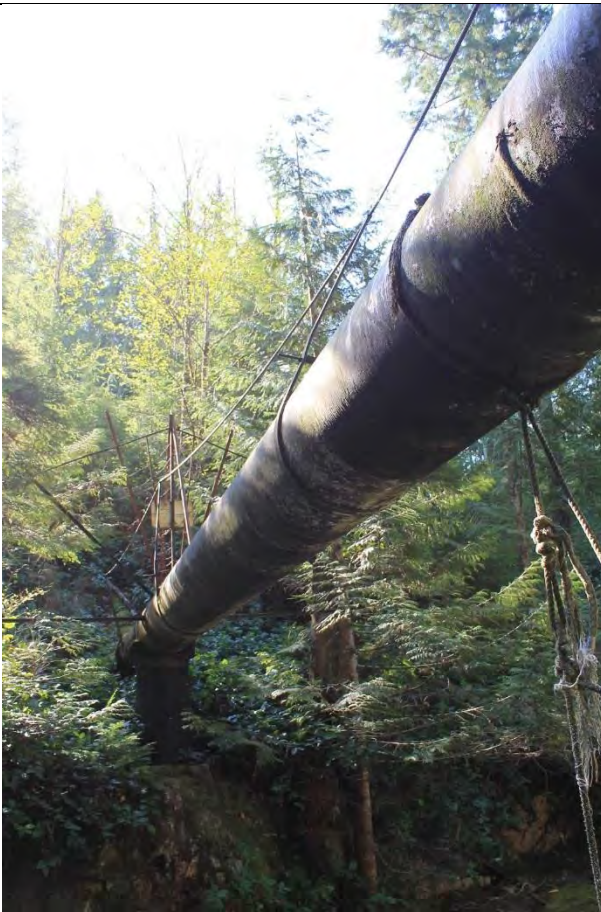
General view of the underside of the water main where it crosses Chapman Creek showing it to be in a good condition.

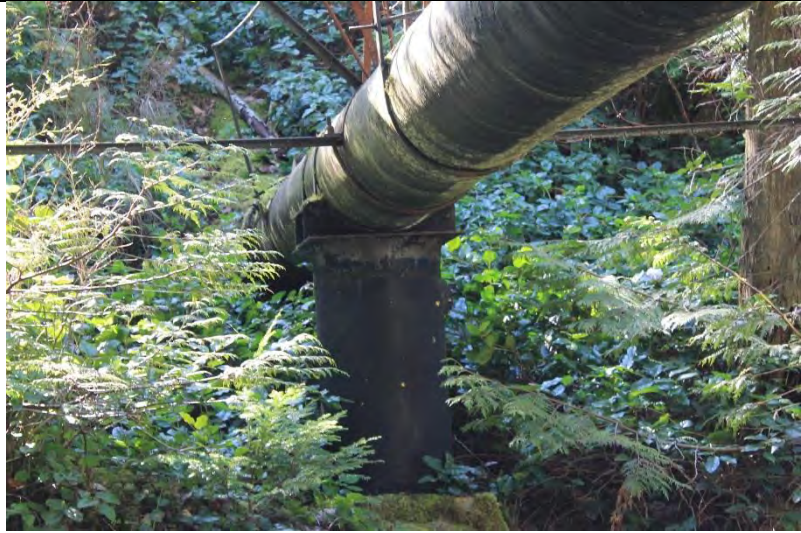
<p>View of the water main and support above the southern stream embankment, as viewed from the northern embankment. Note surface corrosion is visible to the support base plate and climbing protection straps but this appears to be minor.</p>
------------------------------------------------------------------------------------	--------------------------------------------------------------------------------------------------------------------------------------------------------------------------------------------------------------------------------------------------

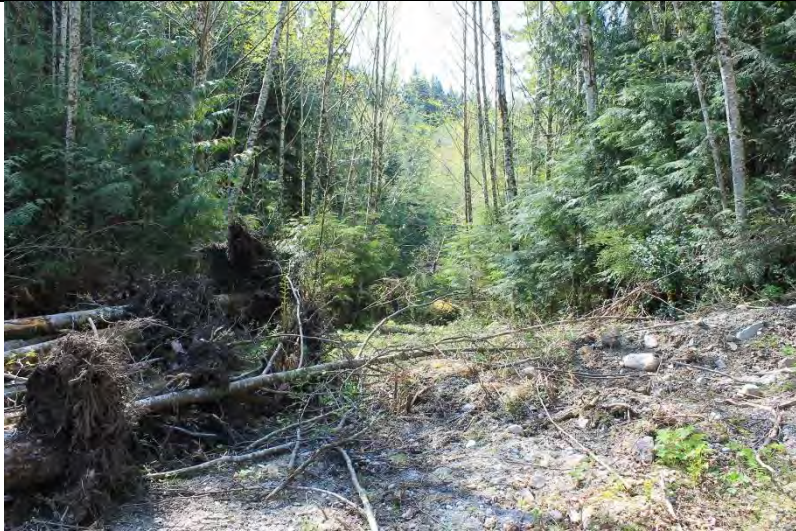
<p>General view of the north-eastern approach to the structure which is partially blocked by fallen trees.</p>
