# Sunshine Coast Regional District

# Request for Proposal

**Number: 2337009**

## **Exposed Watermain Rehabilitation**

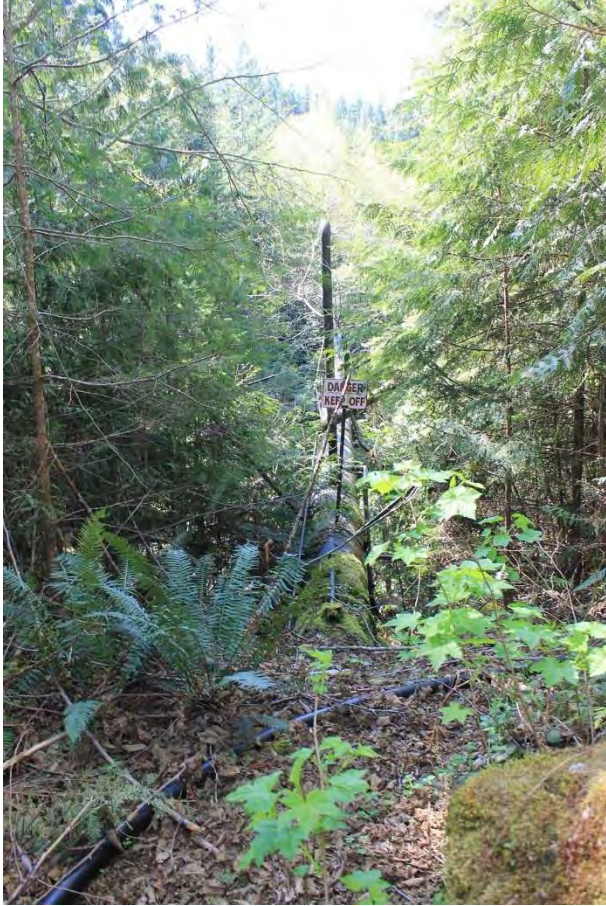
<p>General view of the north-eastern end of the water main where it meets the northern Chapman Creek embankment.</p> <p>Note access to this structure for inspection and maintenance of the water main and supports is extremely difficult therefore a detailed close quarters inspection using specialist access techniques is recommended to get a clearer understanding of the defects and risks to this structure.</p>

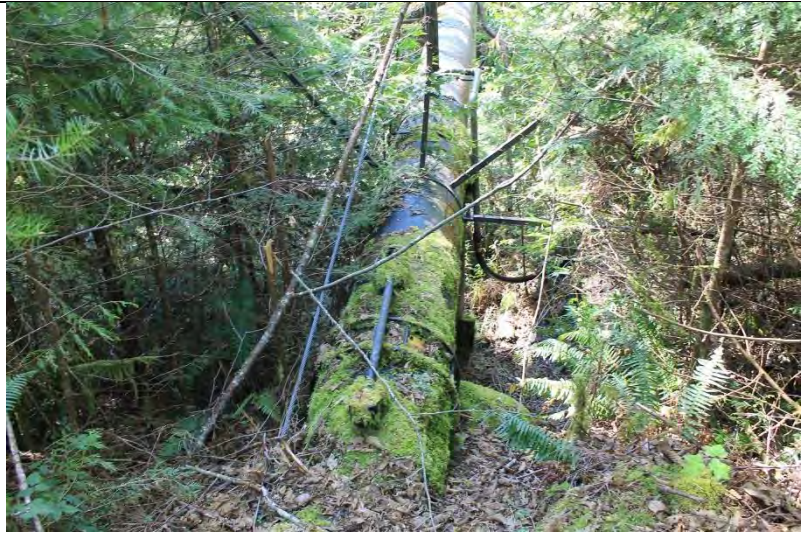
<p>Close up view of the north-eastern end of the water main where it meets the embankment. Note the expansion joint and linkage bar are in a good condition.</p>

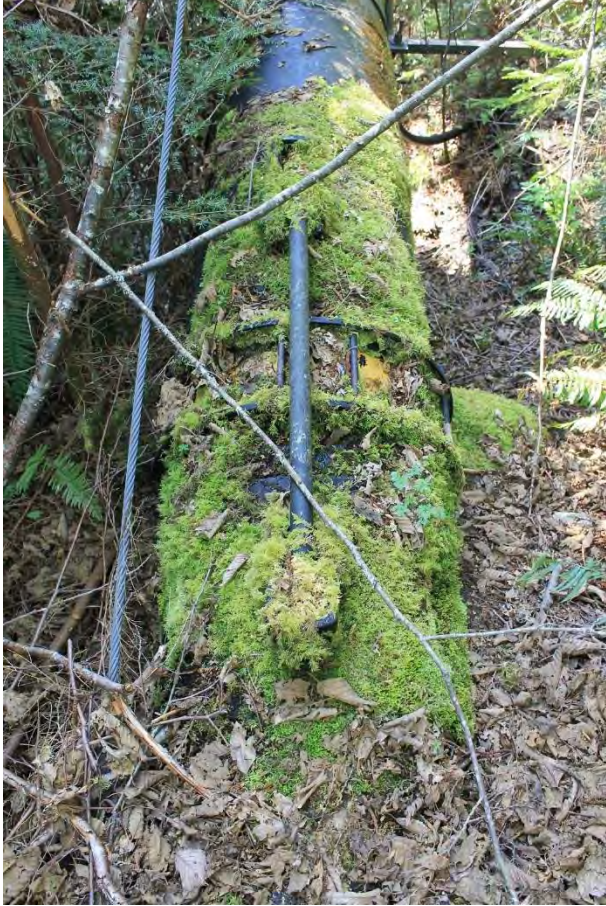
<p>Further view of the expansion joint and linkage bar at the north-eastern end of the water main showing all components to be in a good condition.</p>

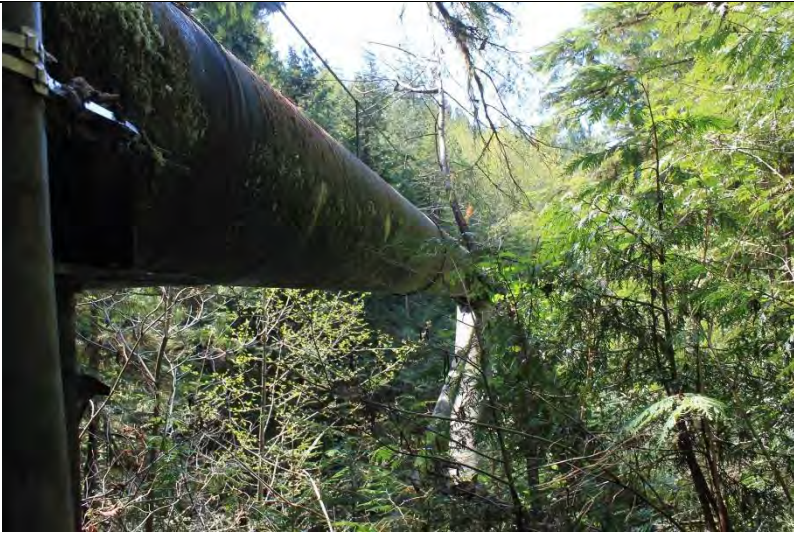
<p>General view of the water main from the northern embankment showing it to be in a good condition where visible.</p>

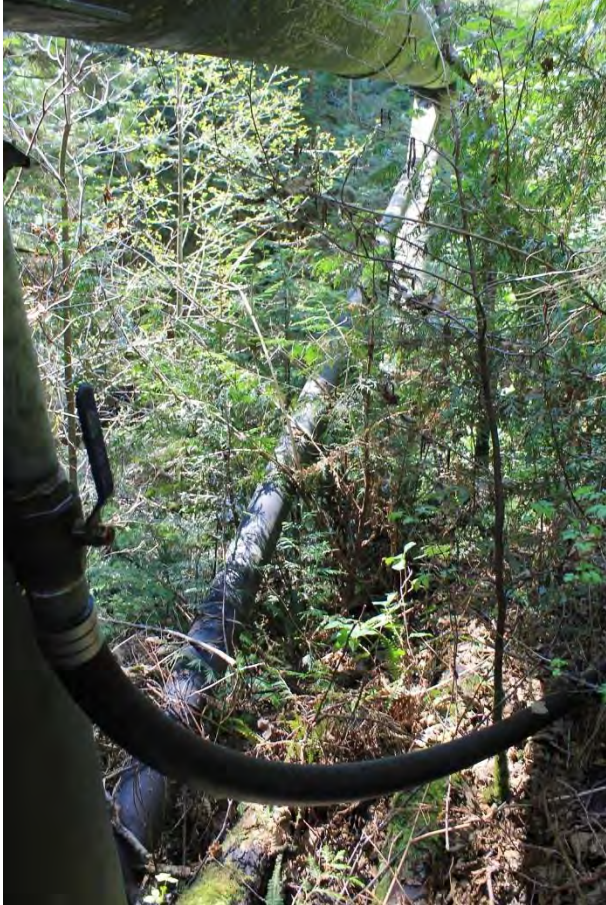
<p>View of the lower support/bracing member which is in a good condition where visible.</p>

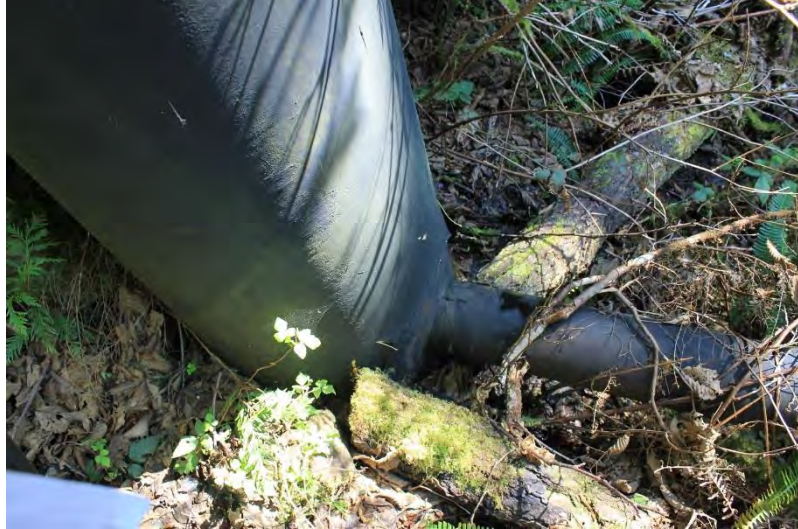
<p>View of the connection between the lower support/bracing member and the north-eastern support column showing it to be in a good condition with very minor surface corrosion to the support column.</p>

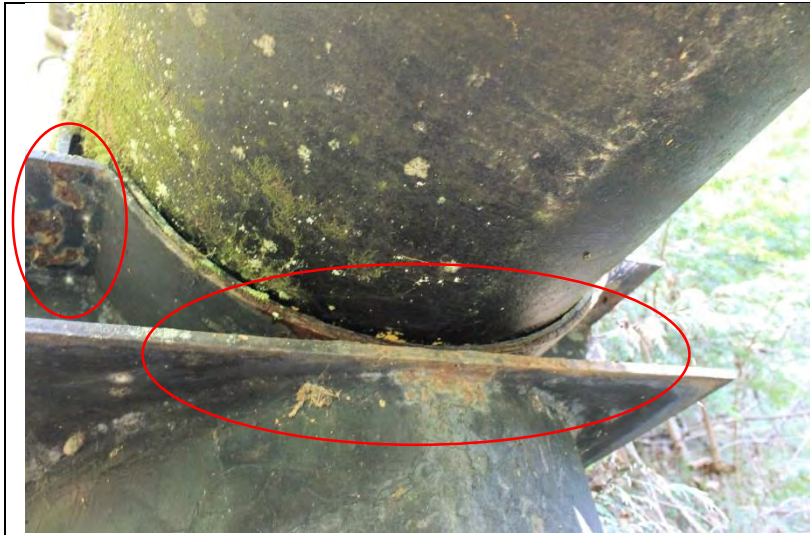
View of the top of the north-eastern support where it meets the water main, showing minor surface corrosion to the support structure. Monitor during future inspections.

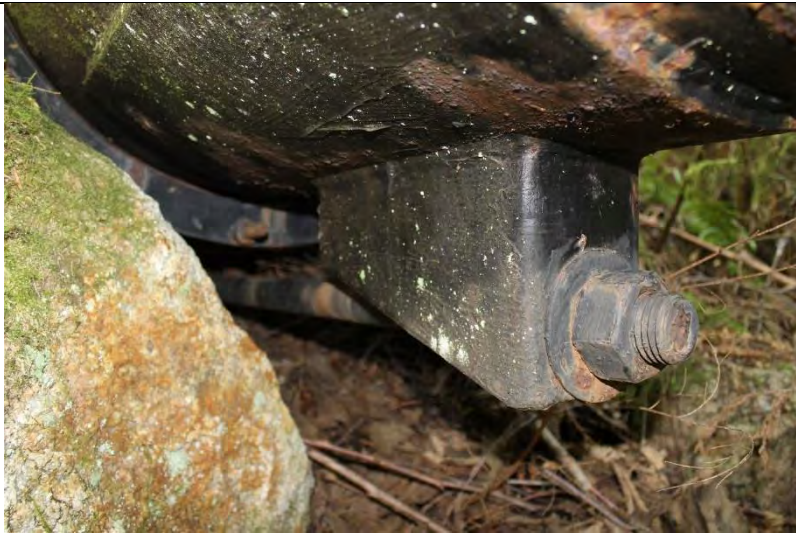
<p>Close up view of the surface corrosion to the linkage bar and plate to the underside of the water main at the north-eastern end. Monitor during future inspections.</p>

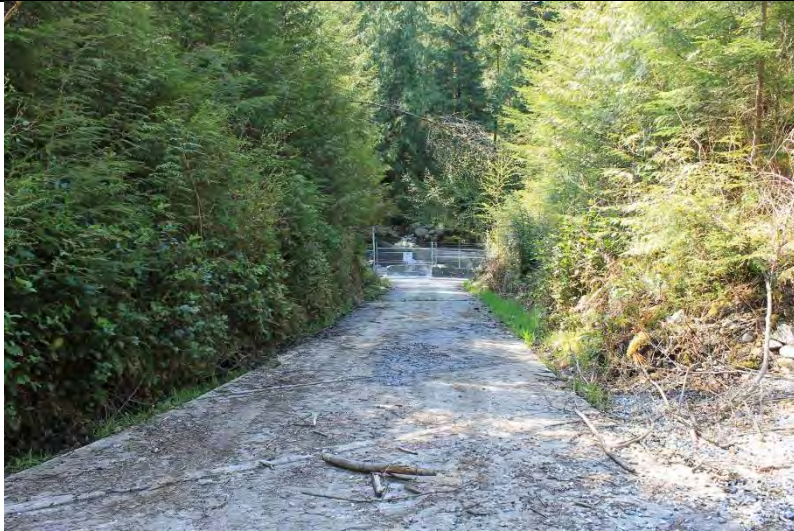
<p>General view of the approach to the inlet structure at the eastern end of the Chapman Creek water main crossing.</p> <p>Note the very steep approach with no landing area or turning bay at the bottom.</p>

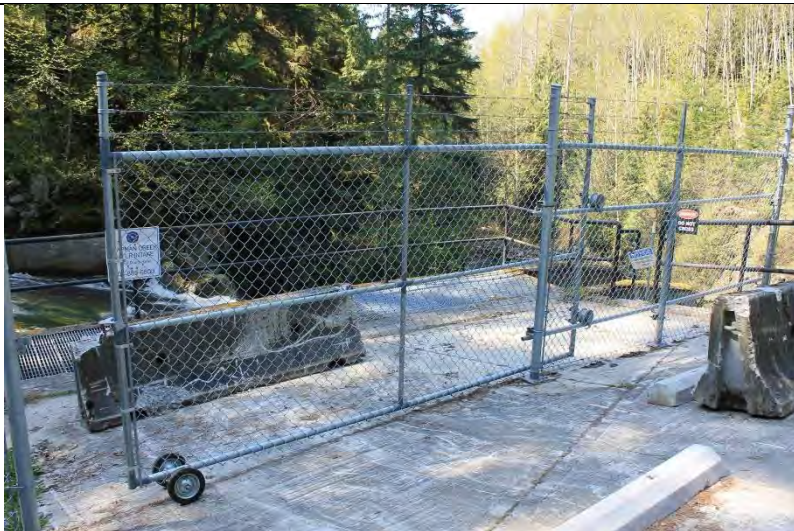
<p>View of the top of the intake structure protected by a gate and fences.</p>

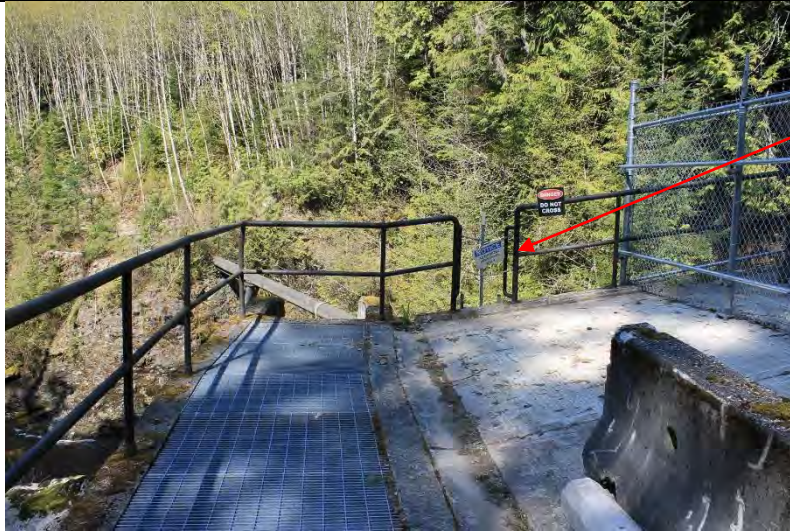
General view of the approach to the eastern end of the water main crossing structure from above the intake, with access via ladder.

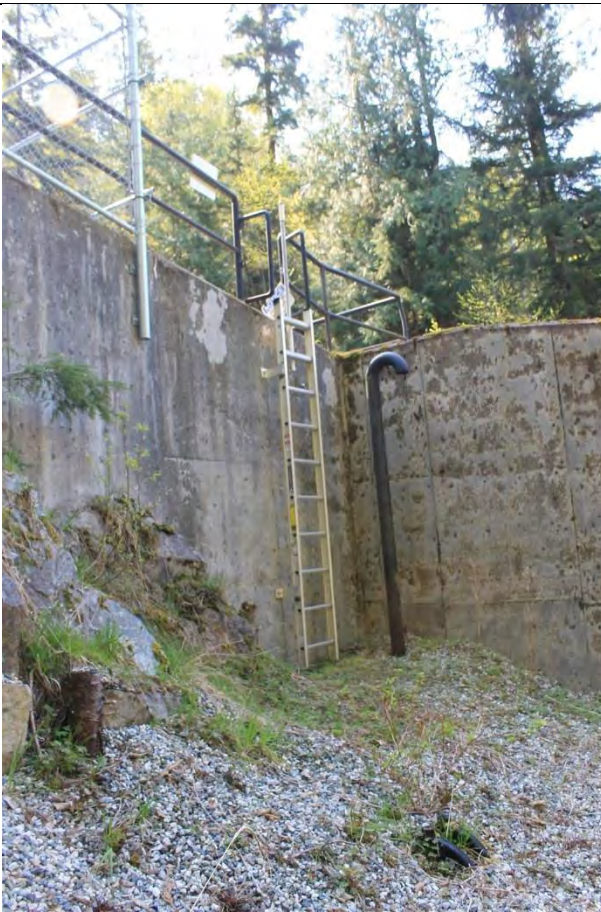
View of the ladder access to the eastern end of the water main structure.

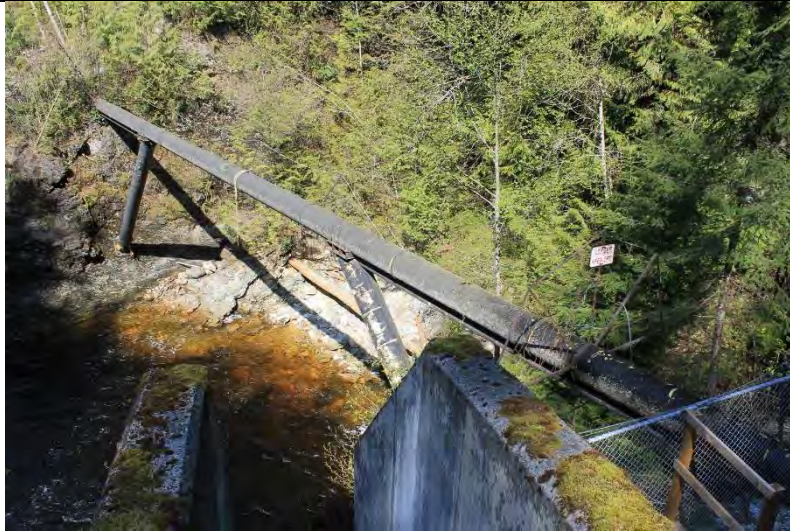
General view of the water main structure from above the intake structure at the eastern end embankment.

Note access for inspection and maintenance of the water main and supports is extremely difficult.

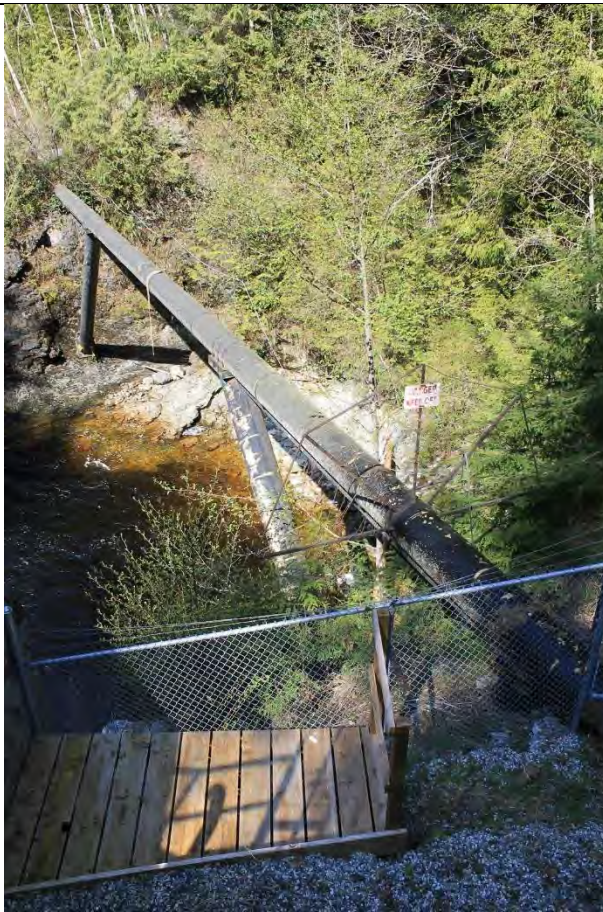
General view of the water main from the intake structure at the top of the previously shown access ladder.

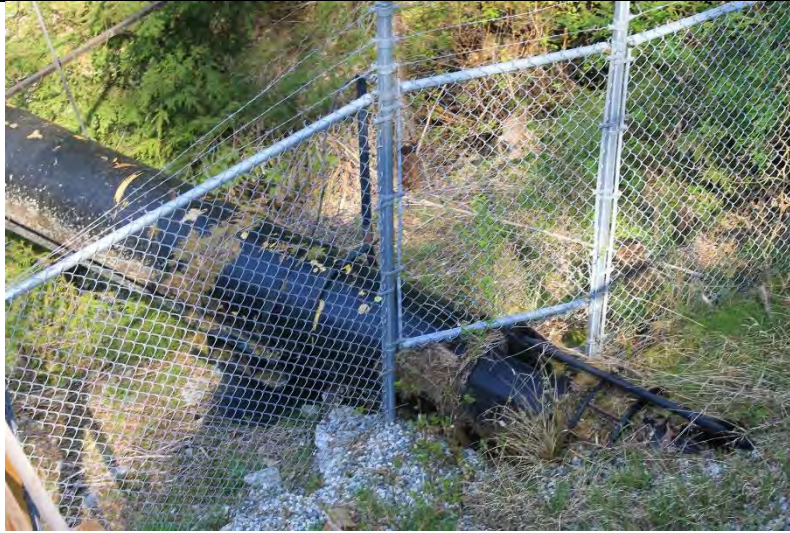
General view of the eastern end of the exposed water main where it meets the stream embankment.

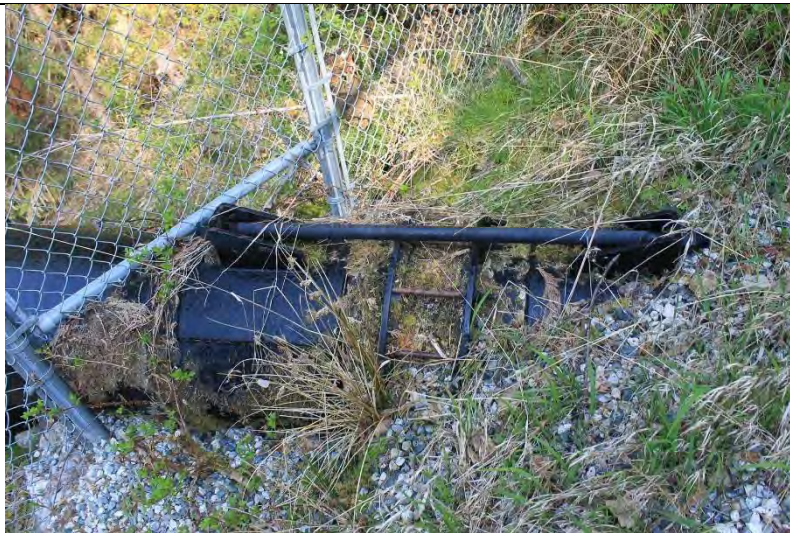
Close up view of the expansion joint and linkage bar at the eastern end of the exposed water main. Note the majority of components are in a good condition, with minor surface corrosion to the bolted connection between the pipe sections at the joint. Monitor during future inspections.

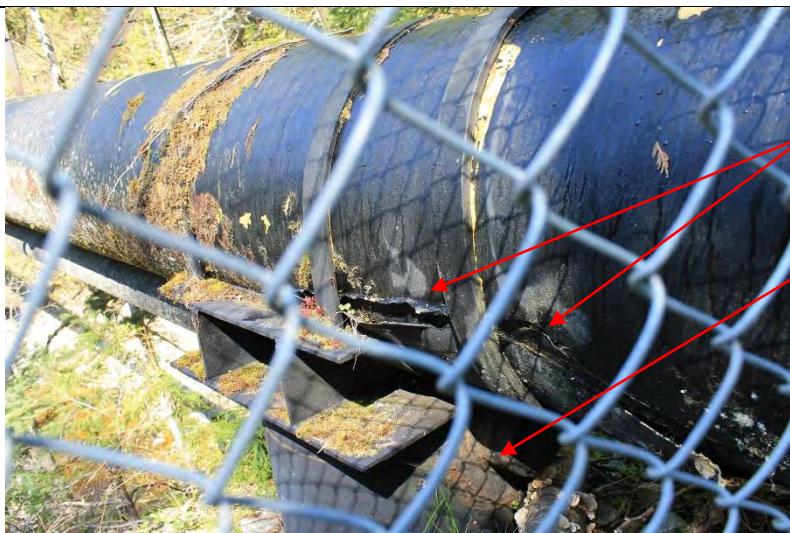
View of the connection between the eastern-most support and water main. Note the significant tear in the water main protective jacket and surface corrosion to the connection between the raked pile support and longitudinal support member.

A detailed close quarters inspection is recommended to get a clearer understanding of the defects and risks to this structure.

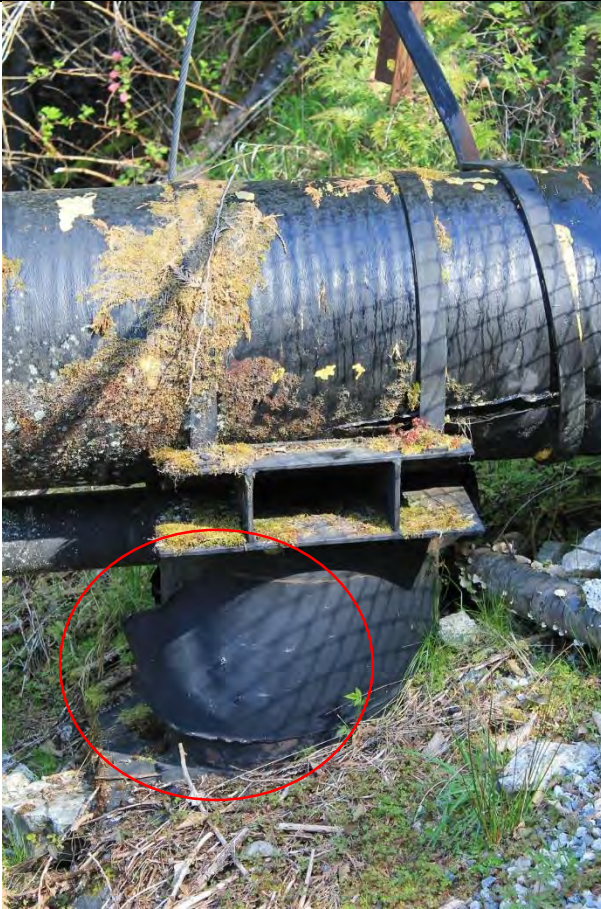
Further view of the eastern-most water main support showing the tear in the protective jacket and further peeling of the jacket to the western side of the support column.

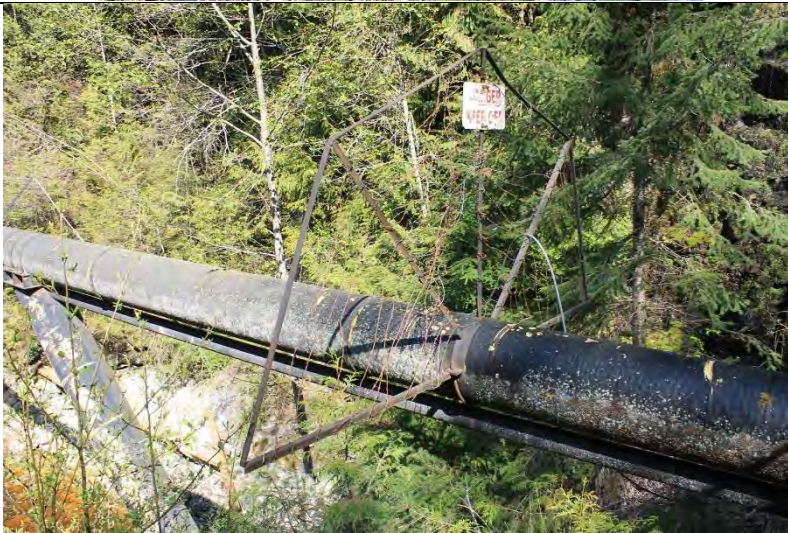
View of the original climbing protection to the water main which is in a serviceable condition. Note this combined with the more recent security fencing at each end provide an adequate barrier to the public.

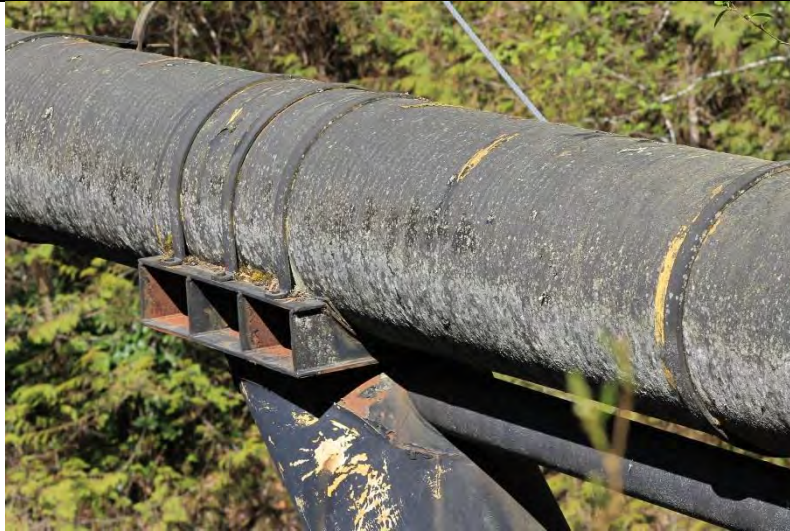
View of the eastern main support of the water main structure showing minor surface corrosion to the top of the raked support pile and base plate structure. Minor abrasion of the water main protective jacket is also visible in isolated areas.

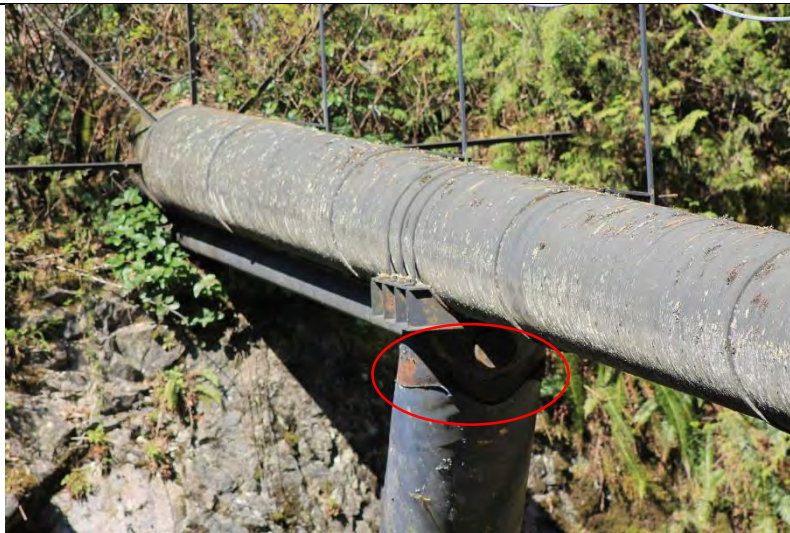
General view of the top connection of the western water main support showing inconsistencies in the protective jacket and minor surface corrosion.

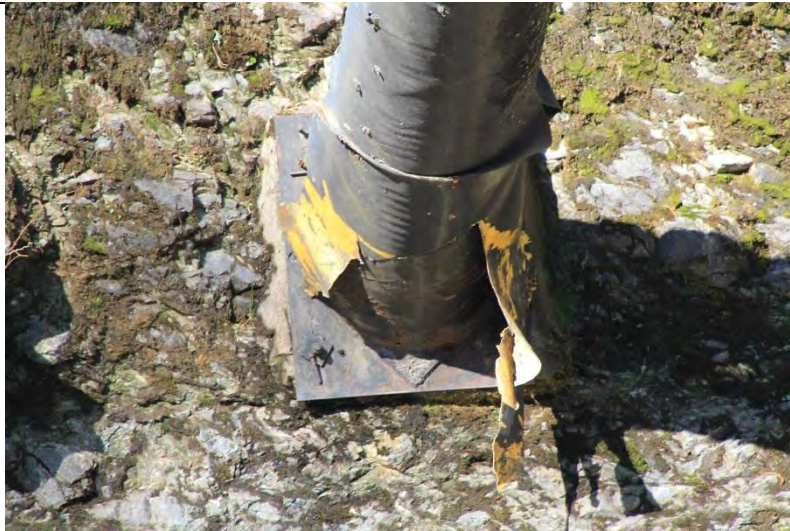
View of the base connection of the western raked support column showing tearing of the protective jacket and surface corrosion to the exposed areas.

Note this support is potentially submerged in water during high flows.

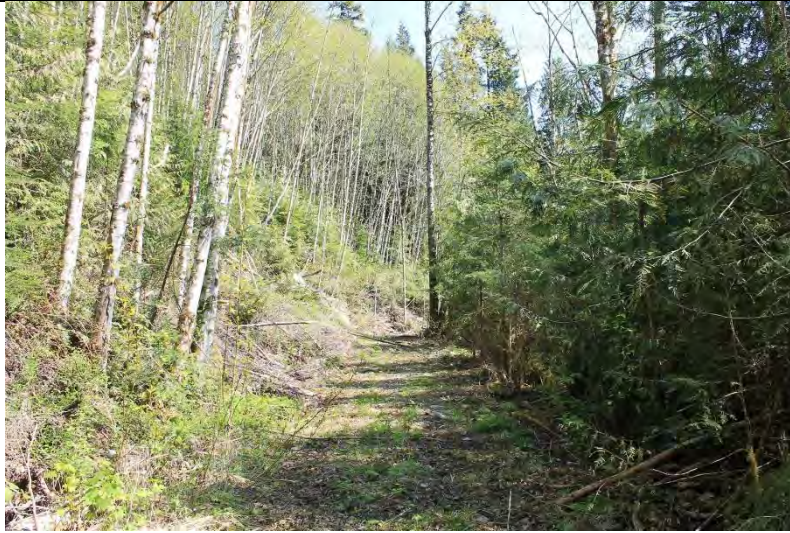
General view of the approach to the western end of the water main structure.

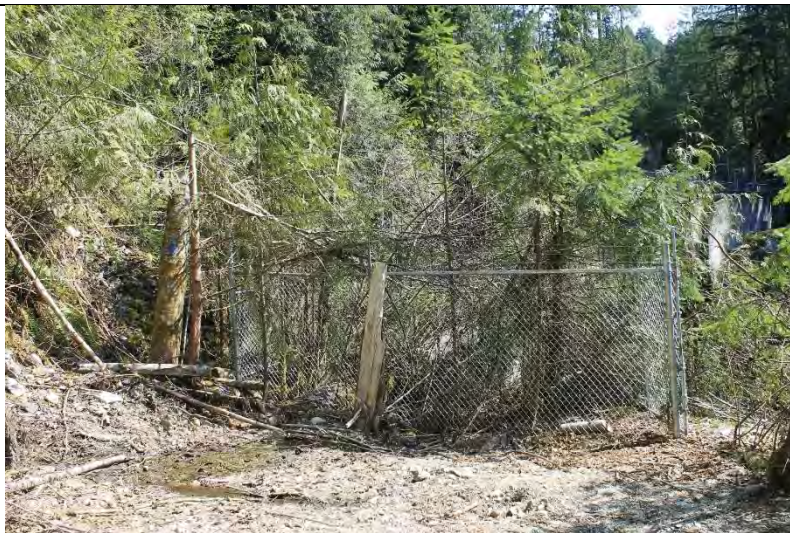
View of security fencing protecting the western end of the water main structure and preventing public access.

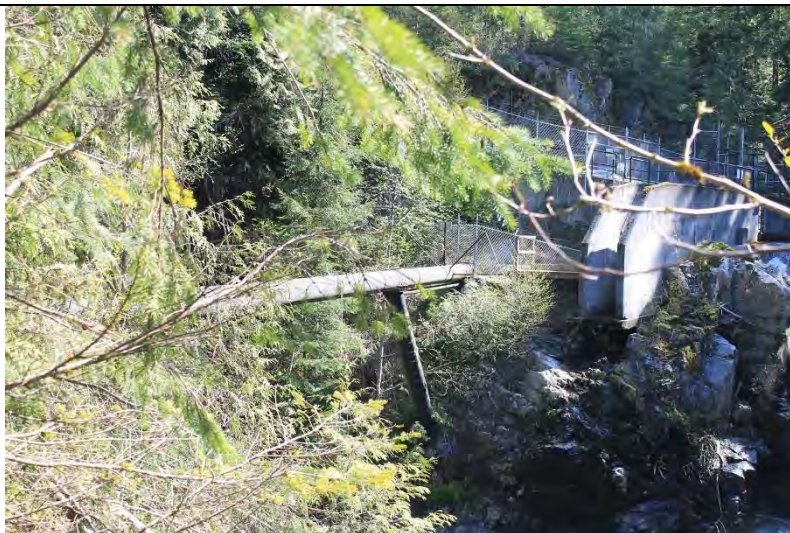
General view of the eastern end of the water main from the western embankment.

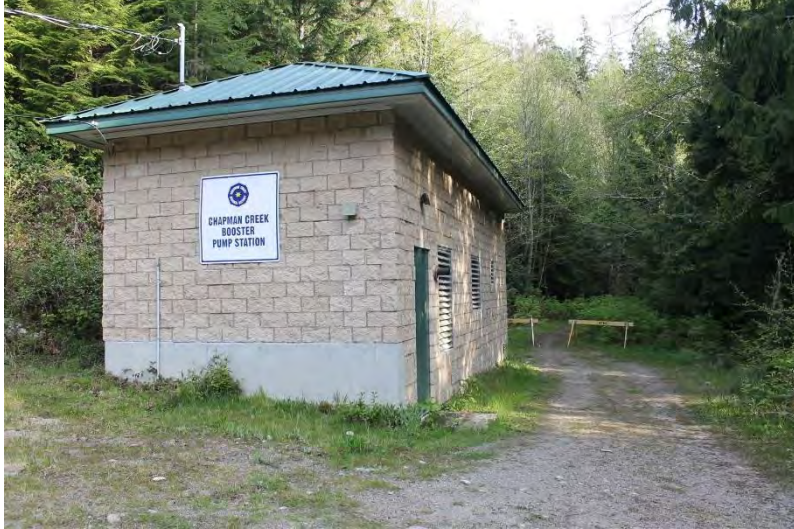
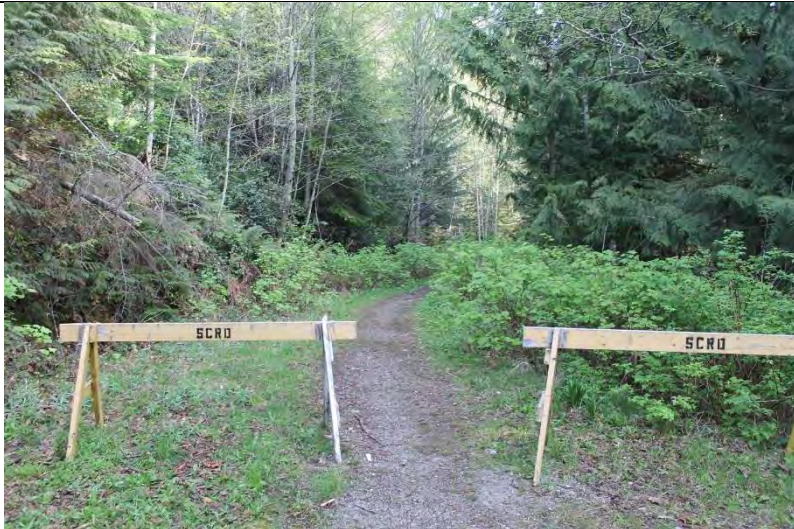
<p>General view of the trail/maintenance track access from Reservoir Road, adjacent to the Chapman Creek Booster pump station.</p> <p>View of the partially overgrown access trail to the trestle and water main. The trail is serviceable for pedestrian access in its current state, although may require vegetation removal for maintenance vehicles.</p>

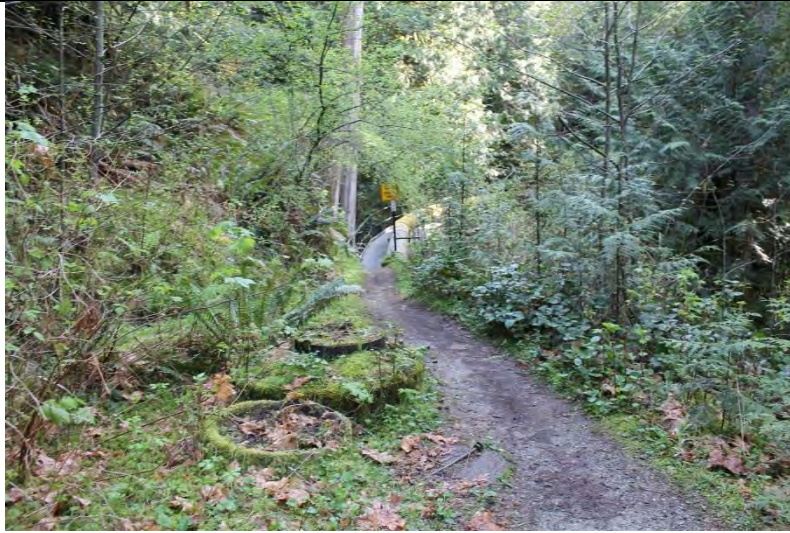
View of the approach to the trestle and water main looking east. Note man hole covers in foreground to buried water main.

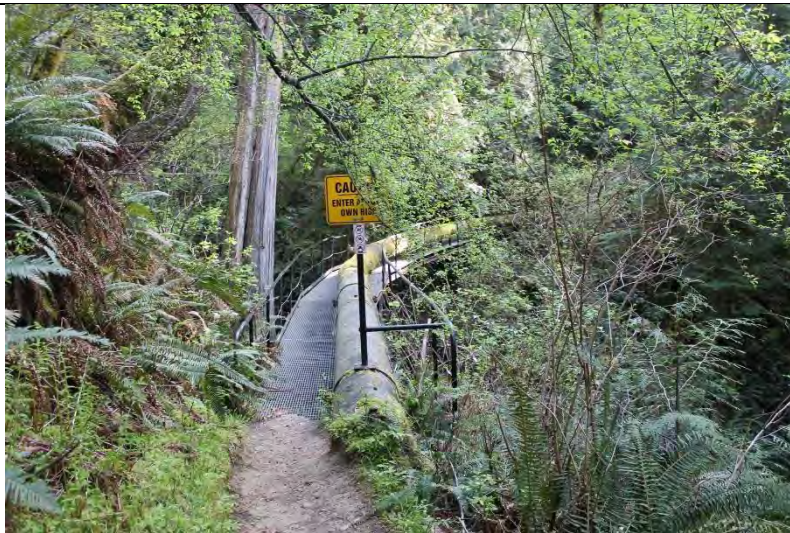
Further view of the approach to the trestle and water main looking east. Note partially obscured signage requiring vegetation removal.

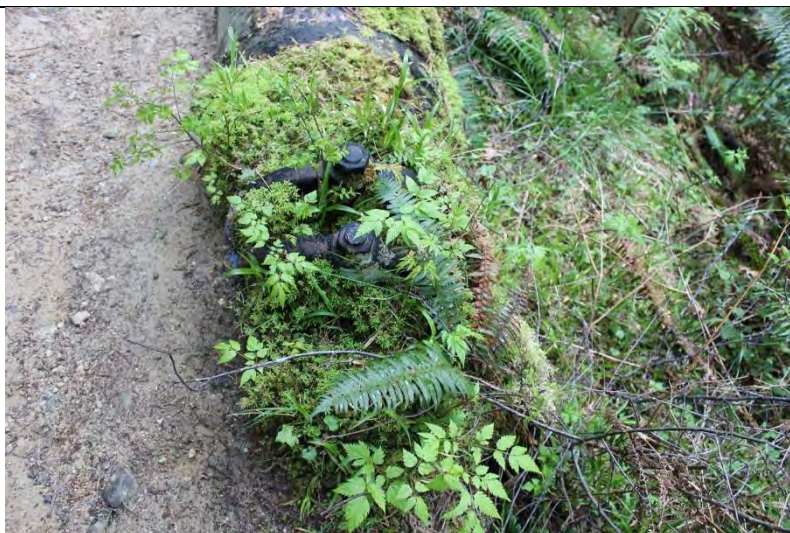
View of water main access cover at the western end of the exposed section. Note all visible steel in good condition with very minor surface corrosion.

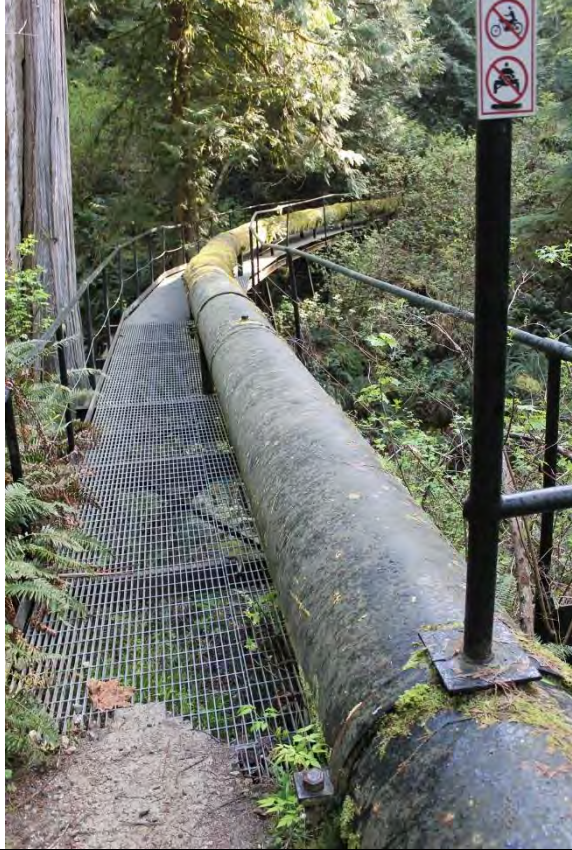
<p>View along the water main and trestle structure looking to the east. Note the floor grating and handrails are intact and in good condition.</p>

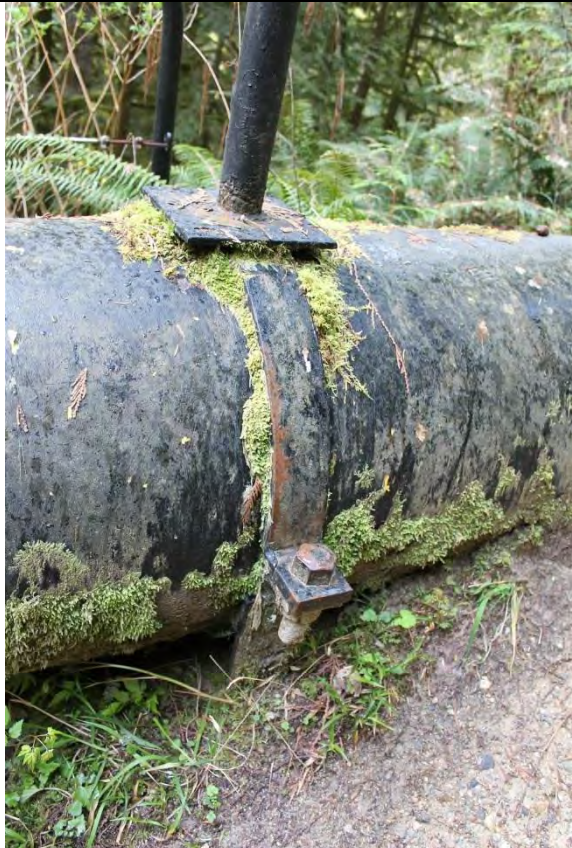
<p>View of the western-most water main support which is ground mounted (i.e. not on the trestle structure). The water main and support are in a good condition with minor surface corrosion to isolated areas of the support – monitor during future inspections.</p>

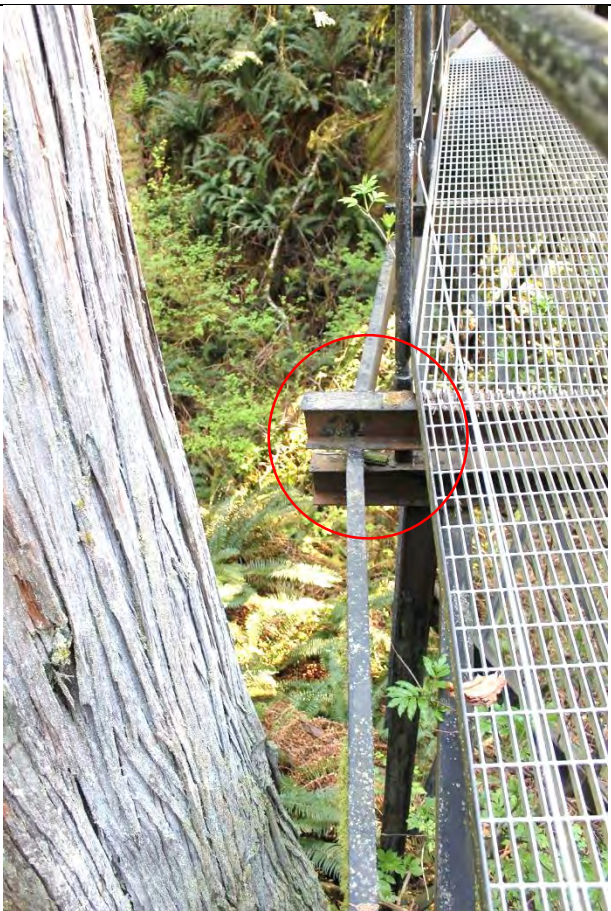
<p>View of minor surface corrosion to the transverse members at the second trestle from the western end. Monitor.</p>

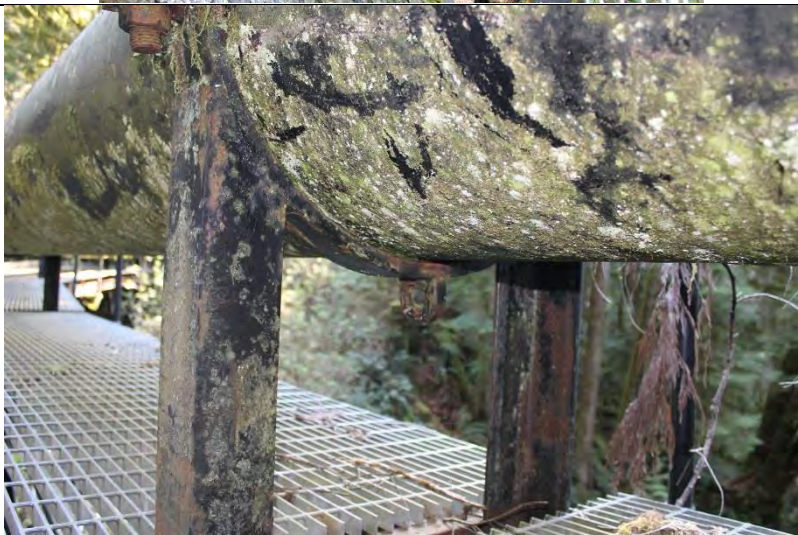
<p>View of the underside of the support showing very minor areas of surface corrosion to the support.</p>

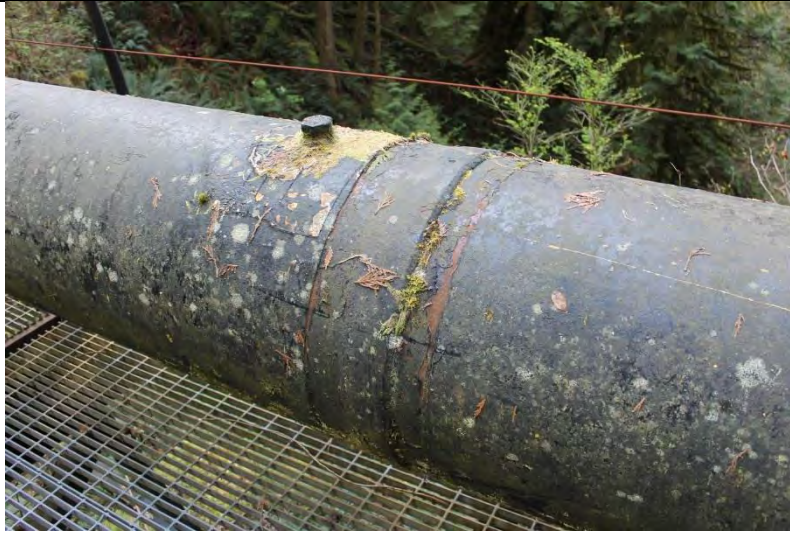
View of a water main joint near the first trestles from the western end. Note minor surface corrosion to the water main surface where the protective jacket has been removed near the joint. Monitor corrosion during next inspection.

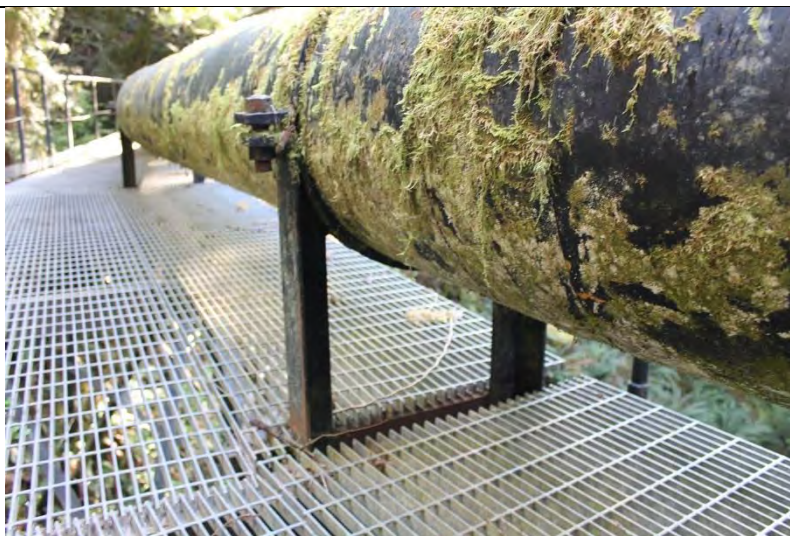
View of minor surface corrosion the third trestle from the western end of the exposed water main.

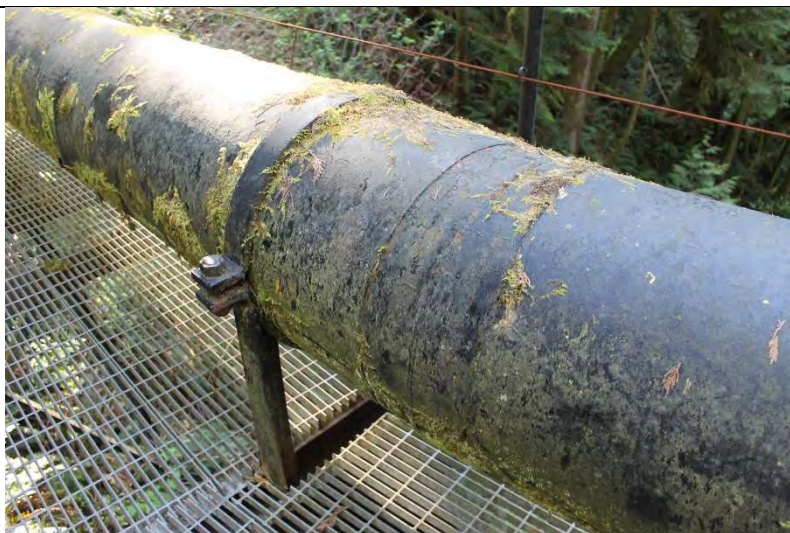
View of an elbow joint near the third trestle from the western end. Very minor surface corrosion is present where the protective jacket has been removed – no action required.

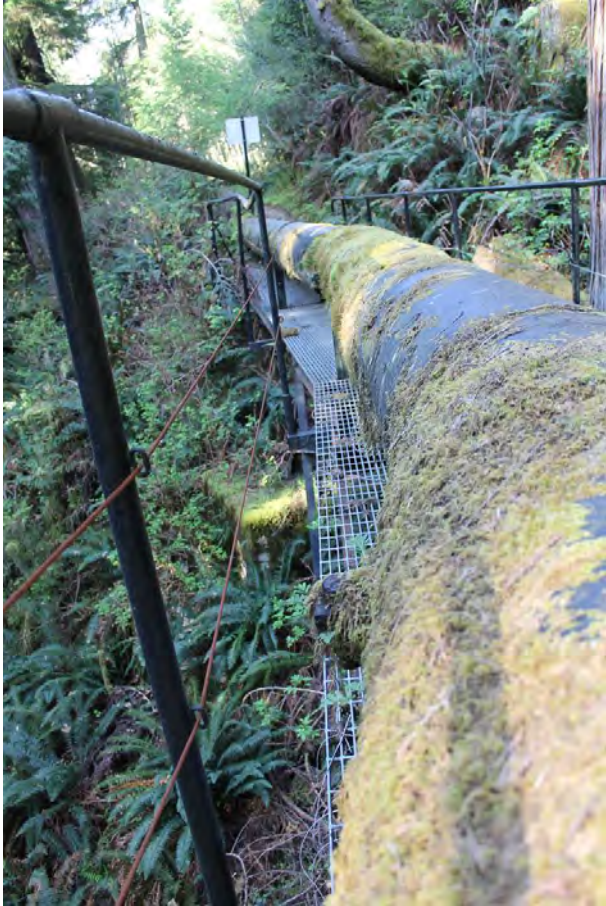
<p>View along the southern edge of the water main looking west showing the water main to be in a good condition.</p>

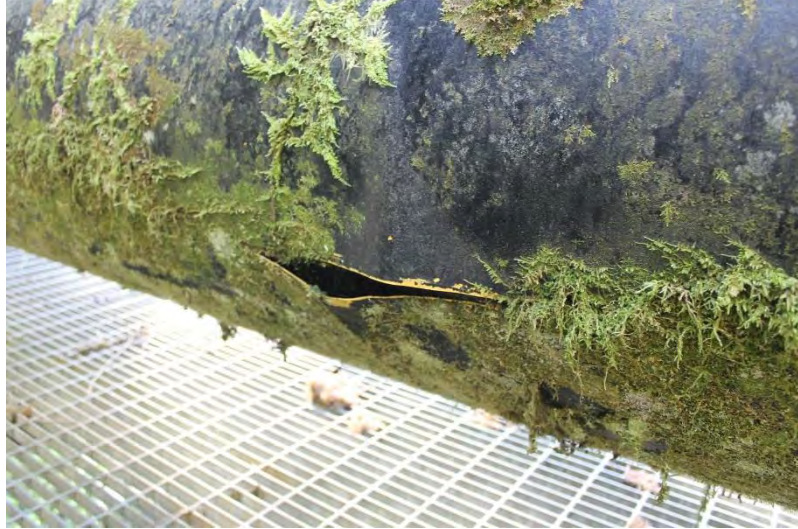
<p>View of a split in the water main protective jacket between the third and fourth trestle from the western end. This split has allowed water to pool against water main surface, promoting corrosion.</p> <p>It is recommended that a small section of the jacket around this split is removed, the underlying water main surface cleaned of corrosion and repairs made with a suitable tape (e.g. Denso) within 24 months.</p>

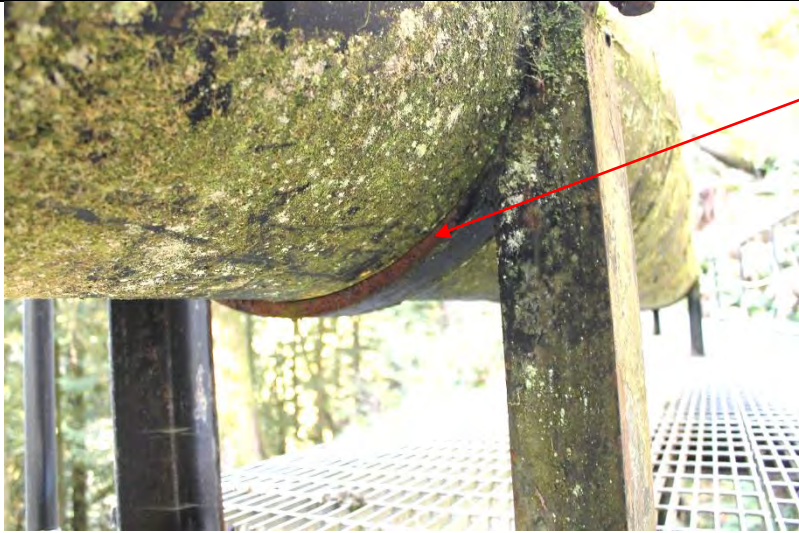
<p>View of the fourth trestle water main support looking west showing minor surface corrosion to the edge of the support band. Monitor.</p>

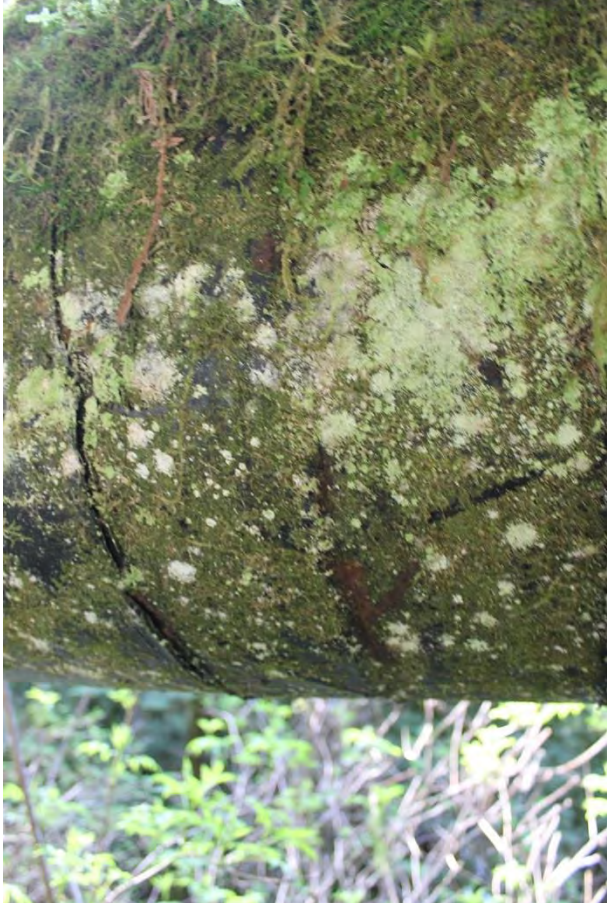
<p>View of minor surface corrosion to the underside water main at the joint between the fourth and fifth trestle. Monitor.</p>

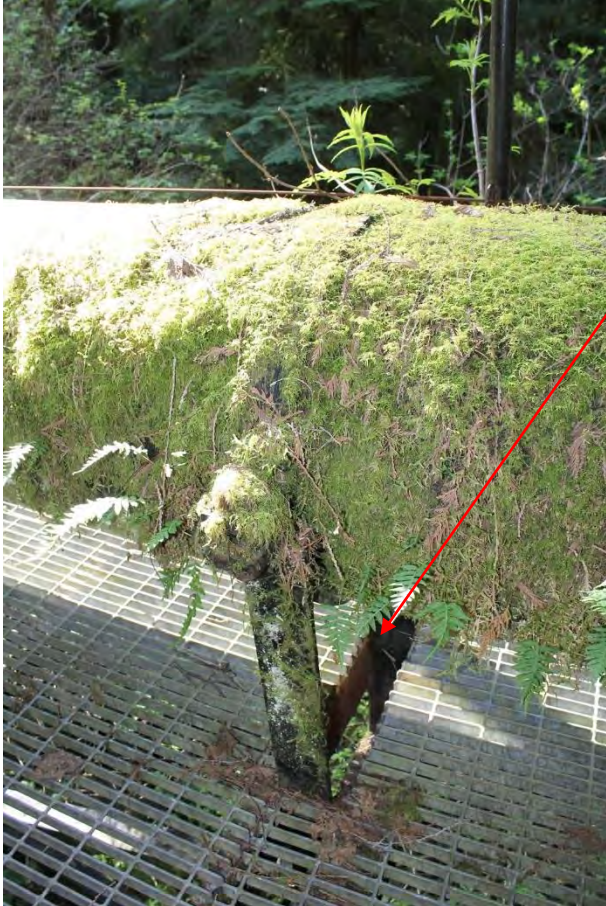
<p>View of the fifth trestle water main support showing heavy vegetation coverage and minor surface corrosion to the support structure.</p>

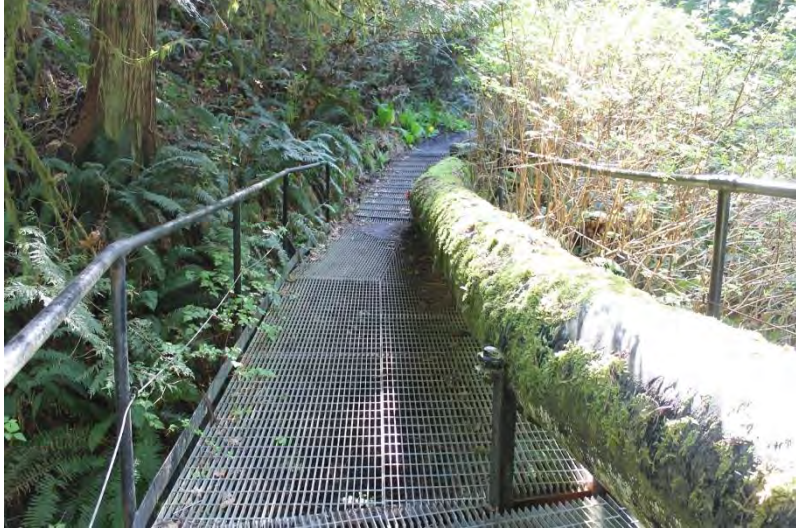
<p>General view from the sixth trestle to the eastern end of the exposed water main.</p>

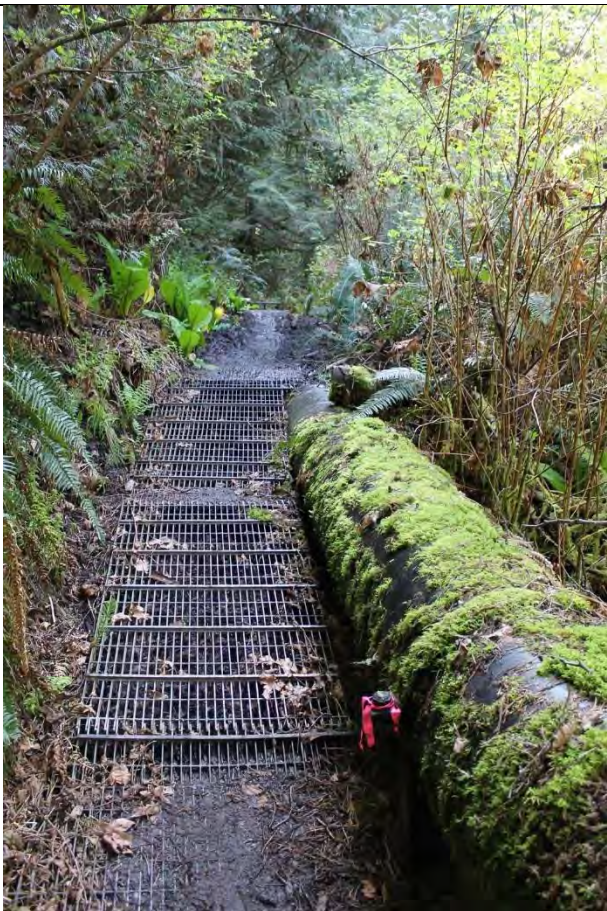
<p>View of the eastern end of the exposed water main showing it to be in a good condition.</p>
--	------------------------------------------------------------------------------------	------------------------------------------------------------------------------------------------

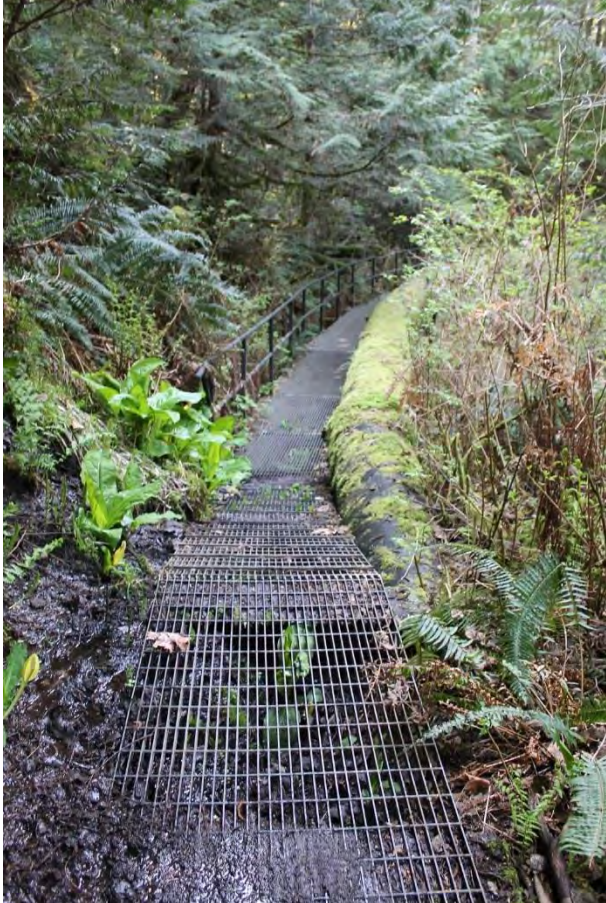
<p>General view of the water main and trestle structure from the western end looking east.</p> </div>
