# Sunshine Coast Regional District

# Request for Proposal

**Number: 2337009**

## **Exposed Watermain Rehabilitation**

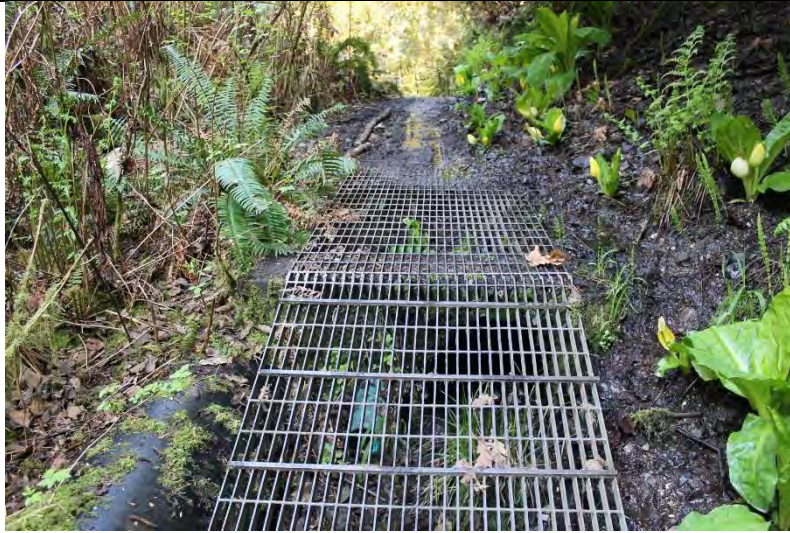
View of the steel grating ramp to the western approach supported on a shallow concrete footing, all of which are in a good condition. Note the partially buried western end of the water main to the left hand side of the photograph.

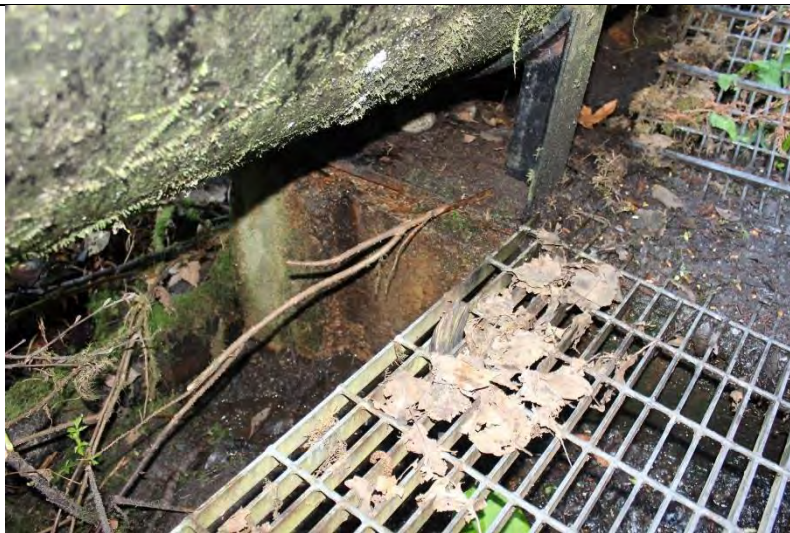
View of the first ground mounted support at the western end of the structure. Note staining is apparent to the face of the concrete footing due to surface corrosion to the steel base plate. Monitor during future inspections.

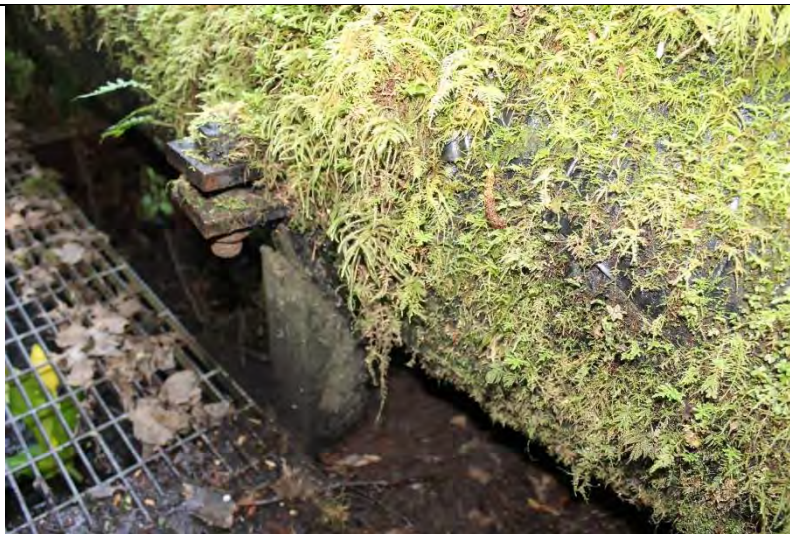
Further view of the ground mounted support showing the fixtures and support post to be in good condition, with minor surface corrosion to the bolted connection.

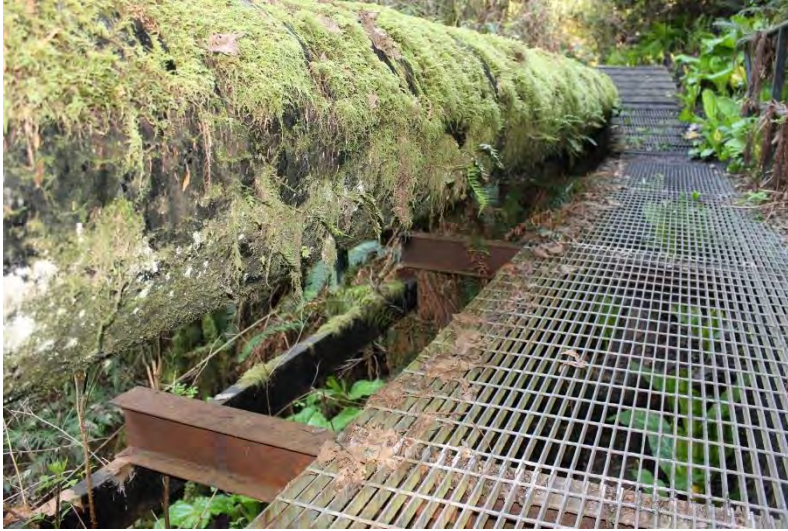
View from the first trestle looking west showing minor surface corrosion to the transverse support members. This level of surface corrosion is present to all transverse support members throughout the structure. Monitor during future inspections.

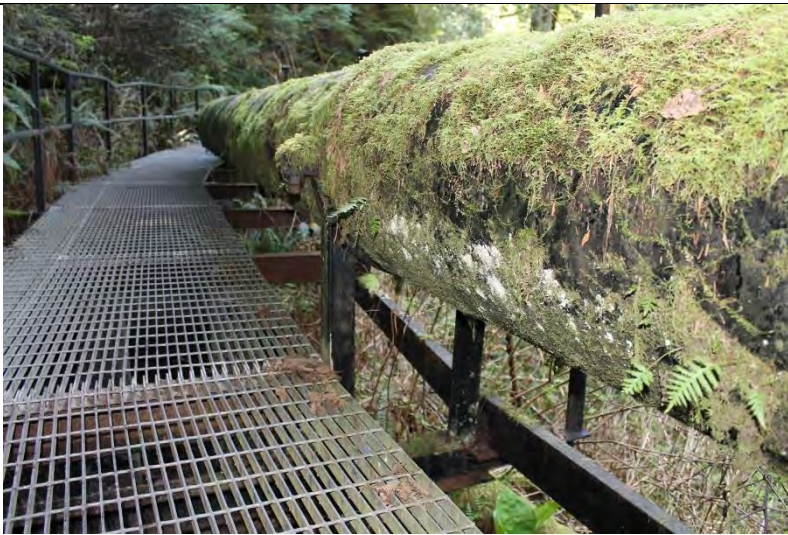
View of the first trestle water main support looking east. The support and visible areas of the trestle are in a good condition with minor surface corrosion to isolated areas. Monitor.

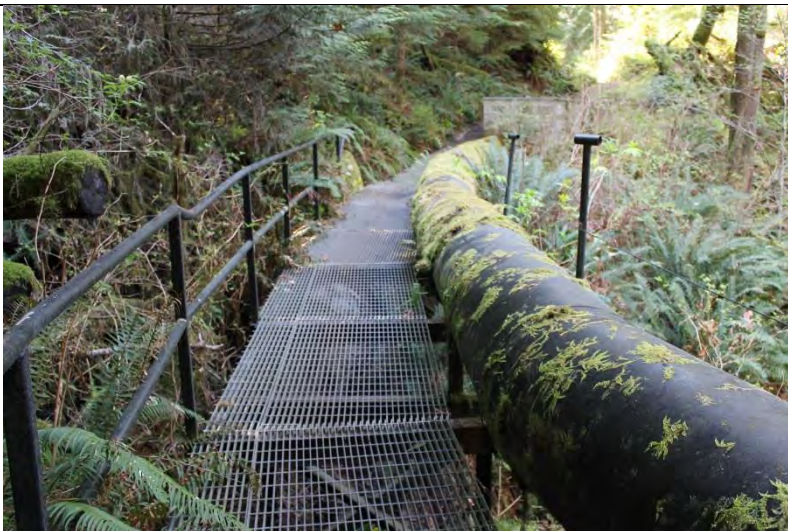
General view from the first trestle looking east. Note the top rail of the northern handrail has been damaged, likely due to a fallen tree.

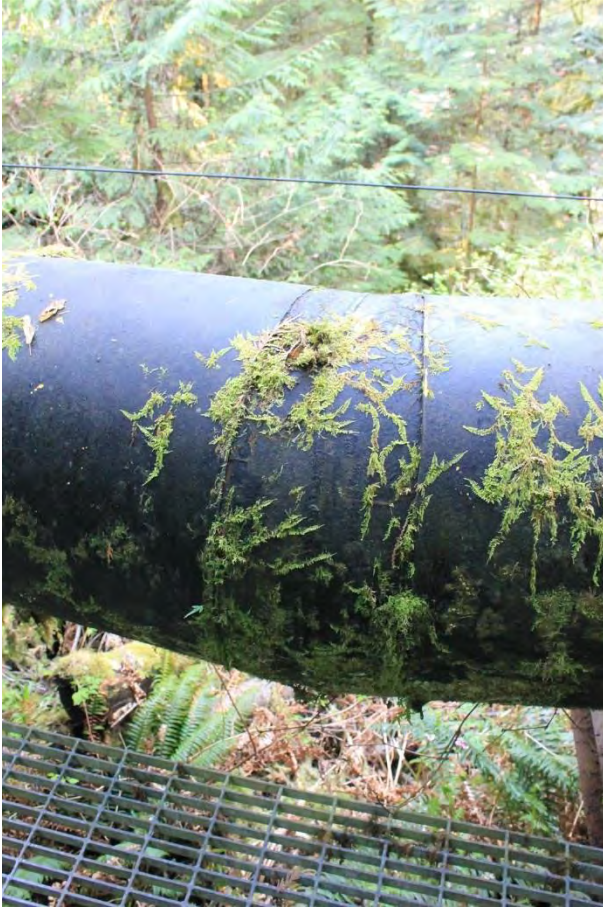
View of the elbow joint between the first and second trestle which is in good condition with minor surface corrosion at the edges of the protective jacket sections. Monitor.

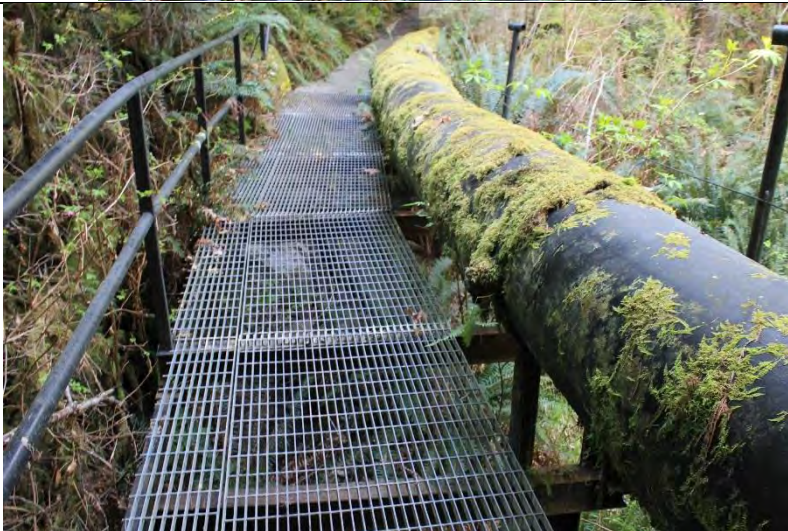
View of the second trestle looking east.

<p>View of the water main support at the second trestle showing it to be in a good condition with minor surface corrosion to the transverse support member.</p>
 	<p>View of the ground mounted support at the eastern end of the structure. All components are in a good condition where visible.</p>

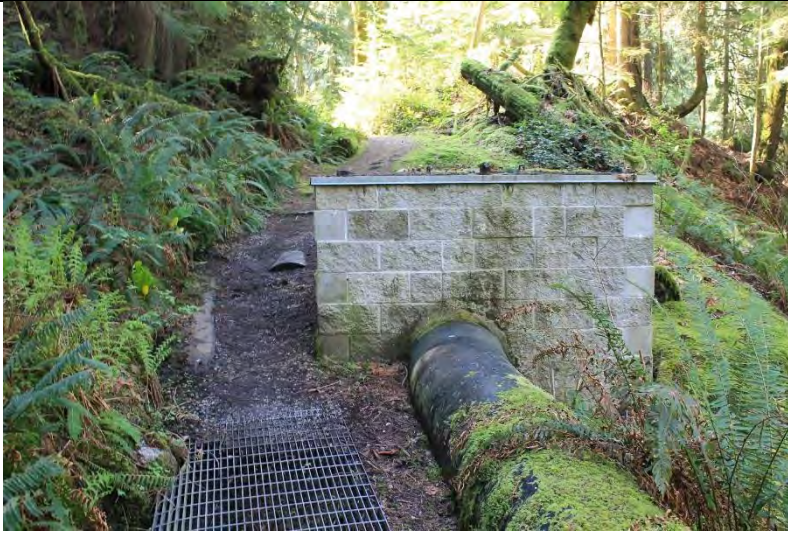
View of the eastern end of the exposed water main where it meets the valve chamber structure.

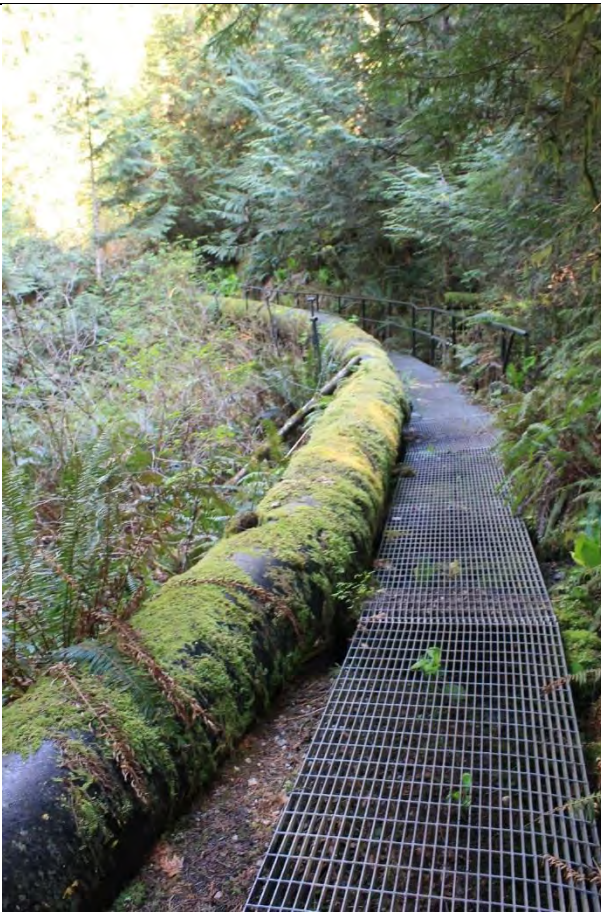
General view of the exposed water main and trestle structure from the eastern end looking west.

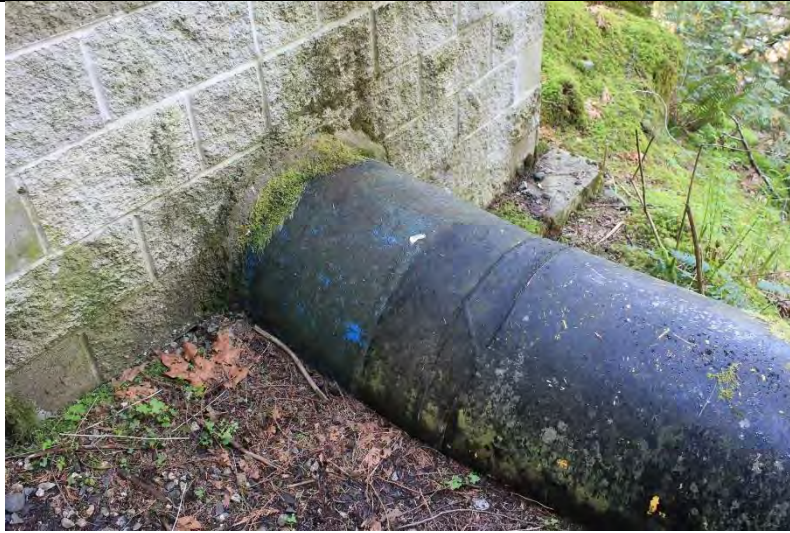
View of the water main where it enters the valve chamber beyond the eastern end of the trestle structure.

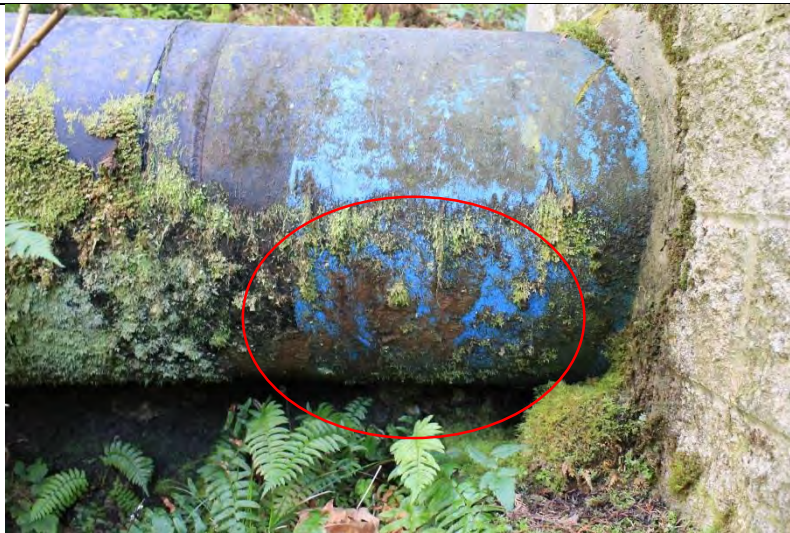
View of the water main where it enters the valve chamber looking north (opposite side to trail). Note the blue coloured protective coating system has broken down on the lower portion of the water main leading to surface corrosion over an area approximately 600mm in length.

Recommend clean and paint within 24 months to prevent further deterioration.

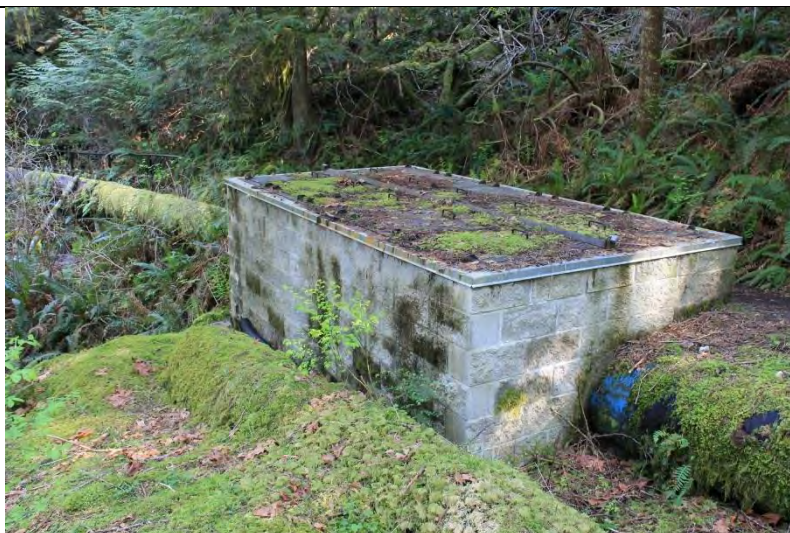
General view of the valve chamber with the trestle structure in the background to the left hand side of the photograph.

The exterior of the valve chamber structure appears in good condition.

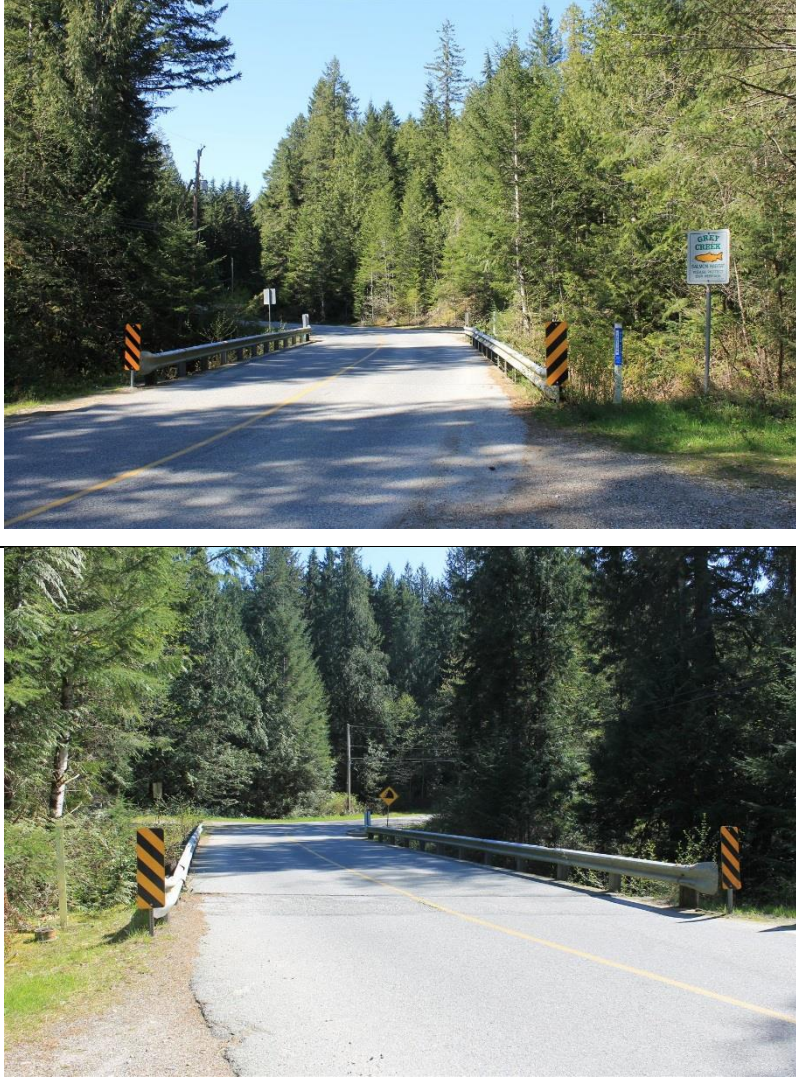
General view of Gray Creek Bridge looking north, with the water main supported from the eastern side of the bridge (right hand side of photograph).
	General view of Gray Creek Bridge looking south.

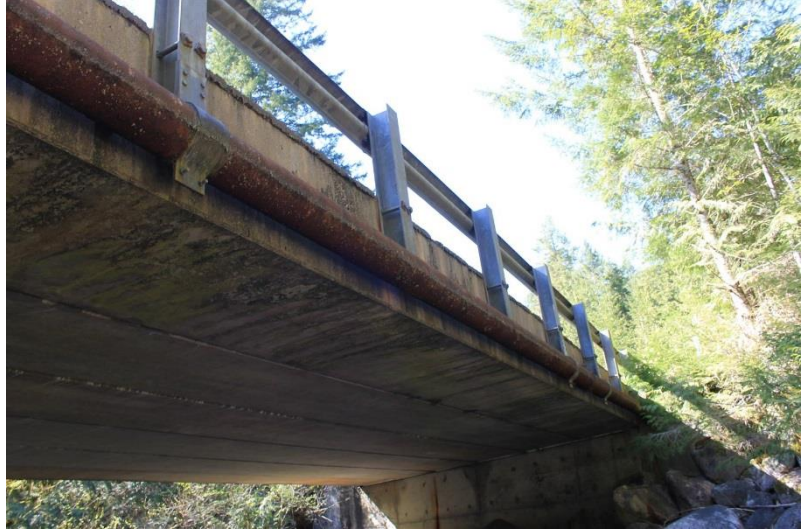
<p>View of the eastern side of Gray Creek Bridge from the southern stream embankment showing the water main with support brackets to the side of the bridge.</p> <p>Note widespread failure of the paint system with surface corrosion throughout the length of the water main.</p>

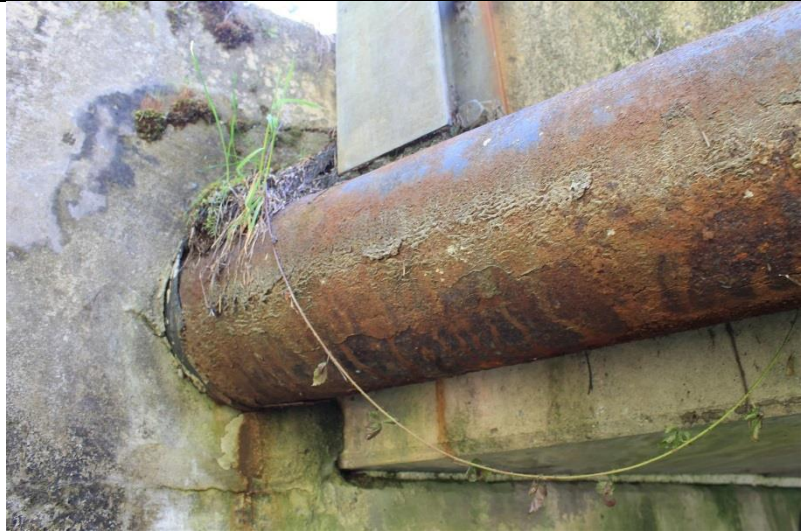
<p>View of the southern end of the water main where it passes through the bridge abutment. Note failure of paint system and surface corrosion throughout.</p>

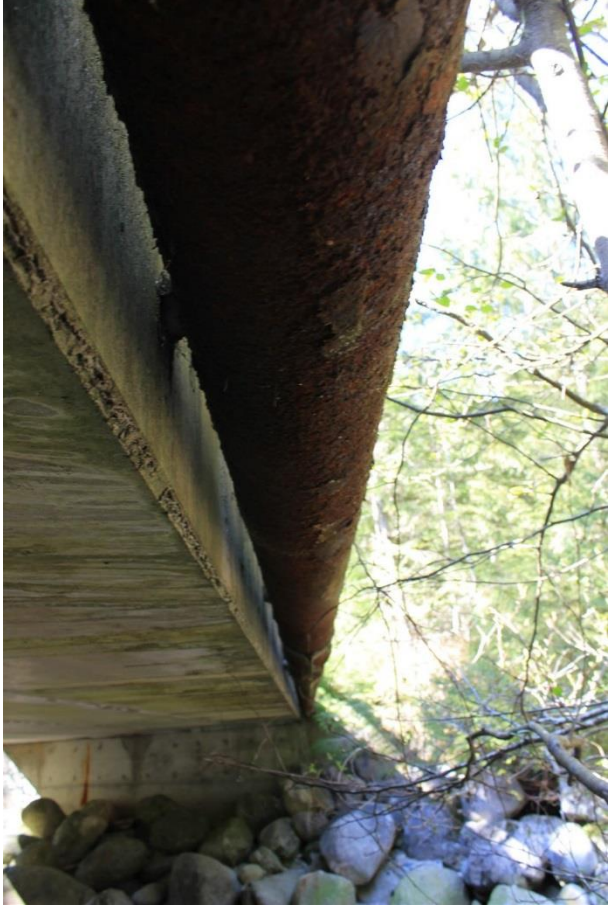
<p>View of the underside of the water main from the southern stream embankment showing wide spread failure of the paint system and subsequent loss of steel section depth due to corrosion flaking to underside of the water main.</p> <p>Recommend that the water main is cleaned and painted throughout its length within 12-24 months to prevent further deterioration.</p>

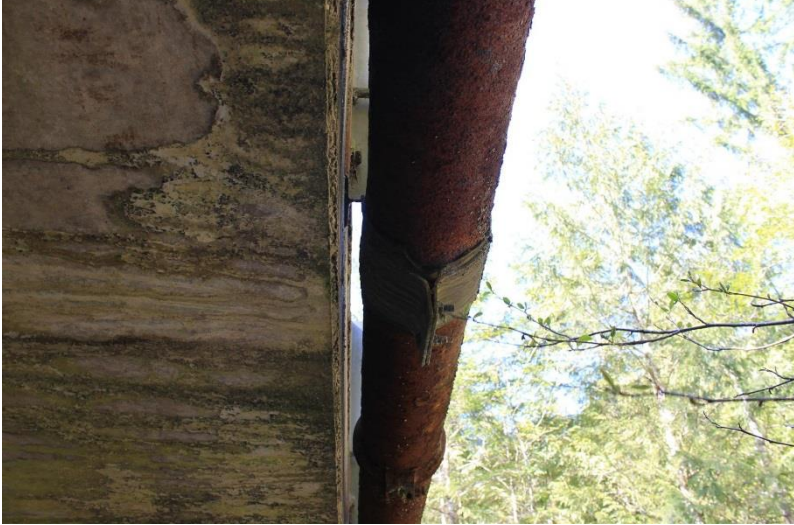
<p>View of the southern-most support bracket and flange connection. Note the support brackets are in a good condition throughout.</p>

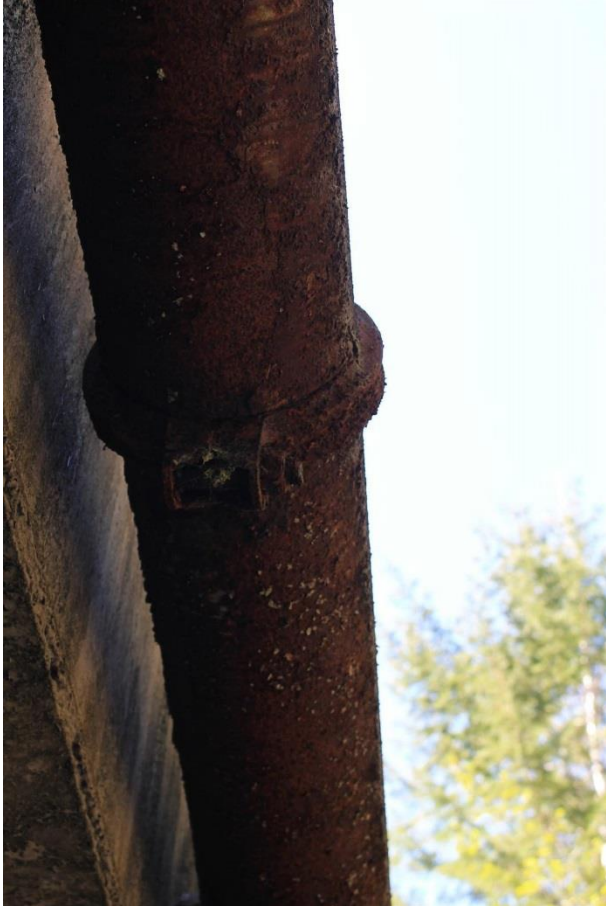
<p>View of the southern-most grooved coupling from the underside showing widespread corrosion.</p>

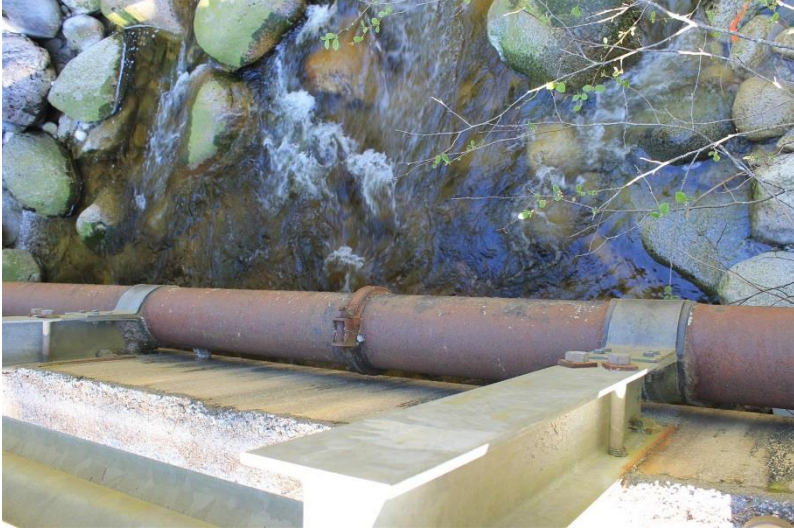
<p>View of the southern-most support brackets and grooved coupling from above showing widespread corrosion to the water main with the support brackets in a good condition.</p>

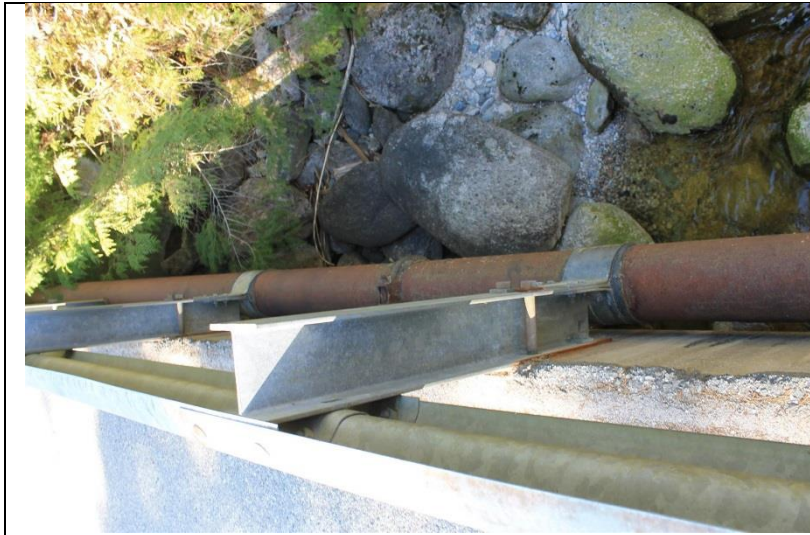
View of the northern-most support brackets and grooved coupling from above.

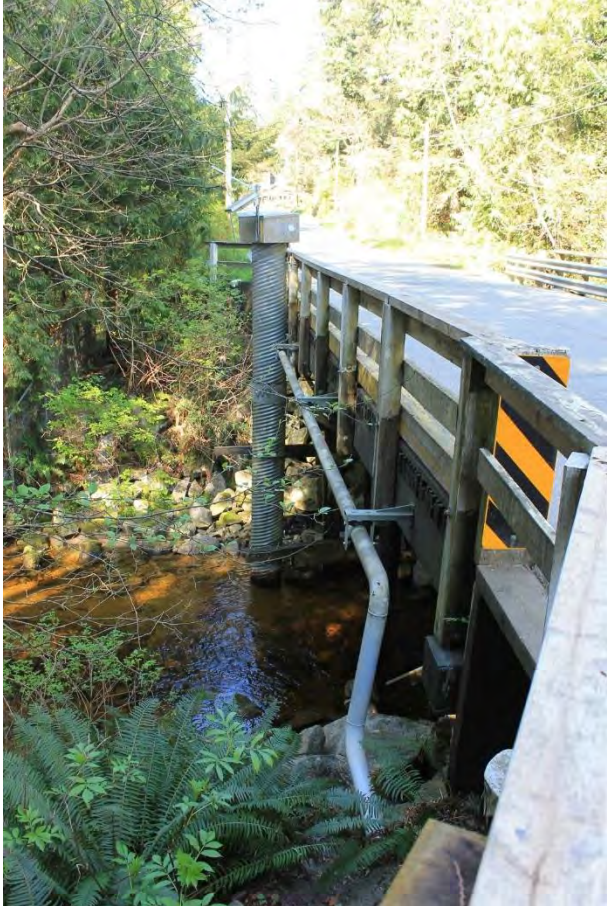
<p>General view of the southern side of the bridge looking west showing the gas main supported from the side of the bridge and a water survey station to the western stream embankment.</p>

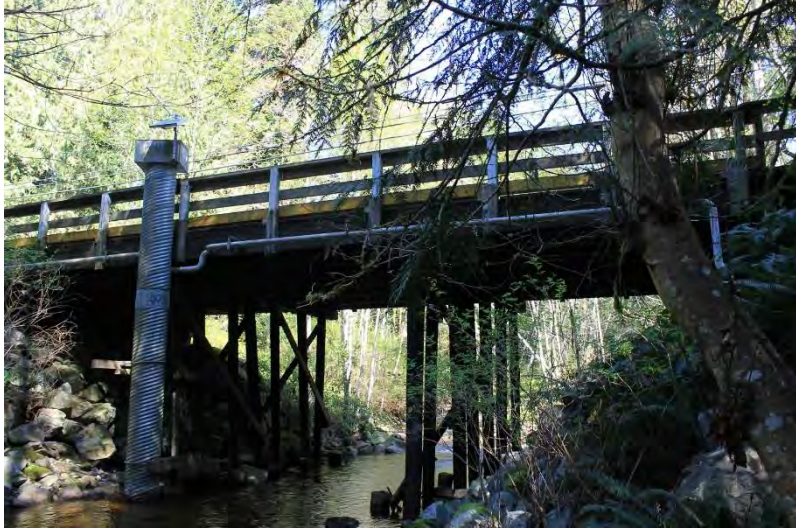
<p>Additional general view of the southern side of the bridge from the eastern stream embankment showing the gas main profile.</p>

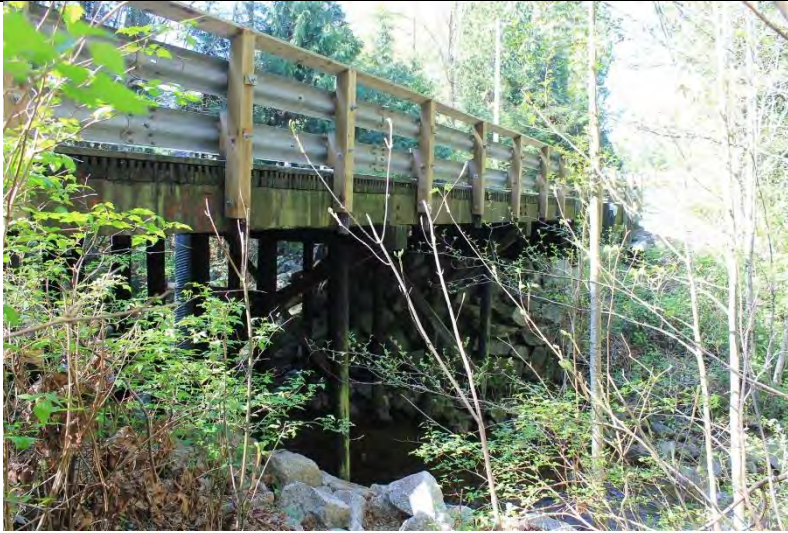
General view of the northern side of the bridge showing it to be in a good condition.

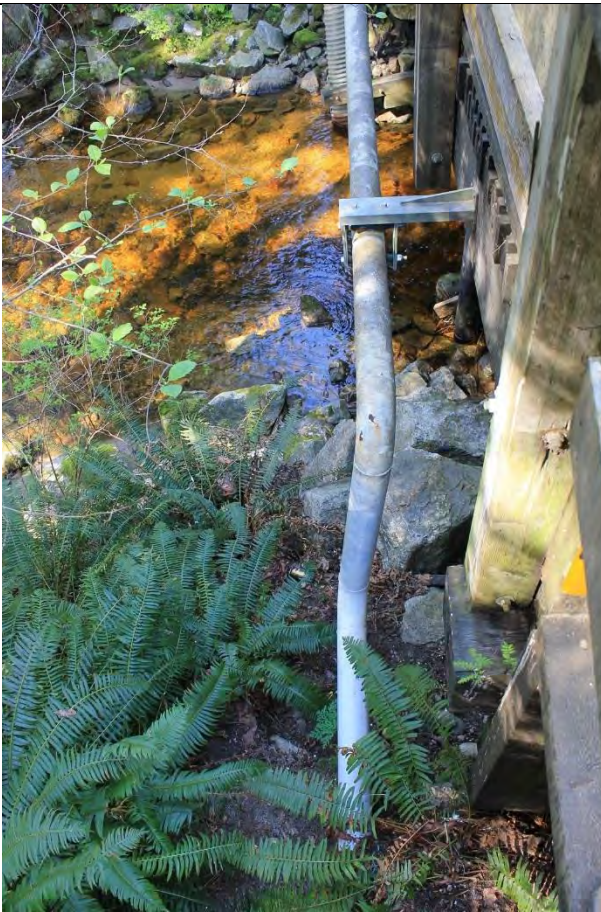
View of the eastern end of the gas main showing a newer paint system to the vertical section and bottom elbow to the point where the main passes into the embankment.

Note minor corrosion spots to the outside face of the top vertical elbow.

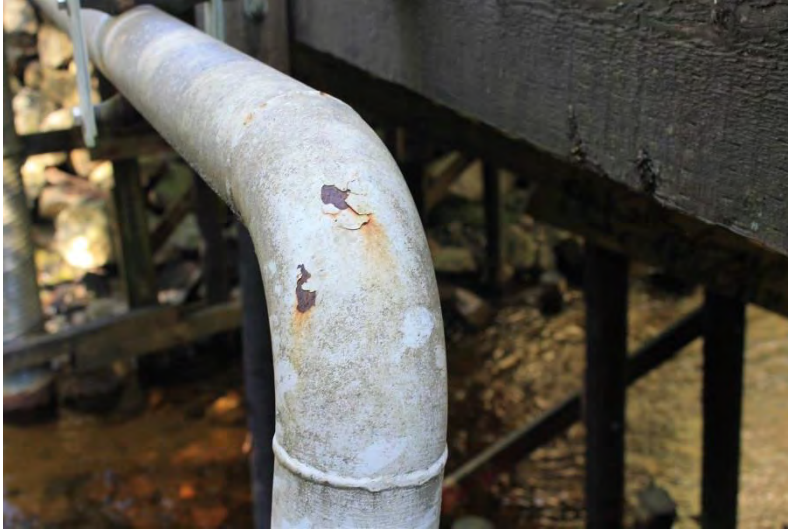
Close up view of paint breakdown and minor surface corrosion to the outside face of the top vertical elbow at the eastern end of the bridge.

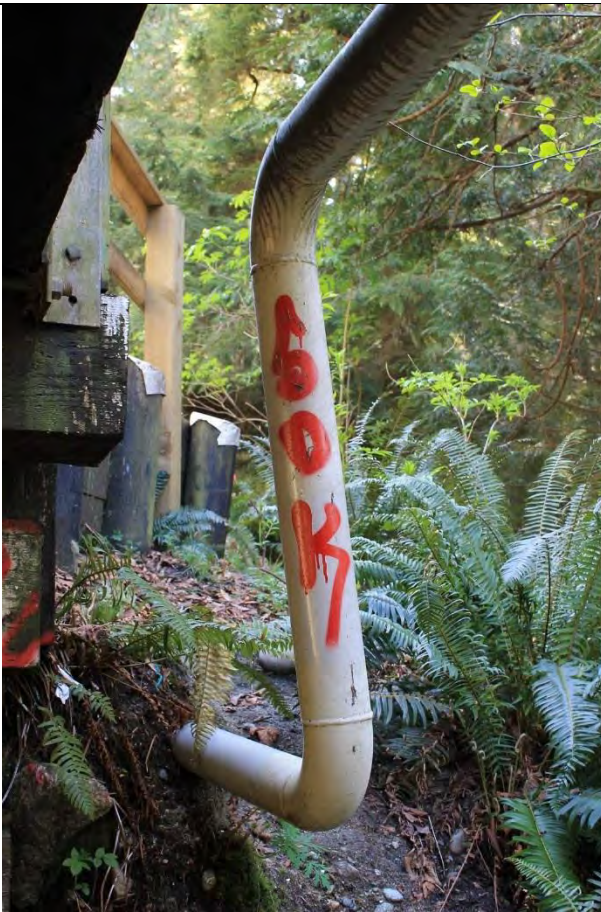
View of graffiti to the vertical section of main at the eastern end of the bridge.

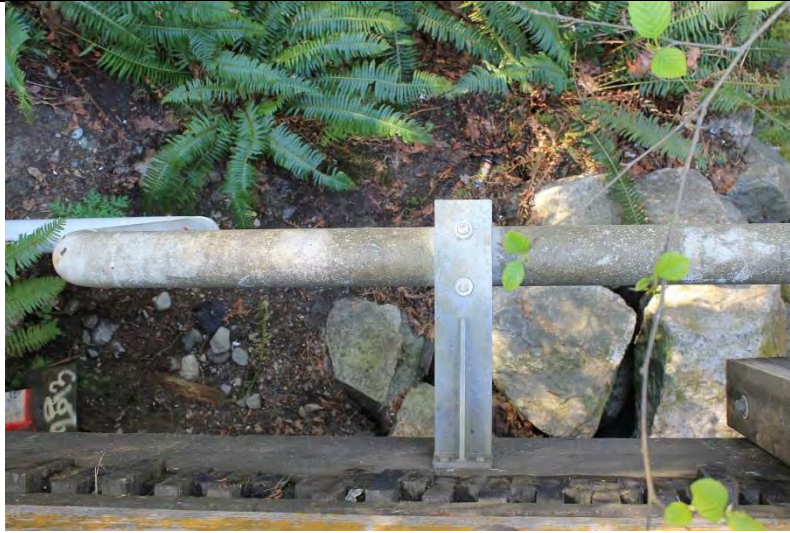
View of the eastern-most support bracket showing it to be in a good condition. This is typical of the support brackets throughout the bridge.

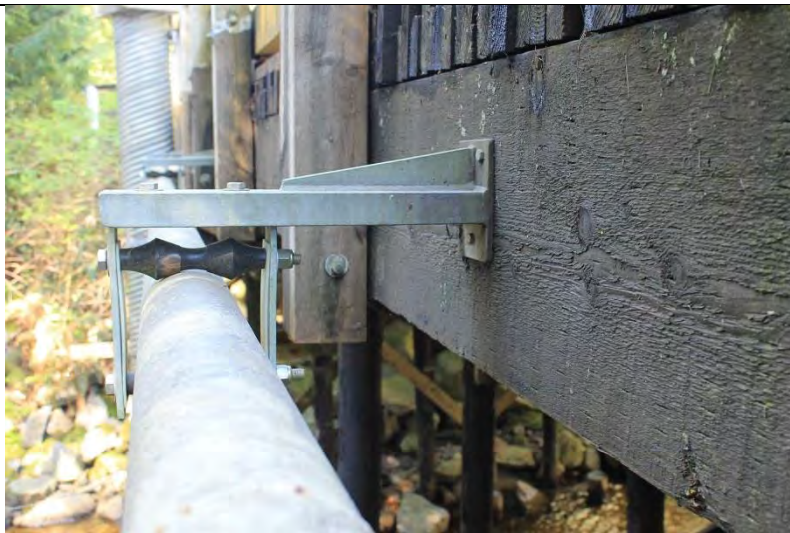
Additional view of the eastern-most support bracket showing the connections and rollers to be in a good condition.

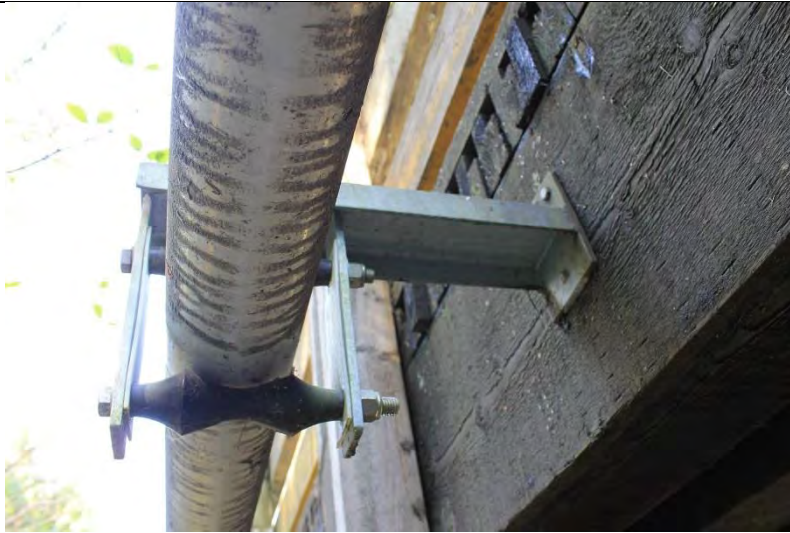
Underside view of the eastern-most support bracket showing all components to be in a good condition.

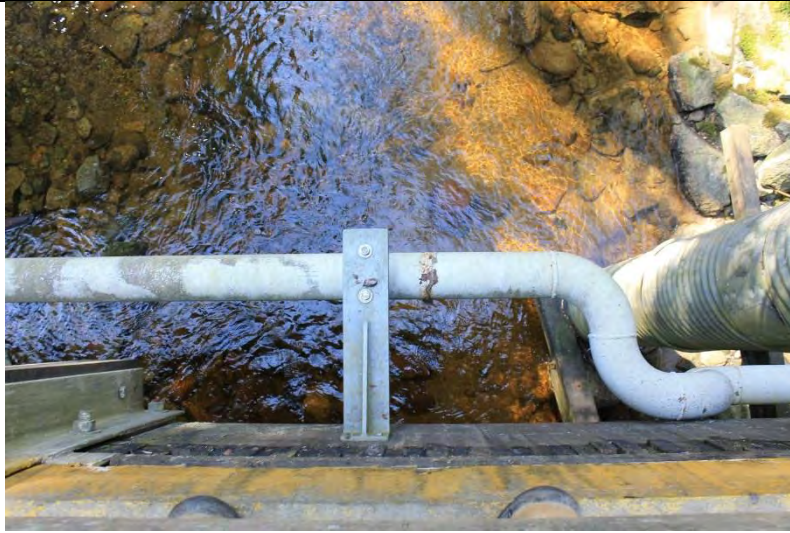
View of the central support bracket and main to the east of the water survey station. Note corrosion to the weld to the west of the bracket.

The main includes a series of horizontal and vertical elbows to navigate around the water survey station to the right hand side of this photograph.

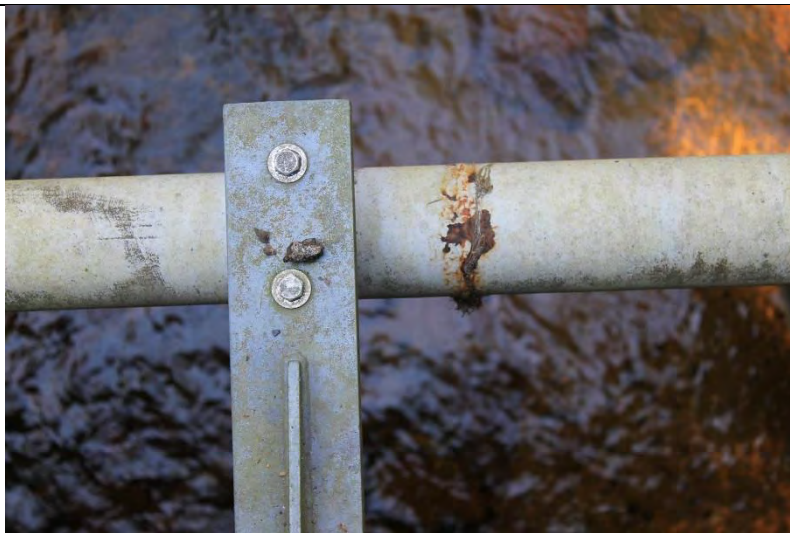
Close up view of paint breakdown and subsequent corrosion to the weld and main near the central support.

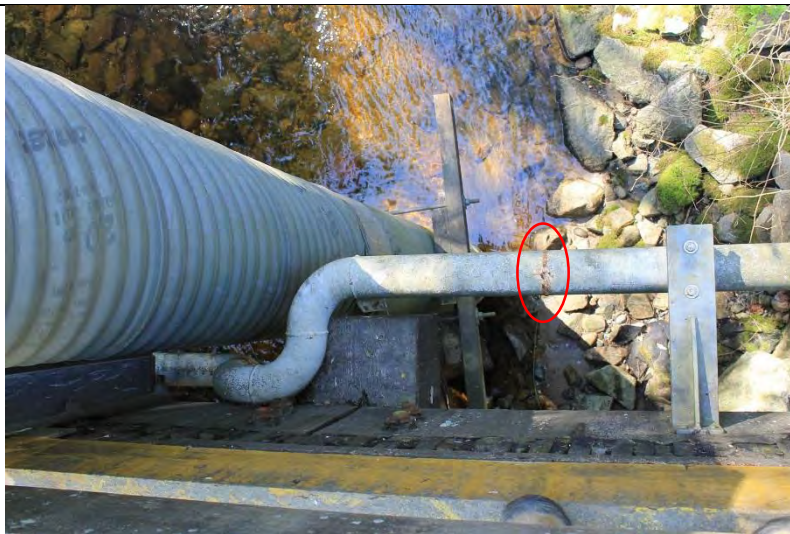
View of the main to the western side of the water survey station. Note surface corrosion to the weld between the water survey station and the support bracket.

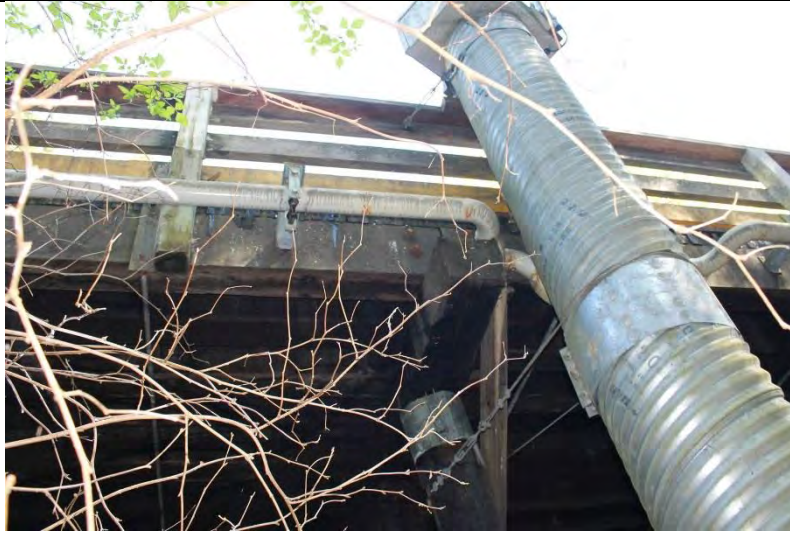
View of the underside of the main to the west of the water survey station.

Note several areas of surface corrosion are visible to the underside of the welds at the mains elbow section. It is recommended that these areas are cleaned and painted within 12 months to limit further loss of weld section depth.

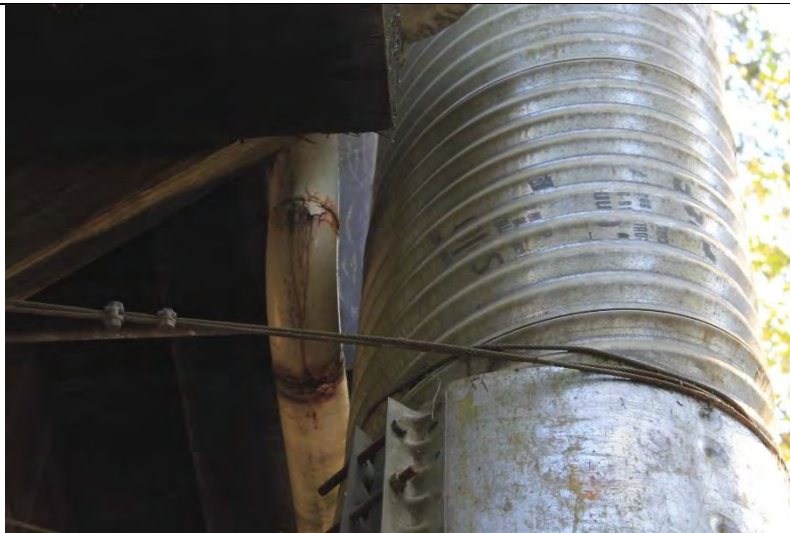
Close up view of weld corrosion to the western side of the water survey station.

The same defect is present to the underside of the main on the eastern side of the water survey station.

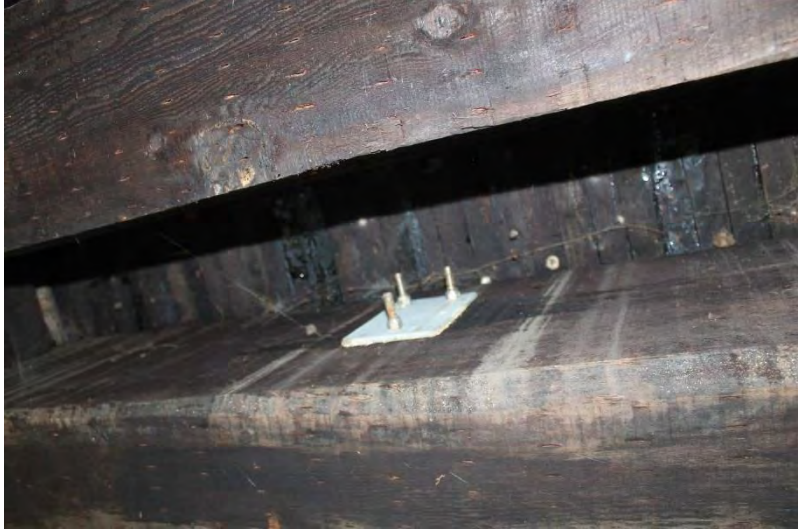
<p>View of a support bracket connection on the inside face of the outer timber bridge beam. These connections are in a good condition.</p>
------------------------------------------------------------------------------------	--------------------------------------------------------------------------------------------------------------------------------------------

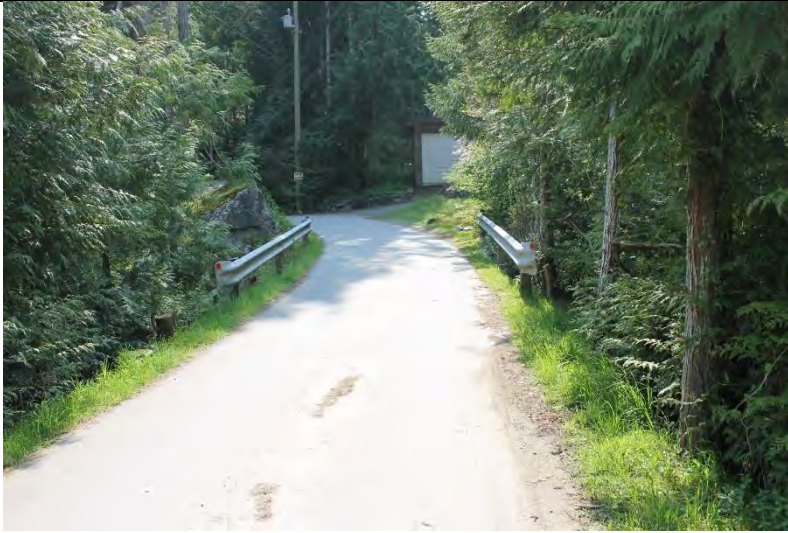
Further view of the approach to Sans Souci Road Bridge looking south-west.

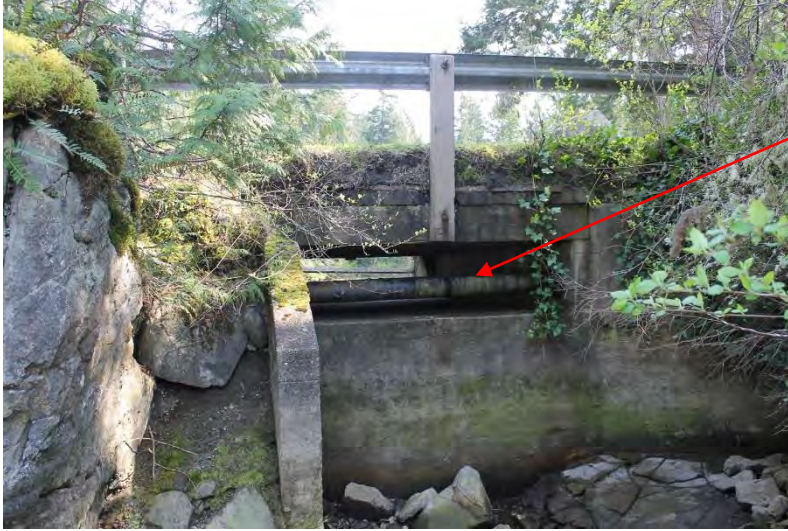
View of the north-western elevation of the Sans Souci Road Bridge showing the water mains spanning between abutments below the bridge deck.

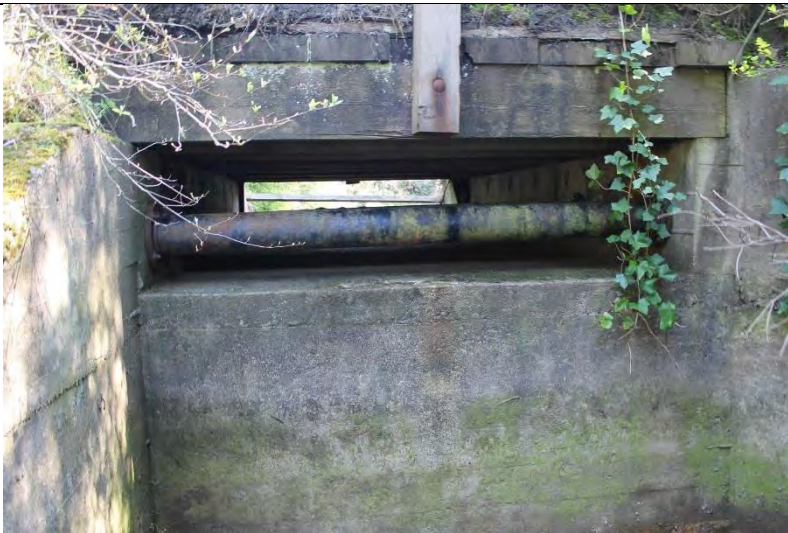
View of the water mains spanning between the bridge abutments.

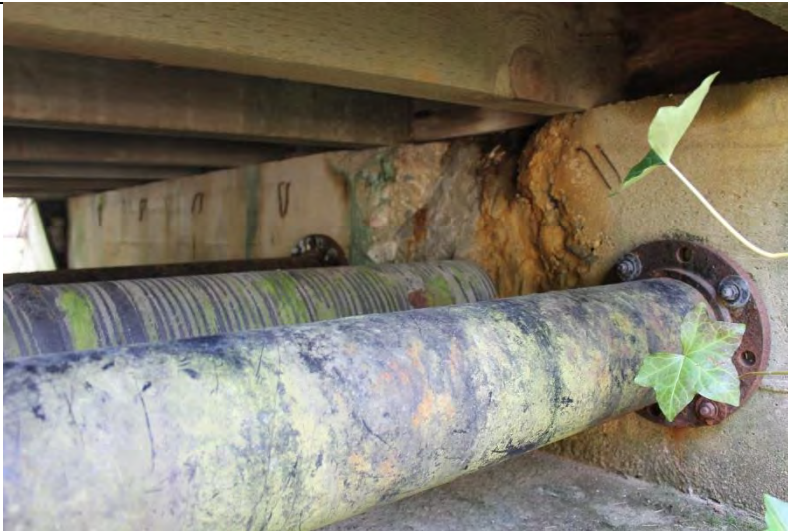
View of the three service mains at the interface with the south-western abutment of Sans Souci Road Bridge. Note the outer service mains are steel or ductile with bolted flange connections to the abutment. The central service main appears to be wrapped steel and passes directly through each bridge abutment.

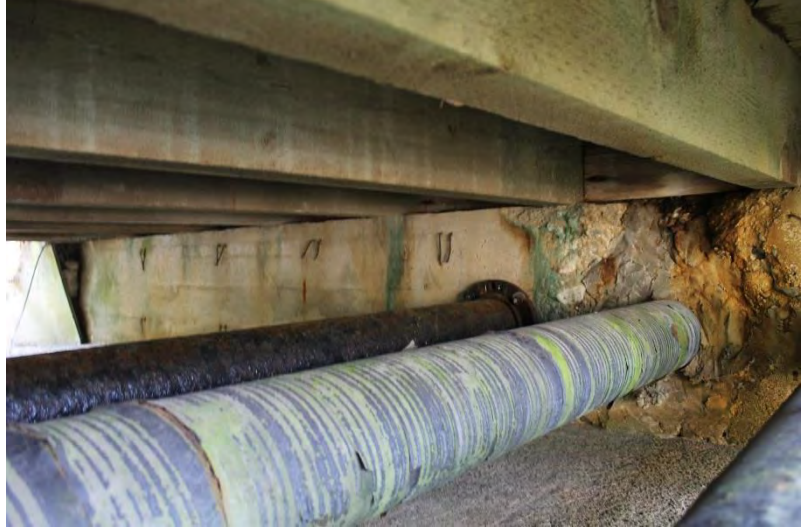
<p>Further view of the second and third service mains where they pass through the south-western bridge abutment. Note surface corrosion to the outer service main and flange plate.</p> <p>Note damage to the south-western bridge abutment near the second service main. Recommend this is discussed with the department responsible for bridge maintenance.</p>

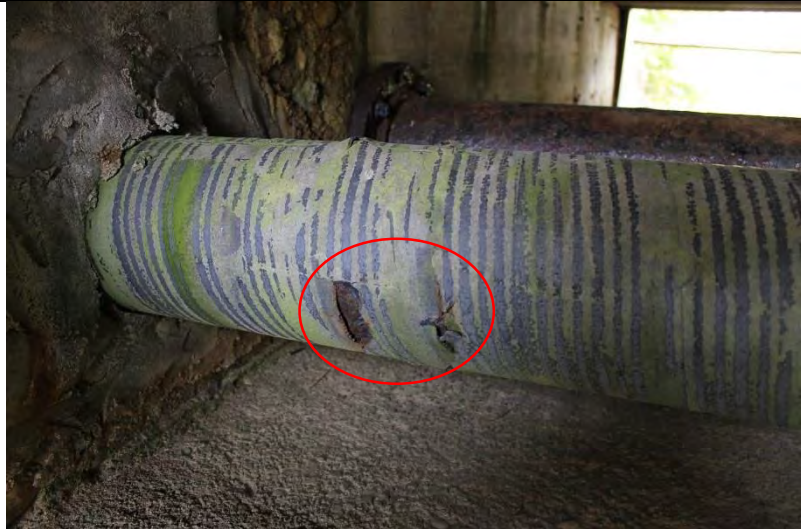
<p>View of the north-eastern end of the second and third service mains. Note the visible defects in the second service main wrap leading to corrosion of the underlying steel.</p> <p>Recommend repairs are completed to this area within 12 months to limit loss of steel section depth.</p>

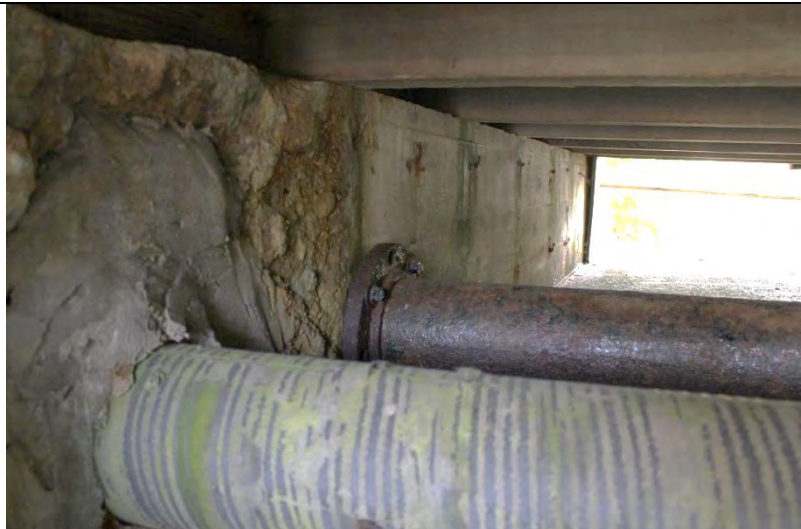
<p>Further view of the north-eastern end of the second and third service mains. Note consistent surface corrosion to the third service main. Recommend the entire main is cleaned and painted within 12 months to limit loss of steel section depth due to corrosion.</p>

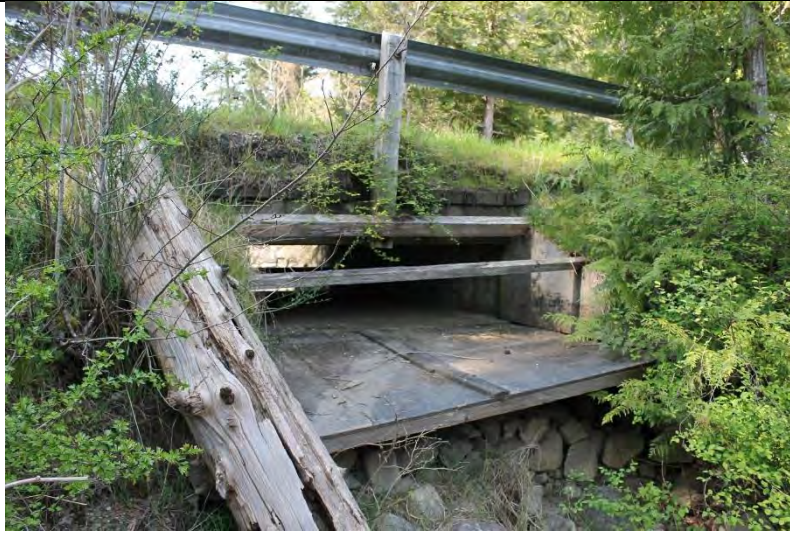
View of the south-eastern elevation of the Sans Souci Road Bridge with timber staging to the edge of the bridge.

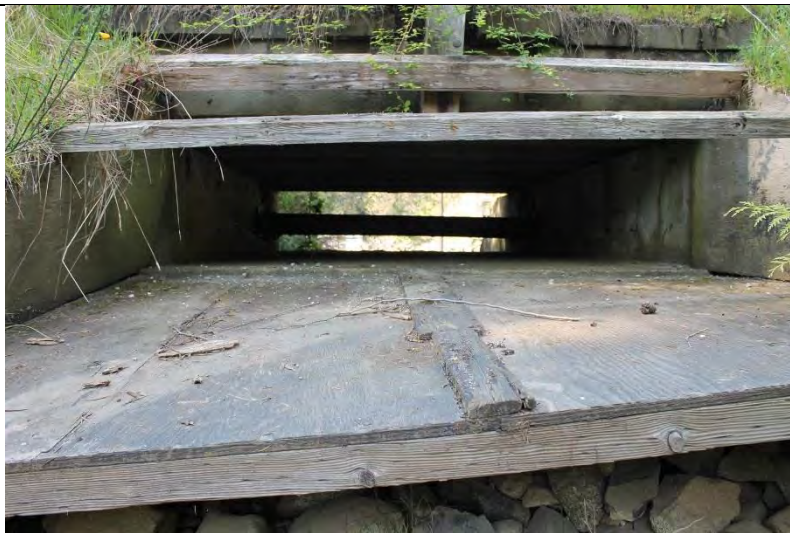
View below the bridge deck looking north-west. Note the service mains visible in the background.

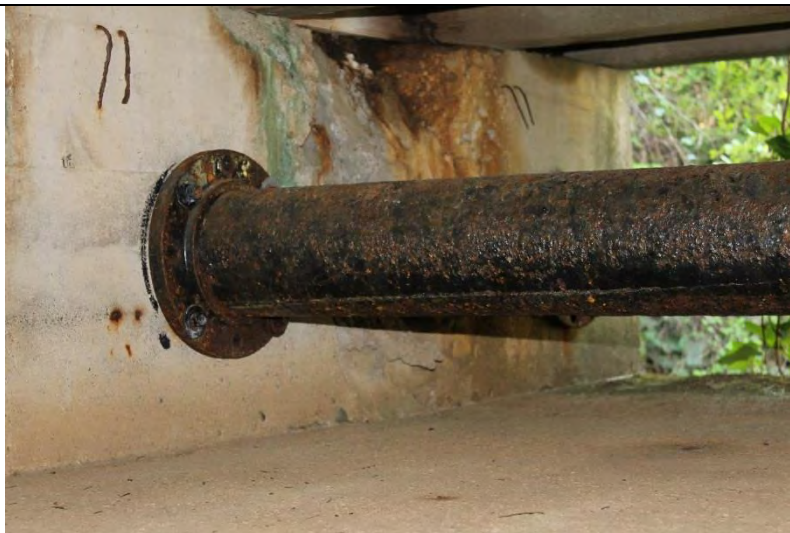
Close up view of the south-western end of the third service main. The main is in a good to moderate condition with pitting corrosion visible in areas where the existing coating has broken down. Recommend the entire main is cleaned and painted within 12 months to limit further deterioration.
