# Sunshine Coast Regional District

# Request for Proposal

**Number: 2337009**

## **Exposed Watermain Rehabilitation**

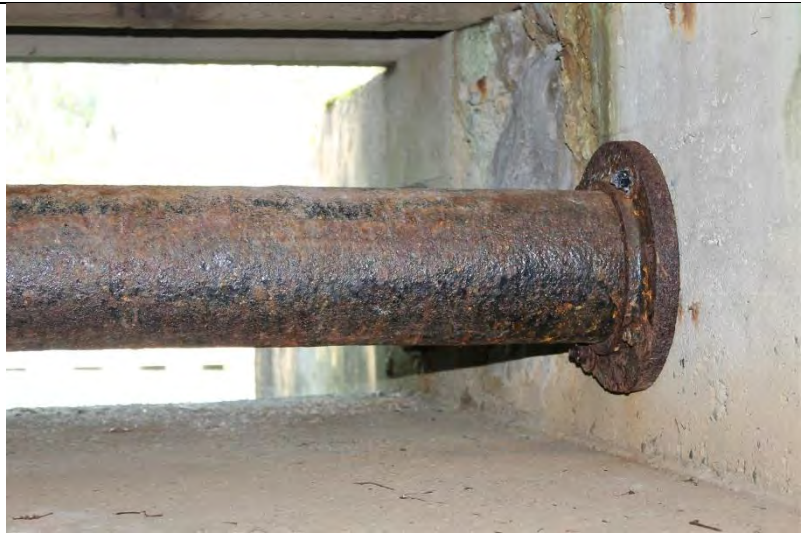
<p>Close up view of the north-eastern end of the third service main showing surface corrosion and some pitting to the section. As previous it is recommended that the main is cleaned and painted within 12 months to limit further deterioration and loss of steel section depth.</p>
------------------------------------------------------------------------------------	----------------------------------------------------------------------------------------------------------------------------------------------------------------------------------------------------------------------------------------------------------------------------------------

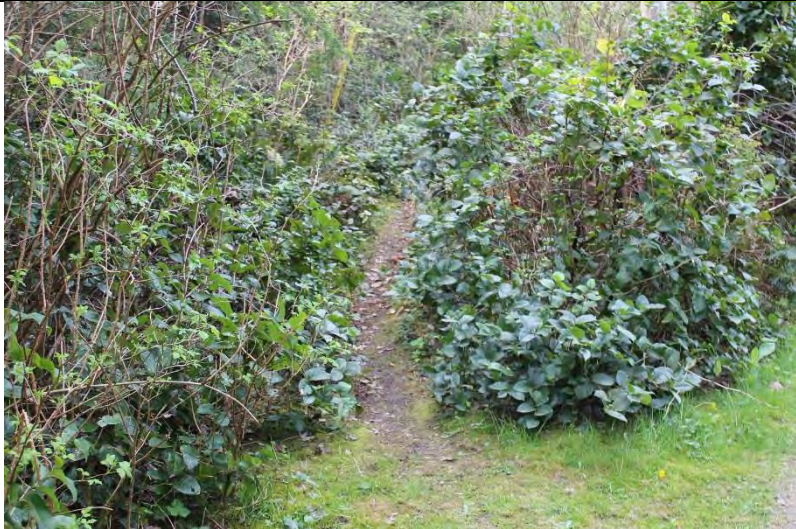
General view of the approach to the exposed water main from Secret Road. Note pedestrian access only.

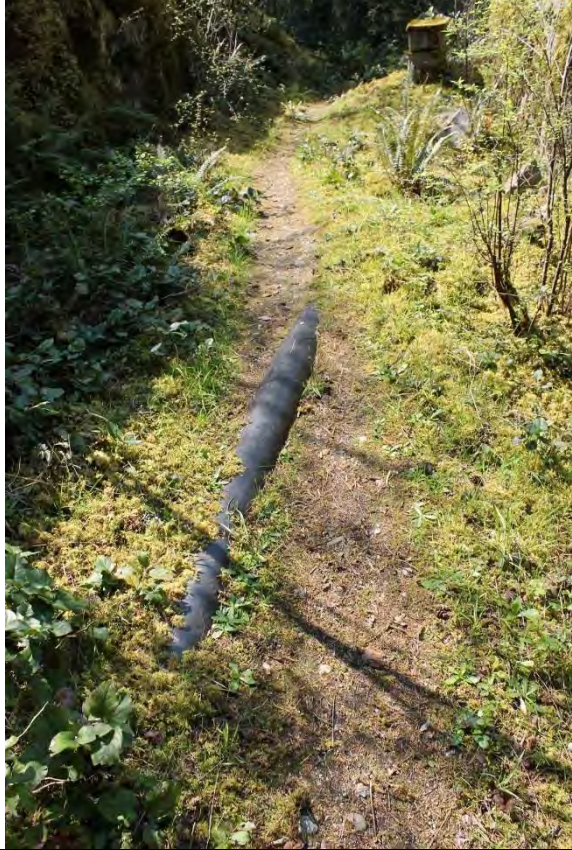
<p>Close up view of the exposed section of HDPE water main running across the pedestrian trail showing it to be in a good condition.</p>

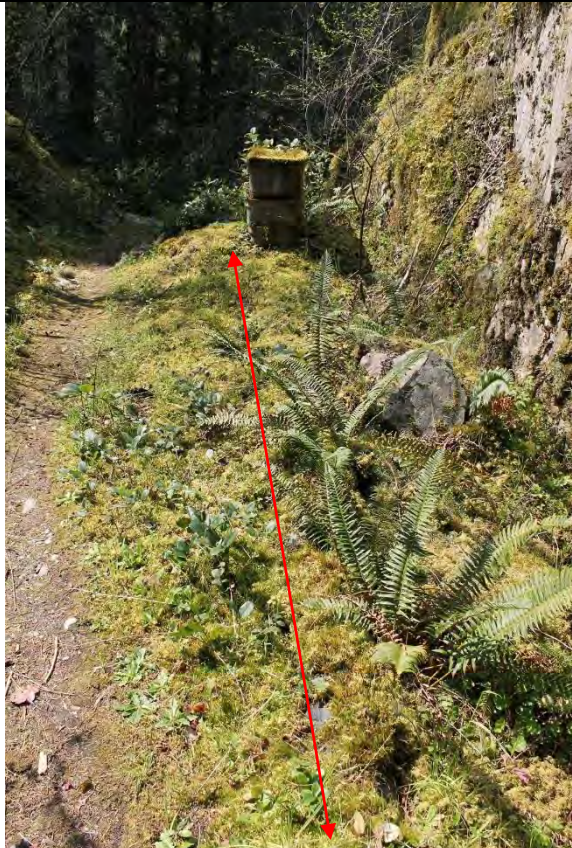
<p>View of the exposed HDPE water main to the north side of the pedestrian trail with concrete weights in the background. Note visible sections of the water main are in a good condition and appear stable.</p>

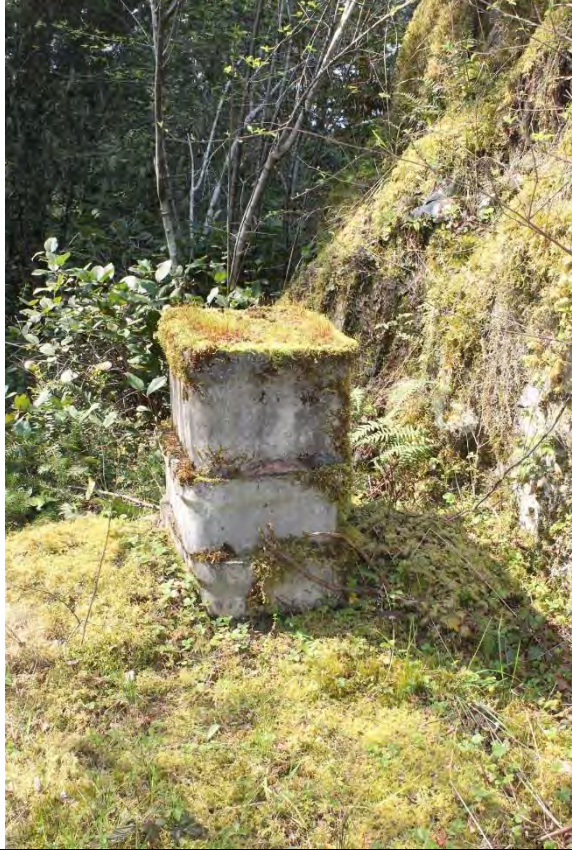
<p>View of the concrete block weights securing the HDPE water main at the top of the hill between Secret Road and Wescan Road, showing them to be in a good condition.</p>

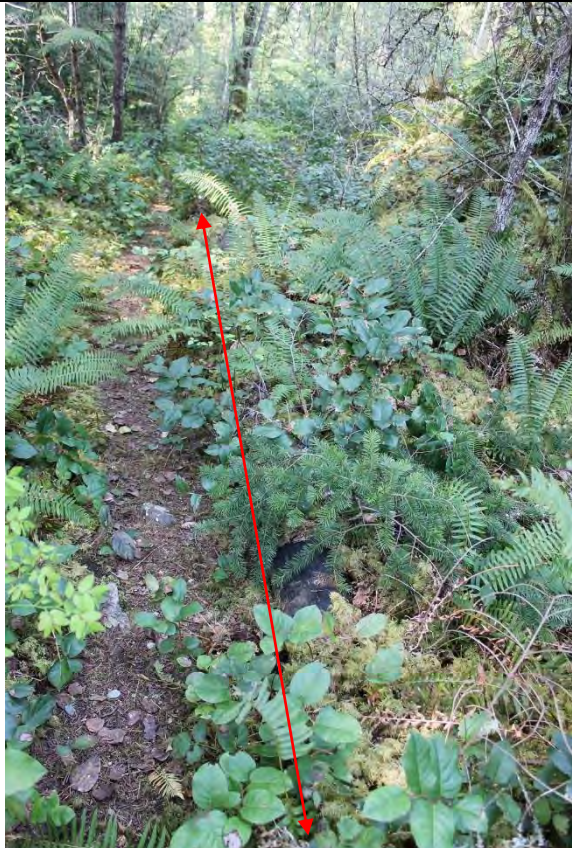
<p>General view of the pedestrian trail travelling downhill towards Wescan Road with the HDPE water main obscured by vegetation to the north of the trail (right hand side of photograph).</p>

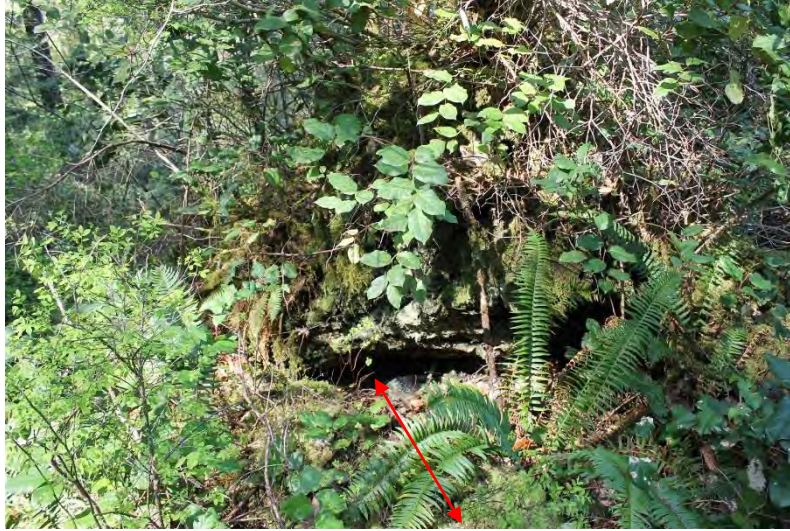
View of the HDPE water main looking west approximately halfway down the hill between Secret Road and Wescan Road where a large fallen tree stump covers the water main. There was no visible damage to the water main in this area.

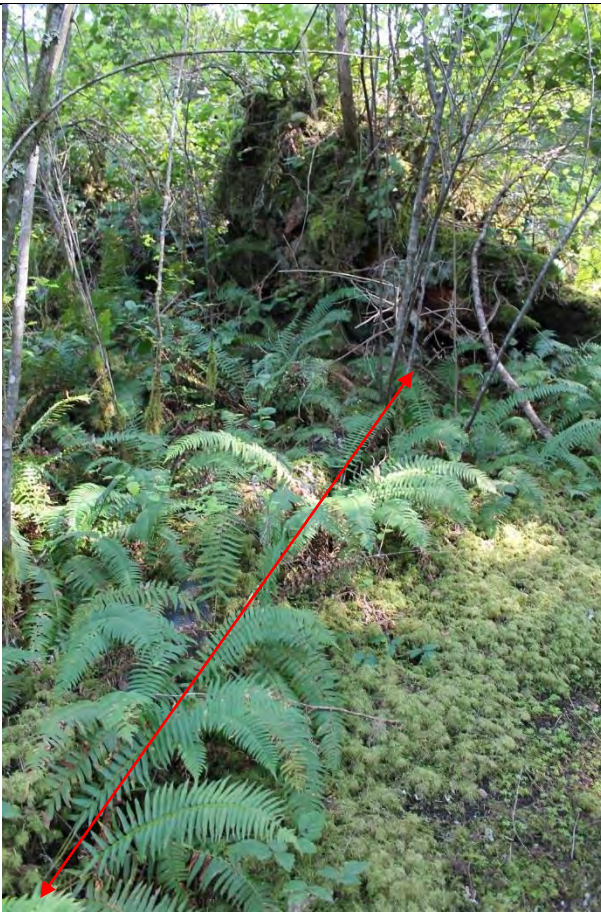
View of the HDPE water main passing below the fallen tree stump looking east (uphill).

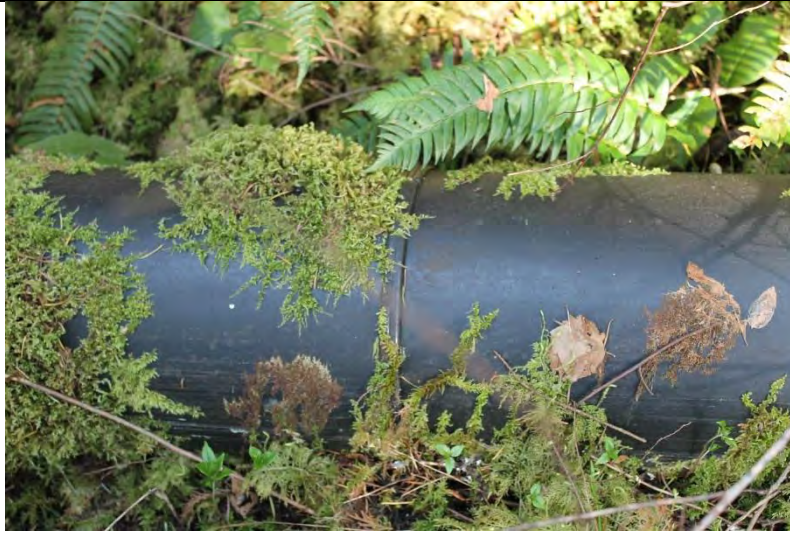
View of a welded joint in the HDPE water main which is in a good condition.

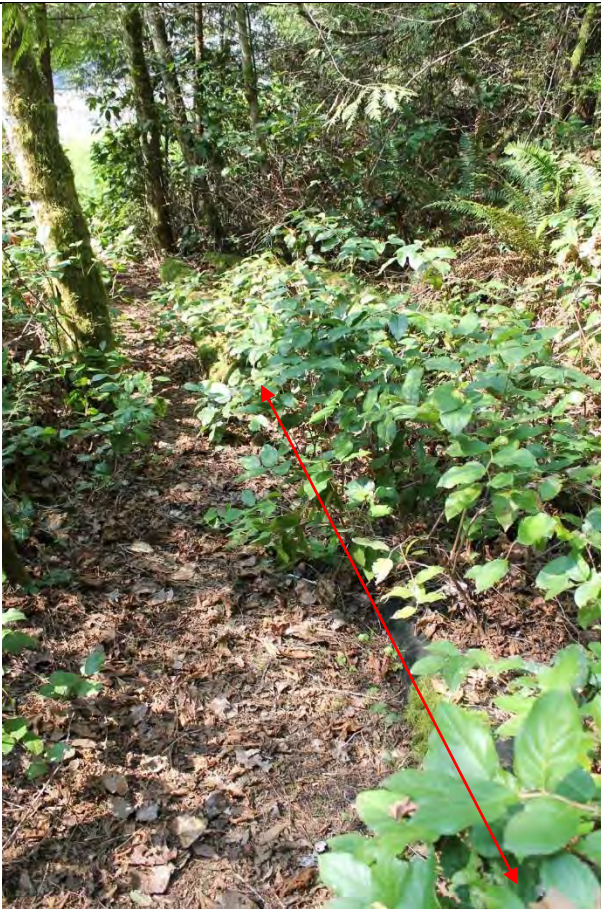
View of the western end of the exposed water main where it becomes submerged near Wescan Road which is visible in the background.

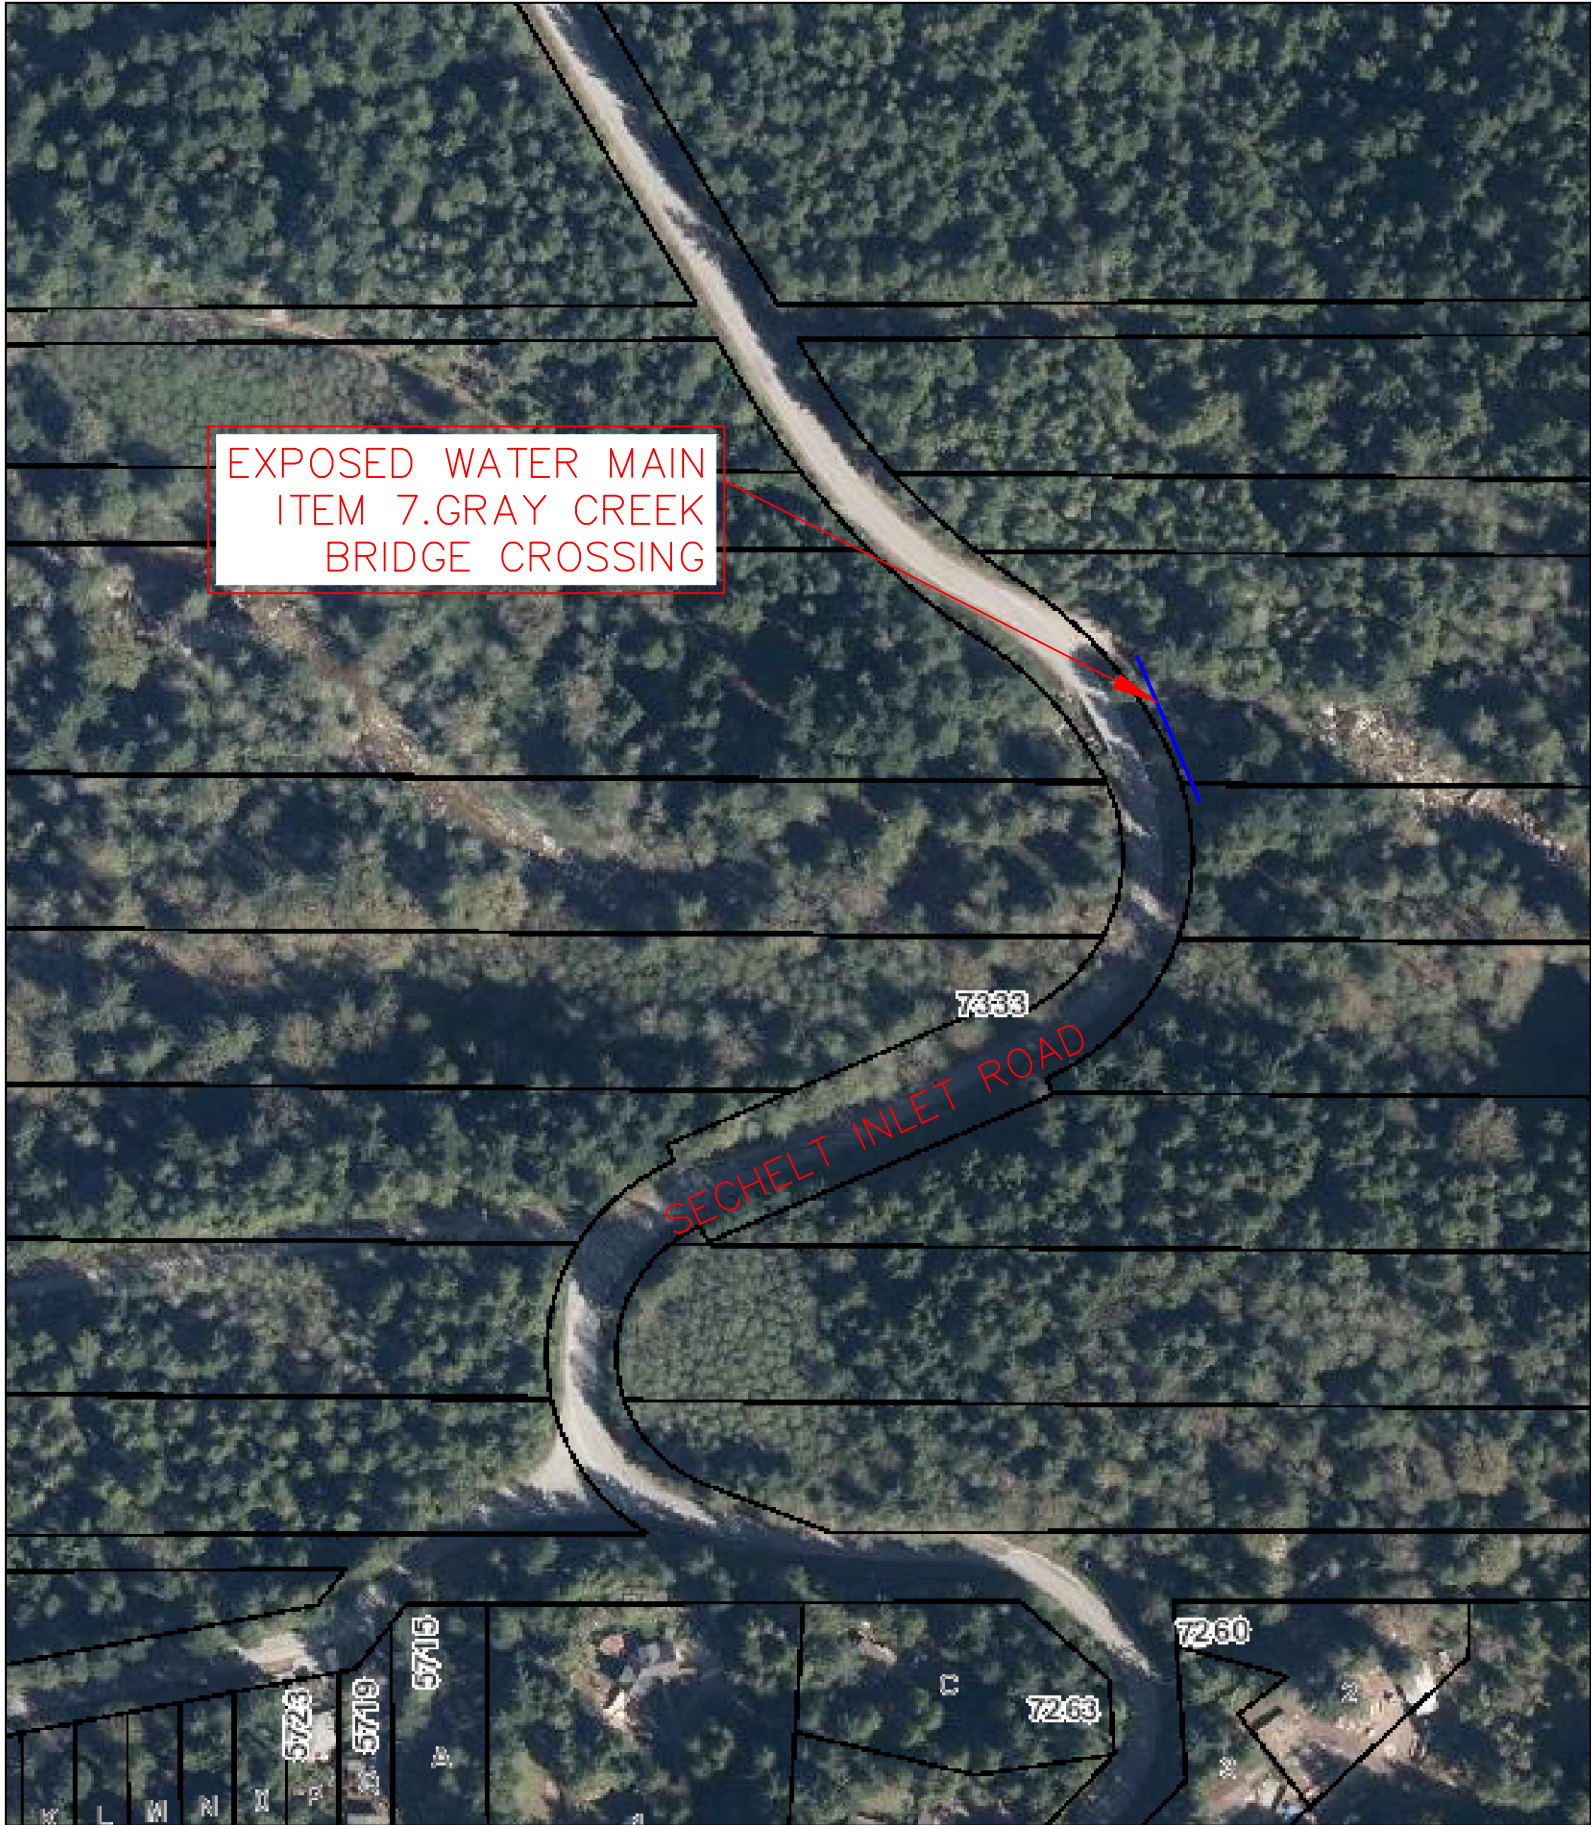
WORK ORDER NO.	WO106424
DRAWING NO:	C-04
SHEET NO :	06 OF 07

DRAWING :  
REQUIRED WORK ITEM 6.  
BURNETT CREEK  
CROSSING APPROX. 13 m  
200 STEEL PIPE
