# Sunshine Coast Regional District

# Request for Proposal

# Geotechnical Assessment Slope Stability Chapman Water Transmission Intake Line

Issue Date: March 19, 2024

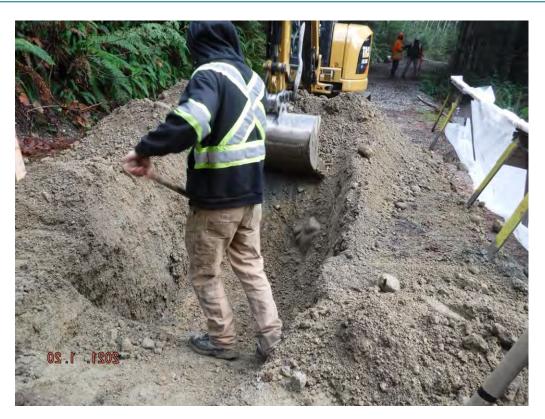
Figure 1: Utility Potholing.

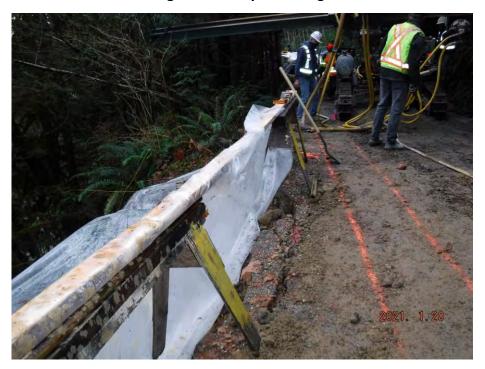
Figure 2: Watermain and Temporary Support Alignment Determination.

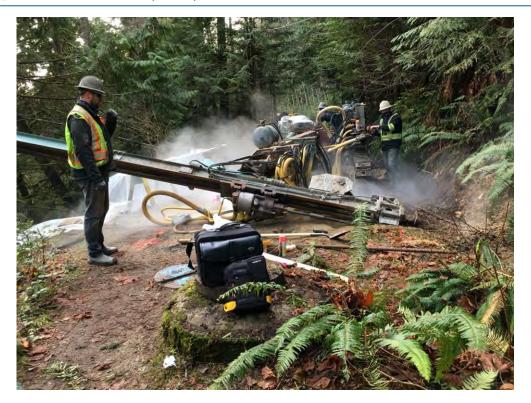
Figure 3: Drilling and Grouting of Anchor (East).

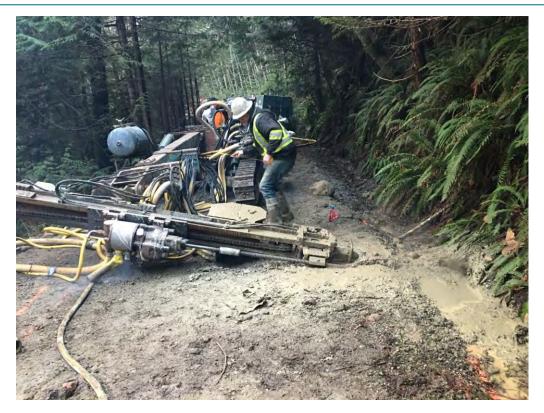
Figure 5: Drilling and Grouting of Anchor (West).

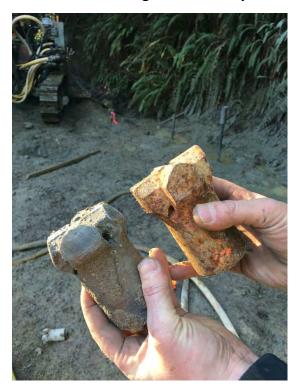
Photograph 4: Differences Between a Worn-Out Drill Bit (Left) and a New Drill Bit (Right).

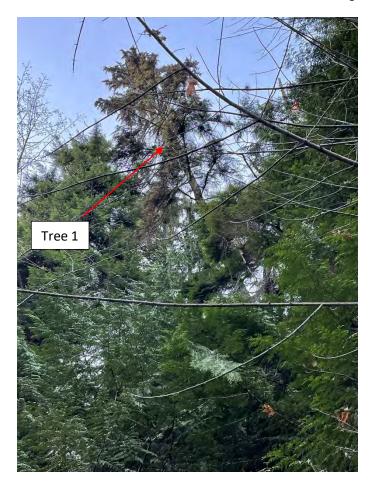
Photo 1 – tree 1 seen from remediation area leaning toward road

Tree 1 is considered a <u>moderate hazard</u>. The assessment matrix is based on the possibility of partial or complete stem failure as these are considered the most likely forms of failure at this time.

Tree 1 is recommended to be removed before workers begin slope remediation work as planned. This tree should be left as a 6-9m wildlife snag if manageable for the tree service.

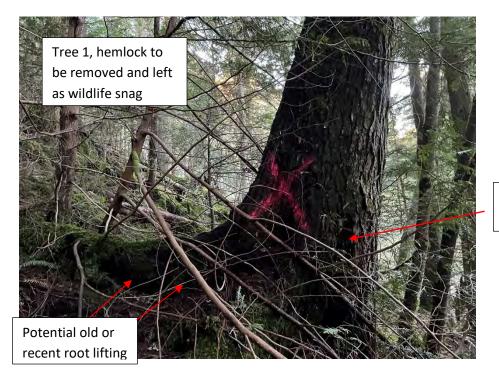
Photo 3 – tree 1 located on slope above road marked with pink X to identify; black wound at base and gap between large root and soil.

Suspect, blackened wound

Leaving tree 1 as a 6-9m wildlife snag is strongly encouraged to retain weight on the slope and provide wildlife habitat.

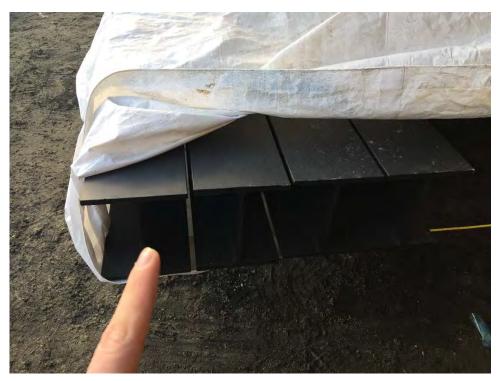
Photograph 2: W8 x 28 Beams

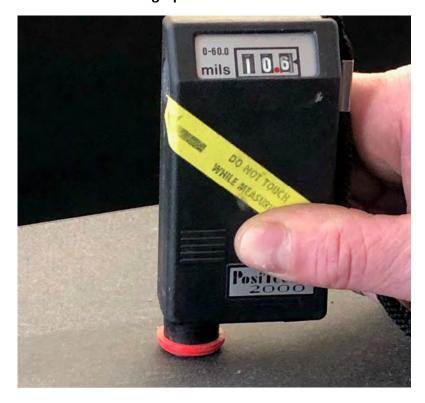
**Photograph 4: Contractor Measured Coating Thickness (Provided by Contractor)**

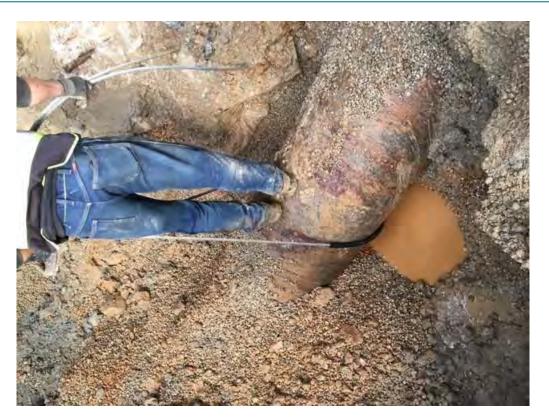
Figure 1: Hand Digging and Placing the Steel Strap with Rubber Sleeve.

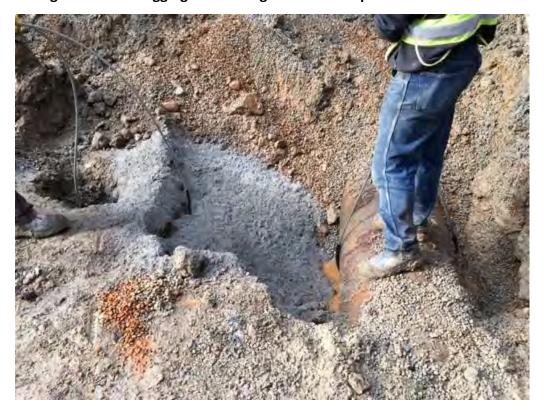
Figure 2: Backfilling with Clean Sand to Secure the Steel Straps.

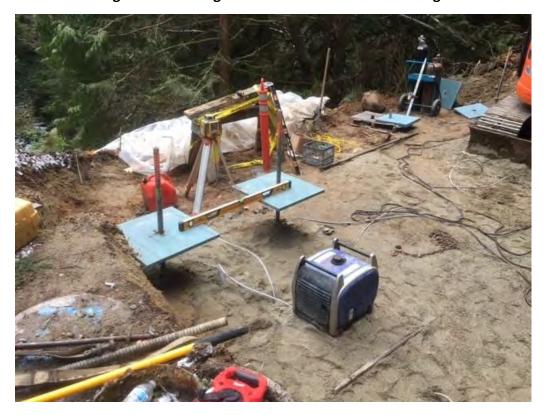
Figure 4: Levelling the Base Plates Prior to the Installation of Grade Beams.

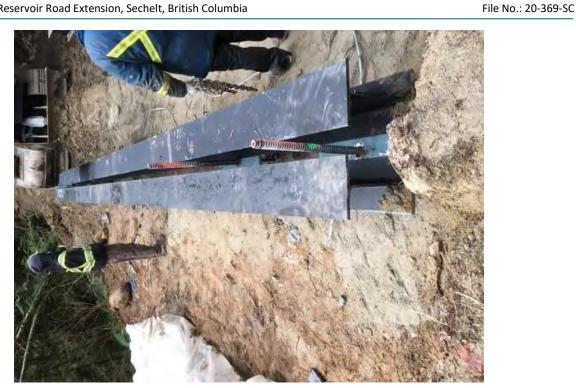
Figure 5: Installation of Grade Beams over the Base Plates

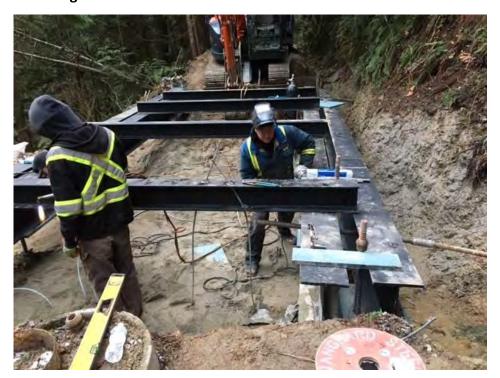
Figure 6: Installation of Cross-Over Beams after Welding the Grade Beams to the Base Plates and Making Holes at the Opposite Sides of the Flange for the Connection of Steel Straps to the Cross-Over Beams

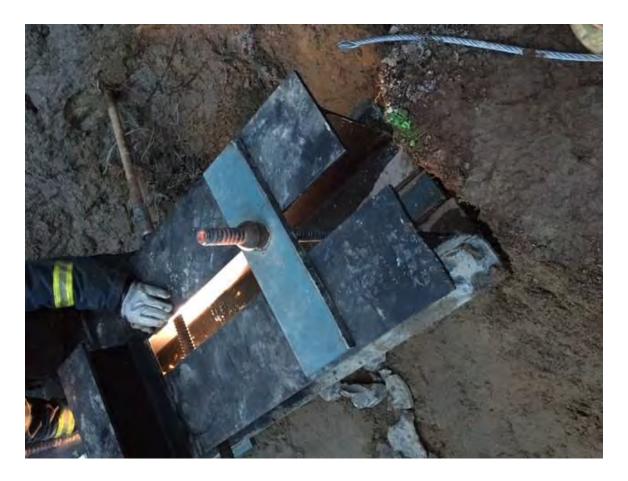
Figure 7: Installation of Additional Base Plates at the Top of the Grade Beams to Provide Proper Seating for the Nuts Connected to the Micropiles and Completing the Welding

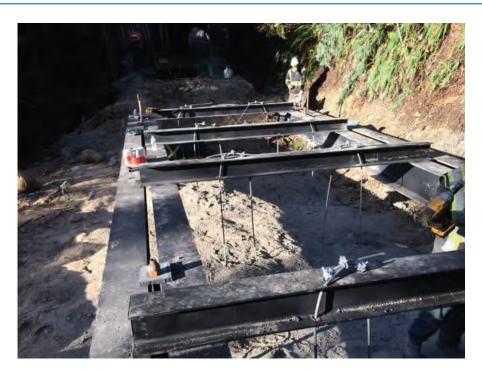
Figure 1: Installation of the Last Cross-Over Beam and Steel Straps.

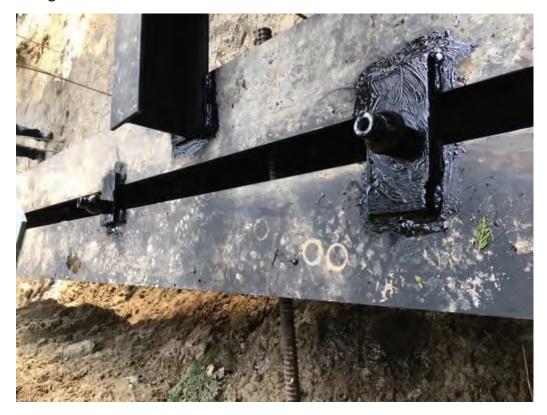
Figure 4: Application of Protective Paint Patch over the Grade Beam

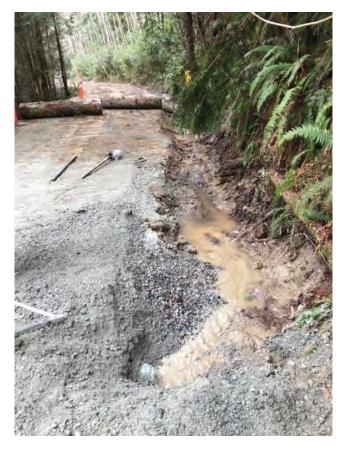
Figure 6: Installation of Wood Logs and Surface Preparation of the Ditch and Connection to the Drainpipes

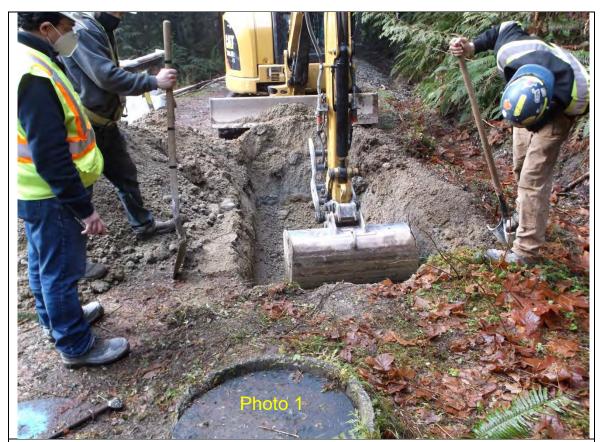
Jan 20, 2021; 10:43 – Chapman Creek Landslide - SCRD Waterline Stabilization View west - expose and locate 2 waterlines

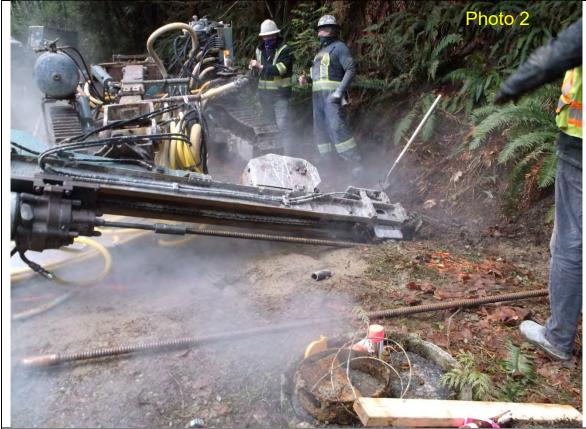
Jan 20, 2021; 15:25 – Chapman Creek Landslide - SCRD Waterline Stabilization View west - drill horizontal anchor pile

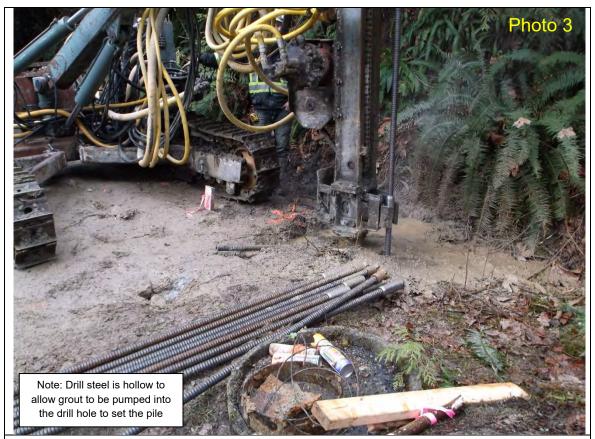
Jan 21, 2021; 09:52 – Chapman Creek Landslide - SCRD Waterline Stabilization View to west - drill vertical pile

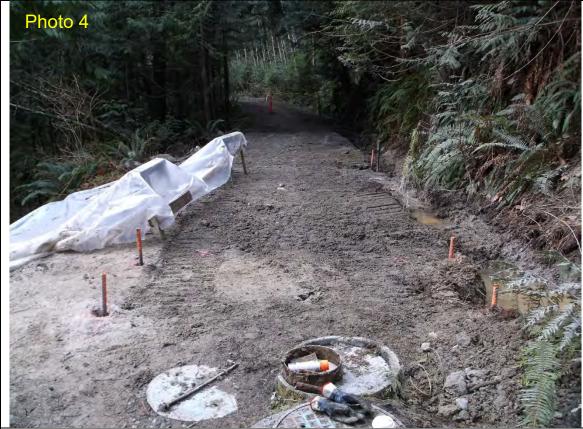
Jan 23, 2021; 11:11 — Chapman Creek Landslide - SCRD Waterline Stabilization View to west - piles installed and grouted

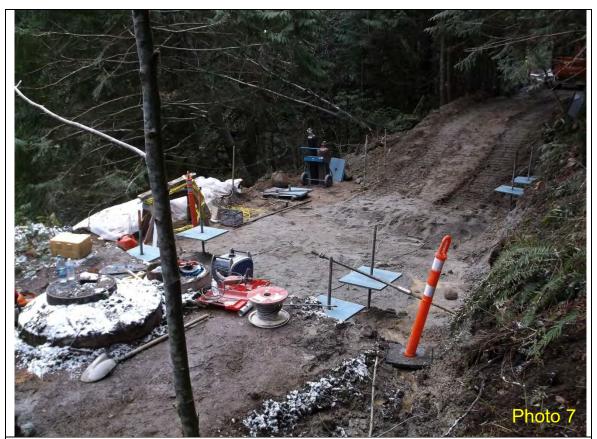
Feb 11, 2021; 12:52 — Chapman Creek Landslide - SCRD Waterline Stabilization View west - steel cable straps installed and steel plate preparation for grade beam installation

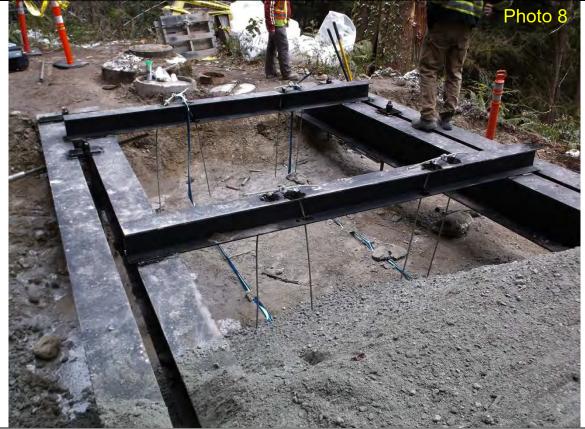
Feb 12, 2021; 13:23 — Chapman Creek Landslide - SCRD Waterline Stabilization View east - grade beam installed with steel cable straps; backfilling structure

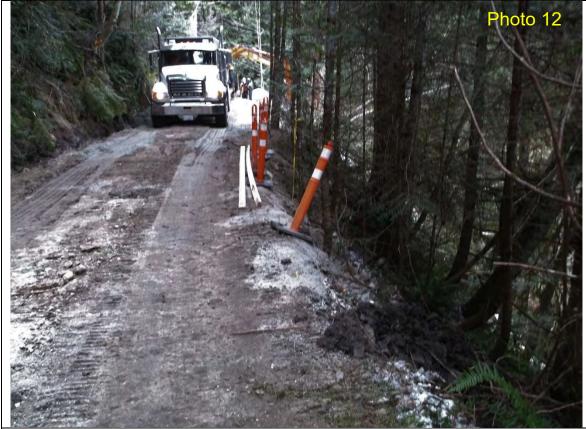
Feb 12, 2021; 14:25 — Chapman Creek Landslide - SCRD Waterline Stabilization View east - grade beam installed, over steepened placed fill soils before removal

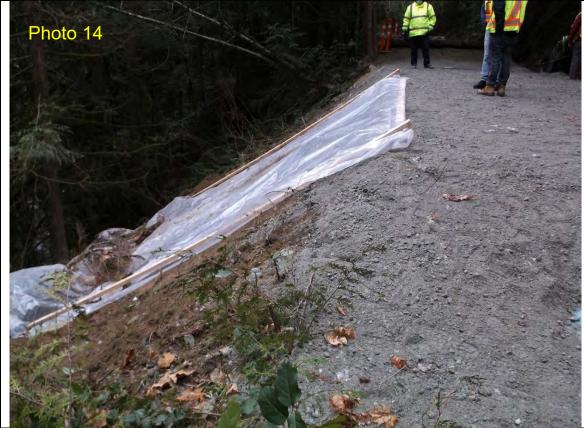
Feb 12, 2021; 15:08 – Chapman Creek Landslide - SCRD Waterline Stabilization View west - grade beam installed, poly sheet fill slope erosion protection
