**DAKOTA CREEK BIOINVENTORY
FOR SUBDIVISION OF LOTS G & J, HILLSIDE INDUSTRIAL PARK,
PORT MELLON**

(B.C. Environment File No. 72000-25/01-005-13385)

prepared by:
Alan J. Whitehead, M.Sc., R.P.Bio.
Whitehead Environmental Consultants Ltd.
R.R. 1 CH-11, Bowen Island, B.C.
V0N 1G0

October 1999

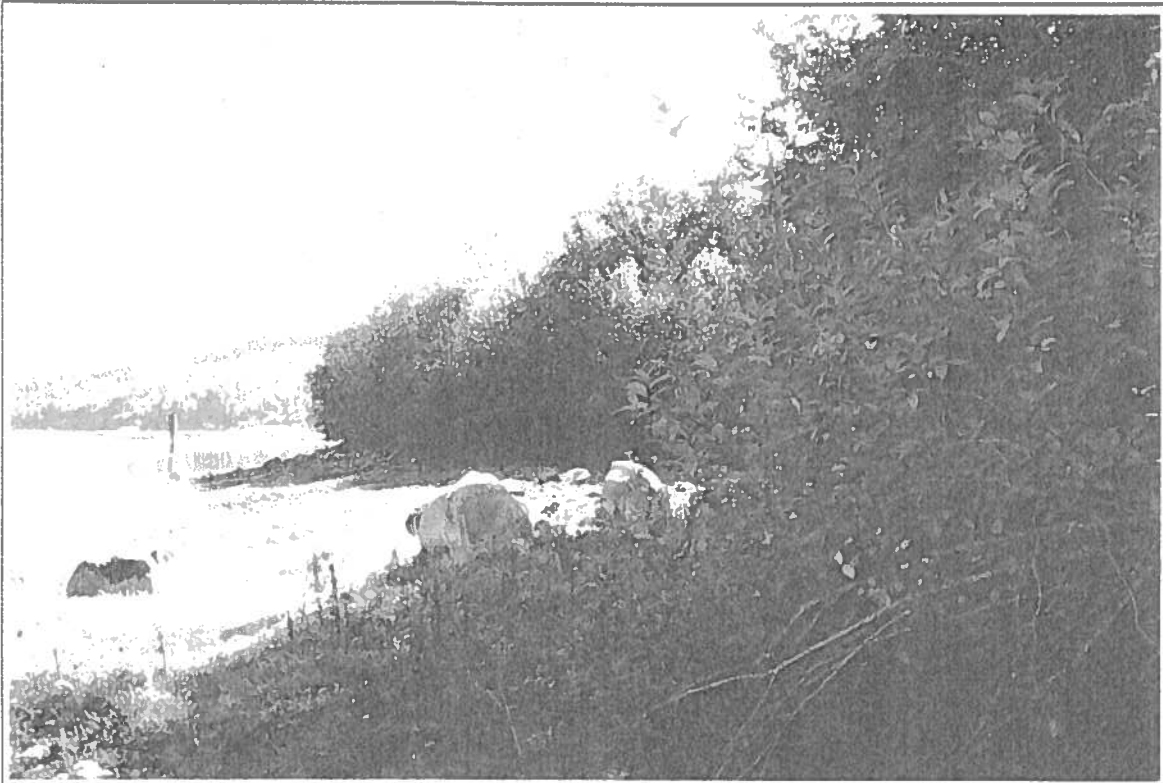
Photo 1. Marine foreshore and riparian leave-strip of dense regenerating red alder on the SE side of Lot G, viewed to the south. Vegetation is growing on decomposed wood waste. 2-Sep-99.

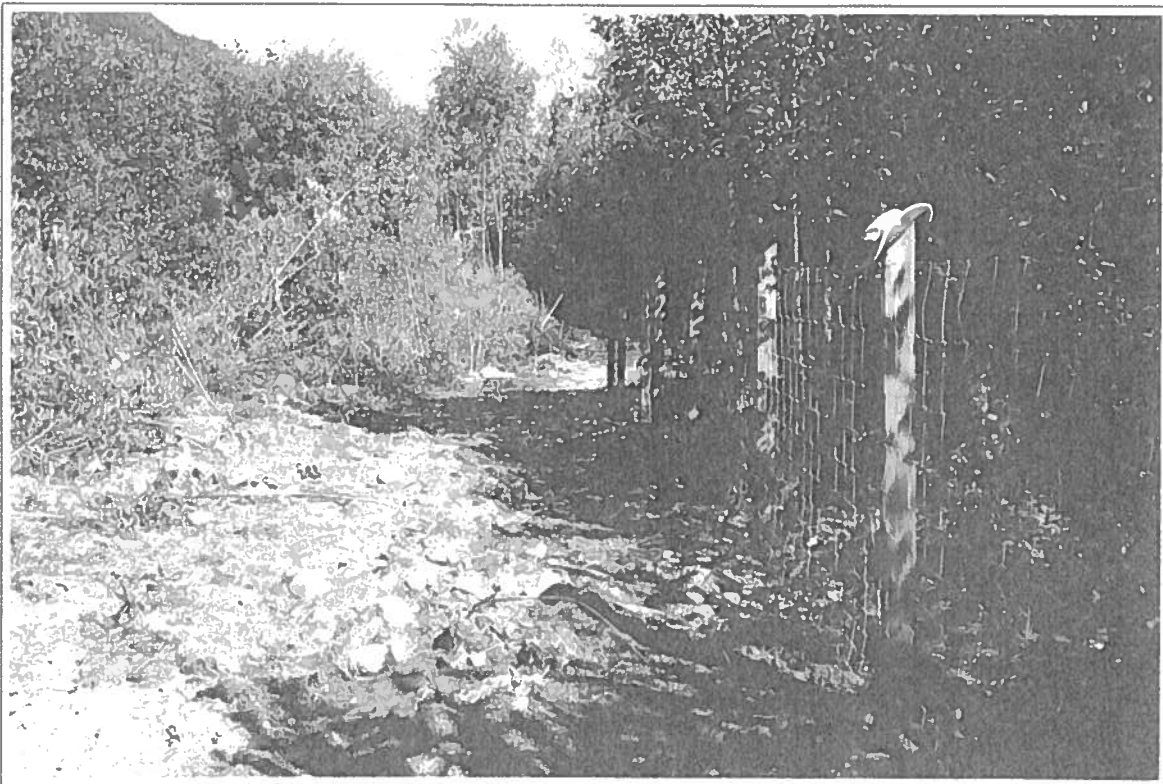
Photo 2. Inland (W) side of covenanted riparian leave strip along the marine foreshore of Lot G. Fence is approximately 2 m high. Vegetation on left is outside of covenanted area. 2-Sep-99.

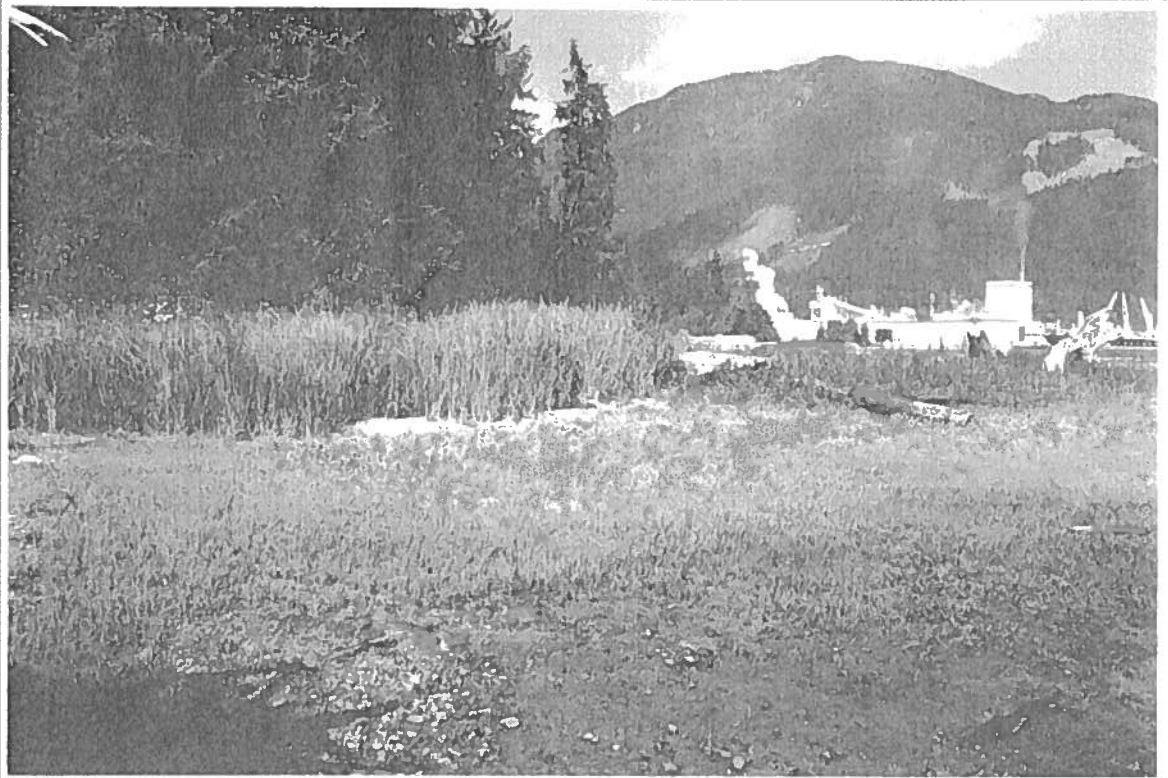
Photo 3. Marine foreshore and riparian leave strip on the NE side of Lot G, viewed to the north. Mill of Howe Sound Pulp & Paper Ltd. at Port Mellon is in background. 2-Sep-99.

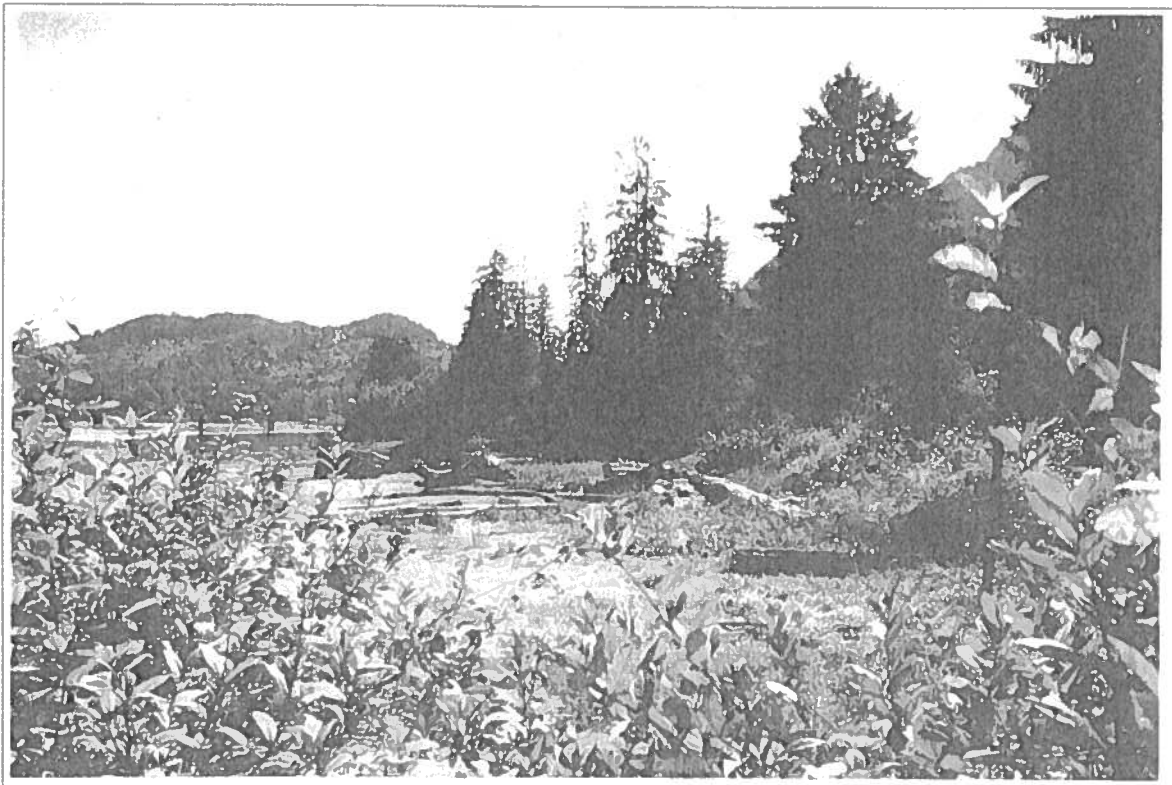
Photo 4. Marine foreshore of Lot G, looking south from the mouth of Dakota Creek at the NE corner. Note band of conifers within covenanted leave strip. 2-Sep-99.

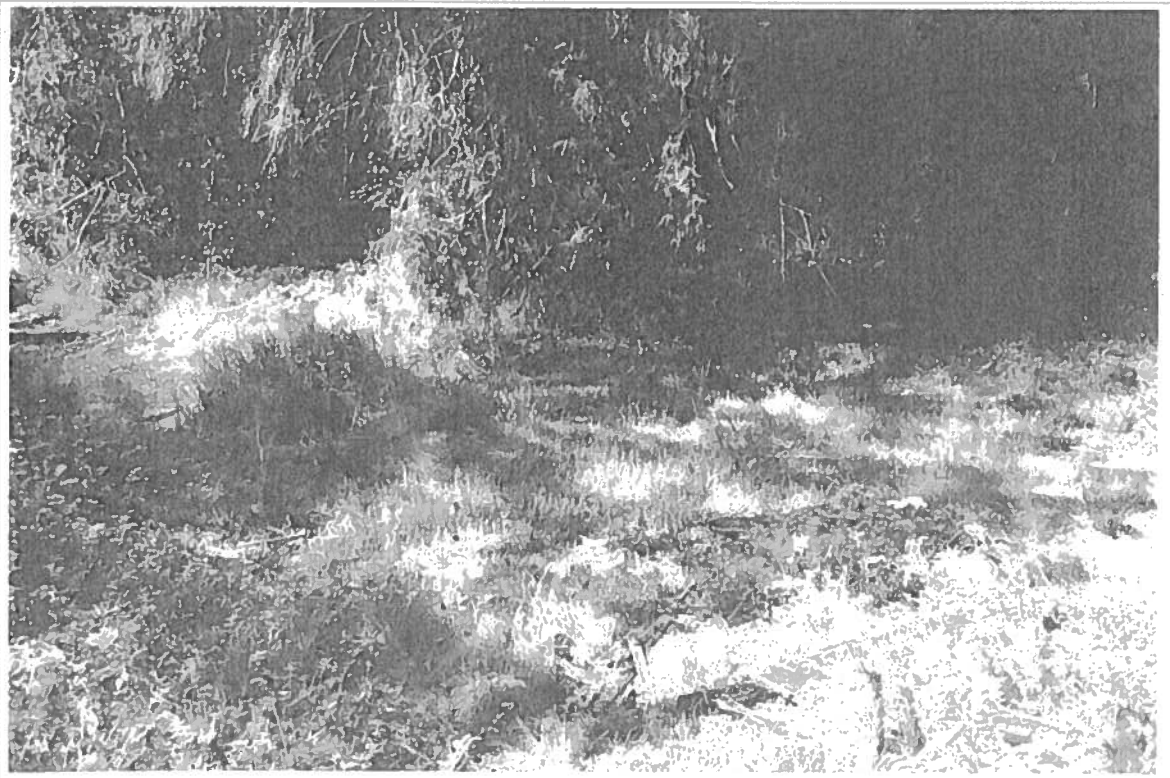
Photo 6. Central portion of constructed habitat compensation saltmarsh at NE corner of Lot G. The entire saltmarsh lies within the covenanted riparian leave strip of this lot. 2-Sep-99.

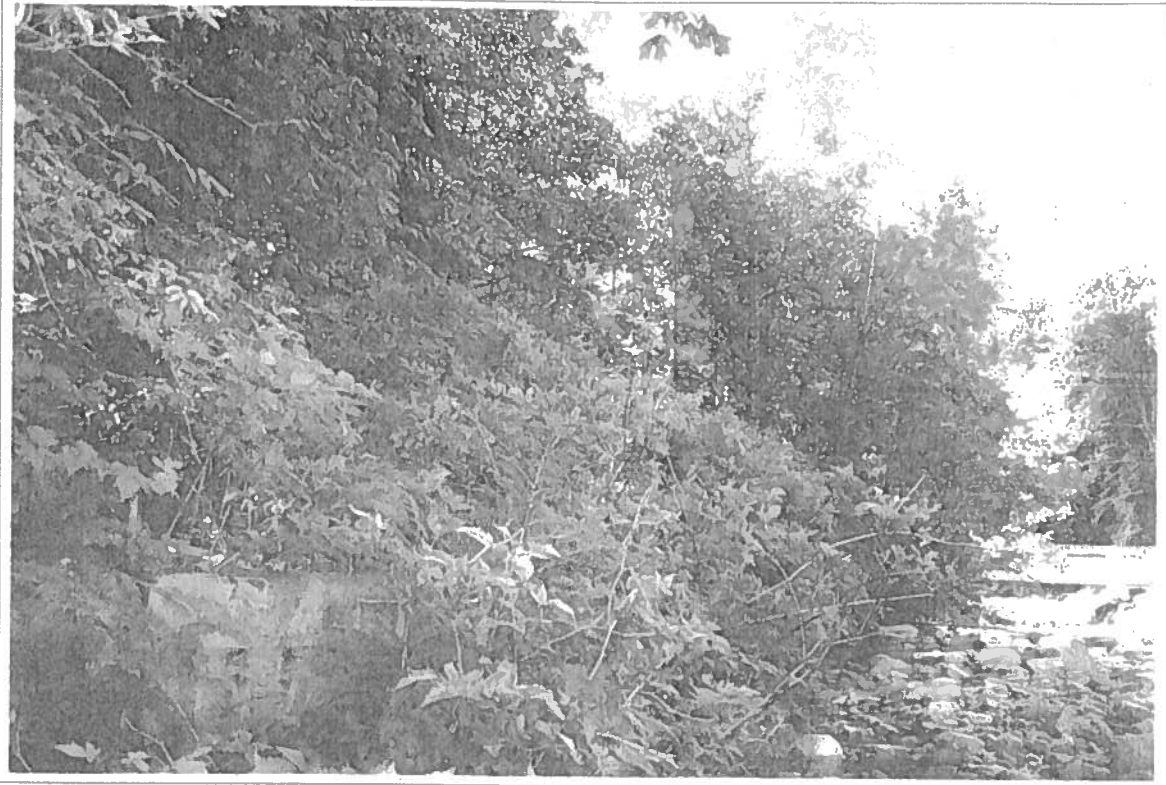
Photo 9. Riparian vegetation along N side of Lot G. Note boulder-cobble channel, Forest Service Road bridge upstream and old car body on lower left. 2-Sep-99.

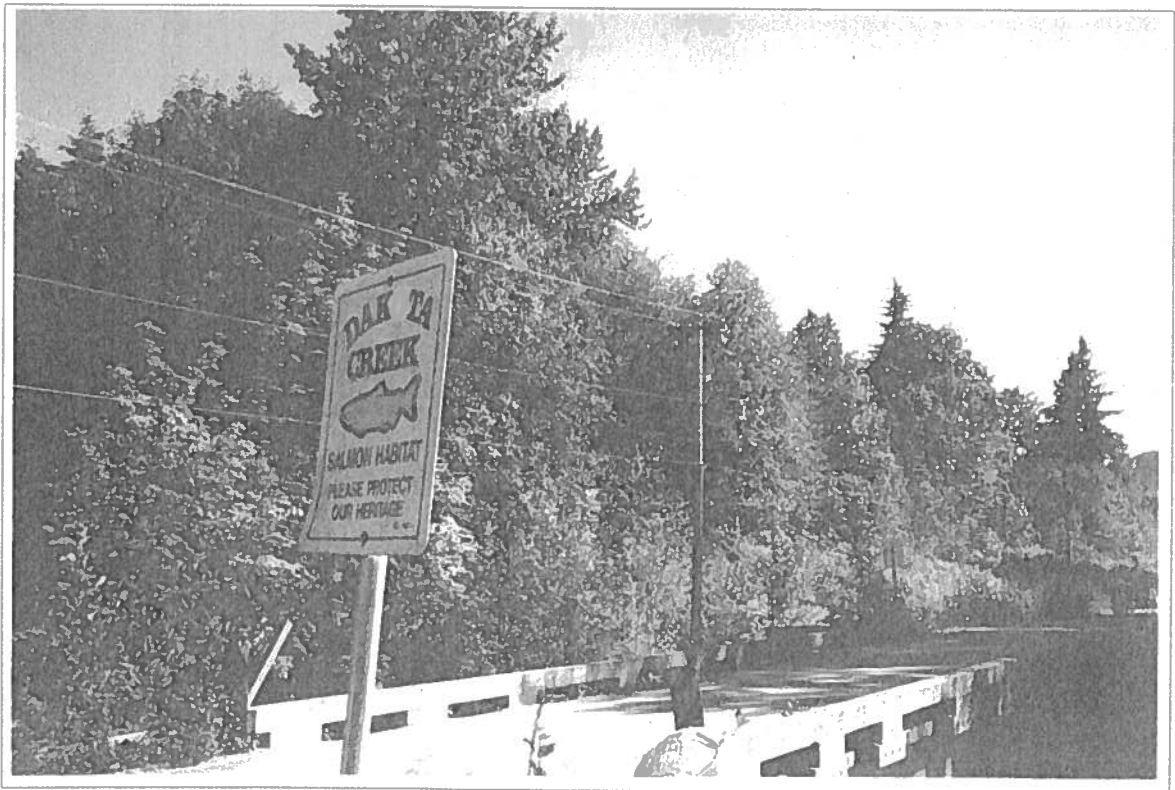
Photo 10. Riparian vegetation at NW corner of Lot G, viewed to SE from opposite side of Dakota Creek. Note Forest Service Rd. bridge, fish sign and tall cottonwood tree. 2-Sep-99.

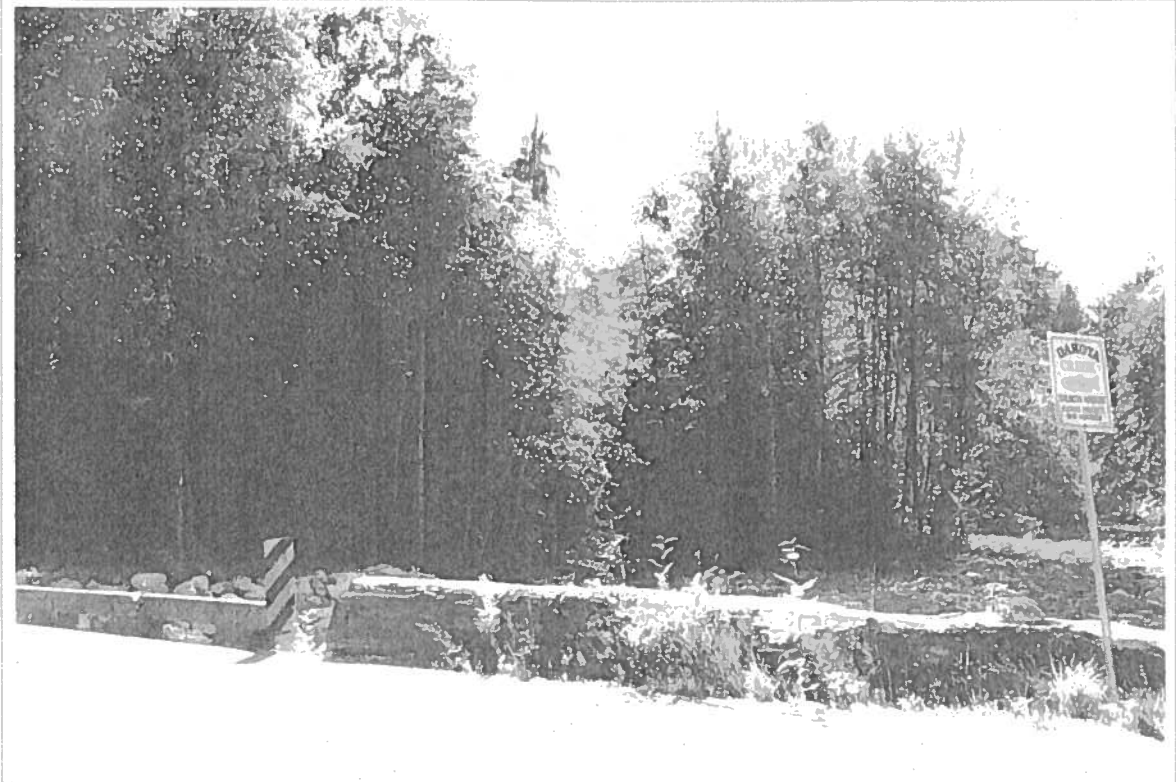
Photo 11. Riparian vegetation next to Dakota Creek at north end of Lot J, viewed to SW from Forest Service Road. Abandoned channel is in lower centre. 2-Sep-99.

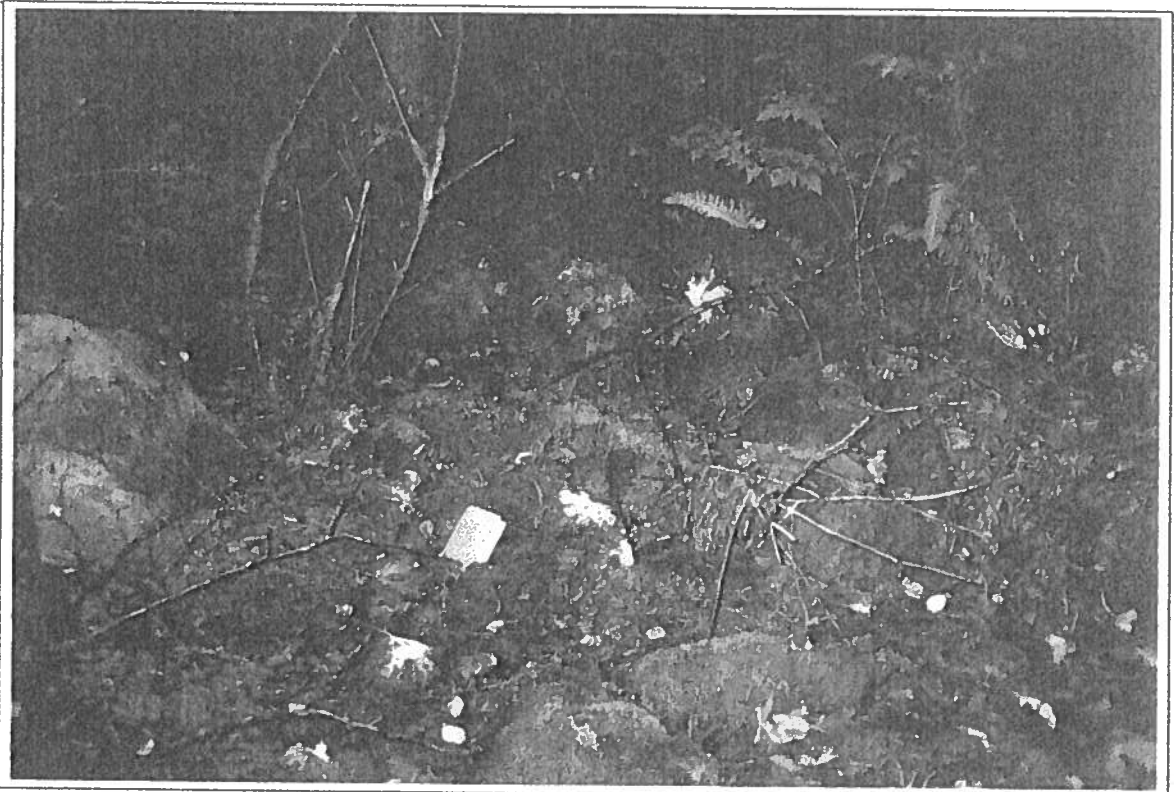
Photo 17. Stormwater channel in abandoned roadway within Lot J to south of the fenced covenanted area. (Scale, orange notebook is 0.2 m high.) 8-Oct -99

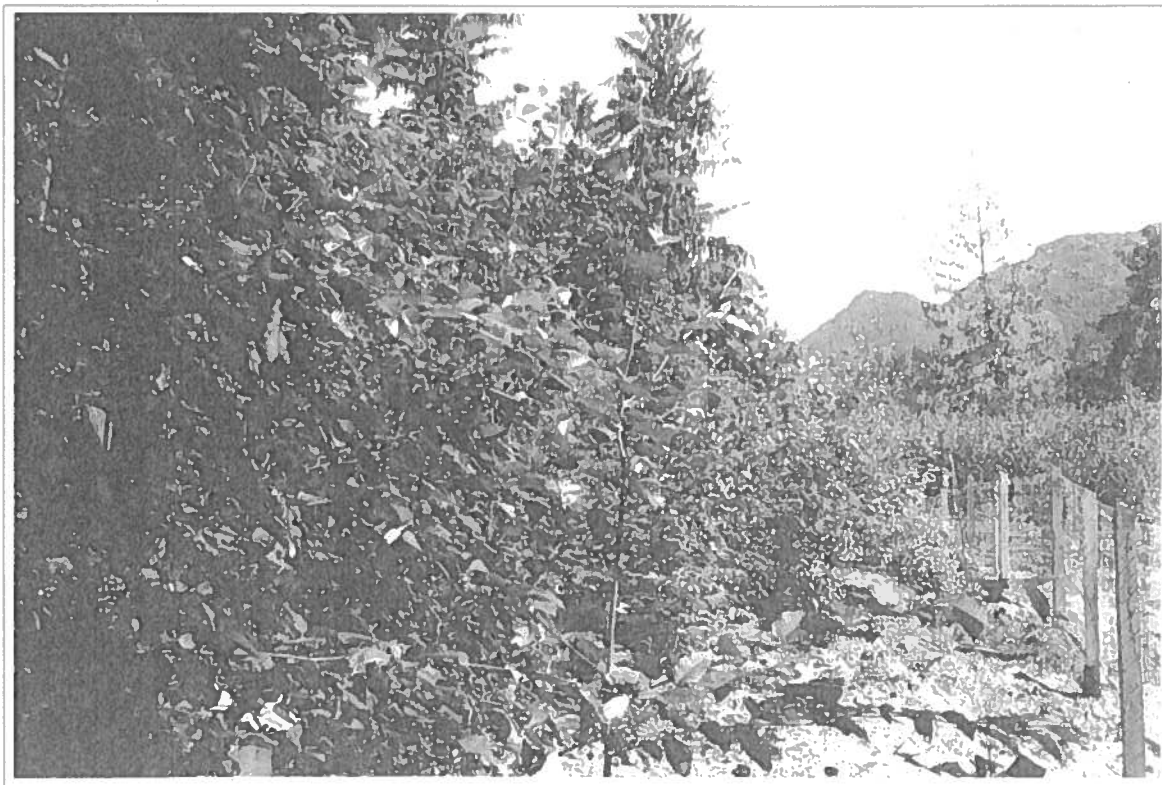
Photo 20. Dense alder thicket within covenanted area at north end of Lot G, viewed to east. Sufficient mineralization of residual woodwaste allows natural successful revegetation. 2-Sep-99.

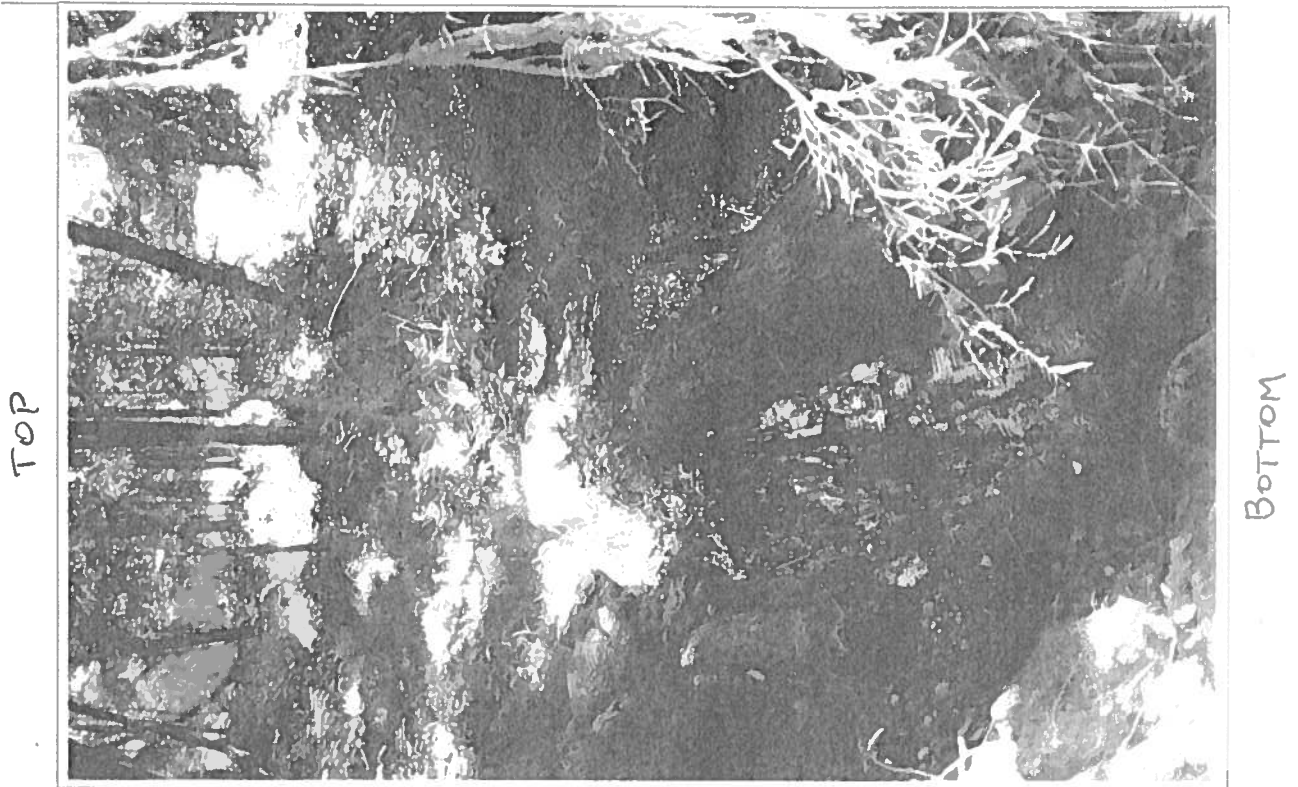
Photo 21. Upper pond constructed for fish habitat enhancement at upper end of Little Dakota creek in Lot J, viewed downstream. Pond is fed by spring outside lower corner of photo. 2-Sep-99.

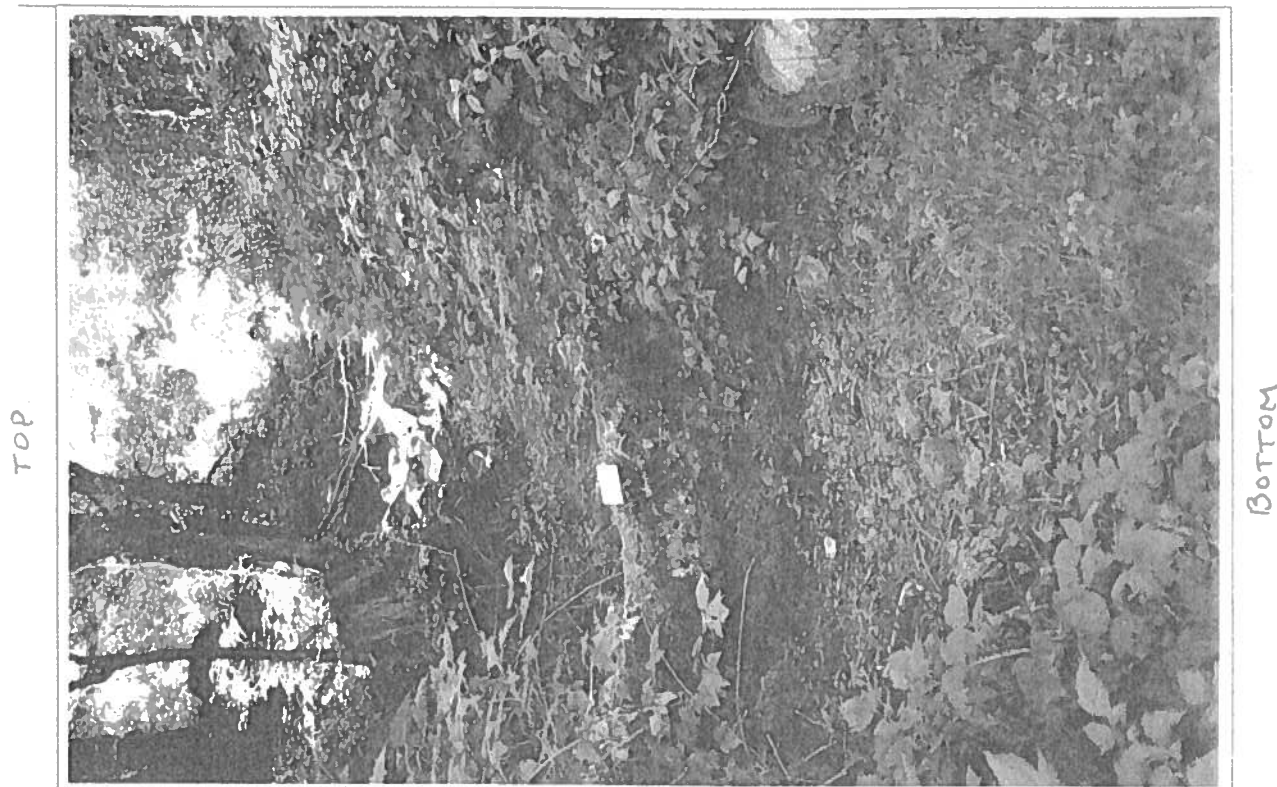
Photo 25. Dry channel of Little Dakota Creek below the Forest Service Rd viewed downstream. Channel receives water during winter storms and/or highest tides. 2-Sep-99.

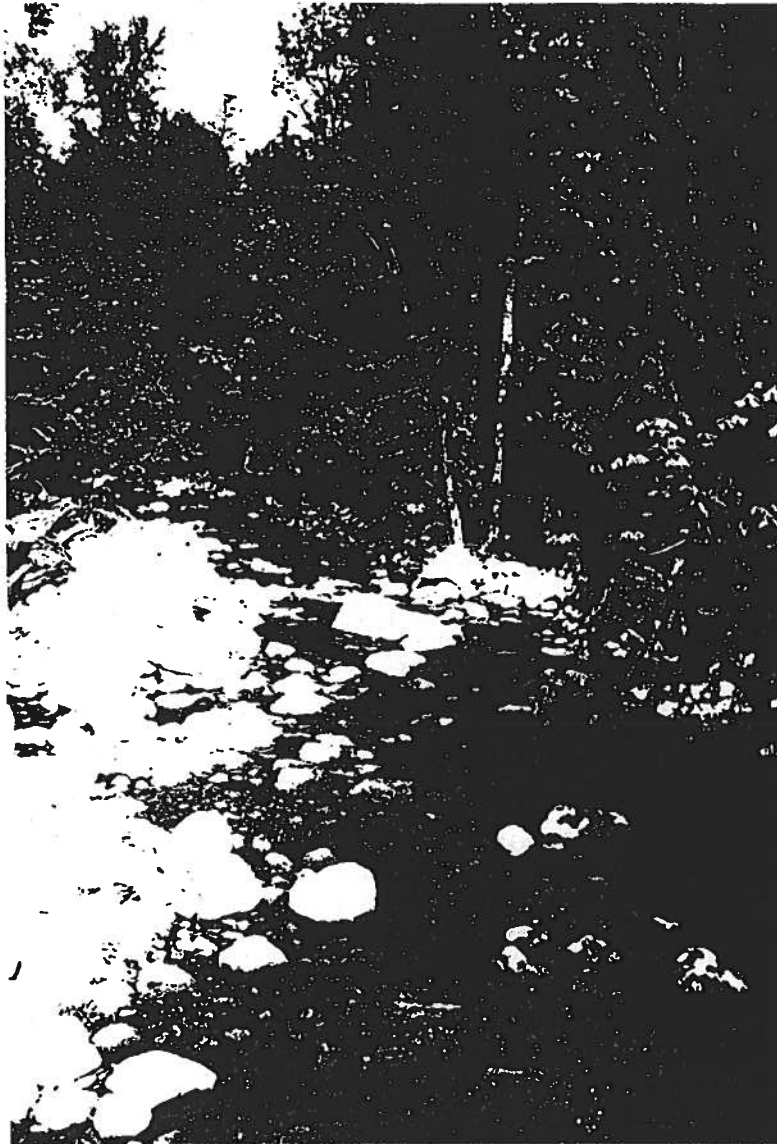
Figure 2: Photograph illustrating the type of habitat found in Reach 1 of Dakota Creek, Howe Sound, BC.
