Reference: Sir Thomas Lipton Park Bridge Inspection Program

We are pleased to submit our draft letter for the Sir Thomas Lipton Park Bridge Inspection Program. This program includes the inspection of three timber pedestrian bridges located in Sir Thomas Lipton Park on Gambier Island: East Creek Bridge, MacDonald Creek Bridge and West Creek Bridge.

Structure Name: East Creek Bridge

PROJECT : 31256 NAME: East Creek Bridge

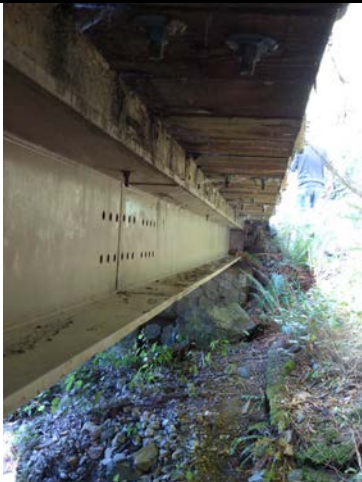
005 – E-W spanning Girder at North Side of Bridge (C.3)

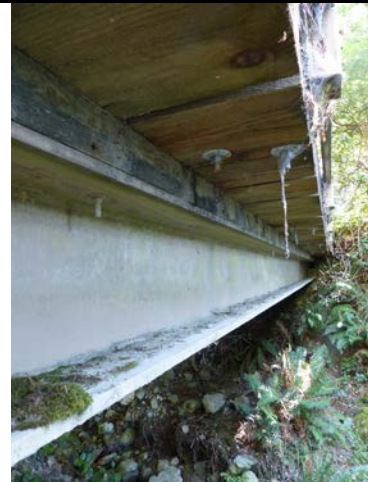
006 – Girder spanning E-W along South side of Bridge (C.3)

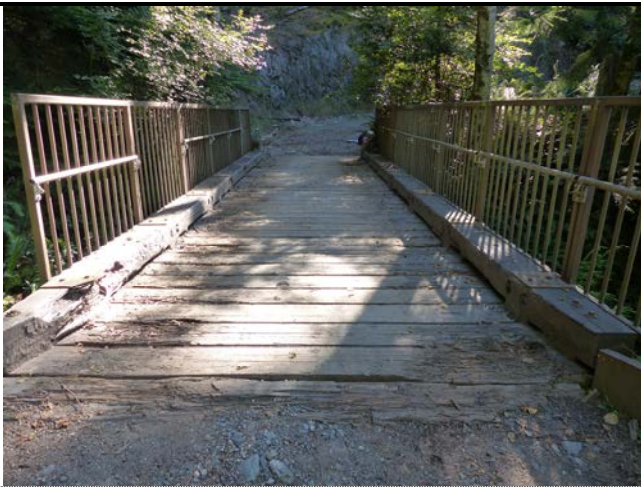
007 – View of Bridge Deck, View from West End of Bridge (D)

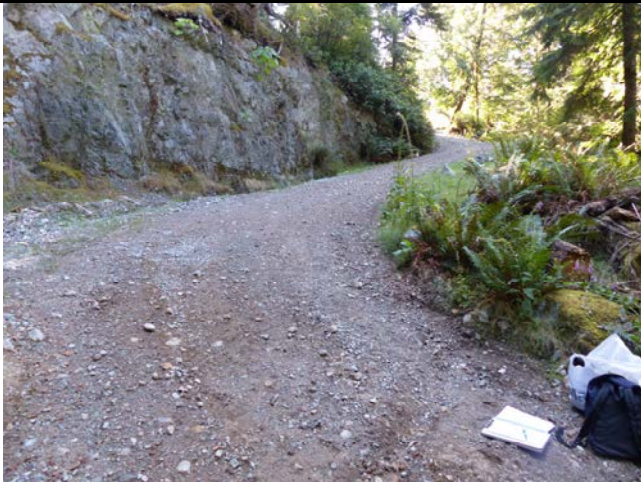
E.2.a – Sharp turns at both approaches. Problematic for oversized vehicles for proper alignment onto bridge; cause of collision damage of curb and railing.

017 – Road Approach at East End of Bridge (E.2)

- Would recommend monitoring bank erosion at road approaches.

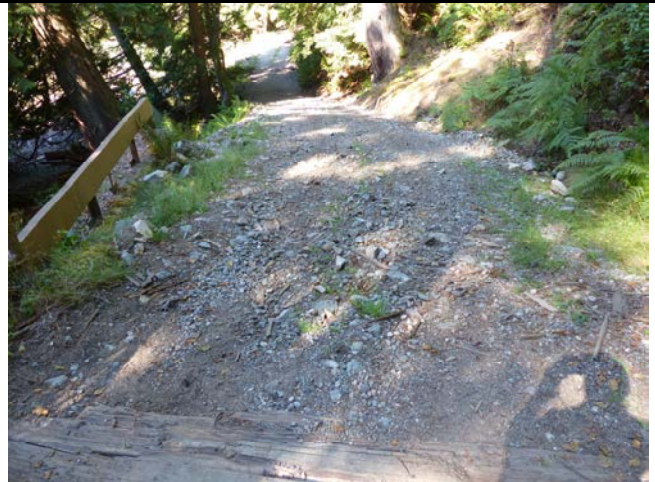
018 – Steep Grade and Curve at Roadway Approach at West end of Bridge (E.2)

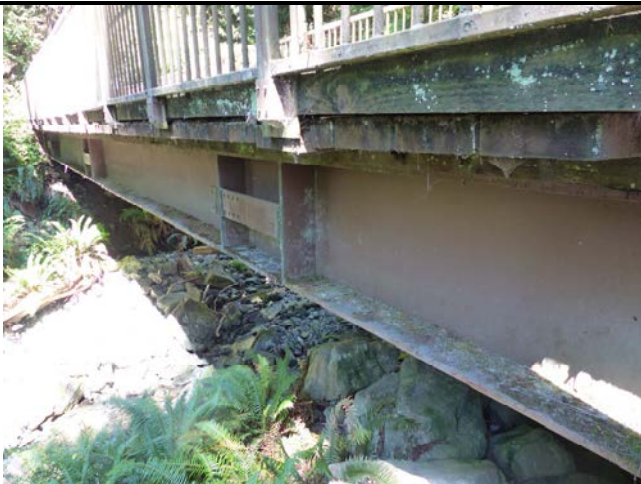
005 – View of Steel Girder along South side of Bridge (C.3)

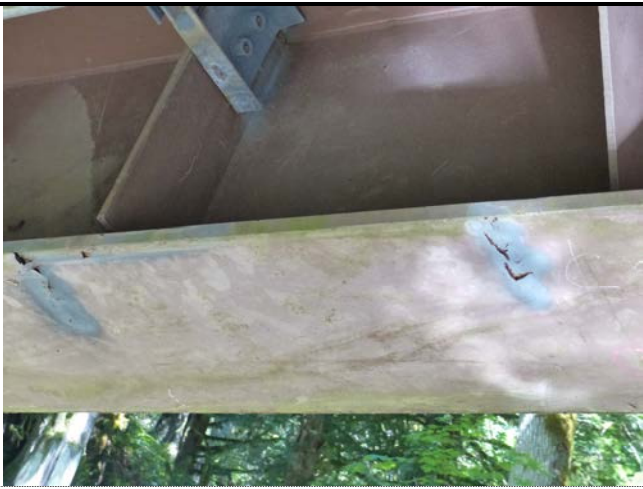
007 – Localized Scaling at Steel Girder, at East end of North side of Bridge (C.3)

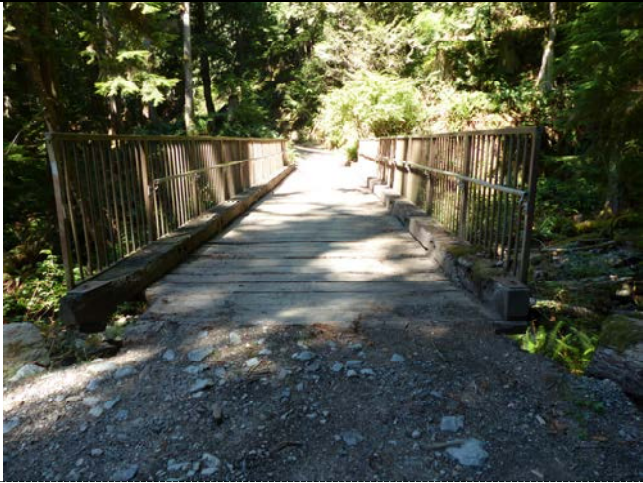
009 – View of Bridge Deck, View from East End of Bridge (D.2)

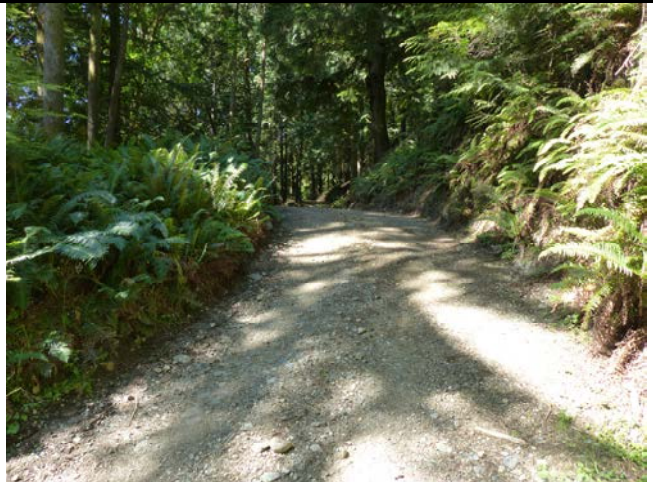
E.2.a – Sharp turns at both approaches. Problematic for oversized vehicles for proper alignment onto bridge; cause of collision damage of curb and railing.

018 – Steep Uphill Grade and Curve at Roadway Approach at West end of Bridge (E.2)

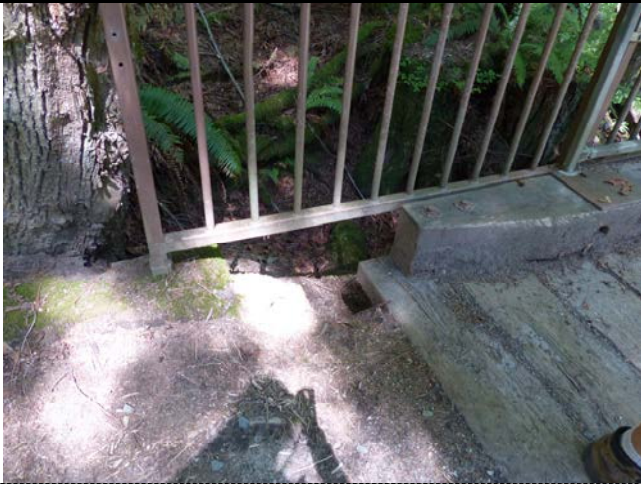
003 – Minor Erosion at NW Corner of Bridge (A.2)

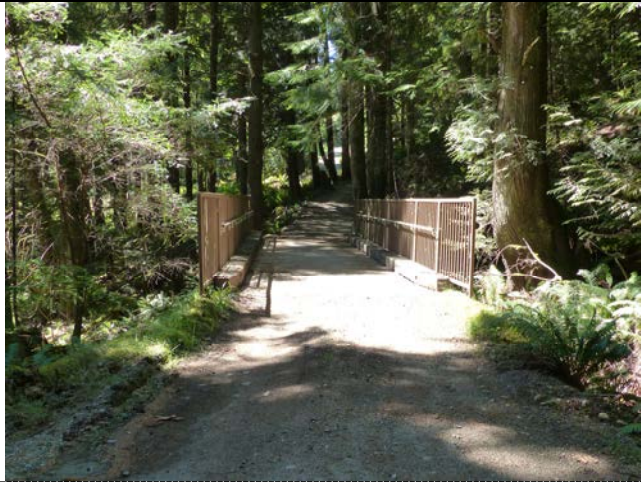
010 – View of Bridge Deck, View from East End of Bridge (D)

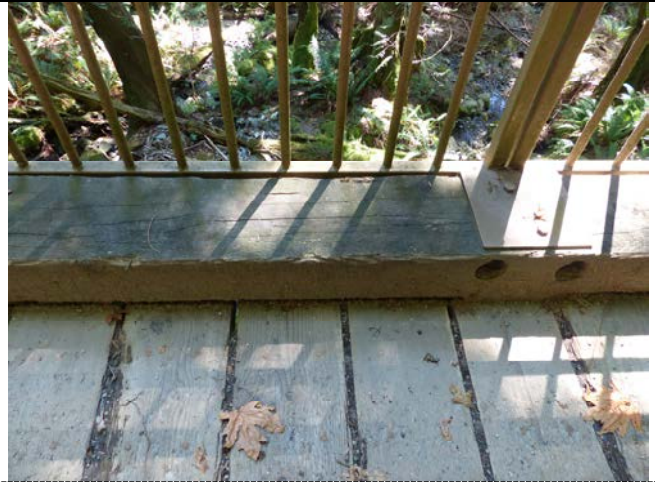
010 – Accumulation of Soil and Gravel between Planks and Wanes at Bull Rail (D.2, D.4)

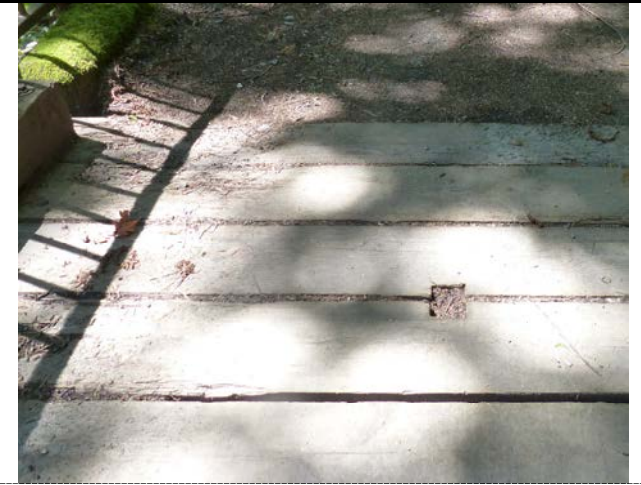
011 – Tread marks on Planking, SW corner of Bridge (D.2)
