## Sunshine Coast Regional District

## 2017 Trail Bridge Inspections – Final Report

Purchase Order # 3000710

Submitted December 1, 2017

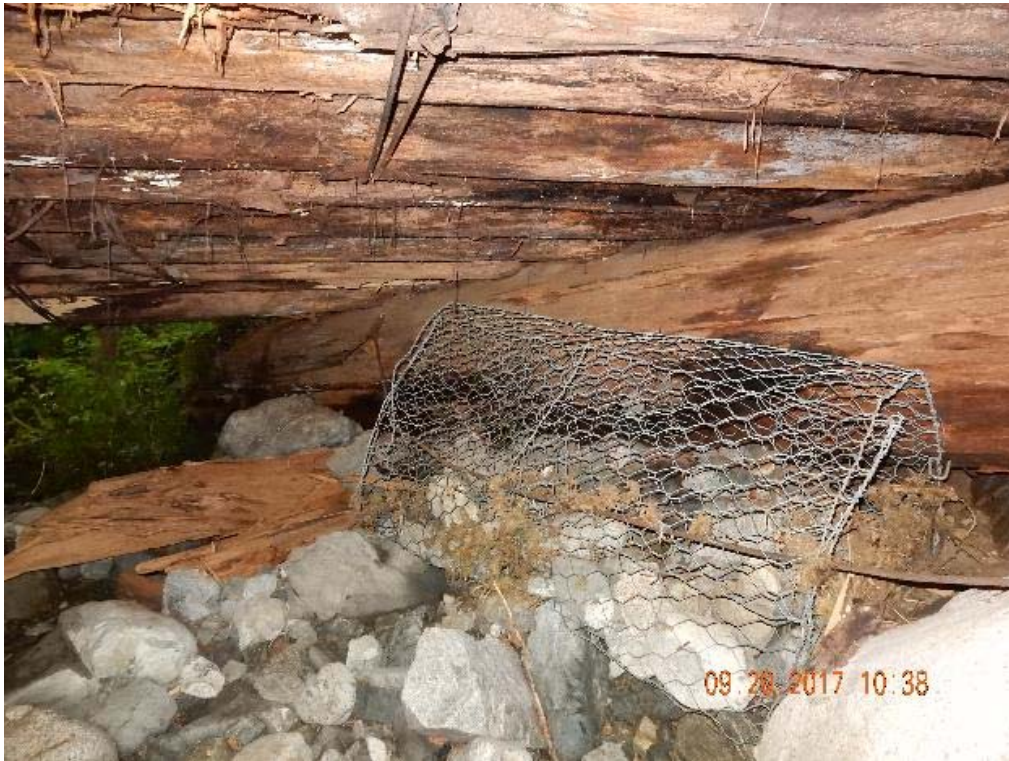
P09 – North abutment, gabion basket has fallen apart  
(DSCN9942.jpg)

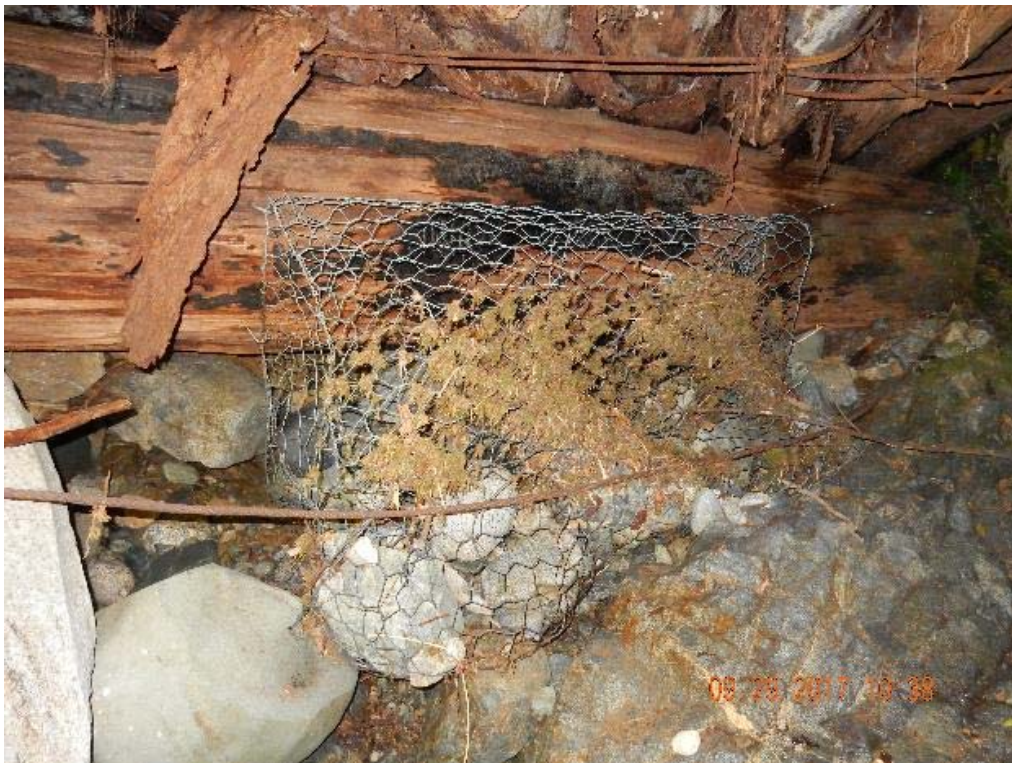
P10 – Gabion basket at north abutment  
(DSCN9944.jpg)

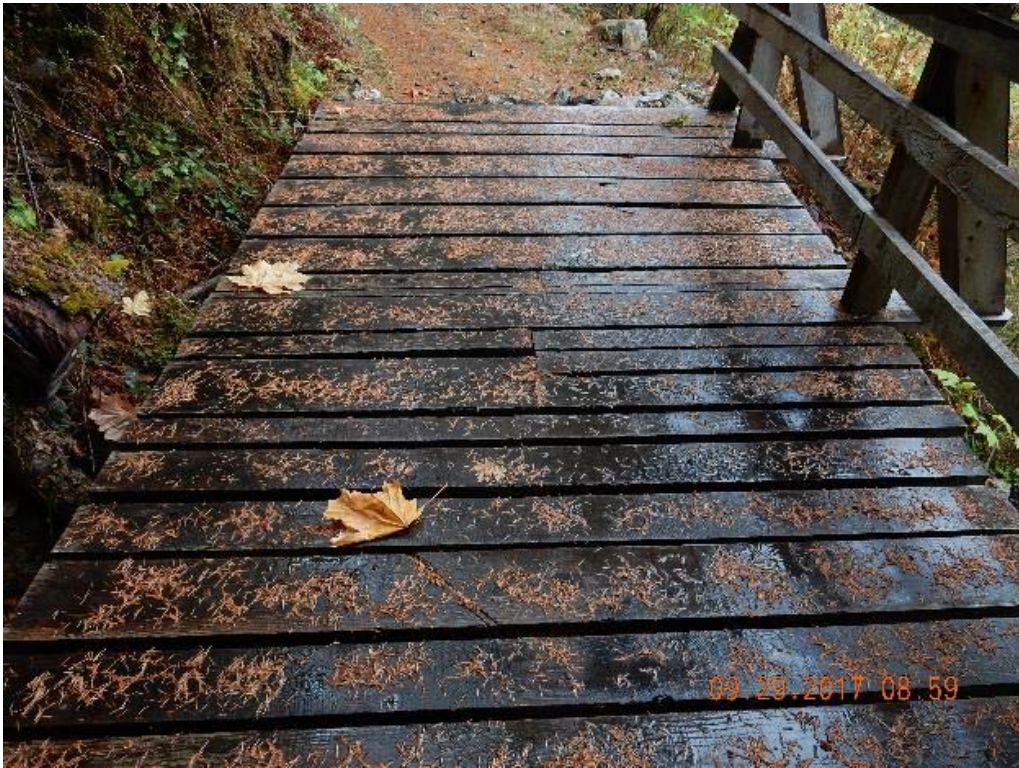
P03 – Overall decking, suggest adding anti-slip pad  
(DSCN9907.jpg)

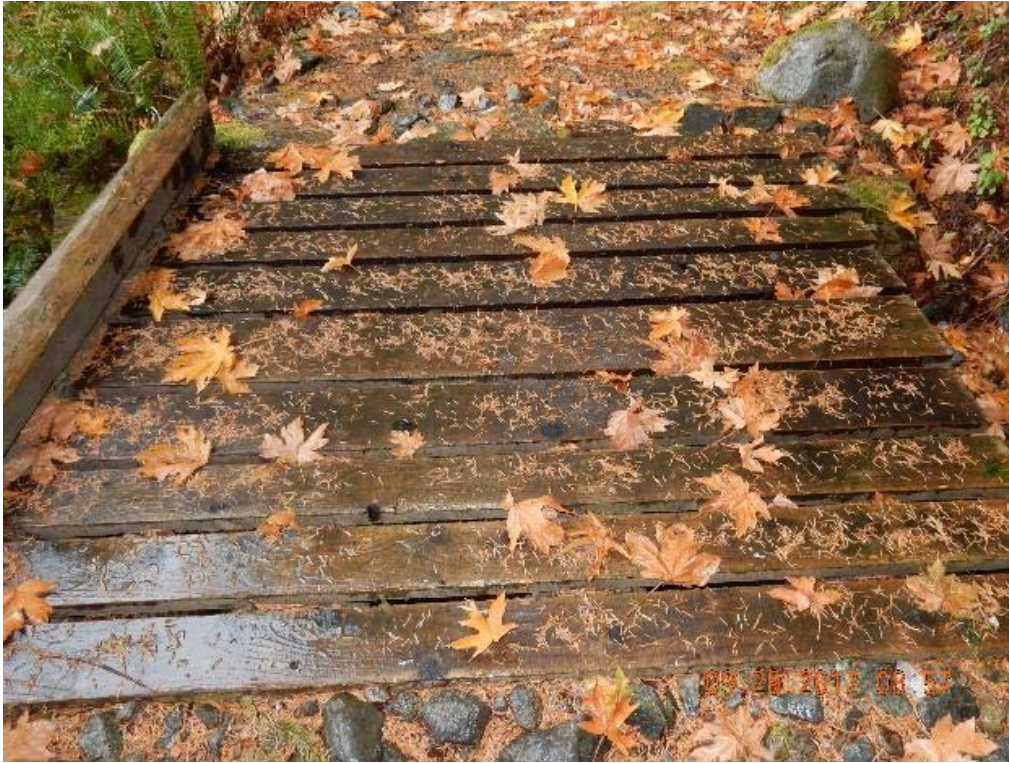
P03 – Overall decking, suggest adding anti-slip pad  
(DSCN9896.jpg)

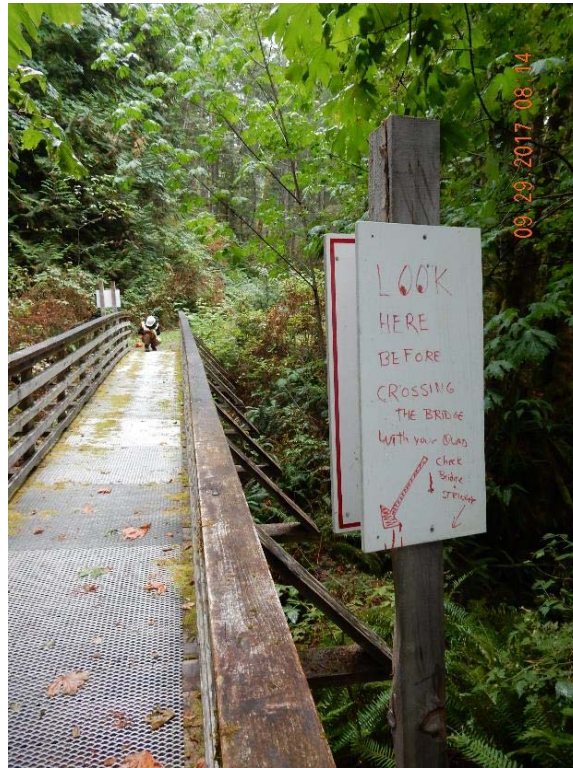
P07 – Sign at northwest corner of the bridge says, “Look here before crossing the bridge with your quad, check bridge stringer” (DSCN9853.jpg)

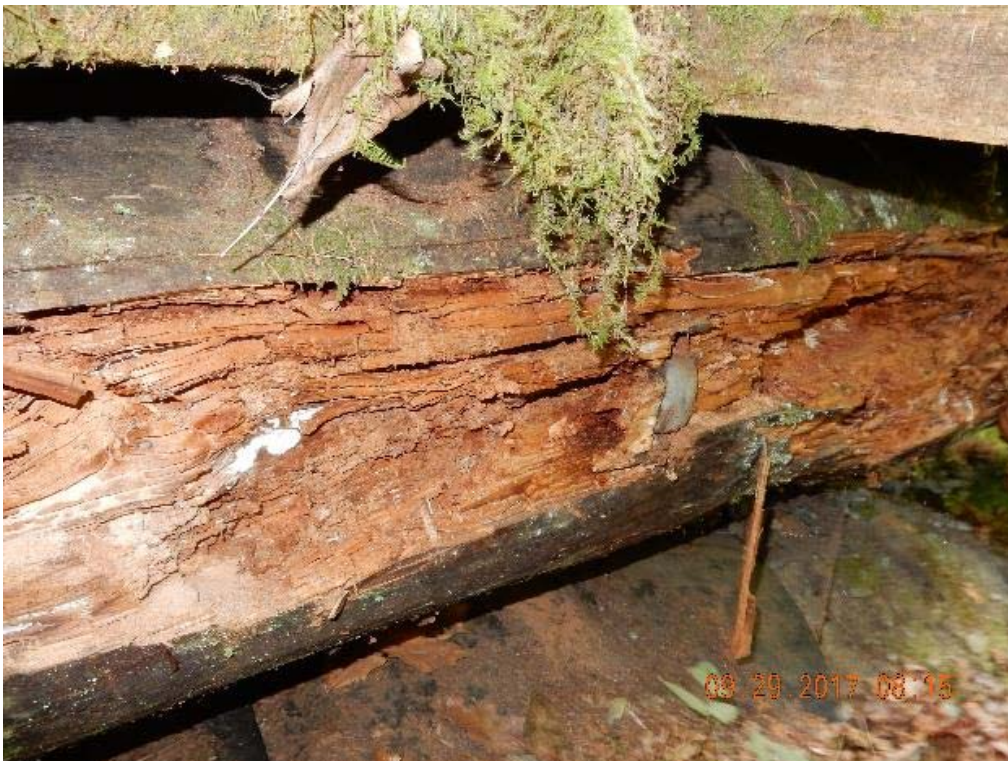
Element	Rating	Comments	Maintenance Recommendations	Estimated Cost	Priority
<b>Primary Components</b>					
Embankments	5				
Foundations	5				
Abutments	5				
Beams, Girders	1	Logs are deteriorating	Replace main load carrying members of bridge	\$20,000	High
Deck	3	Deck is covered in moss	Remove moss to prevent further deterioration	\$1,000	Medium
<b>Secondary Components</b>					
Approaches	4				
Railings	4				
<b>Auxiliary Components</b>					
Slope Protection	4				
Signs	1	No load restriction sign present	This bridge passes strength capacity for more than 5 people, but we would not recommend any horses or ATVs on the bridge. From a deflection criteria, as laid out in the Canadian Timber Design Manual, this bridge requires NEGATIVE two people in order to pass. It is recommended that this bridge be highest on the SCRD's list of replacement bridges.

P10 – Northwest corner of the bridge, log is breaking apart  
(DSCN9856.jpg)

Vine Brook Bridge should be replaced as soon as possible, and various other erosion concerns should be addressed.

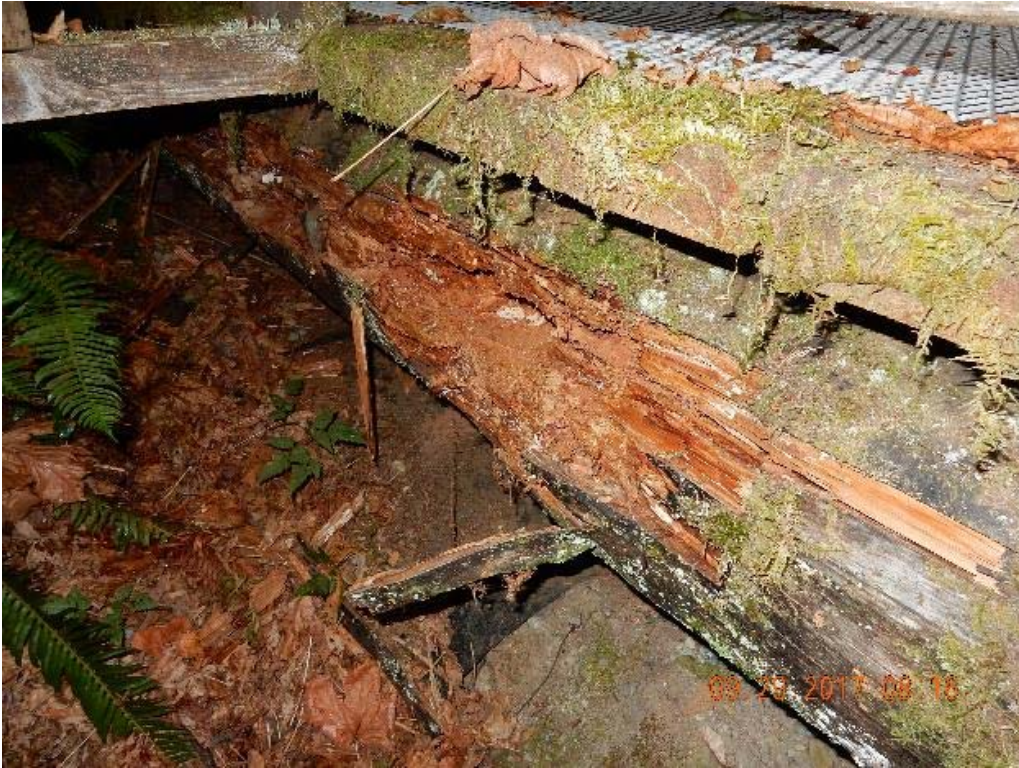
P11 – Northwest corner of the bridge, log is breaking apart  
(DSCN9859.jpg)

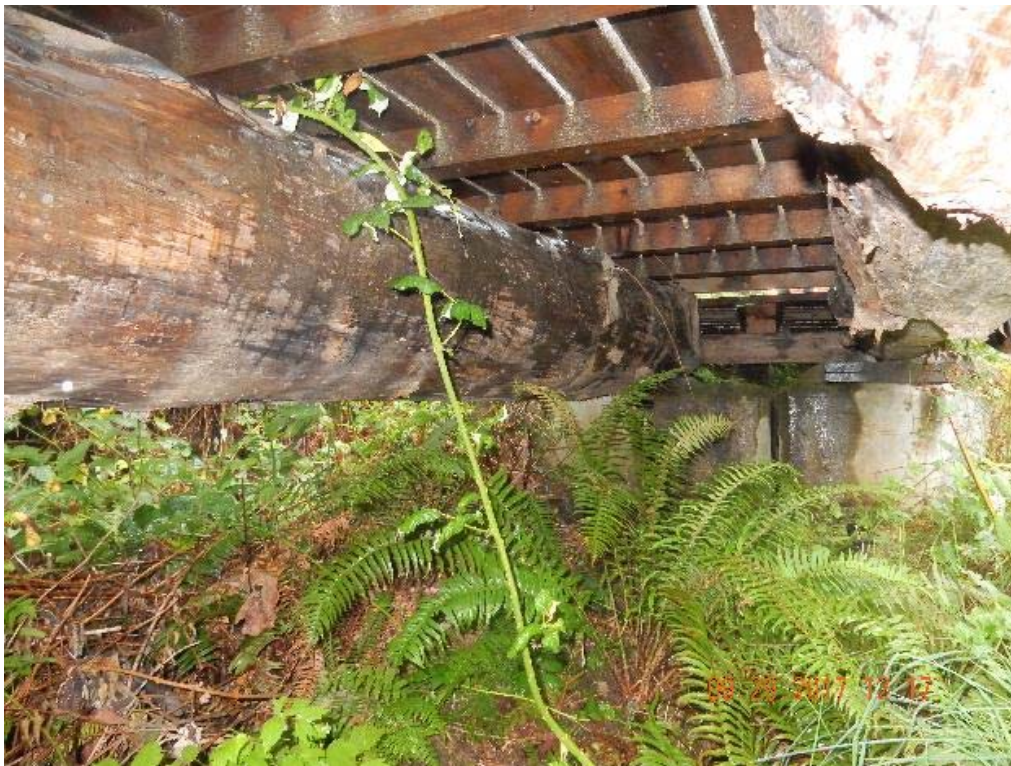
P10 – Under side of the bridge  
(DSCN9992.jpg)

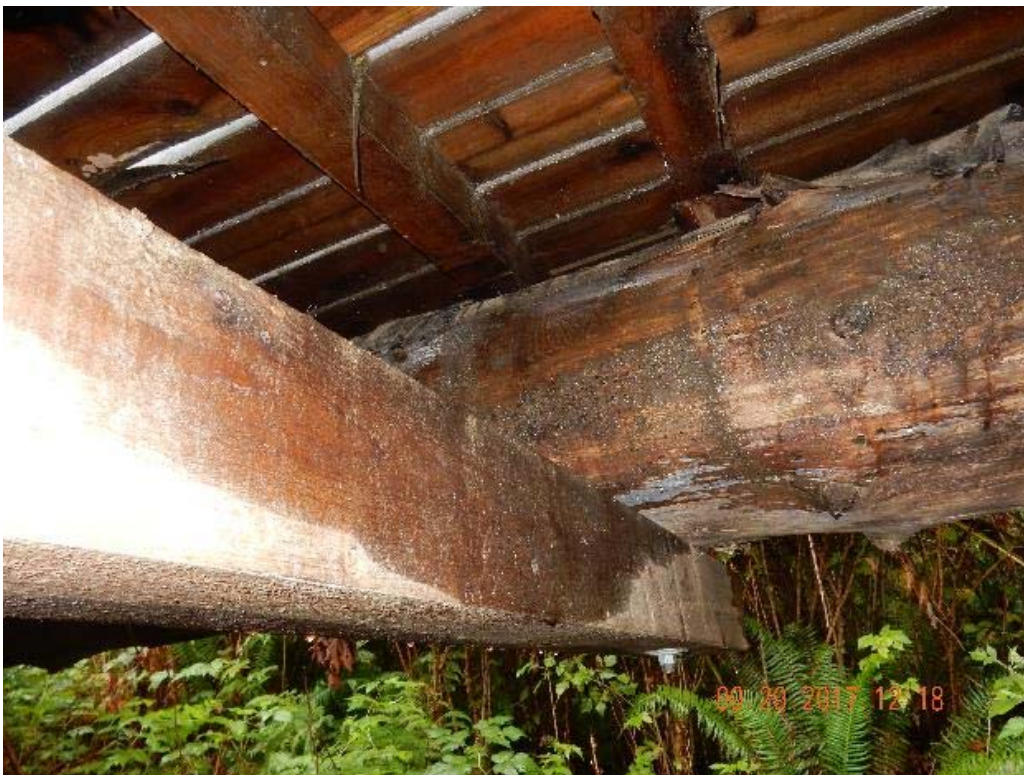
P12 – Under side of the bridge (detail view)  
(DSCN9994.jpg)

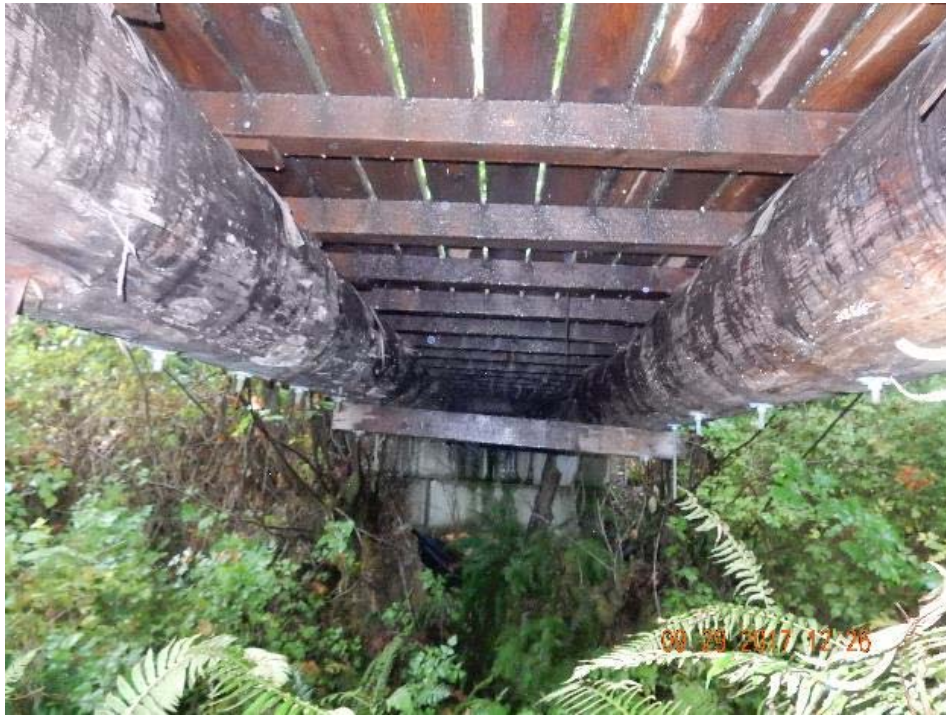
P09 – Under side of the bridge (looking north)  
(DSCN0007.jpg)

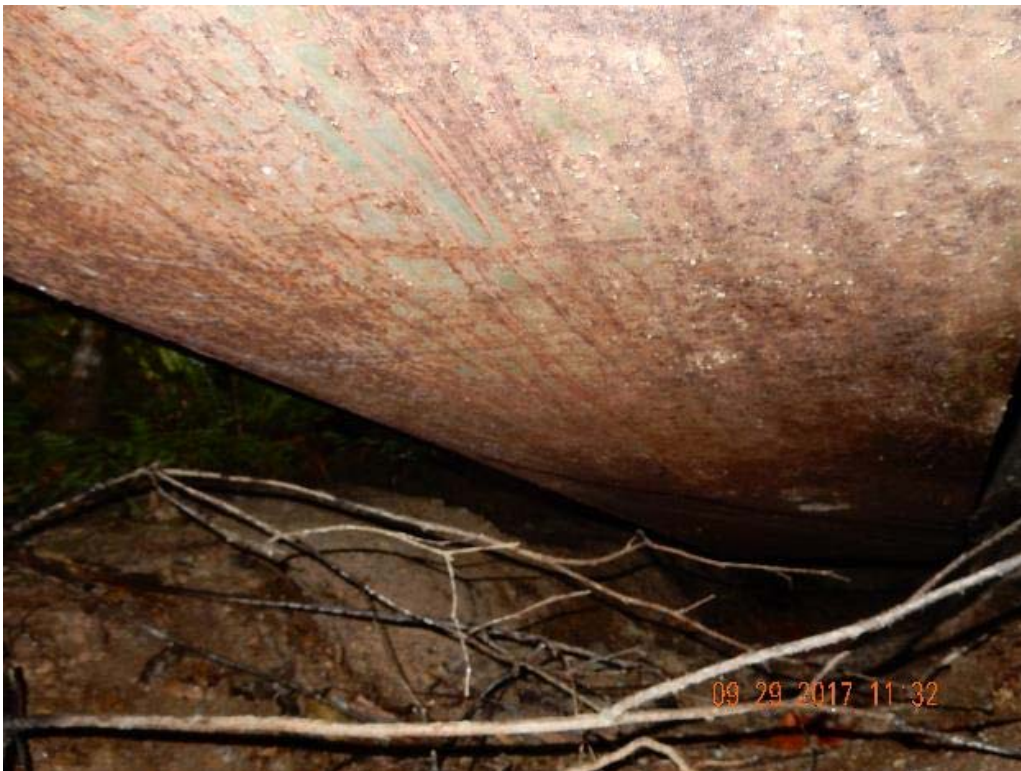
P12 – Under side of the main box girder  
(DSCN9967.jpg)

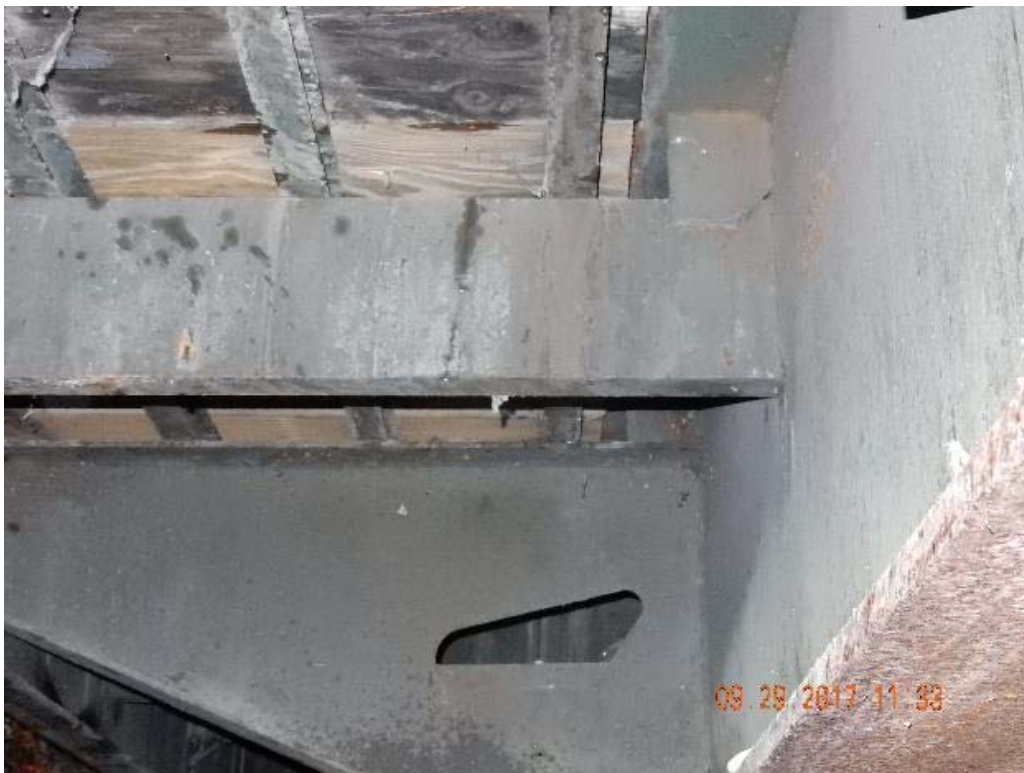
P16 – Detail view of floor beam  
(DSCN9973.jpg)

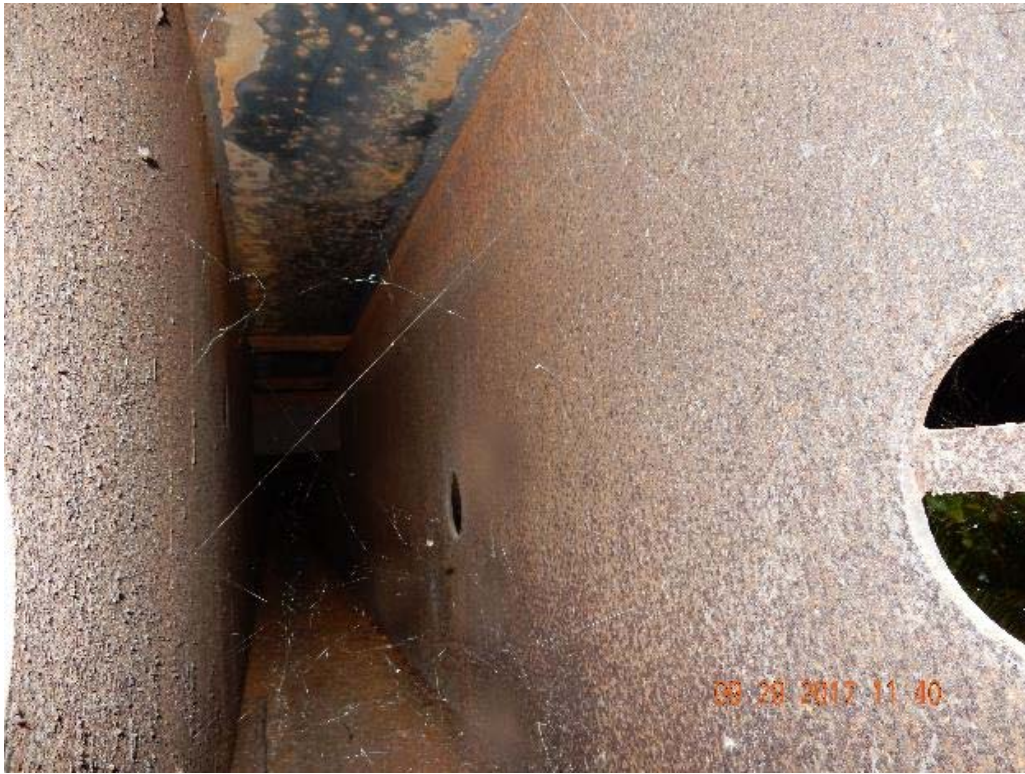
P17 – Looking inside of the main box girder  
(DSCN9975.jpg)

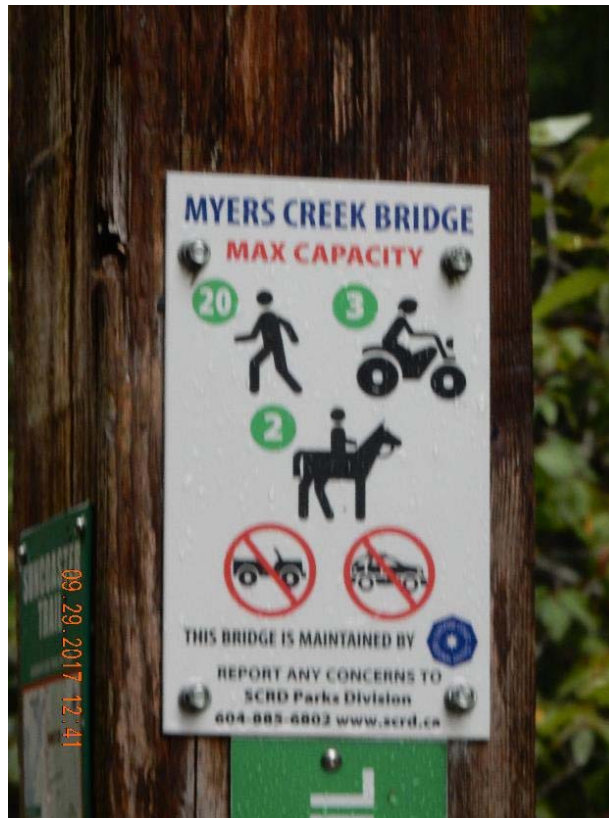
Element	Rating	Comments	Maintenance Recommendations	Estimated Cost	Priority
<b>Primary Components</b>					
Embankments	5				
Foundations	5				
Abutments	5				
Beams, Girders	5				
Deck	5				
<b>Secondary Components</b>					
Approaches	5				
Railings	5				
<b>Auxiliary Components</b>					
Slope Protection	5				
Signs	5	Bridge load rating meets strength and deflection criteria and it is OK to keep the current sign on the bridge.

P03 – Loading rating sign at the southeast corner of the bridge  
(DSCN0014. jpg)

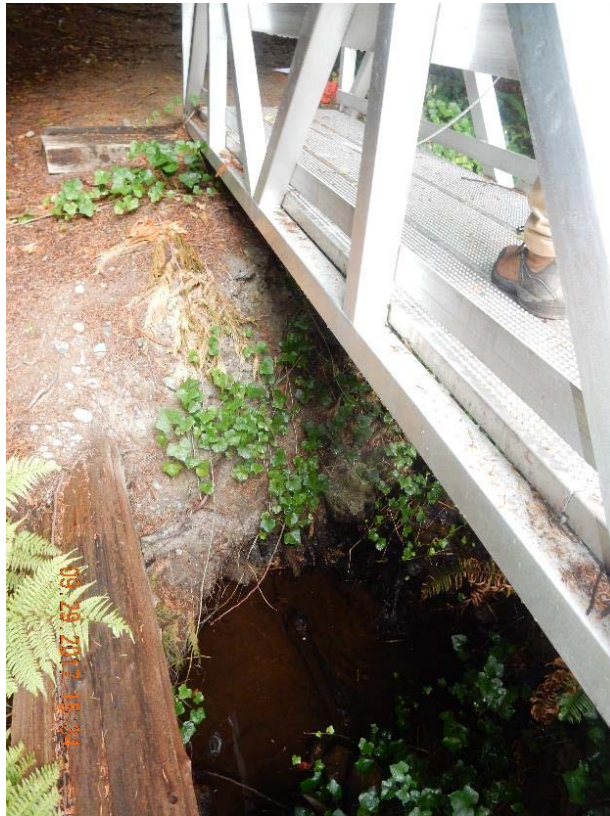
Element	Rating	Comments	Maintenance Recommendations	Estimated Cost	Priority
<b>Primary Components</b>					
Embankments	3	Erosion noticed at north embankment	Monitor erosion	N/A	Medium
Foundations	5				
Abutments	5				
Floor Beams	5				
Trusses	5				
Deck	5				
Coatings	5				
<b>Secondary Components</b>					
Bearing Seats	5				
Approaches	4	Old bridge is still on site (photo 16)	Remove old bridge	\$1,000	Medium
Railings	5				
<b>Auxiliary Components</b>					
Slope Protection	5				
Signs	4	No load restriction sign present

P11 – North embankment, erosion was noticed, needs to be monitored (DSCN0075.jpg)

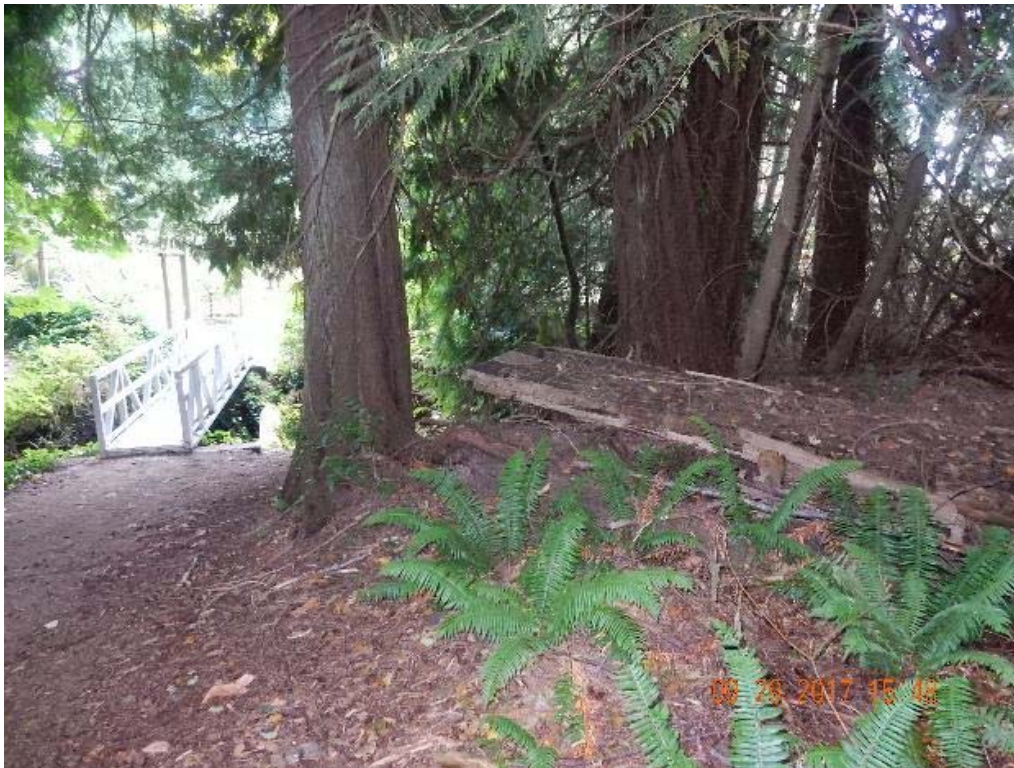
P16 – Old bridge, suggest taking away  
(DSCN0082.jpg)
