To: **Sunshine Coast Regional District** Date: **January 24, 2024**
Attention: **Drew Brennan** Project No.: **33642**
Cc:
Reference: **Chaster Park Pedestrian Bridge and Revetement Wall Planning Options**
Cliff Gilker Park Bridges and Trail Recovery Options – REVISED MAY 22, 2024
From: **Richard Avedon-Savage and Janet Tong**

This memo summarizes the evaluation of existing trail and bridge conditions, reviews conceptual options and provides recommendations for bridge replacements and trail improvements.

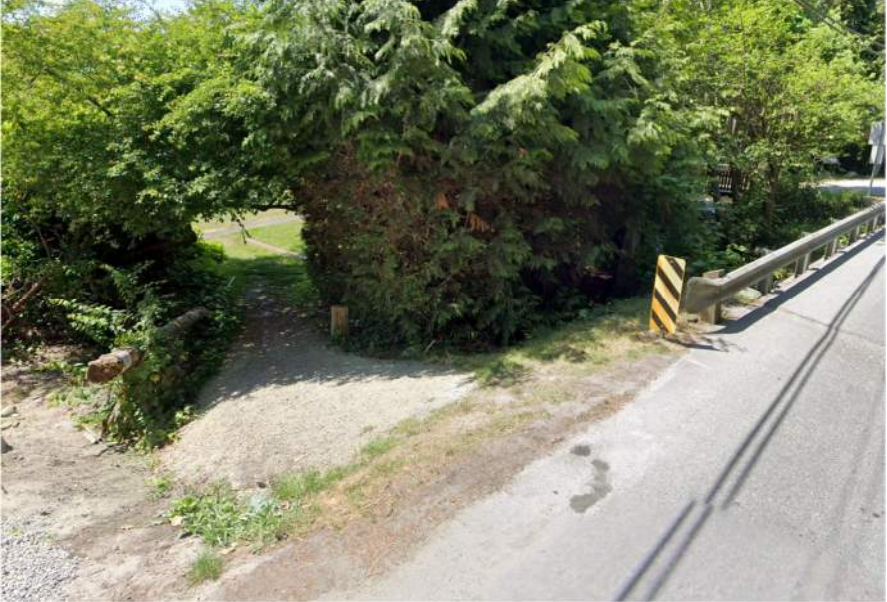
| Option 4: No creek crossing, use existing access east of vehicle bridge | |

| <ul style="list-style-type: none"> • Remove existing bridge and north abutment to widen channel • Improve existing property access on east side of vehicle bridge • Restoration of creek bank • Access to property requires crossing vehicle bridge • Least cost | <p>View looking southwest towards Chaster House property</p> |

An additional option was considered which would remove the need for a creek crossing and use the existing property access that is east of the creek. This is the least cost option and would restore the north creek bank and widen the existing creek channel to help reduce creek overtopping the existing revetment wall at Chaster House.

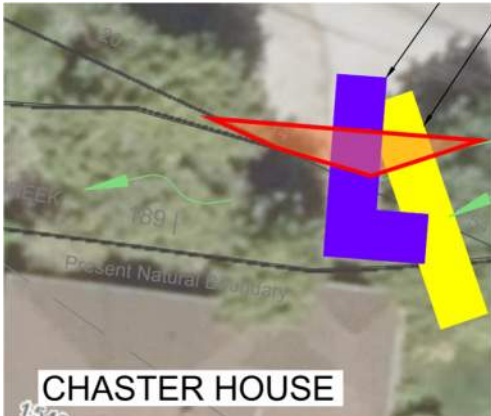
A5. The existing creek channel at the existing bridge location is approximately 5m. We anticipate increasing the channel width to approximately 7m as this matches the creek channel upsteam and downstream of the existing crossing. The area noted in red shows the approximate proposed channel widening/restoration within MOTI property.

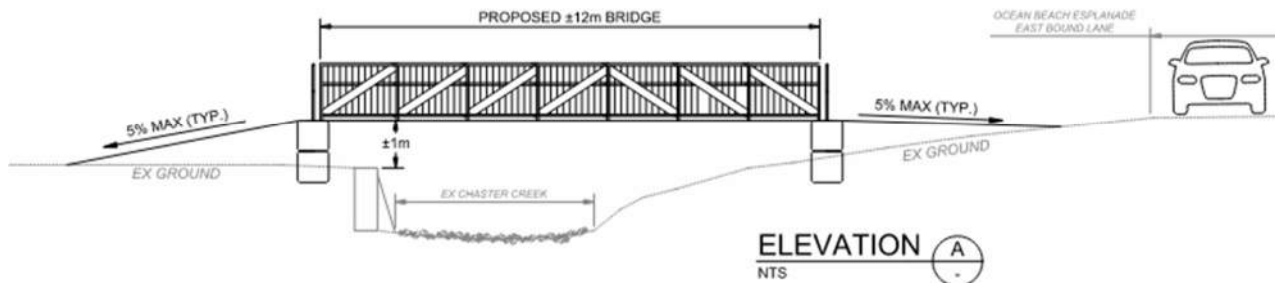
A2. The 1 meter additional height is from the top of the revetment wall as this is the anticipated height of flow during peak flow conditions. The elevation detail A on the drawing "Chaster House Bridge Options" provides some clarity.
