Hopkins Landing

Ports Load Limit Safety Assessment

February 15, 2019

HOPKINS LANDING PORT FACILITY STRUCTURE CONDITION INSPECTION AND REPORT

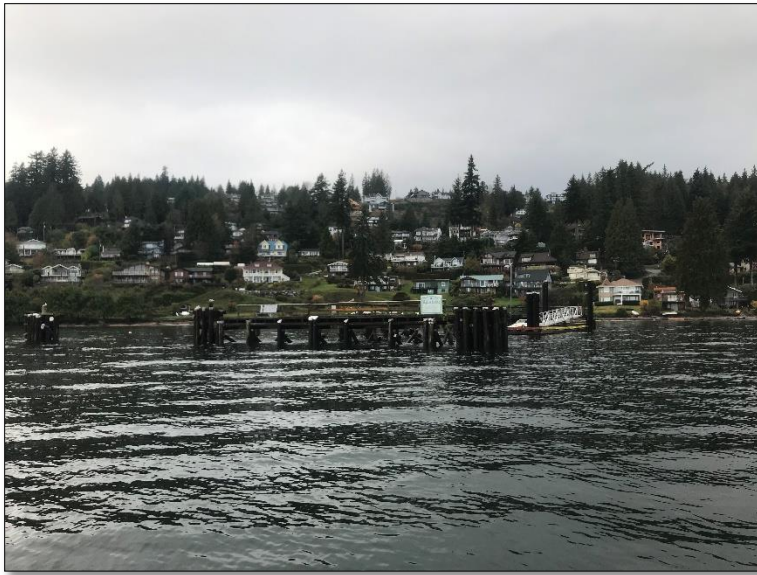
The general arrangement of the facility is shown in Photograph 1, located in Appendix A.

General views of the approach, wharfhead, and floats are shown on Photographs 1.

Photograph 1: Hopkins Landing Port Facility, note: general arrangement looking west

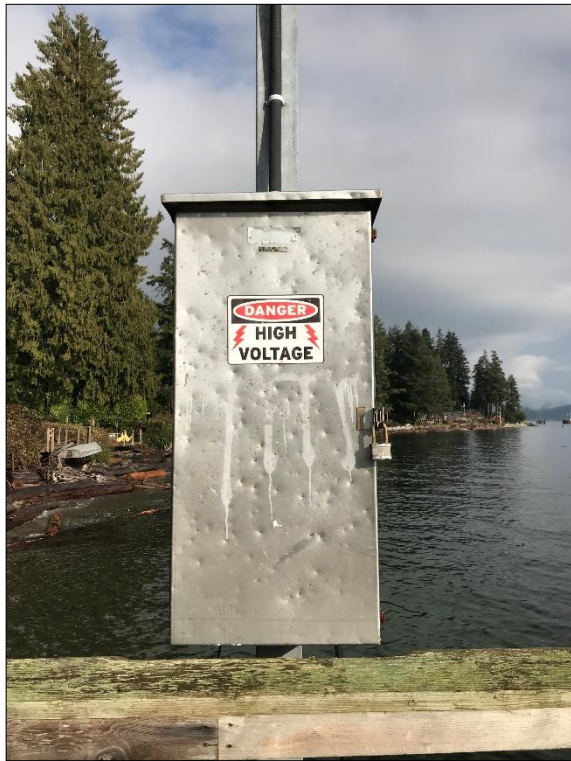
Photograph 18: Electrical services box, note: locked
