COOPERS GREEN PARK

ECOSYSTEM SUMMARY AND RIPARIAN ASSESSMENT

Project file: 004-11

December 2014

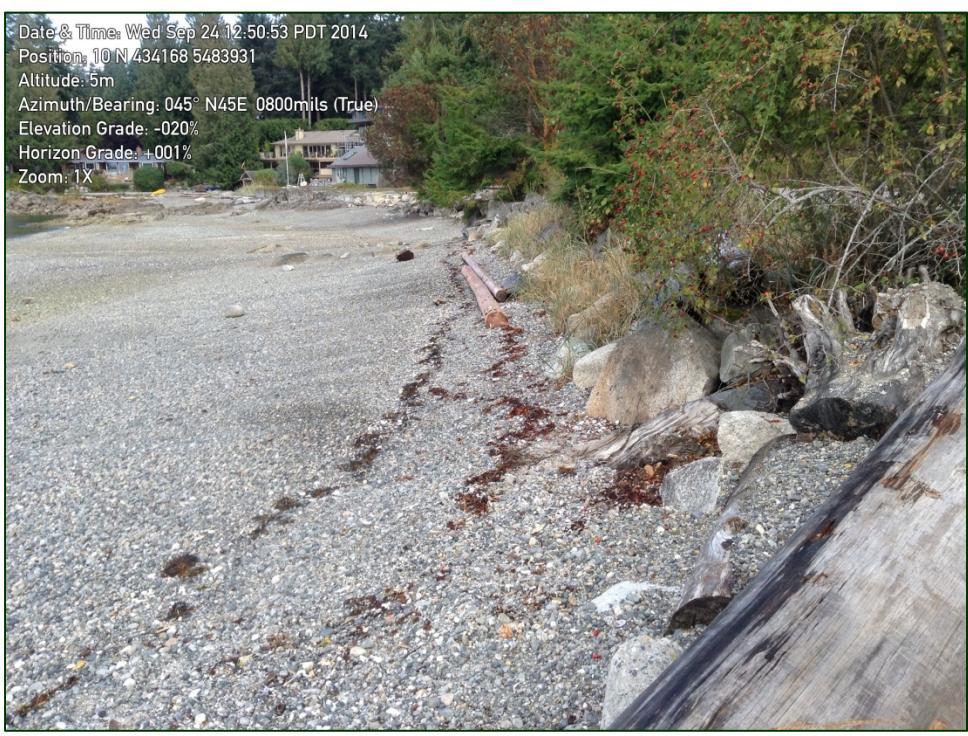
Photo 3. Armour of riprap boulders along the back-shore at Coopers Green park, viewed to north from top of boat ramp. Tide level is approx. 2.1 m.

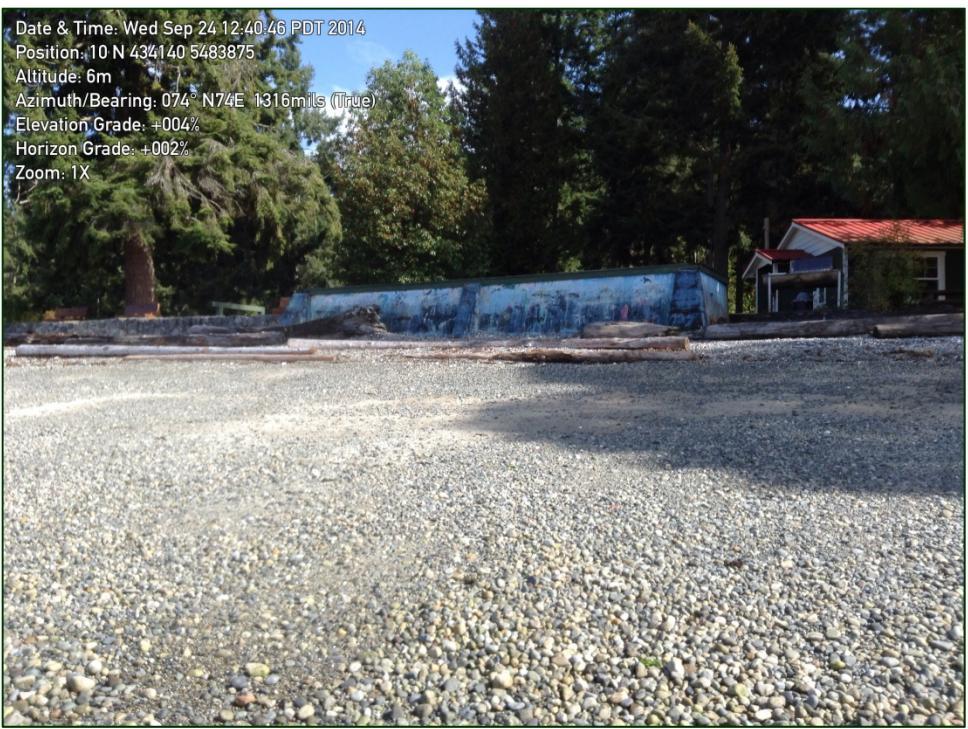
Photo 4. Cement walls along top of beach at Coopers Green Park.

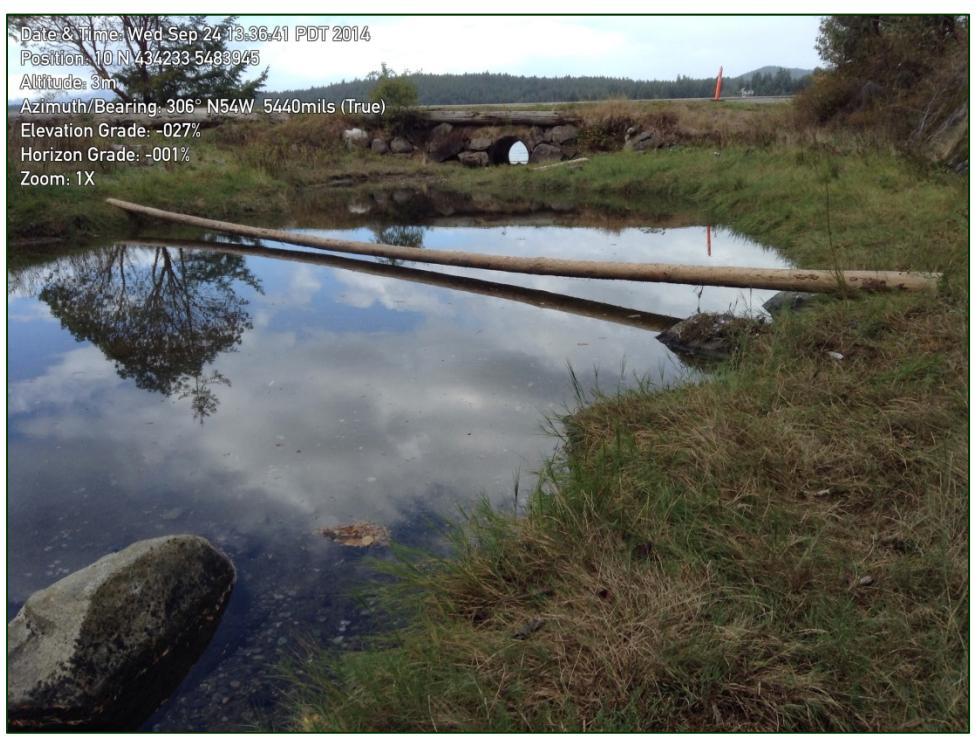
Photo 5. Lower tidal pond (The Pond) at Coopers Green Park, viewed toward outlet under Fisherman Road. Seawater enters culvert when tide is greater than 3.96 m (13 ft).

Logs and other large floating debris commonly enter the Pond through the culvert under Fisherman's Road and get trapped within the Pond or Lagoon. An iron grate over the culvert outlet has become damaged over time and is no longer effective. The damage has been caused, apparently, by logs moved by wave action at high tides and, possibly as well, by logs drifting out of the Pond during periods of high stream flow and ebbing tide. Although the logs are considered unsightly, their environmental impact in the Pond and Lagoon is negligible, in our view. In addition, preventing their entry or removing those that are already in the Pond or Lagoon also has no significant impact.

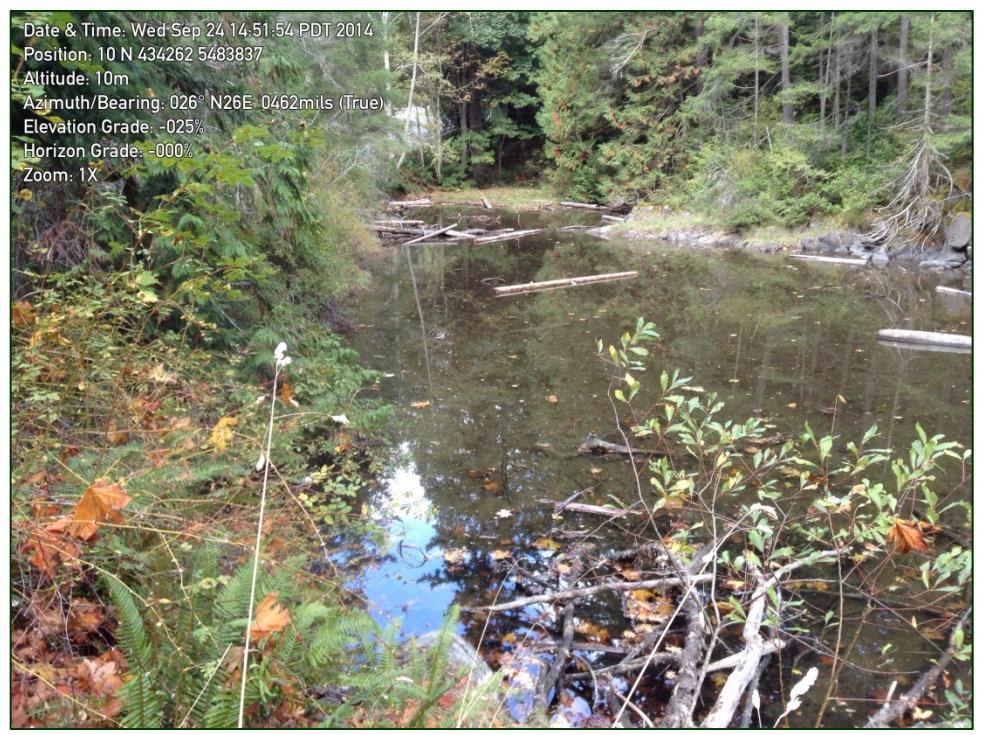
Photo 6. Upper tidal pond (The Lagoon) viewed toward outlet under Redrooffs Road on left.

The culvert under Redrooffs Road is made of logs and is beginning to fail (Bates 2008 and present assessment). The Ministry of Transportation will likely be planning to replace this structure in the near future. However, no information is available on such plans or on the design of the new structure. It is therefore recommended that the SCRD should contact the MoT for an update on this issue.

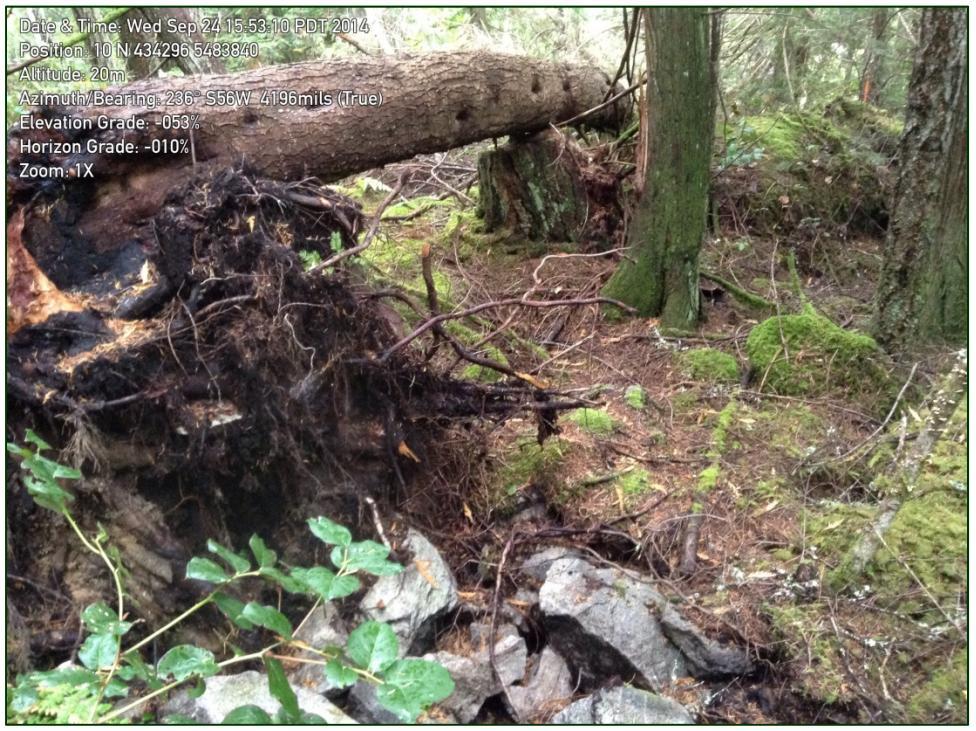
Photo 11. Blown-down Douglas-fir tree in an area of shallow soils where bedrock and boulders predominate in the substrate, on the east side of the park above the Lagoon.

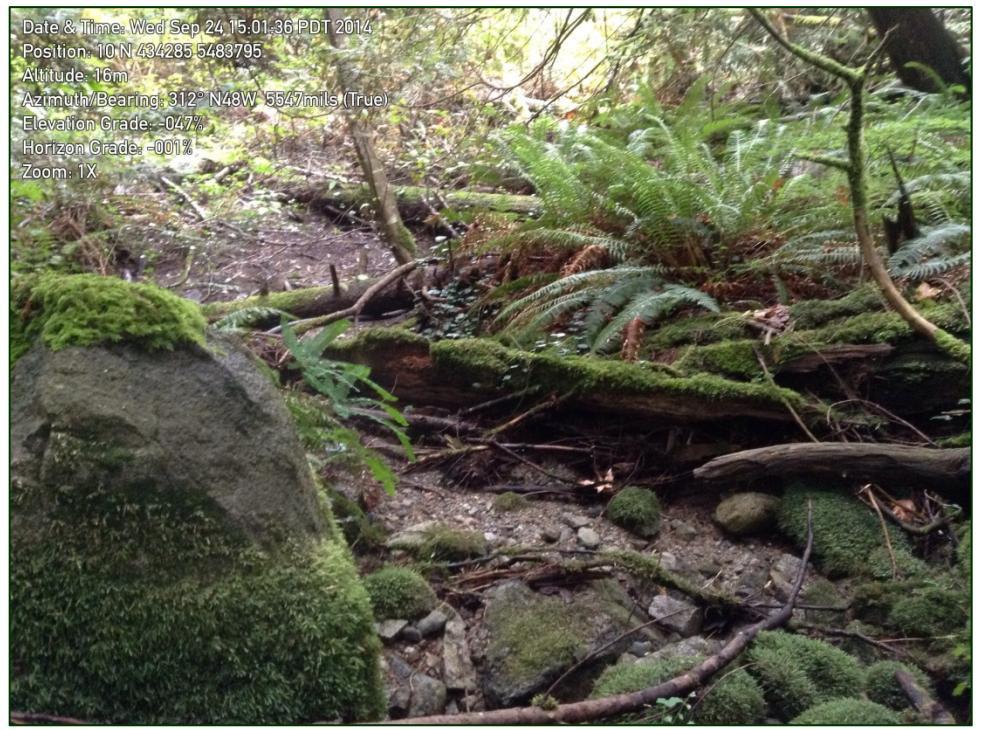
Photo 12. Dry channel of Kitchin Creek immediately above the mouth, viewed toward the Lagoon.

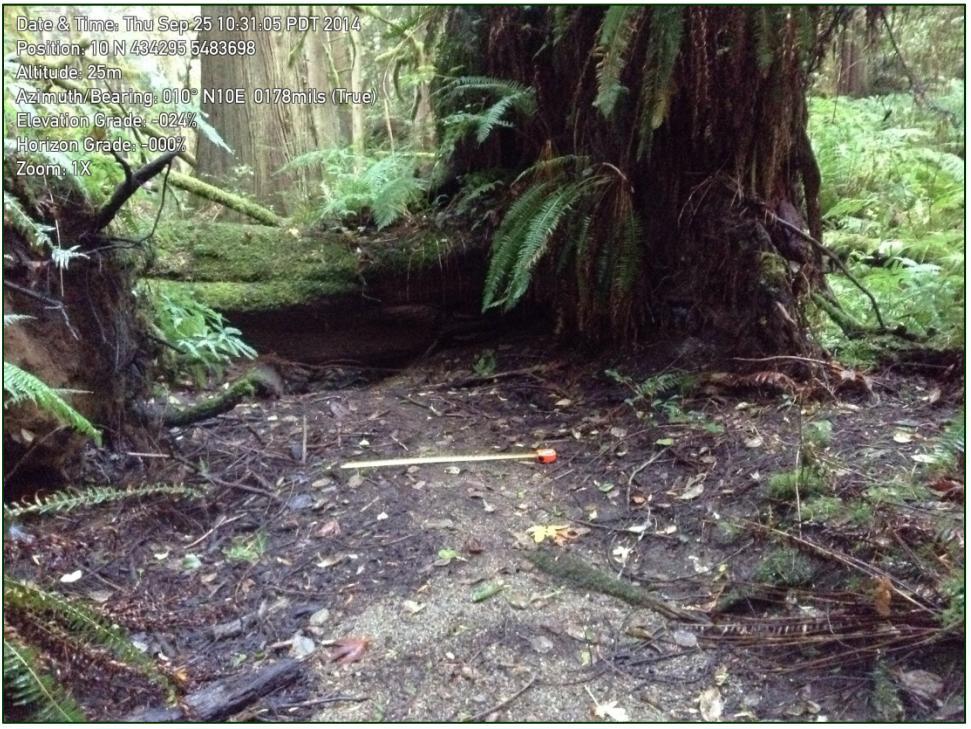
Photo 13. Dry channel of Kitchin Creek in the central area of the park, viewed downstream. Scale is 1 m.

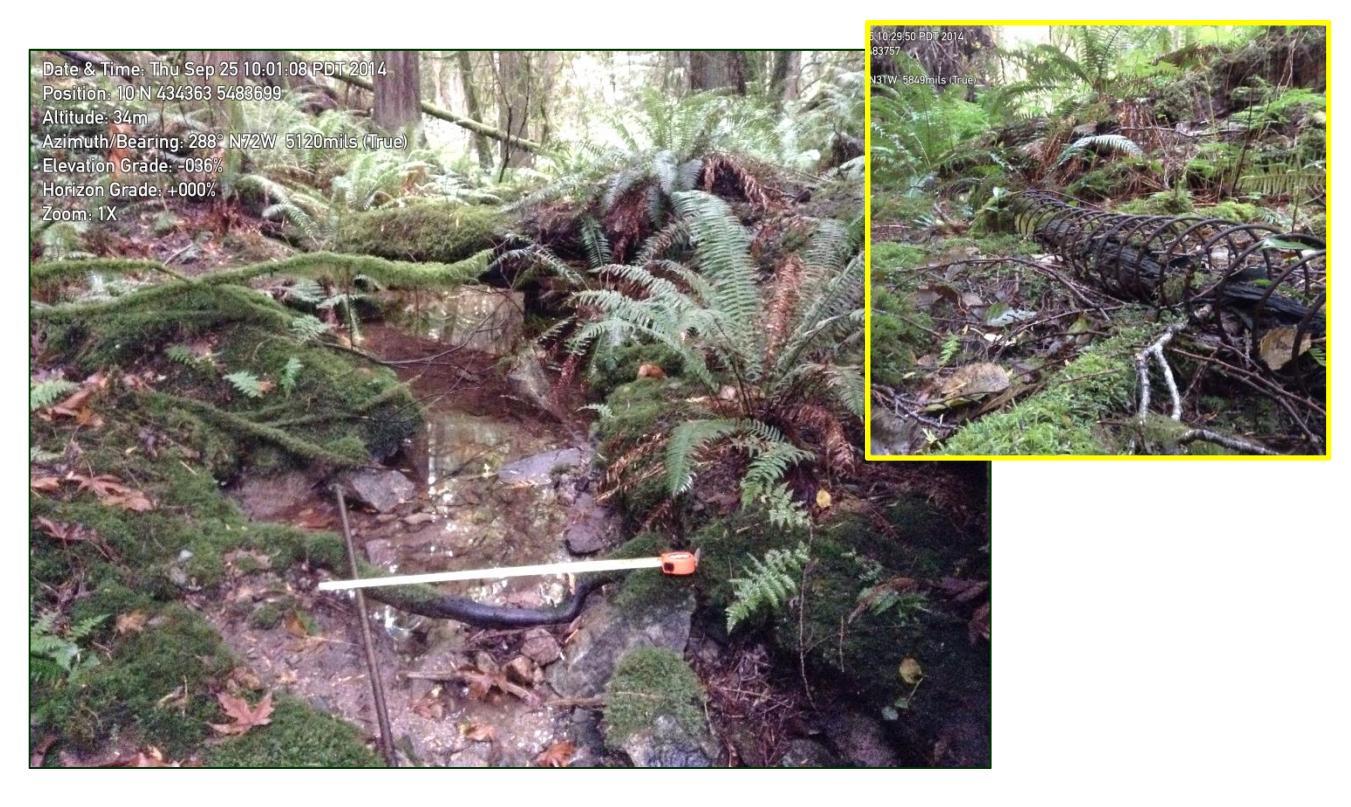
Photo 14. Abandoned waterworks (cement weir and pipes) on Kitchin Creek in the central area of the park (see Fig. 2). Inset: rotting segment of old wood-stave pipe.

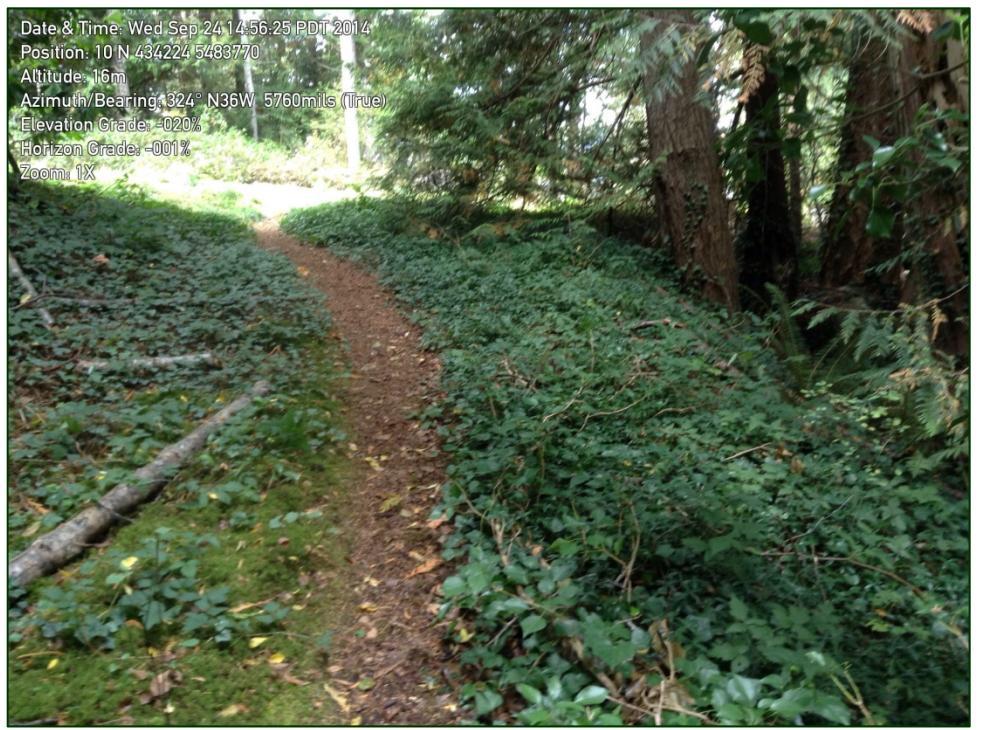
Photo 20. Forest floor is completely covered with English ivy on both sides of trail on south edge of park near Redrooffs Road. Although sparser, the ivy is present deep in the forest as well.

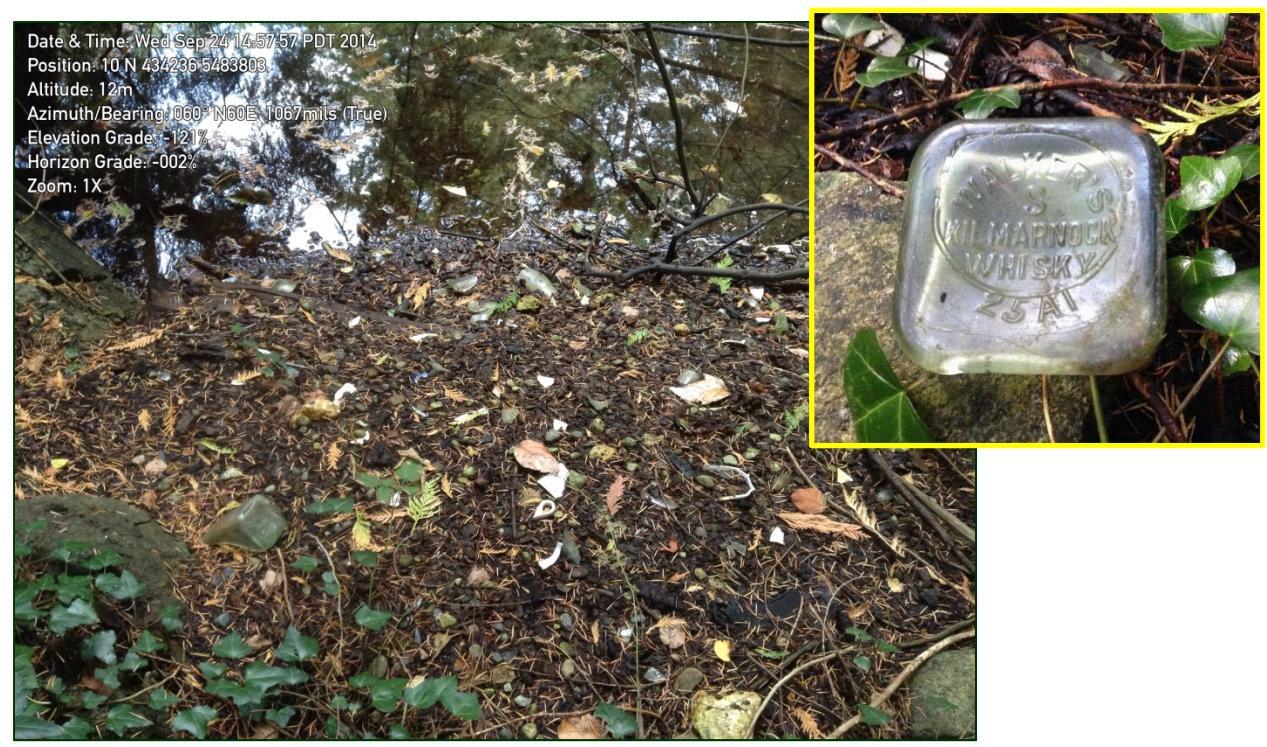
Remnants of garbage were found in several places around the Lagoon (Figure 2). All but one were close to the entrance to the trail that borders the south edge of the park. One deposit at the south end of the Lagoon was partially in the water and consisted of older waste (Photo 21) that might conceivably contain artifacts of historical interest. All the other deposits were on land well away from the water and, with one possible exception on the northeast side, appeared to be much more recent, judging by the presence of plastics and aluminum foil (Photo 22). In general, all of the garbage deposits observed were small (less than 1 m³) and did not appear to be the source of any significant environmental impacts. However, the more recent deposits, in particular, do present an aesthetic impact, and shards of broken glass in any of the deposits may present a safety hazard.

Photo 21. Deposit of "older" garbage at the edge of the Lagoon at the southwest corner (see Fig. 2). The pile is well decomposed and much localized. Inset: bottom of broken Killmarnock Whisky bottle.

Removal of the one deposit within the Lagoon is not recommended, in our view, because the small amount of material does not warrant the disturbance to the bank and adjacent aquatic habitat. However, the more recent material in the upland deposits can be readily removed by hand for proper disposal off site.

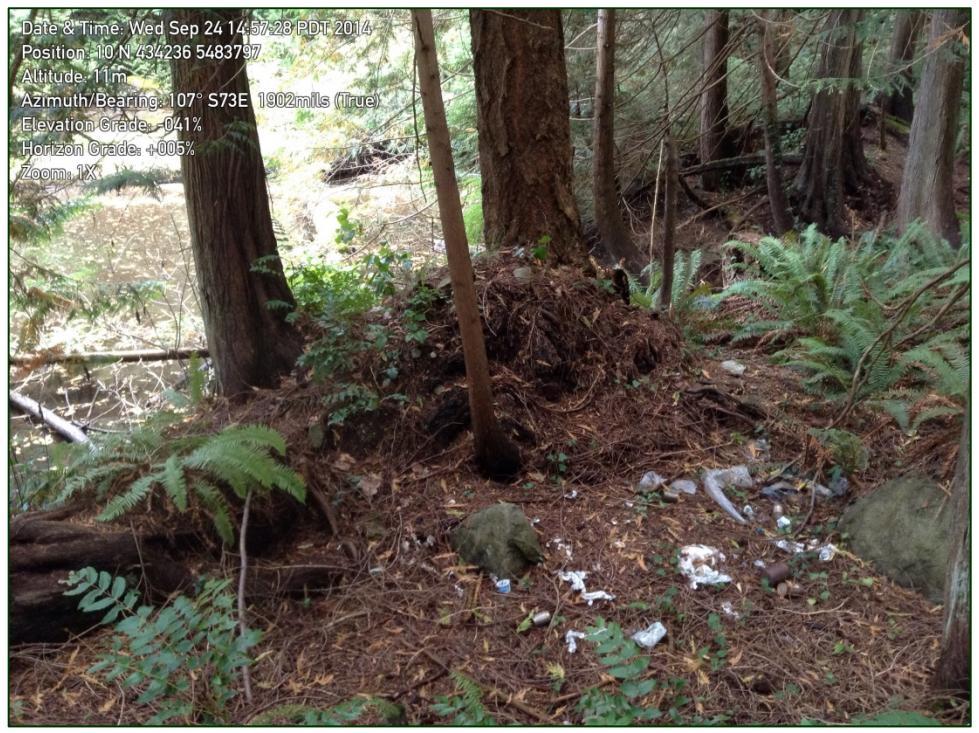
Photo 22. Deposit of "newer" garbage above the south bank of the Lagoon below the trail. There are several small deposits containing plastics and aluminum foil.

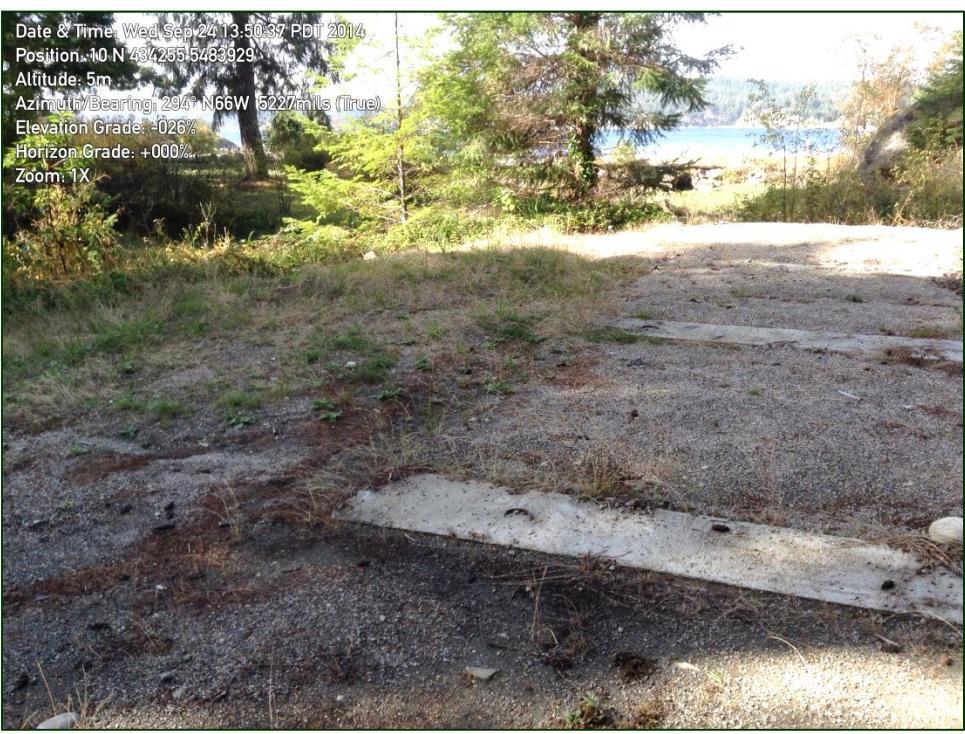
Figure 3, provided by the SCRD, shows the locations where construction of possible additional buildings has been considered. Only building site #2 falls within the riparian zone of the Pond; all the other potential sites (# 1, #3 and #4) lie well away from the marine or estuarine riparian areas. It is also evident from the figure that there used to be two building beside the Pond in the past, which have since been removed. Site #2 is also located in an area that was formerly developed and no longer supports exclusively native riparian vegetation (Photo 23).

Photo 23. Conceptual building Site #2 on the northeast side of the Pond, viewed from Redrooffs Road. Note that this site was formerly developed.

Since the Pond's riparian zone falls under the jurisdiction of the SCRD, it is conceivable that any proposed building at site #2 could be designed to lie outside of the 7.5 m riparian protection zone or setback normally required under SCRD policy, or a variance approved. The potential environmental impacts of constructing and, in future, using such a building are considered negligible, provided that the setback is respected or adequate site-specific mitigation is implemented.

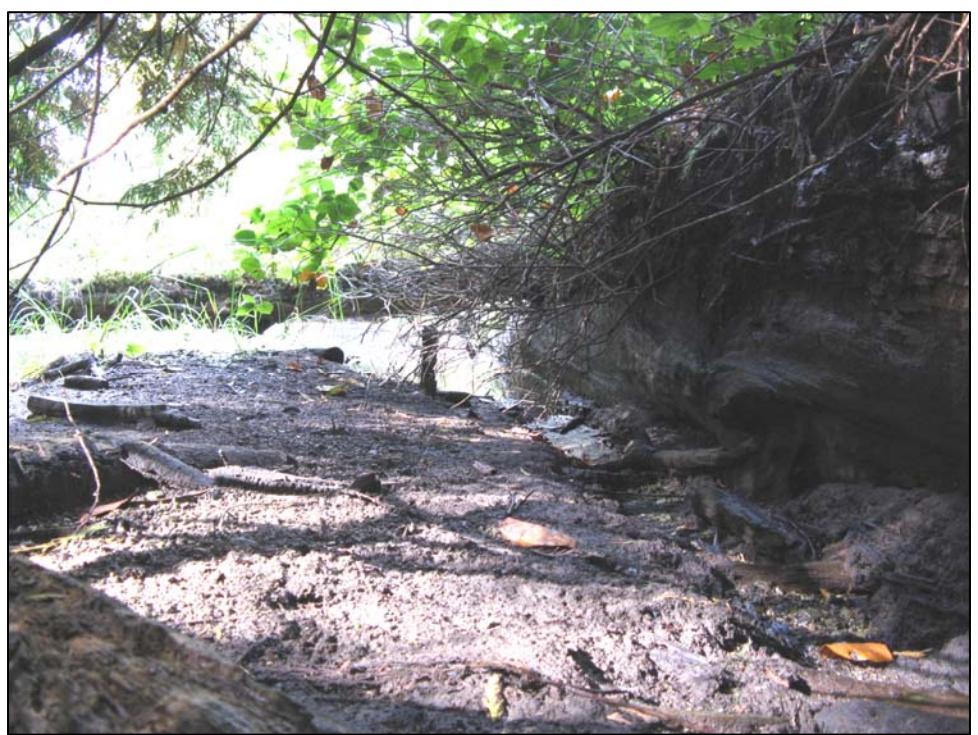
Photo 1. Mouth of Kitchin Creek (dry) viewed toward the estuarine lagoon in Coopers Green Park. 24-Sep-2014

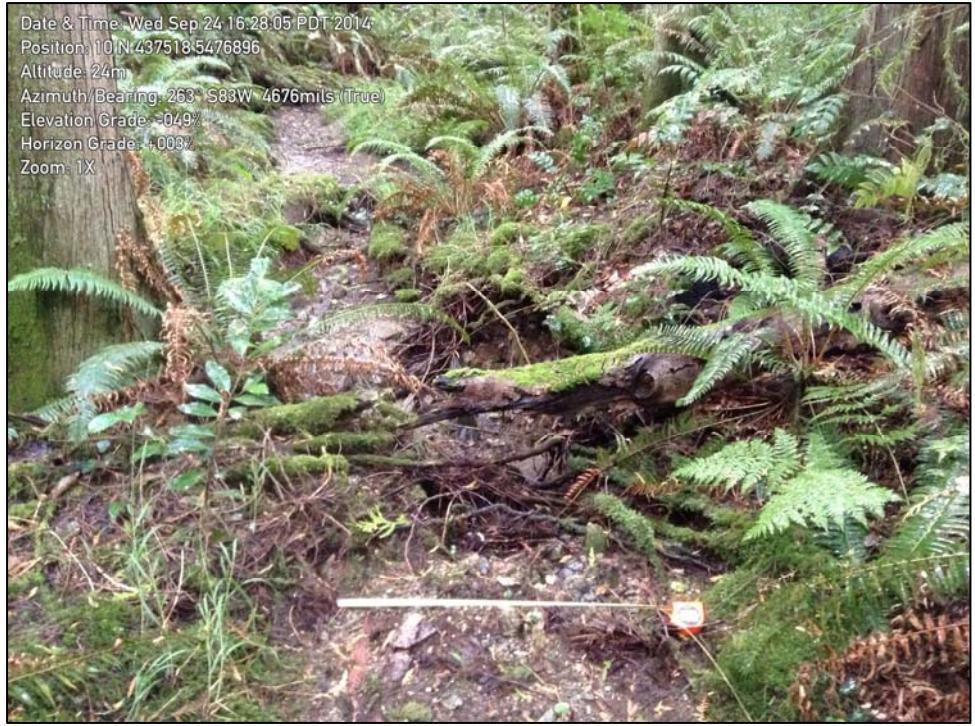
Photo 2. Channel of Kitchin Creek viewed downstream approx. 50 m from mouth. Scale is 1 m. 24-Sep-14

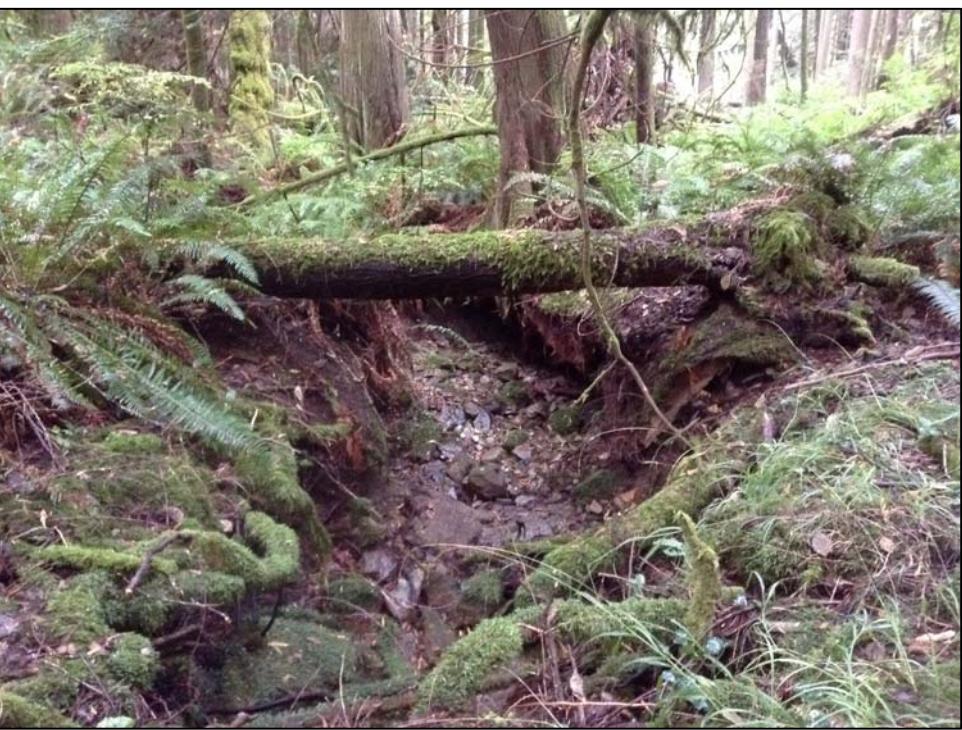
Photo 3. Channel of Kitchin Creek viewed downstream approx. 100 m from the mouth. Channel is approx. 0.7m deep and up to 1.2 m wide. 24-Sep-14

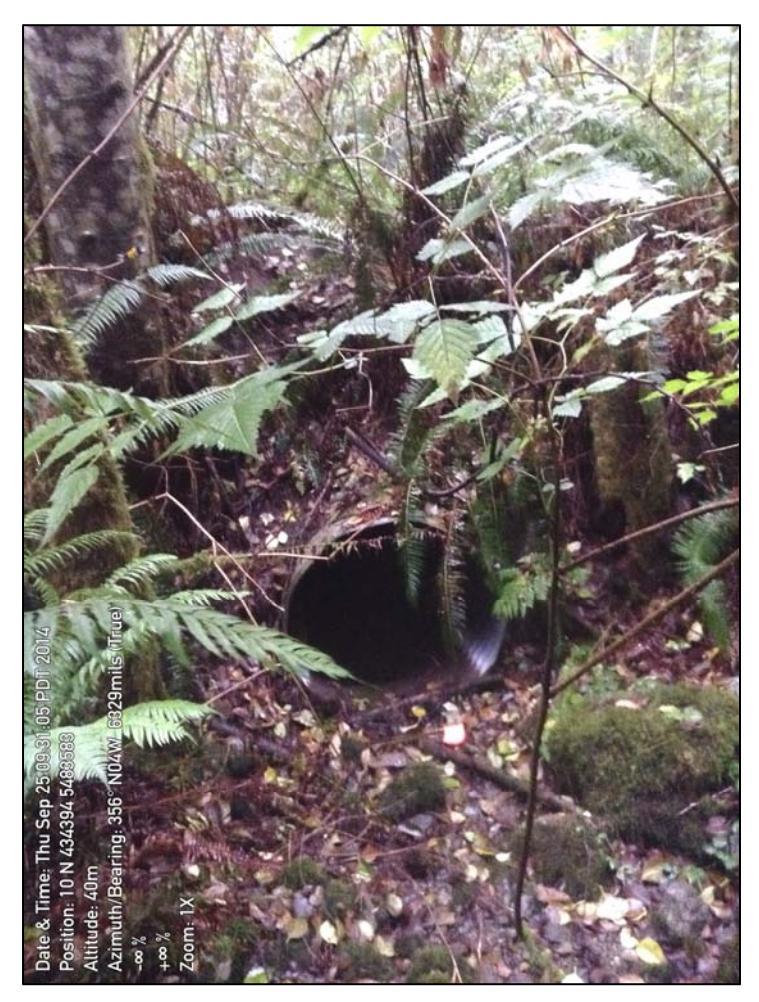
Photo 4. Channel of Kitchin Creek (dry) viewed upstream at point of entry into Coopers Green Park property, approx. 220 m from mouth. 25-Sep-14
