Technical Memorandum

Our File Number: FSCI-21-0036

Re: Fish Salvage below the Chapman Lake Dam (control structure)

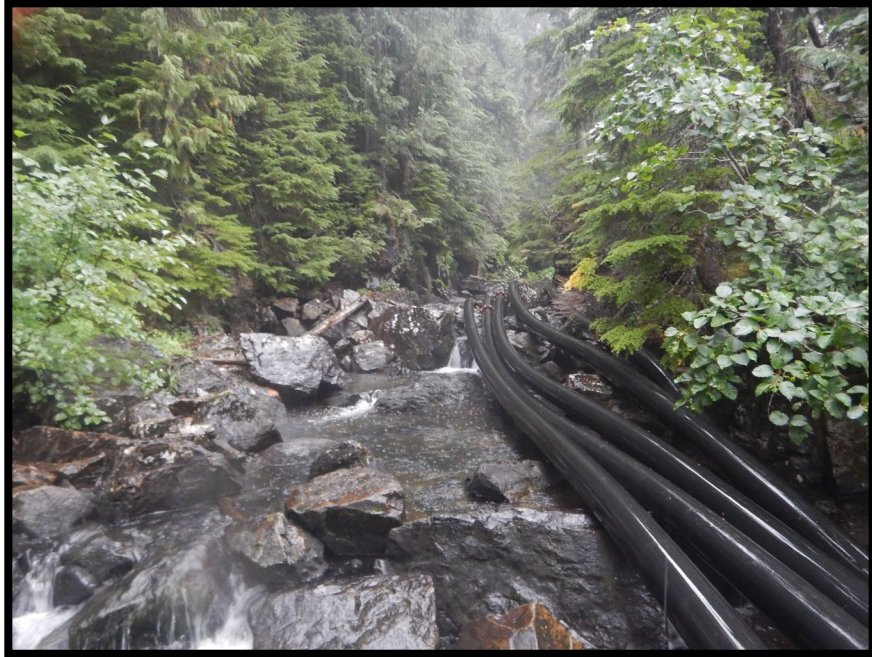
Photo 1: Lower section of Chapman Creek below the SCRDR lake control dam. This section is dominated by bedrock with pools linked by riffle/cascades and containing large angular substrates. Fish remaining in deeper bedrock pools have residual water for survival during prolonged de-watered periods. Riffles are salvaged.

Throughout the bypassed section the channel is characterized by bedrock pools and short riffle areas dominated by large angular rock (Photo 1). Under de-watered conditions the pools retain water and provide safe refuge. The short lengths of riffles between pools dewater and are the focus of increased salvage effort.

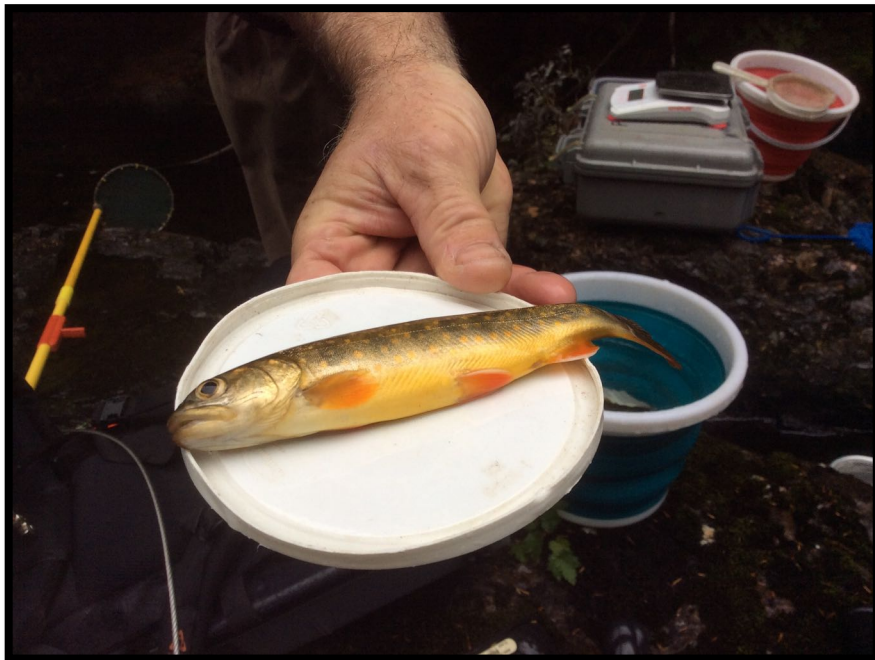
Photo 2: Example of the resident Dolly Varden char salvaged from the dewatered length of Chapman Creek (below the lake) and released unharmed below the siphon outlet.

Salvage effort focuses on collection, removal and relocation of any rearing salmonids within the de-watered stream length. The only species captured in past salvage operations is Dolly Varden char (*Salvelinus malma*) (Photo 2). All captured fish are examined to determine the species, enumerated, sampled and released below the siphon outlet.
