Sunshine Coast Regional District

Request for Proposal

Number: 2365001

Construction Management Services: Development of a Community Hall

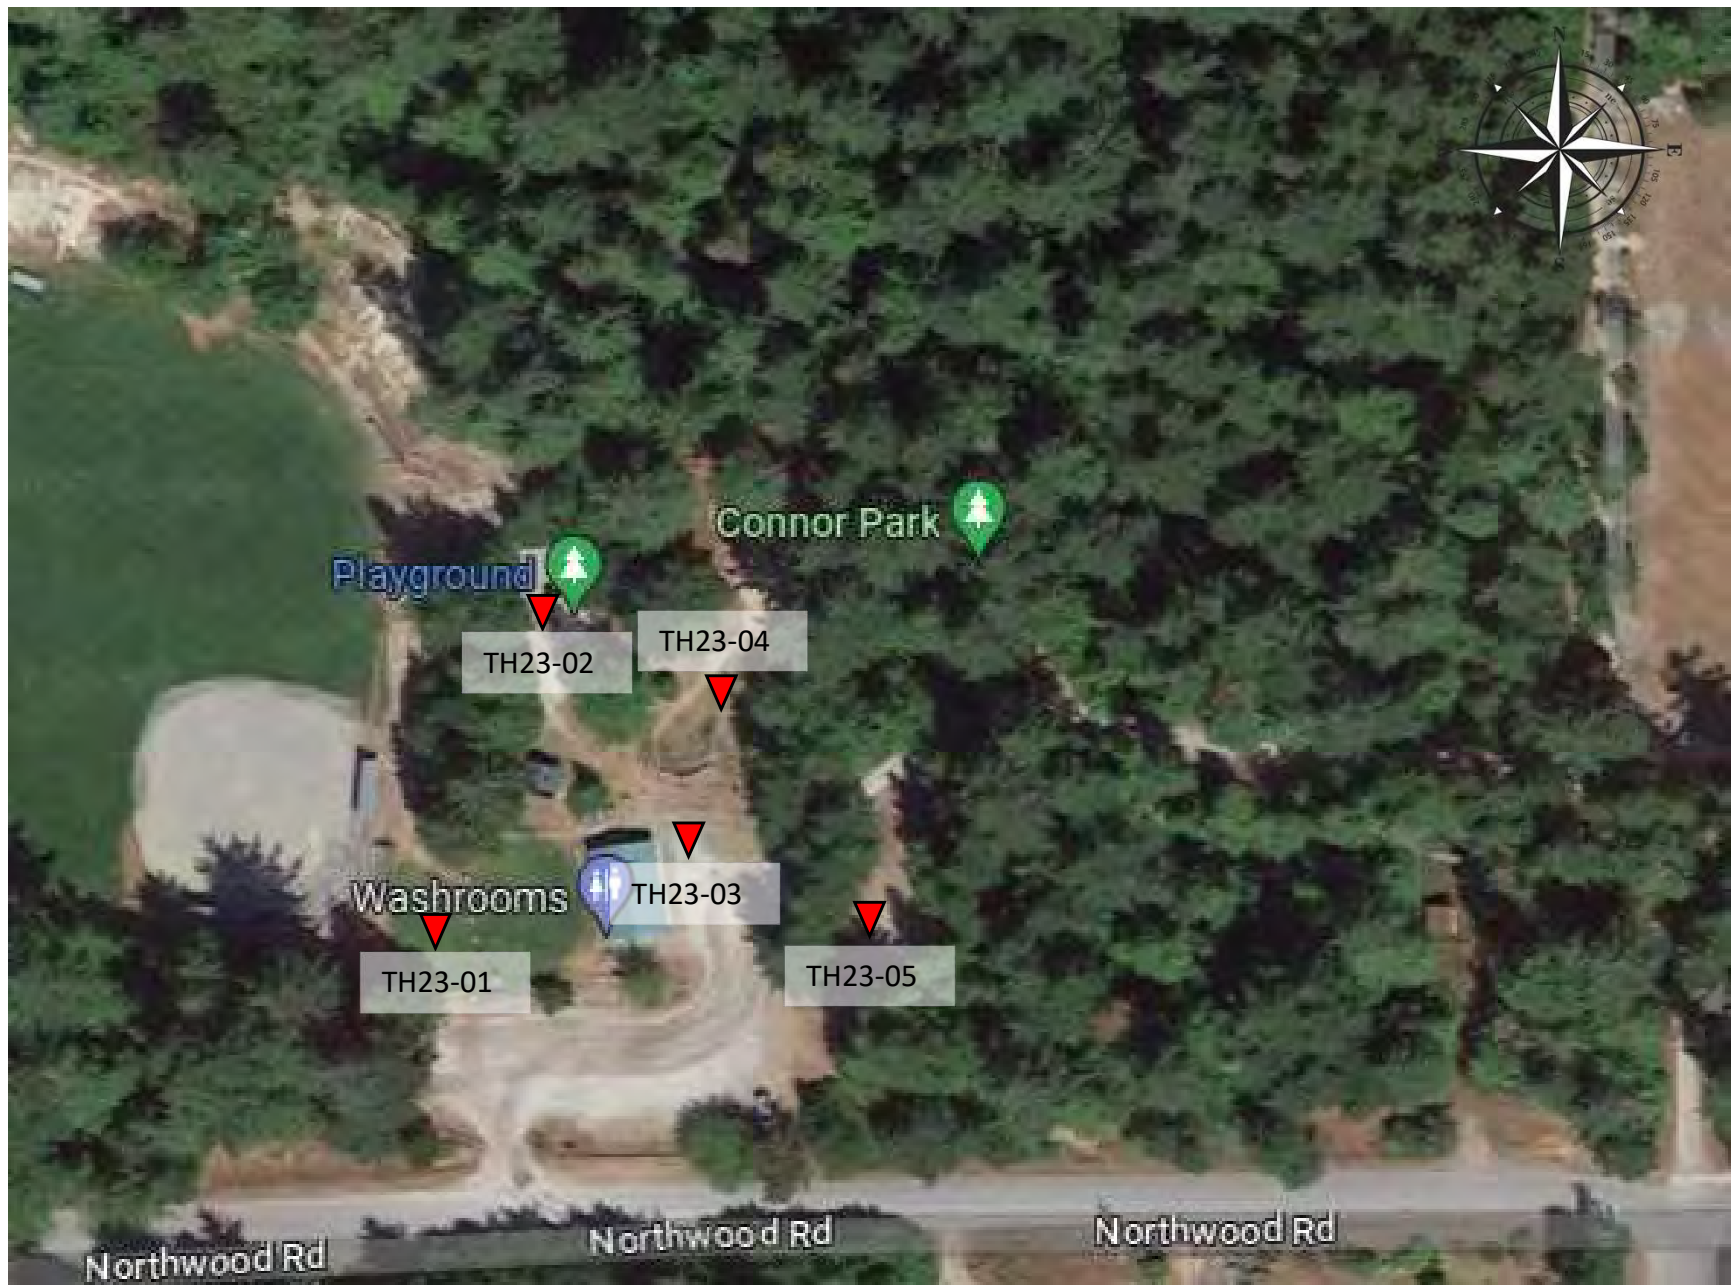
FILE NO.
2031
DWG NO.
2031-01

Geotechnical Investigation Plan
Proposed Community Hall
Connor Park, Halfmoon Bay, BC

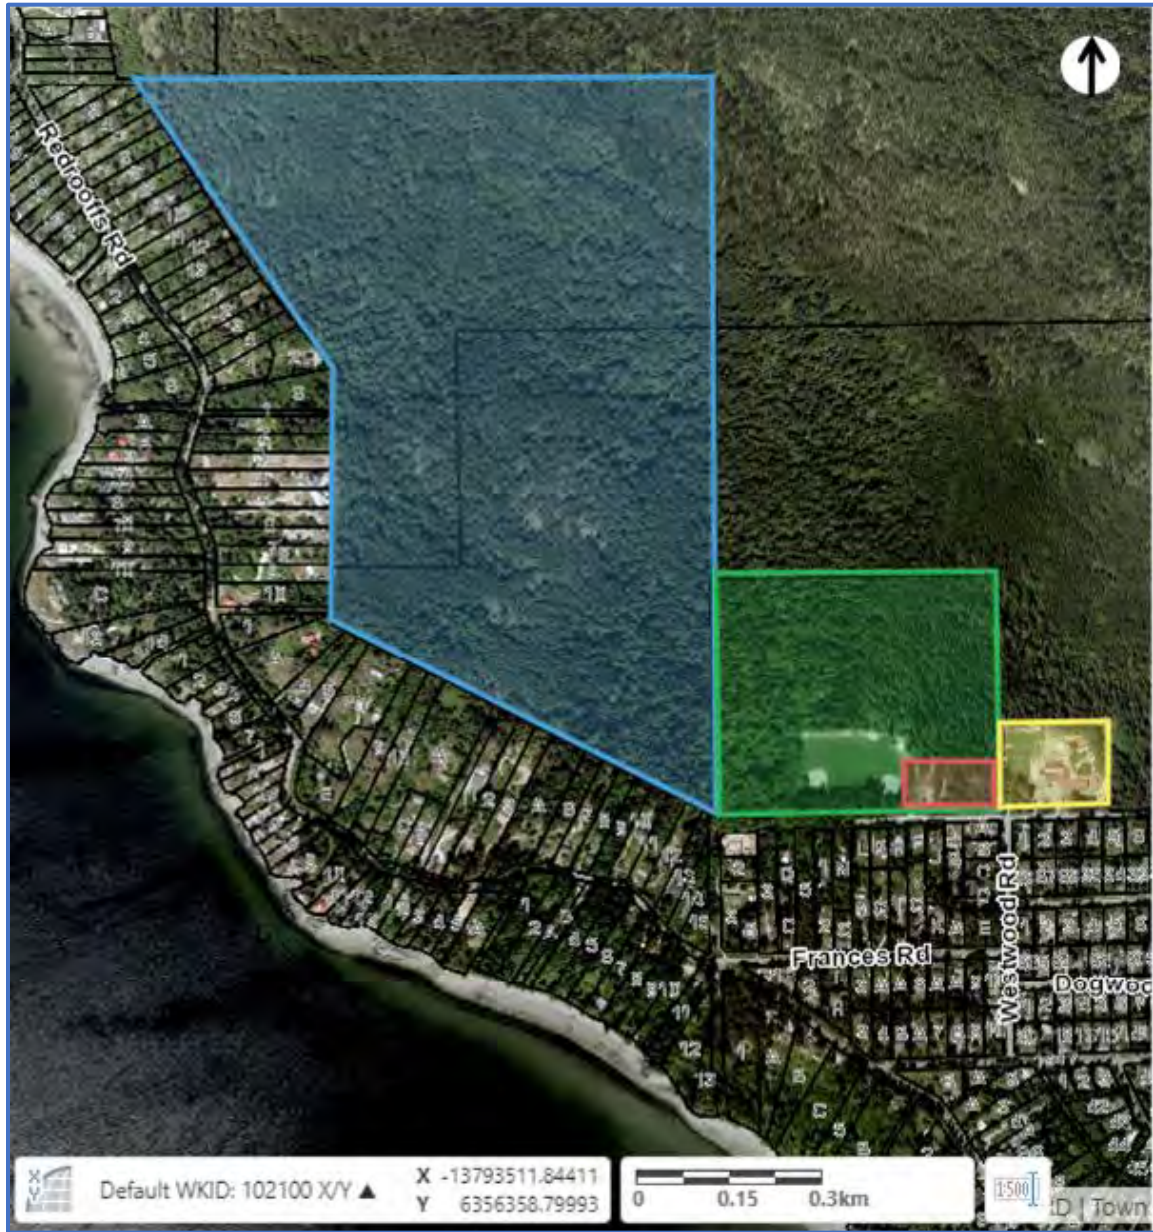
Figure 1. Location of Connor Park and the Project Area. Connor Park, indicated by the green rectangle on the image above, is adjacent to the Welcome Woods Wilderness Park and the Halfmoon Bay elementary school (blue and yellow polygons, respectively). The Project Area, the section of Connor Park assessed for this report, is indicated by the red polygon on the Southeast corner of the park. The *Proposed Development*, a 2,000 sq. ft (approx.) facility designed to facilitate small-medium gatherings and provide a community kitchen, is intended to be built within the Project Area. Image modified from the SCR D Maps Online platform (base image and property boundaries) by Coastal Raintree Consulting, Ltd (coloured polygons).

On June 2nd, 2023, Kyle Doyle, on behalf of the Sunshine Coast Regional District (SCRD), sent to Coastal Raintree Consulting, Ltd. (CRC) a Request For Proposal (RFP) for completing an Environmental Impact Assessment (EIA) to support the proposed construction of a new Community Hall for Halfmoon Bay in **ch'emelak** (Connor) Park (hereafter referred to as Connor Park). The EIA is needed to determine potential short- and/or long-term impacts of the proposed new Community Hall (hereafter referred to as the *Proposed Development*) within Connor Park, located at 8101 Northwood Rd., Halfmoon Bay, BC (PID 015-936-317; Figure 1). Halfmoon Bay is one of the five electoral areas of the SCRD.

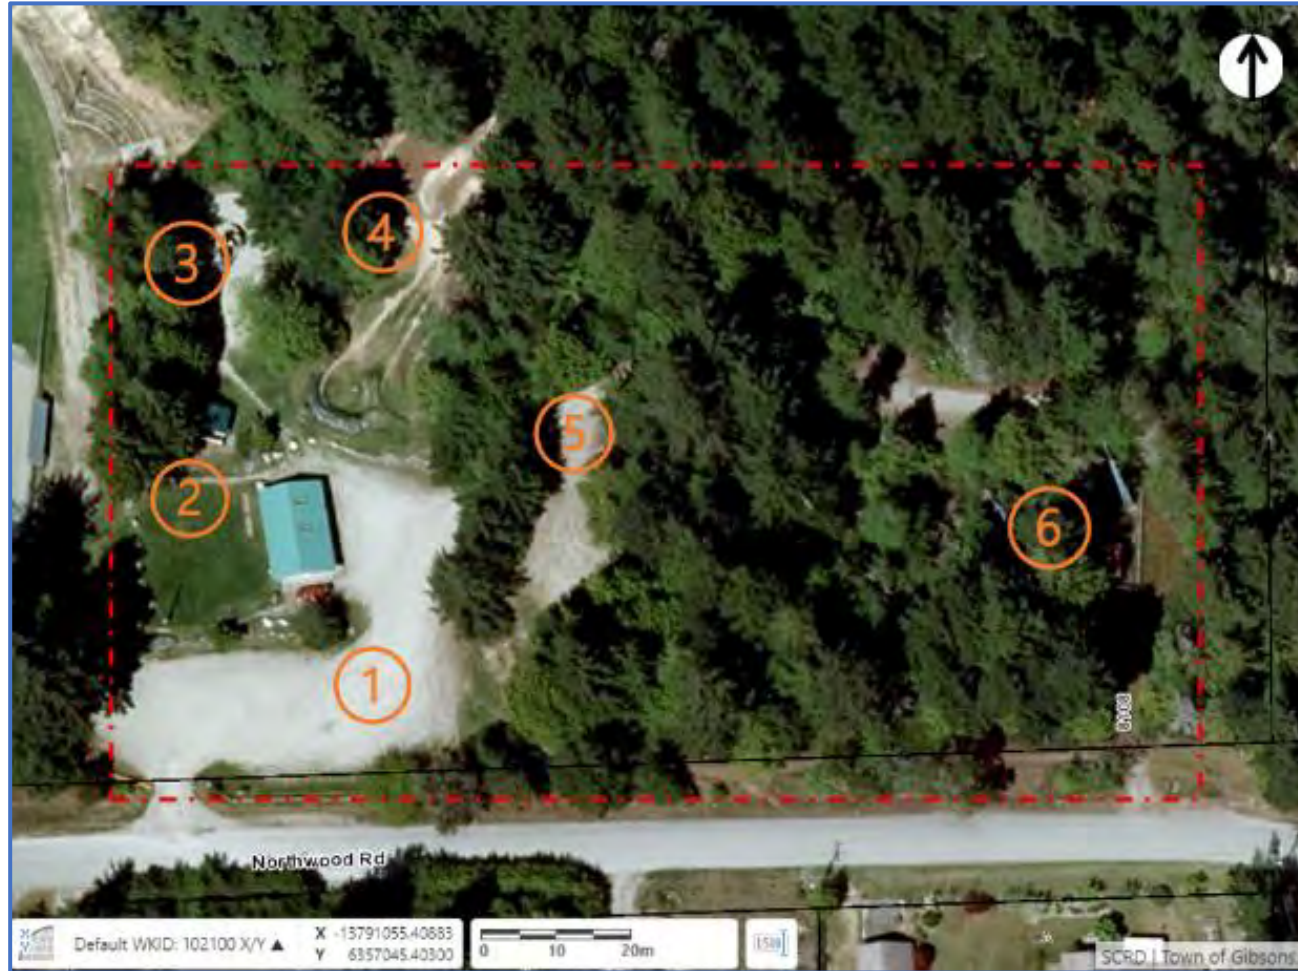
Figure 2. Boundaries and permanent structures within the Project Area. Approximately 64% of the Project Area, delineated by the red dashed line rectangle, is occupied by vegetation characteristic of secondary forests within the Coastal Douglas-Fir biogeoclimatic zone. The remaining 36% is occupied by access and service areas, including parking space (1), washrooms (2), playground (3) and skill areas (4), as well as a gravel access road (5) to a cellphone tower (6). *Image modified from the SCRD Maps Online platform (base image) by Coastal Raintree Consulting, Ltd.*

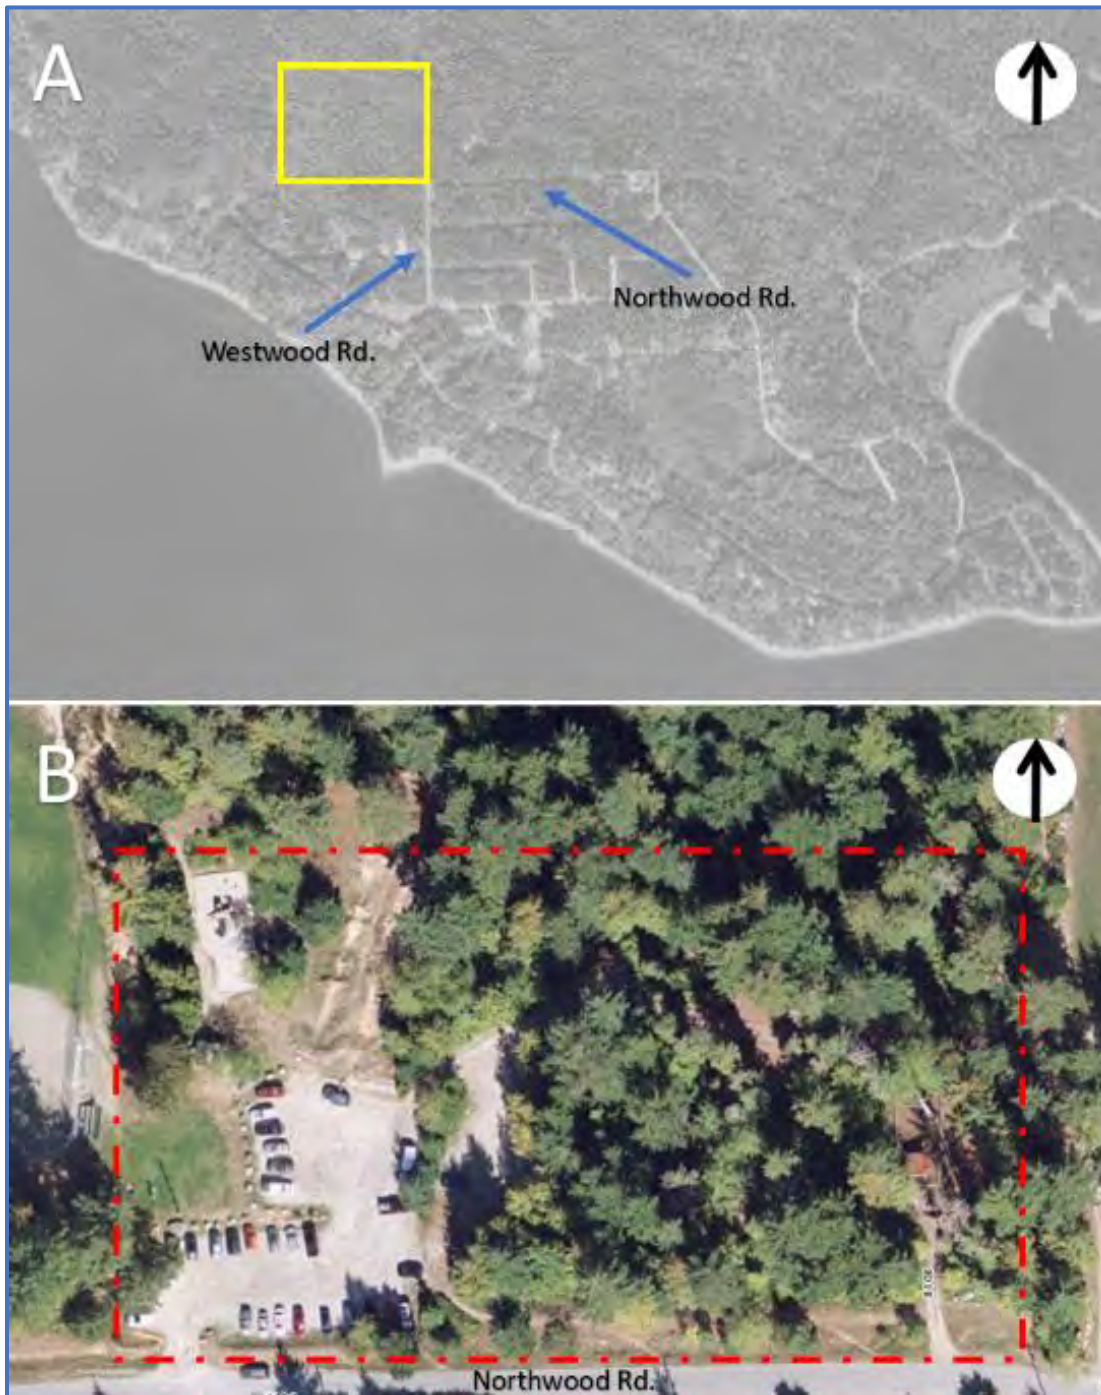
Figure 3. Historical images of Connor Park and the Project Area. A review of historical photographs suggests the area occupied today by Connor Park (approximated location indicated by the yellow rectangle in A) was undeveloped in 1976. Most of the facilities and service areas present today in the Project Area (indicated by the red rectangle in B) are clearly visible in images from 2009 (B). *Image modified from the Base Maps Online Store of BC (A, base image) and the SCRD Maps Online platform (B, base image) by Coastal Raintree Consulting, Ltd.*

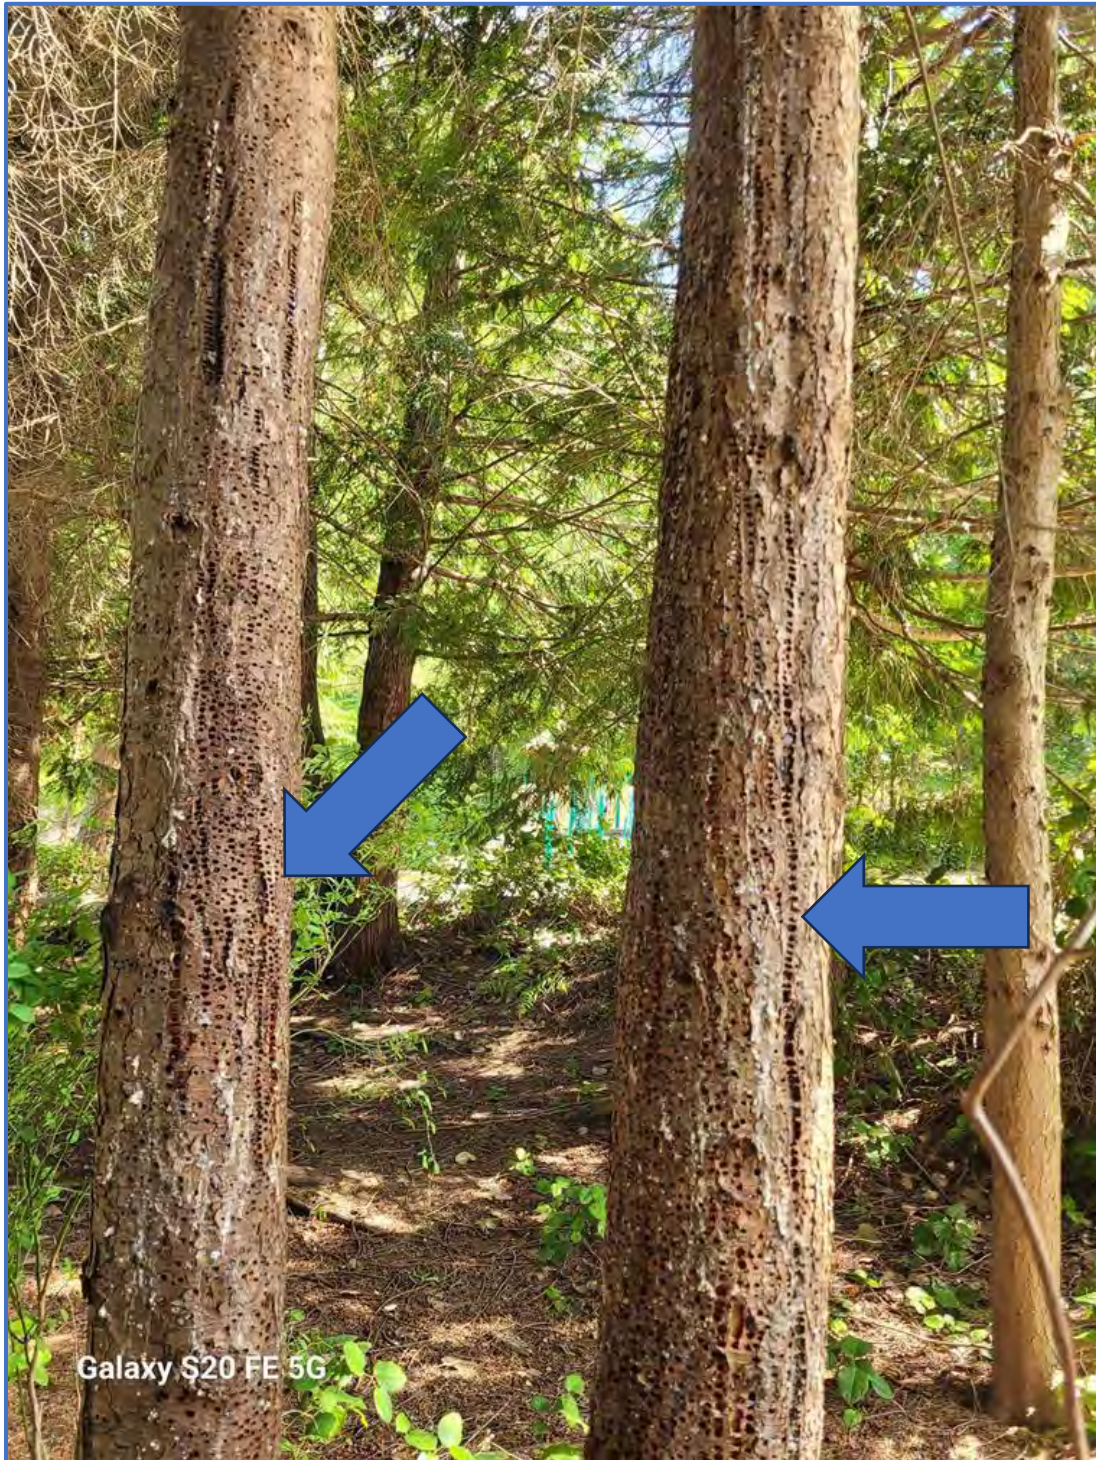
Figure 5. Feeding holes of other woodpecker species observed in the Project Area and surrounding area. The vertical rows of machinegun bullet-hole-like patterns, indicated by blue arrows, suggest the presence of sapsuckers (*Sphyrapicus* sp.) Image by Brent Matsuda captured on July 8, 2023, modified by Coastal Raintree Consulting, Ltd.

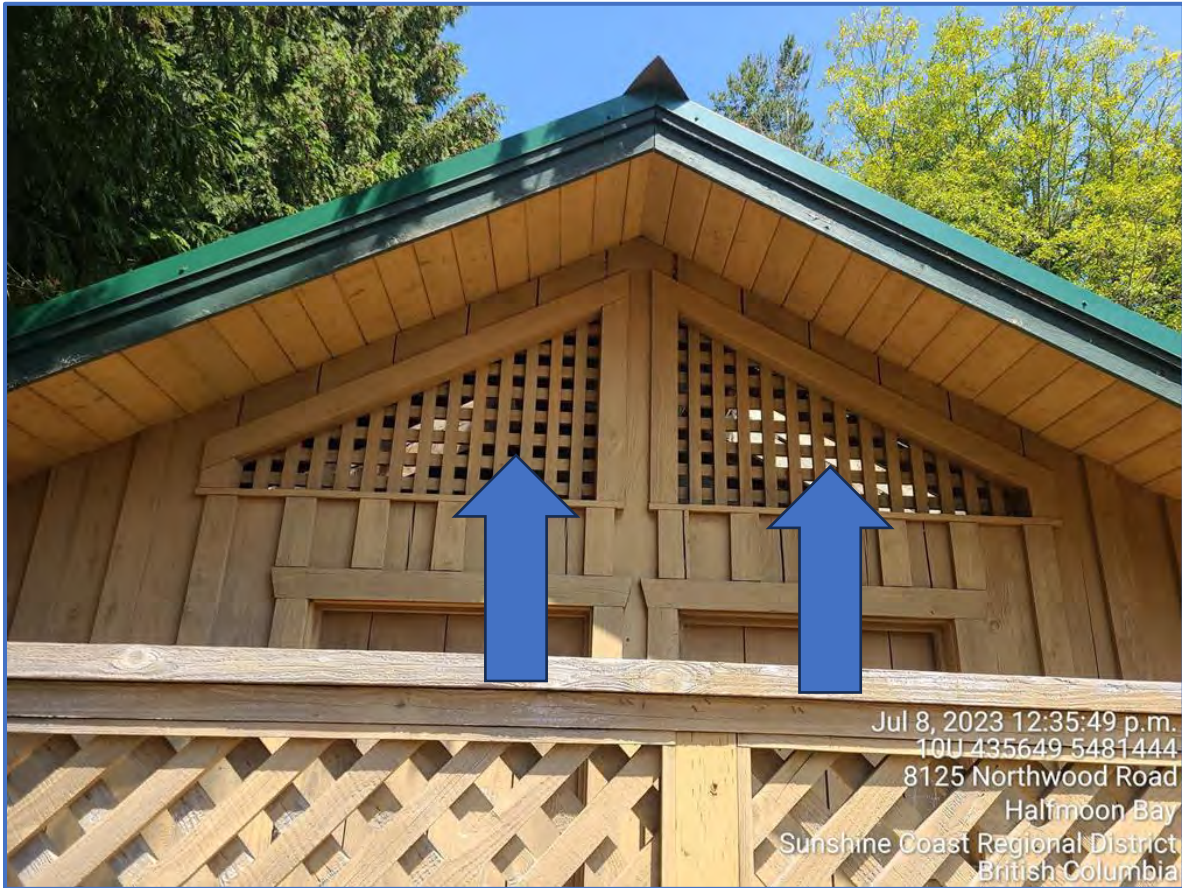
Figure 6. Openings on the upper part of decommissioned washrooms. These openings, indicated by blue arrows, are potentially accessible to bats. *Image by Brent Matsuda captured on July 8, 2023, modified by Coastal Raintree Consulting, Ltd.*

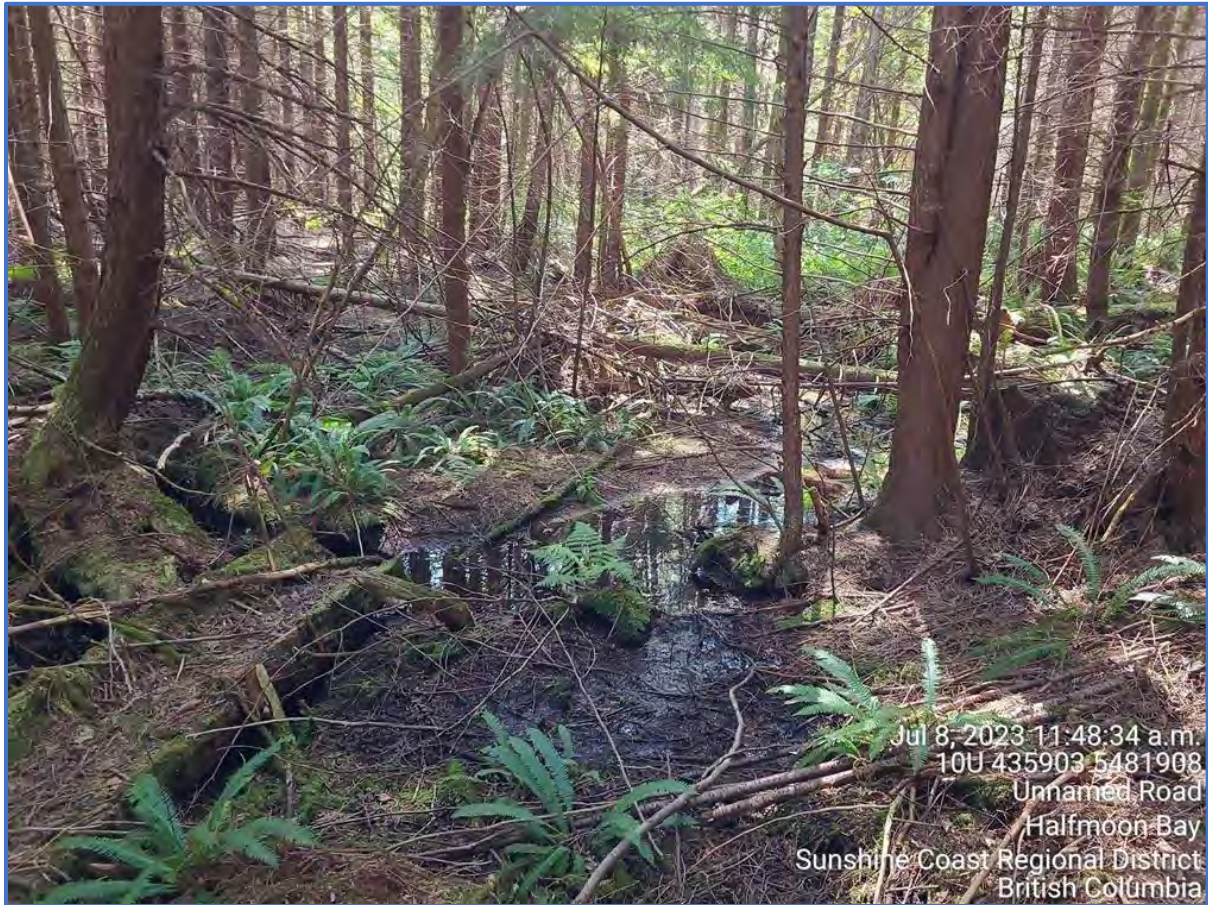
Figure 7. General appearance of Colvin Creek area during the field visit completed on July 8, 2023. The watercourse of the creek was reduced to stagnating water pools with little to no flow. These conditions may be suitable as a movement corridor for wildlife (e.g., Red-legged Frog), with some pools providing potential breeding habitat for amphibians such as Pacific Treefrog, Northwestern Salamander (*Ambystoma gracile*) and Long-toed Salamander (*Ambystoma macrodactylum*). This habitat is not suitable for Western Painted Turtle. Image by Brent Matsuda captured on July 8, 2023.

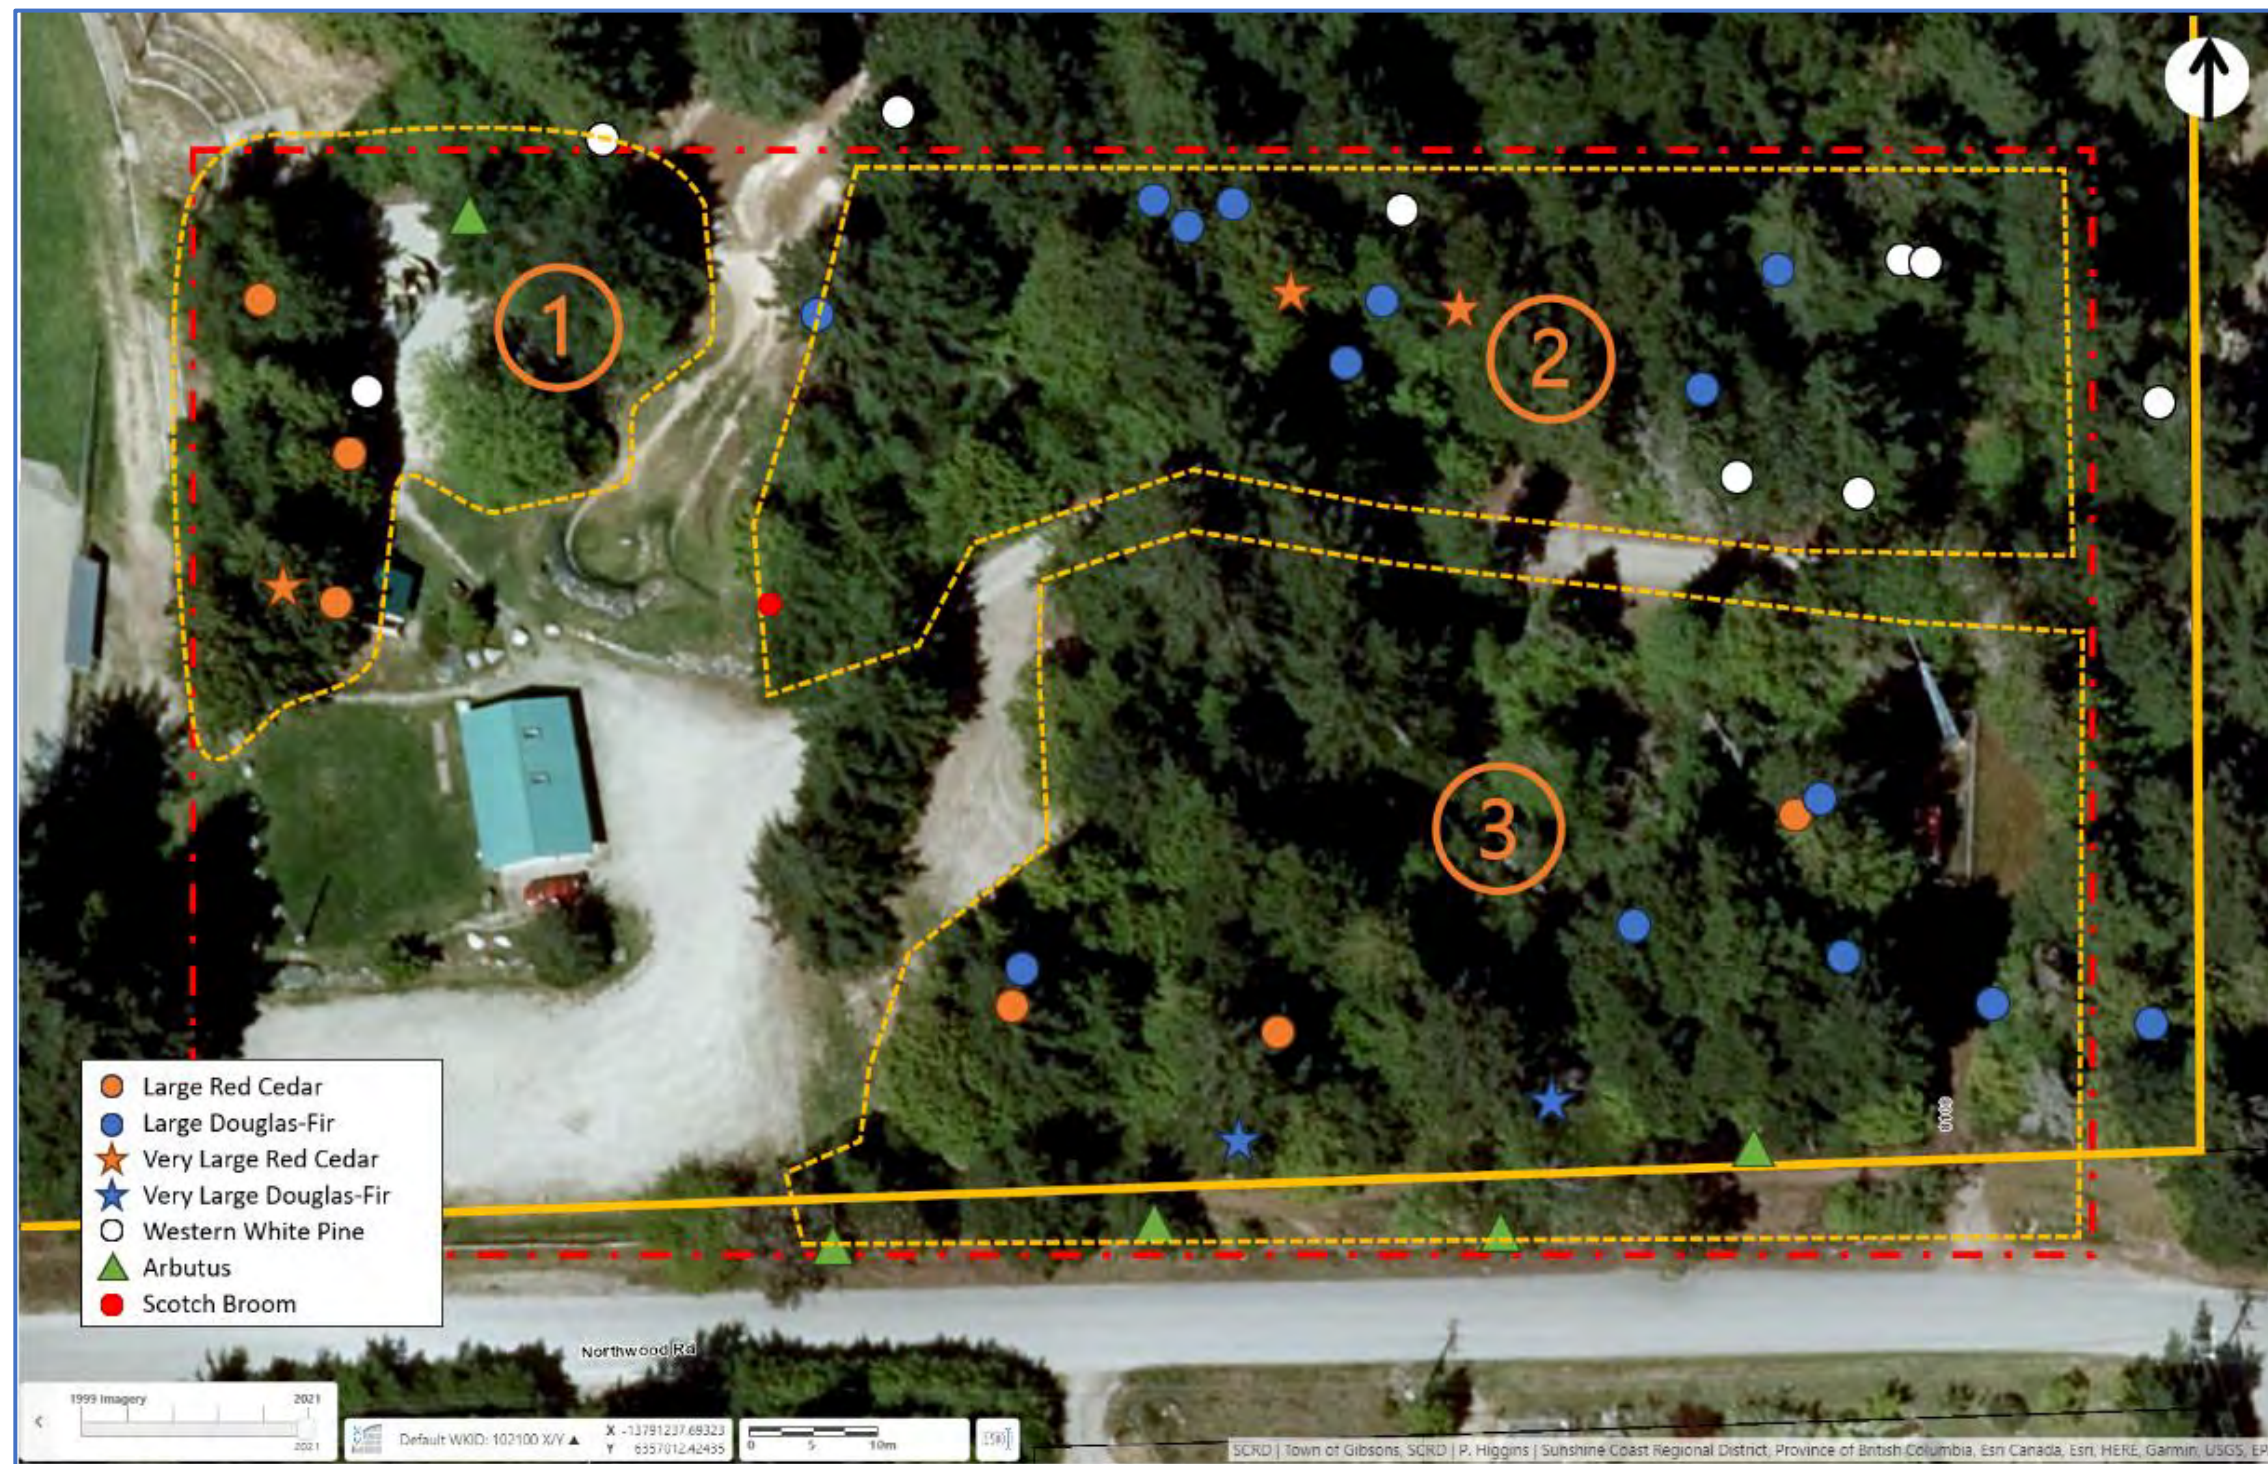
Figure 9. Vegetation polygons in the Project Area. To facilitate characterizing the dominant plant species and key vegetation features within the Project Area, outlined by the red dashed line rectangle, treed areas were divided into three irregular polygons, indicated by the yellow dashed lines. These polygons are referred to in this document as the Northwest corner (1) and the North (2) and South (3) sections. The approximate location of Large (DBH between 60 to 100 cm) and Very Large (DBH greater than 100 cm) Redcedar and Douglas-Fir trees, as well as the location of Western White Pines and Arbutus trees with a DBH equal to or greater than 30 cm are indicated as per the symbols in the figure legend. The location of a large Scotch Broom, an invasive plant species, is indicated by the red dot. *Image modified from the SCRD Maps Online platform (base image) by Coastal Raintree Consulting, Ltd.*

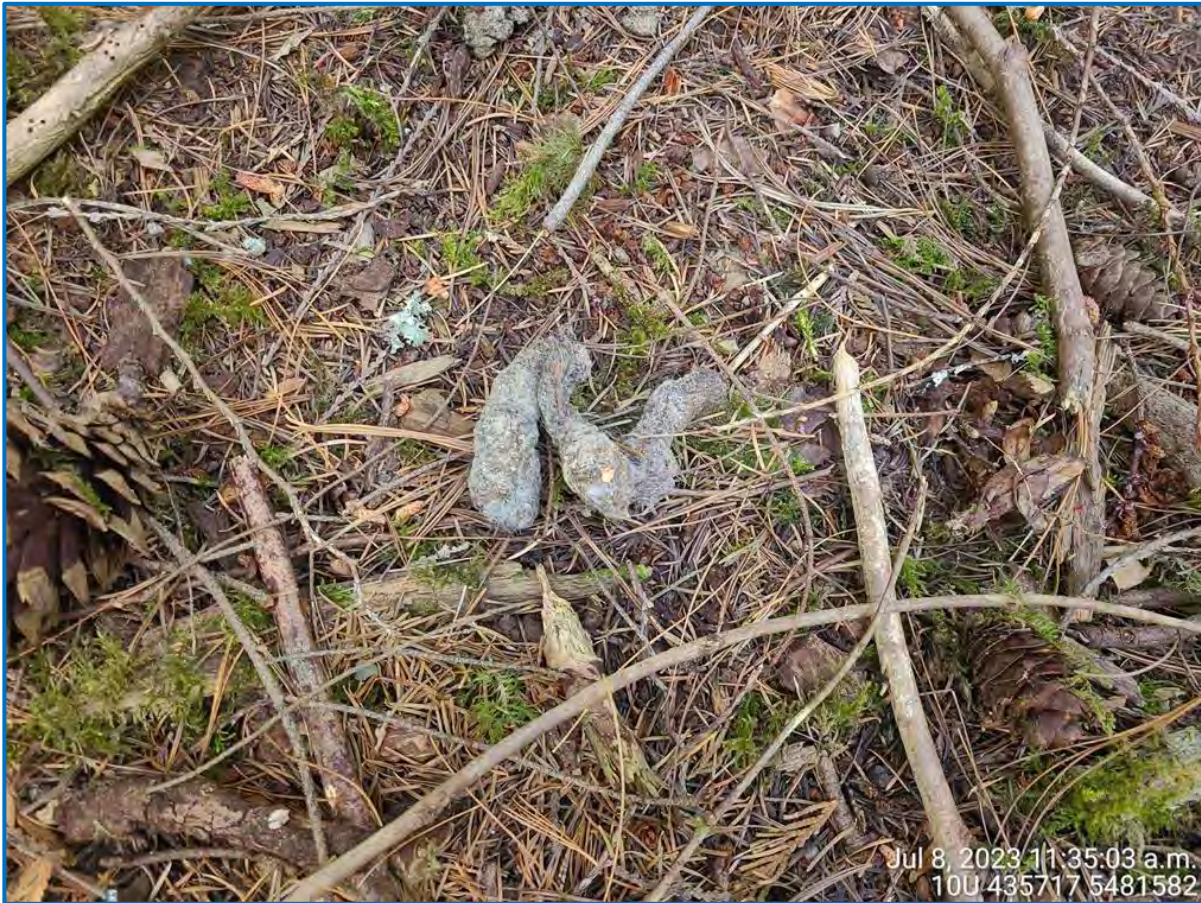
Figure 10. Scats of Coyote (*Canis latrans*) were observed outside the Project Area within Connor Park during the first field visit. Image by Brent Matsuda captured on July 8, 2023.

Coyote (*Canis latrans*) scat was observed outside the Project Area within Connor Park (UTM 10U 435722 5481577; Figure 10). Black Bear (*Ursus americanus*), Columbian Black-tailed Deer (*Odocoileus hemionus columbianus*), and Grey Wolf (*Canis lupus*) are known to occur throughout the area but were not observed during the field visit. The only mammal detected during the site visit was a Douglas Squirrel (*Tamiasciurus douglasii*), and squirrel middens were observed within the site and throughout the surrounding area. It is likely that the site is also used or occupied by other rodents, mustelids (weasels, mink), and insectivores such as shrews and moles.

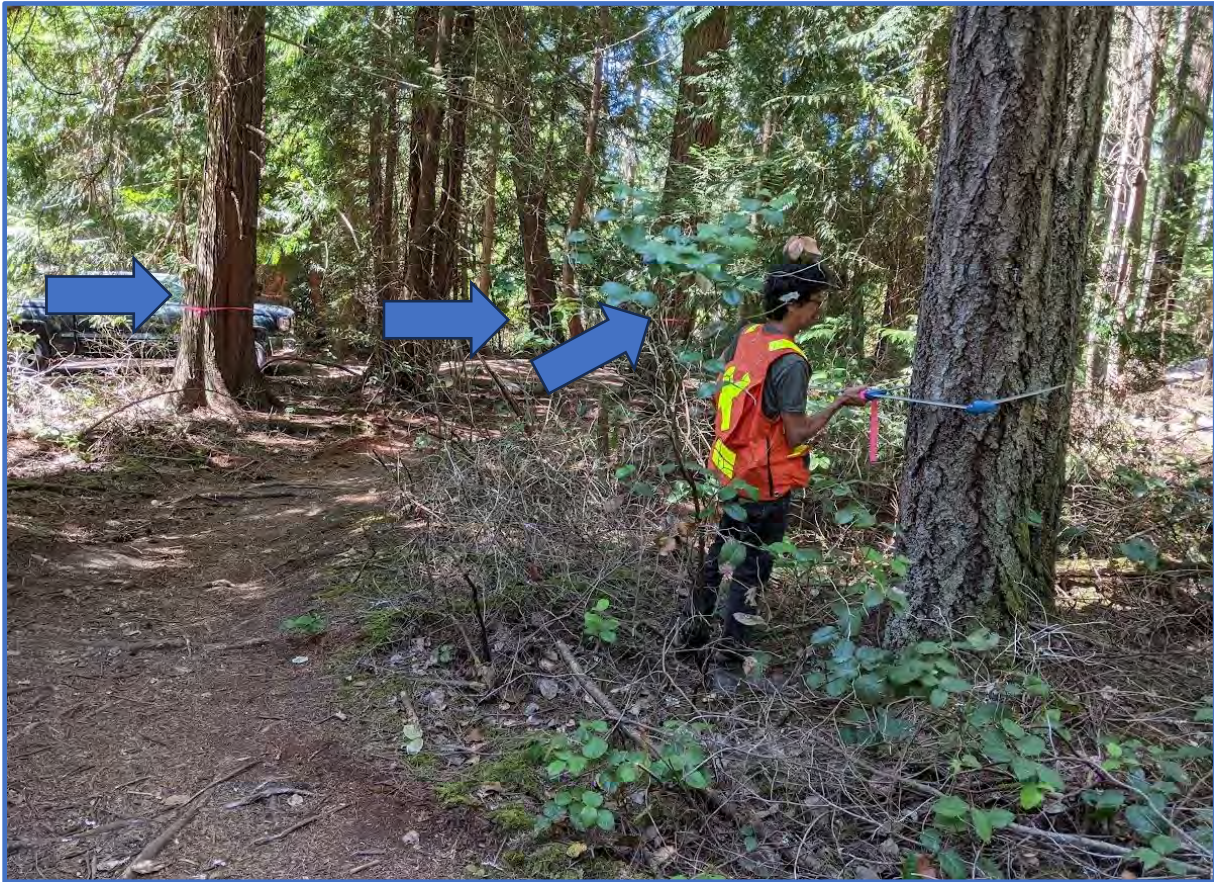
Figure 11. All trees with a diameter at breast height (DBH; approximately 1.3 m (4.3 ft) above ground) equal to or larger than 60 cm and Western white pines (*Pinus monticola*) and Arbutus trees (*Arbutus menziesii*) with a DBH equal to or larger than 30 cm were identified, geolocated and measured during the second field visit. Image by A. Cohen-Fernandez captured on July 15, 2023.

During the field visit completed on July 15, 2023, CRC personnel traversed multiple times each of the three treed sections identified in the Project Area to identify and geolocate all trees with a diameter at breast height (DBH; approximately 1.3 m (4.3 ft) above ground) equal to or larger than 60 cm. Western white pines (*Pinus monticola*) and Arbutus trees (*Arbutus menziesii*), both Yellow-listed species in BC (i.e., the species are apparently secure and not at risk of extinction; BC Species & Ecosystem Explorer, 2023) with a DBH equal to or larger than 30 cm were also identified, geolocated and measured since both species have an expected percent cover in natural forests lower than 1% (CFCGc, n.d.). DBH measurements were completed by recording the DBH of each tree at perpendicular points with a Haglof Mantax Blue tree calliper (Figure 11). The Geolocation data was captured using a Garmin GPSMAP 64ST handheld device with an accuracy of +/- 3.65 m.

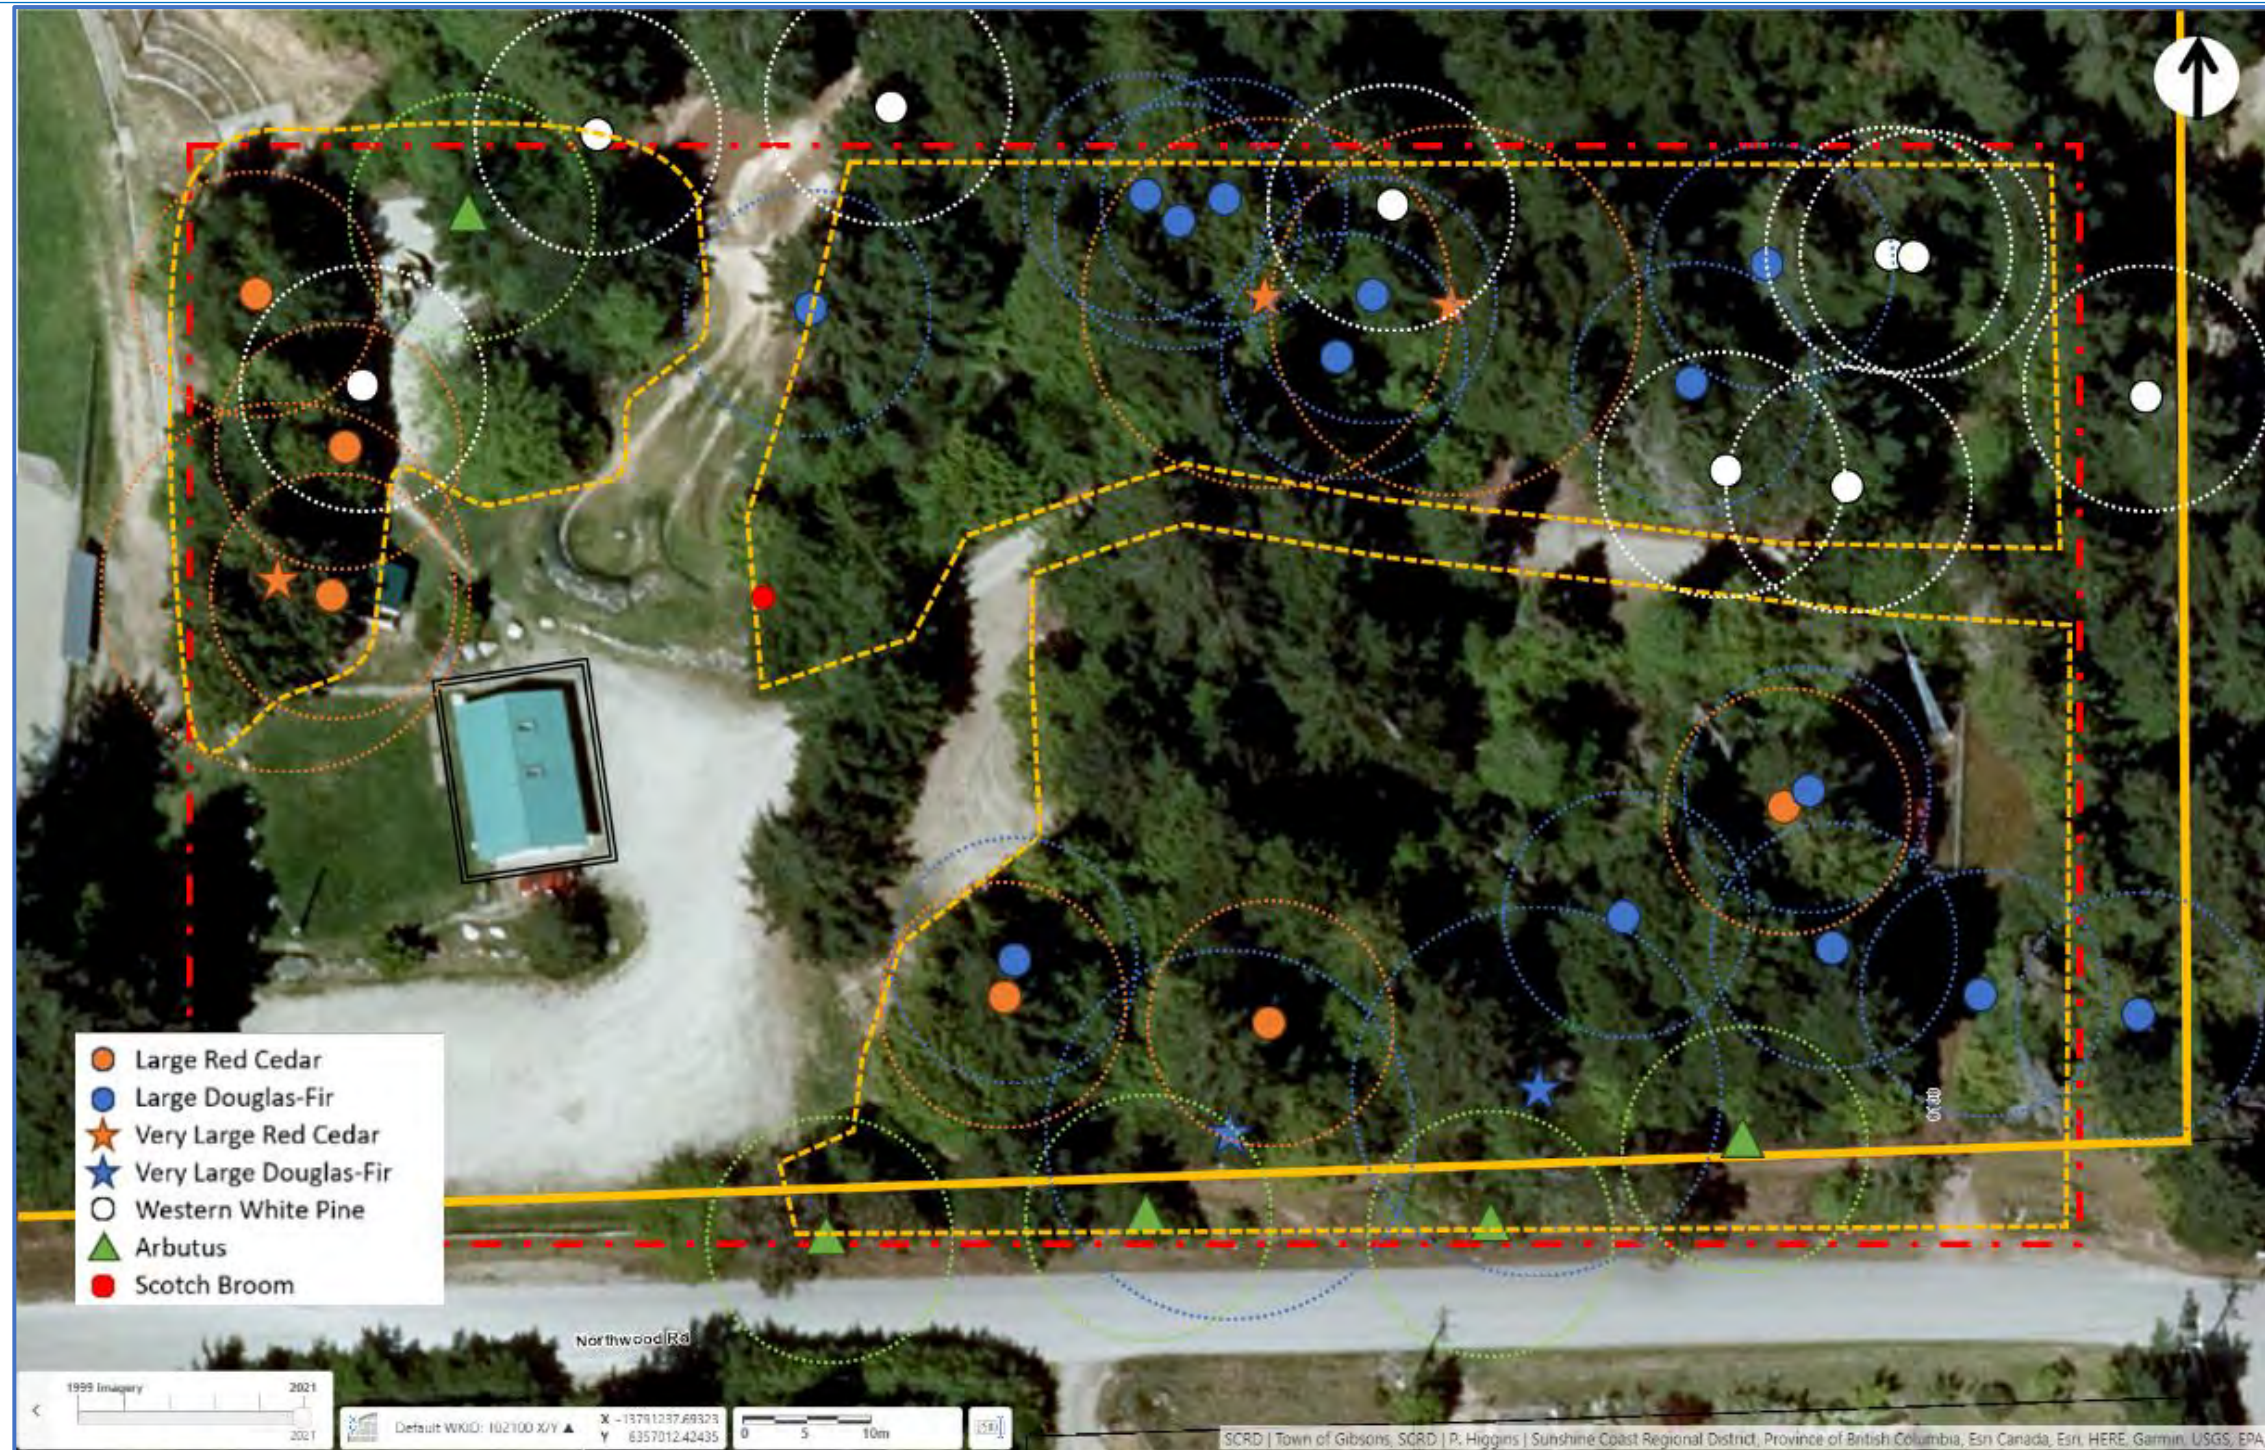
Figure 12. Tree Protection Areas for Large and Very Large trees. In order to protect Large and Very Large trees located in the treed sections (yellow dashed line polygons) within the Project Area (red dashed line rectangle), Tree Protection Areas (TPAs) should be established around these trees. The TPAs should include the ground, aboveground vegetation and overhanging branches within a circle with a radius of 10 m for Large trees and 15 m for Very Large trees, measured from the trunk of the tree to be protected. TPAs with a radius of 10 m should also be established for Western White Pines and Arbutus trees. A rectangle with an approximate area of 2000 sq ft (i.e., the approximate area currently considered for the *Proposed Development*) is shown around the washroom facility as a visual reference to facilitate selecting a possible location for the future Community Hall, outside the recommended TPAs. Image modified from the SCRD Maps Online platform (base image) by Coastal Raintree Consulting, Ltd.

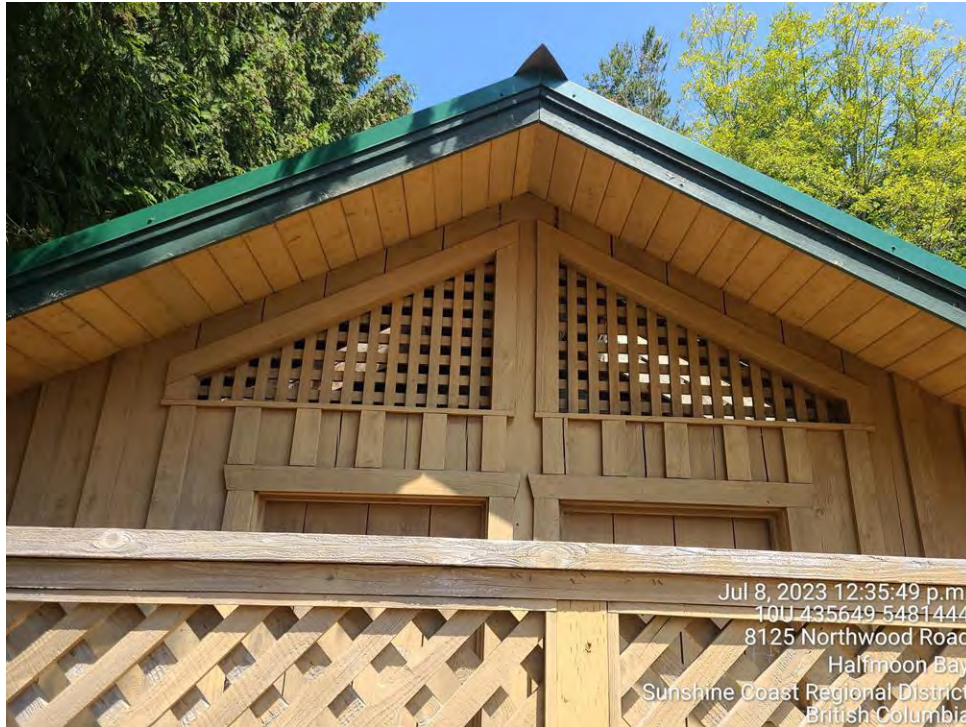
Photo 11. Decommissioned washrooms with gaps and openings potentially accessible to bats.

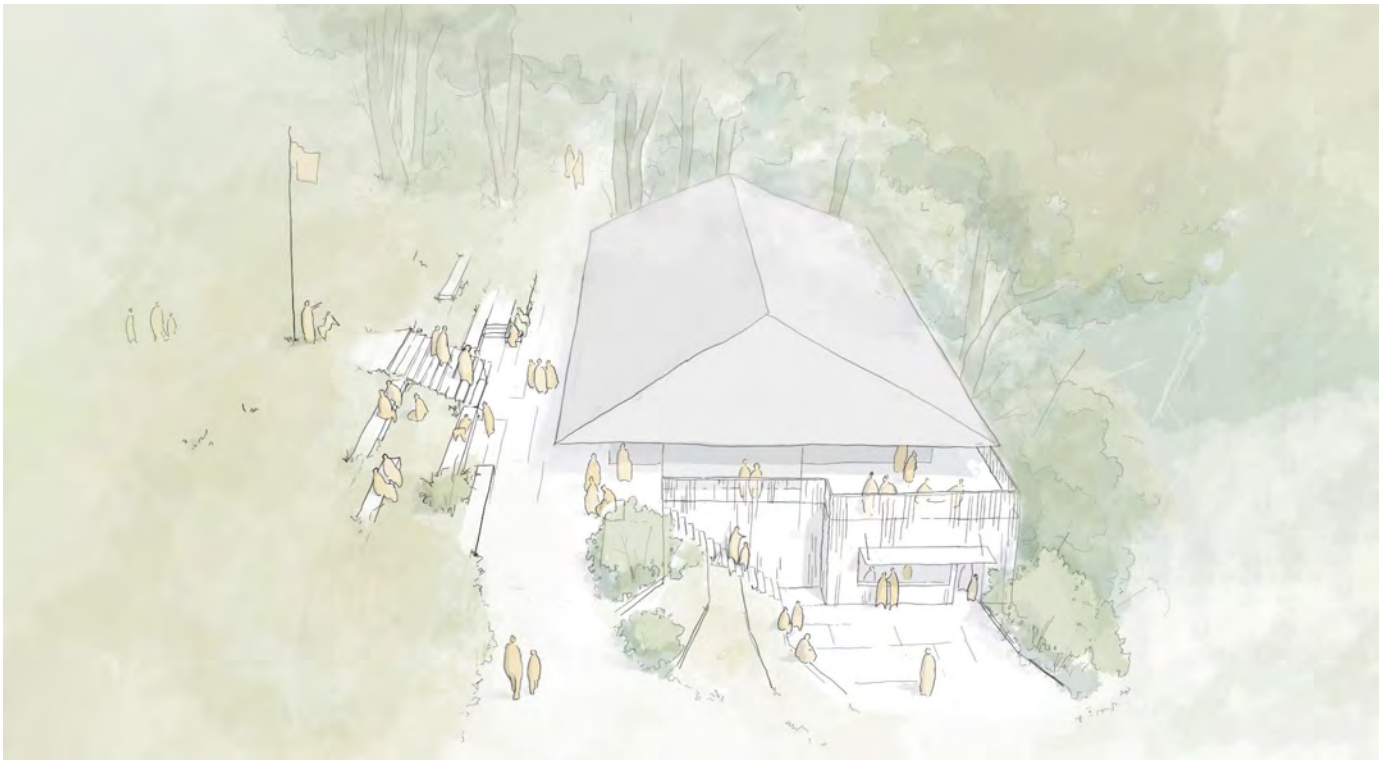
△ Dining Hall Project - Conceptual Sketch
