Sunshine Coast Regional District

Request for Proposal

Number: 2365001

Construction Management Services: Development of a Community Hall

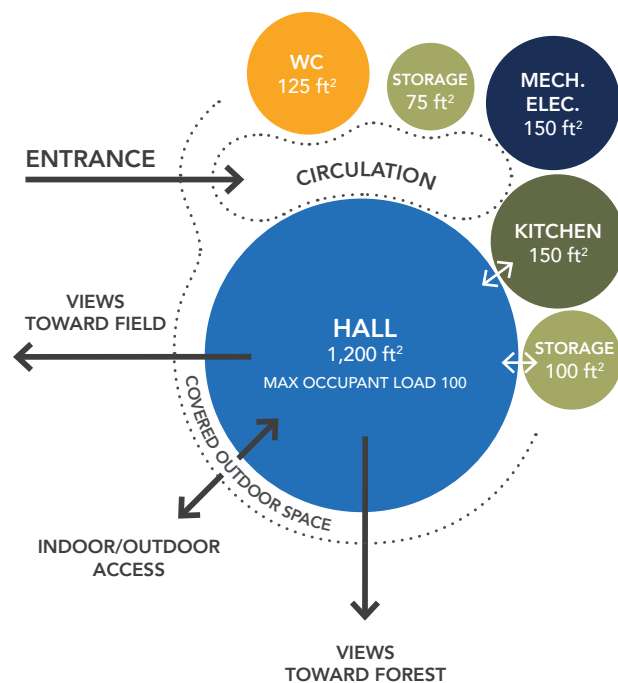
△ Functional program adjacency diagram

Finally, a locking service room will house the building electrical and mechanical components. The room will be adjacent to the kitchen and the hall so as minimize plumbing and duct runs. The service room must also have direct access to the outside to satisfy hydro requirements.

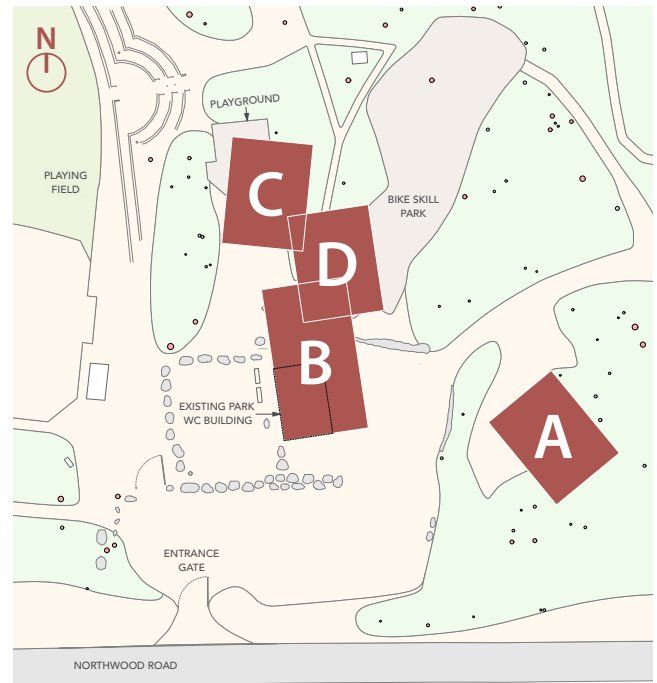
△ Potential building sites thumbnail map

These options were tested against a three-dimensional digital model of the site by inserting a building massing representative of the hall's anticipated size. The test fits provided critical information regarding the physical constraints of each option including its topography, projected grading and potential tree removal.

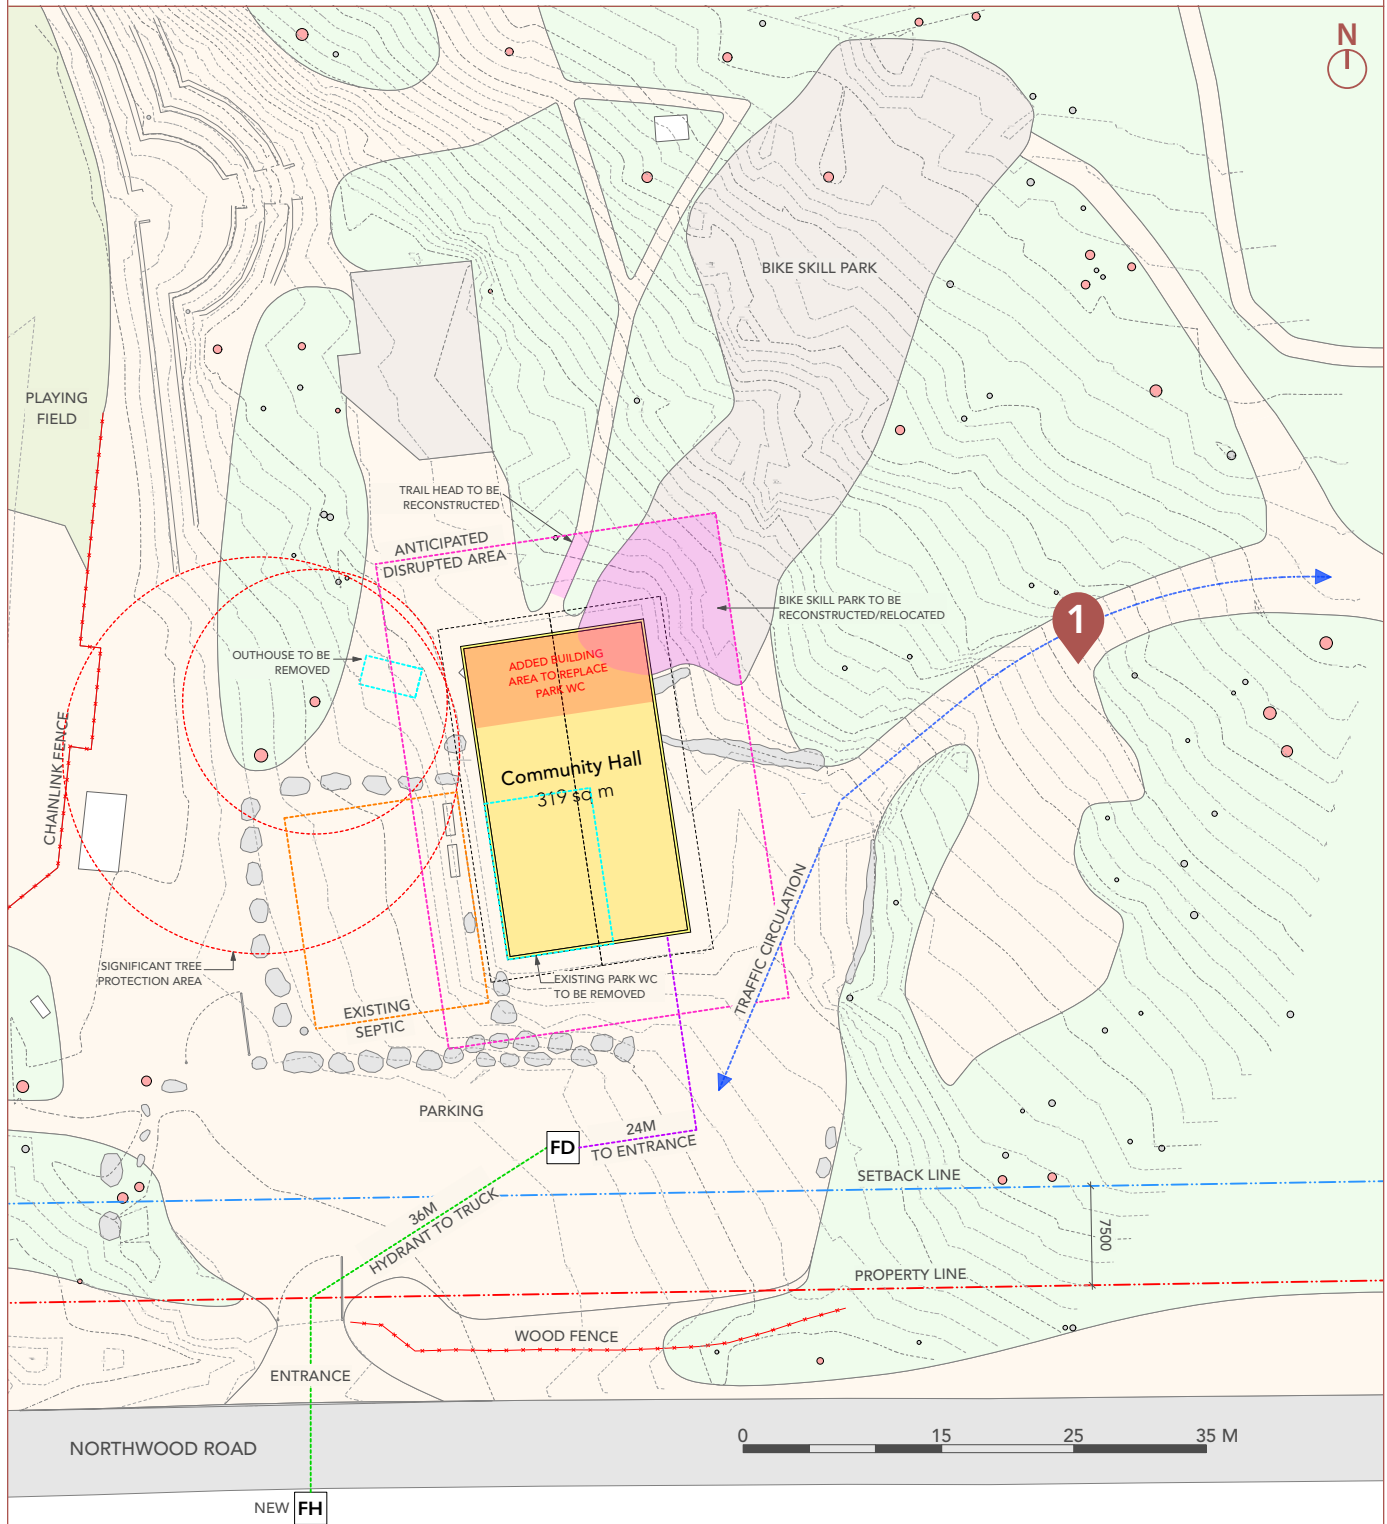
Evaluation Matrix Option B

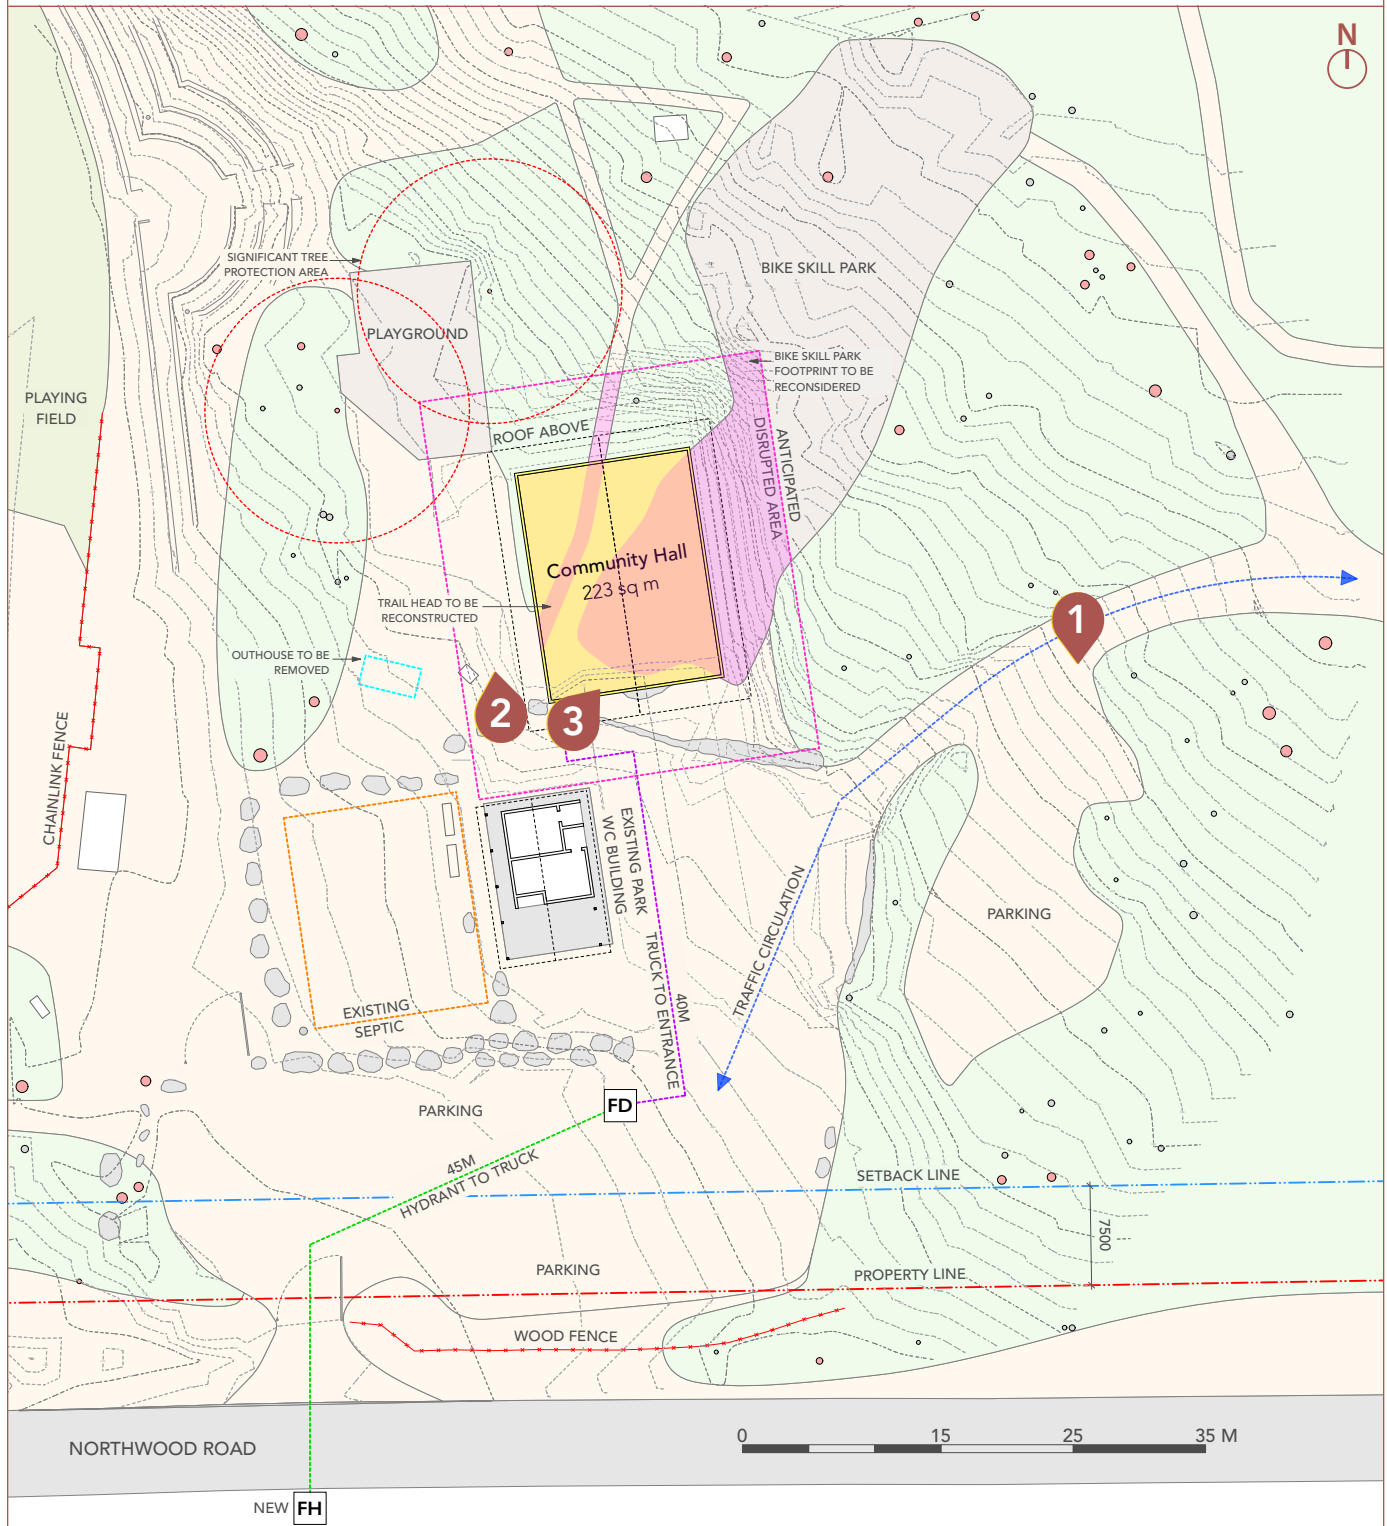
Evaluation Matrix Option D

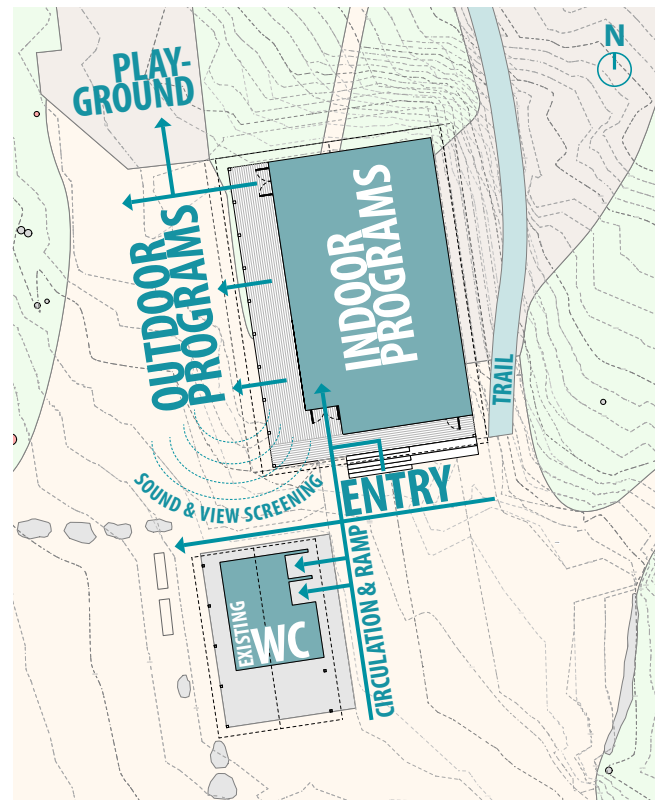
▽ Conceptual Site Circulation Diagram

- On the other side, the West facade is more intimate with its covered patio. Opening up the hall activities onto the West side, it establishes a strong visual and physical connection with the field and the playground. This configuration also prevents having a direct line of sight between the street and the patio which is obstructed by the park washroom. This helps with privacy and minimizes sounds travelling from the hall toward the Northwood Road.

In siting the new community hall building, Option D carefully considers its location with respect to the existing field washroom. The slight and intentional misalignment aims at enriching the in-between space where circulation and impromptu programming can take place.

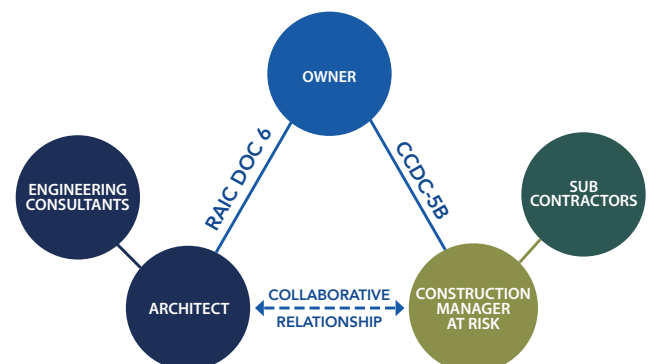
△ Construction management - Contractual relationships diagram

This form of construction management provides an excellent collaborative structure but also remains competitive in its construction procurement as it is in the CM's best interest to proceed as the general contractor. Therefore, this method would be the best suited to delivering a quality building on time and on budget for the Halfmoon Bay community hall project.
