Reference: Sir Thomas Lipton Park Bridge Inspection Program

We are pleased to submit our draft letter for the Sir Thomas Lipton Park Bridge Inspection Program. This program includes the inspection of three timber pedestrian bridges located in Sir Thomas Lipton Park on Gambier Island: East Creek Bridge, MacDonald Creek Bridge and West Creek Bridge.

Structure Name: East Creek Bridge

PROJECT : 31256 NAME: East Creek Bridge

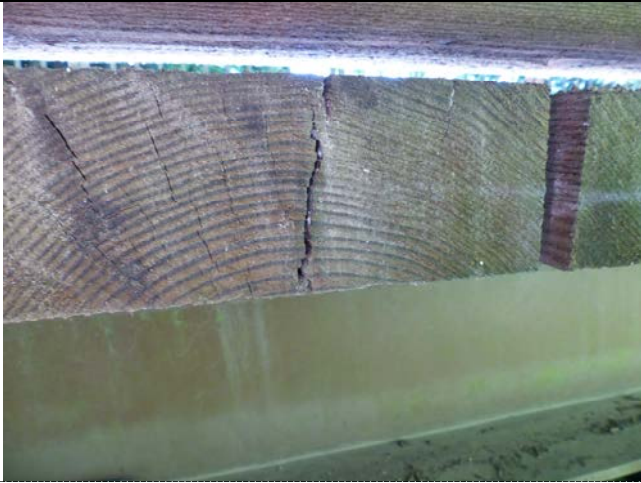
009 – Shake at Planking (D.2)

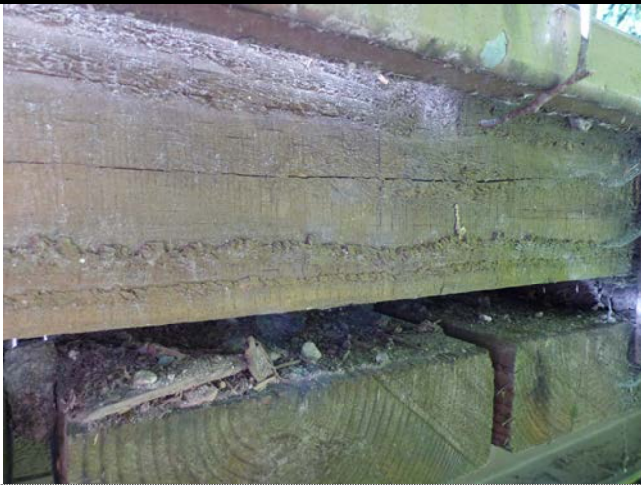
D.4.c – Collision damage at NW end: ~1.080m. Collision damage at NE end: ~0.800m long. Wanes and occasional checks along curb.

013 – Check along Bull Rail (D.4)

- Would recommend replacement of damaged curbs and missing railing.

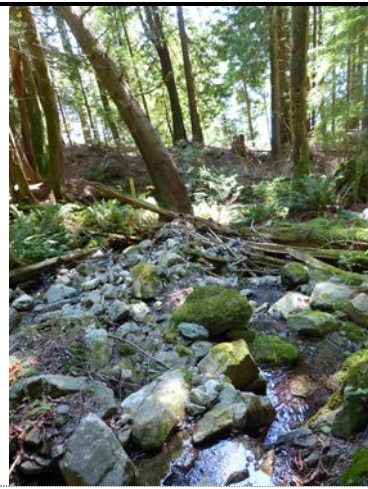
002 – View Downstream, looking South (A.1)
