## Sunshine Coast Regional District

## 2017 Trail Bridge Inspections – Final Report

Purchase Order # 3000710

Submitted December 1, 2017

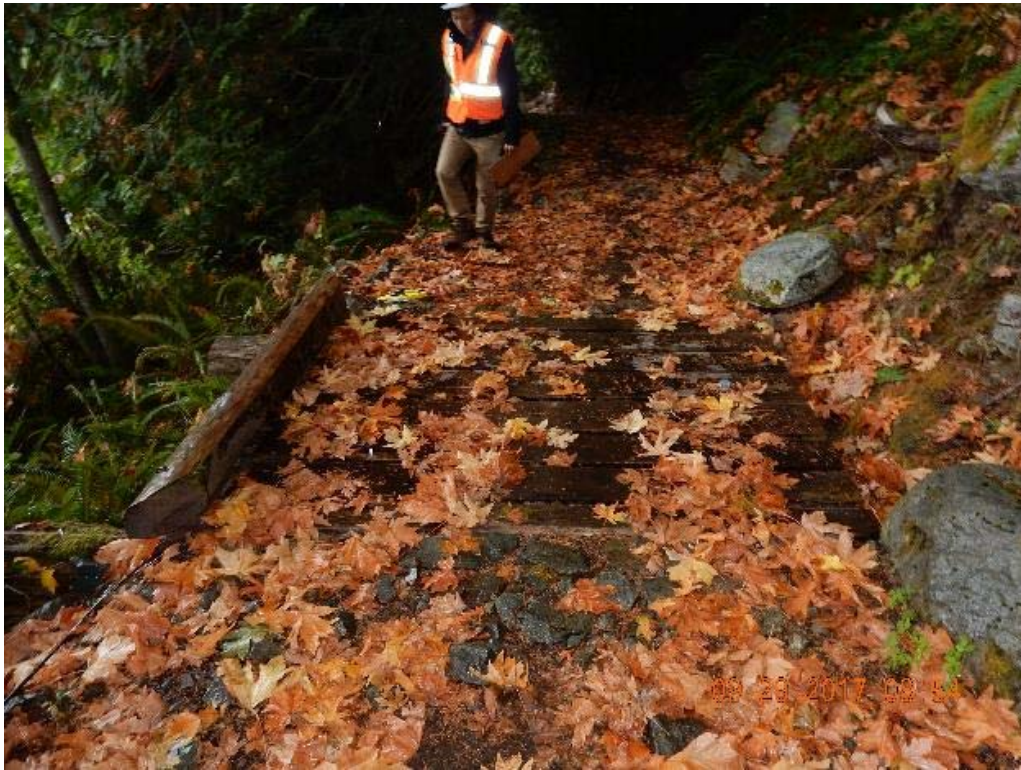
P01 – South approach, suggest adding anti-slip pad  
(DSCN9884.jpg)

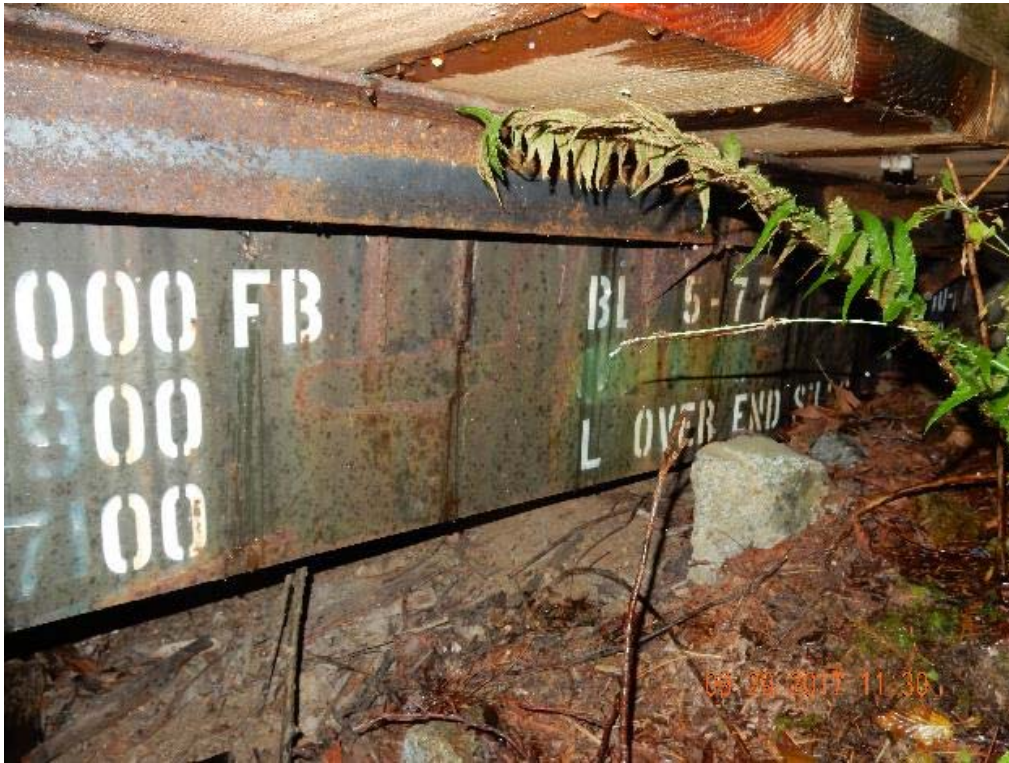
P07 – Side view of the main C-Channel  
(DSCN9961.jpg)
